**PARK CITY MUNICIPAL CORPORATION  
HISTORIC PRESERVATION BOARD  
CITY COUNCIL CHAMBERS**

**August 1, 2018**

227 Main Street – HDDR Material Deconstruction and Reconstruction – The applicant is proposing to reconstruct the historic boarding house designated as “Significant” on the City’s Historic Sites Inventory. In addition the applicant will be removing the existing c.1920 retaining and post-1976 retaining walls; c. 1889, c.1920, and 1976-1977 roof structures, non-historic asphalt and corrugated metal roofing materials; c.1920 brick chimney; c. 1889 wood drop novelty siding and wall structures, c.1920 stucco and wall structures, and 1976-1977 framed walls and wood paneling; c.1920 and 1976 enclosed piazza; c.1920 and contemporary doors units; and c.1889 double-hung wood window, c.1920 wood casement windows, 1976 picture windows, and contemporary aluminum and vinyl window units.

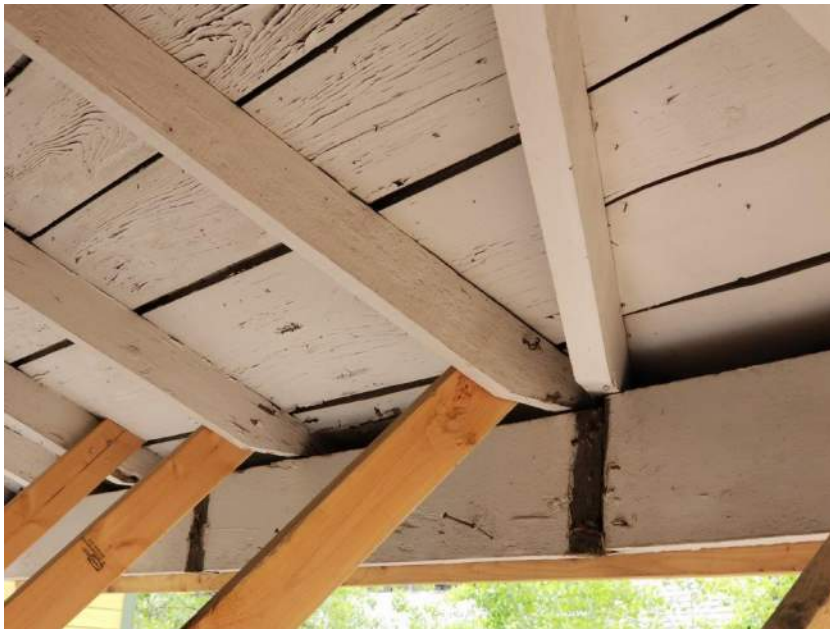
The structural engineer found that the porch roof had similar deficiencies as the house's roof structure. The structural engineer is calling for the reconstruction of the porch roof with new code-compliant joists and overhang. The existing sheathing shall be replaced with new plywood.

The applicant braced the existing porch roof and temporarily lifted it with the house when the foundation is poured. The porch roof is also inadequately tied into the wall and roof structure of the historic house. Because of the way it was built, it could easily pull away from the structure. The applicant believes total reconstruction of the porch roof is necessary in order to meet snow and wind loads.

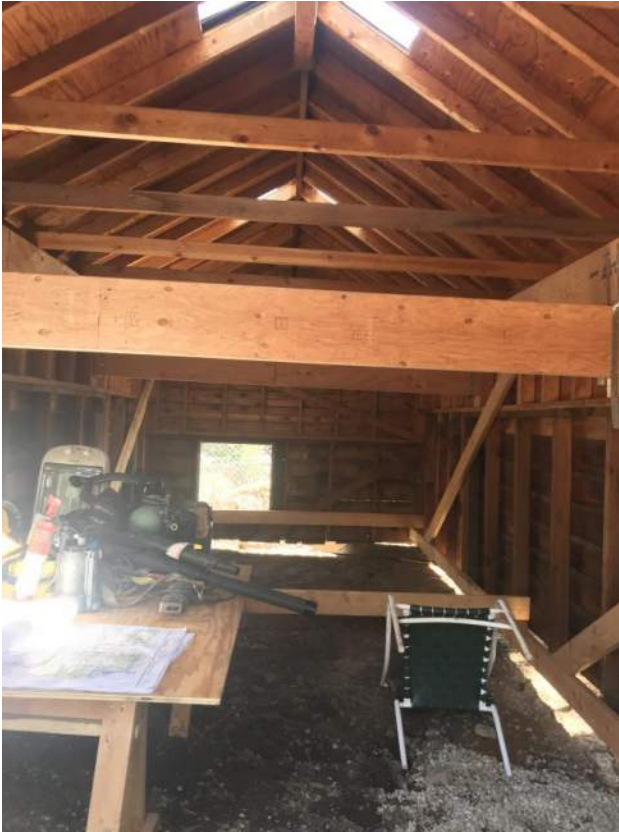
Once exploratory demolition had been completed, the applicant determined that the garage has been reconstructed in phases over time. The existing roof structure consists of contemporary framing and plywood sheathing. The applicant proposes to remove the existing north and south sides of the gable roof and reconstruct it.

Staff finds that the proposed material deconstruction to reconstruct the garage roof is necessary to rehabilitate the historic garage.

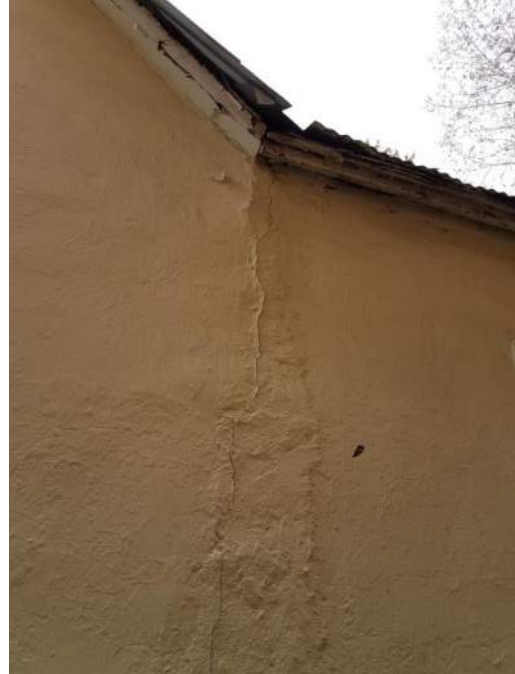
*Common defects of the exterior siding materials*

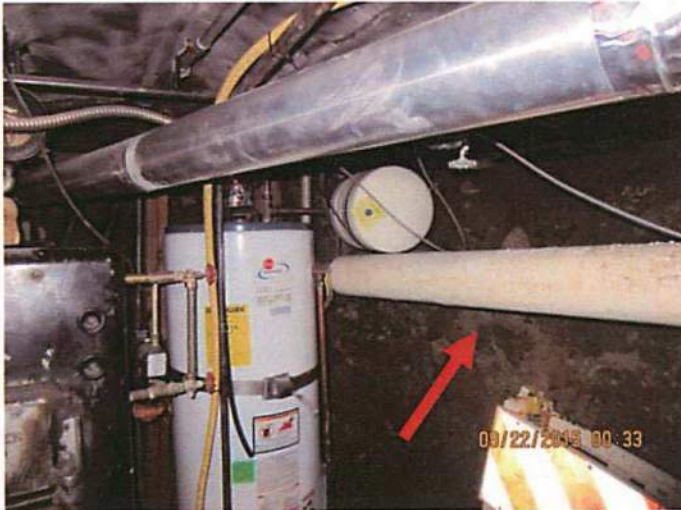
**Photo 1** The structure has no concrete or stable foundation. The foundation consists of rubble, dirt and loose stone matter.

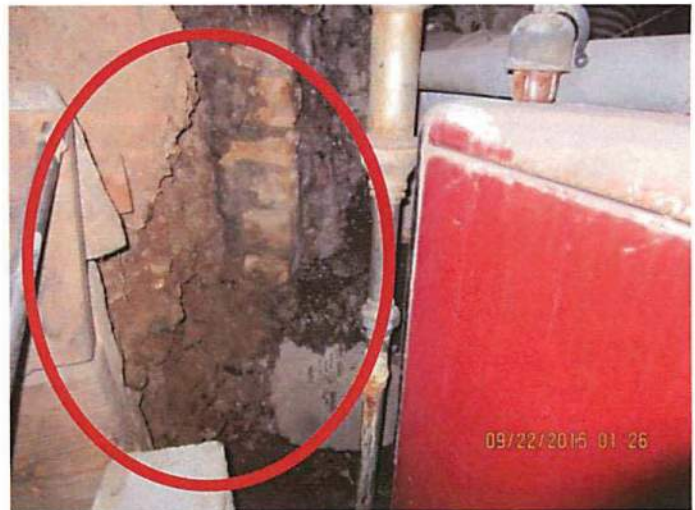
**Photo 2** Decay of the rubble foundation due to water infiltration

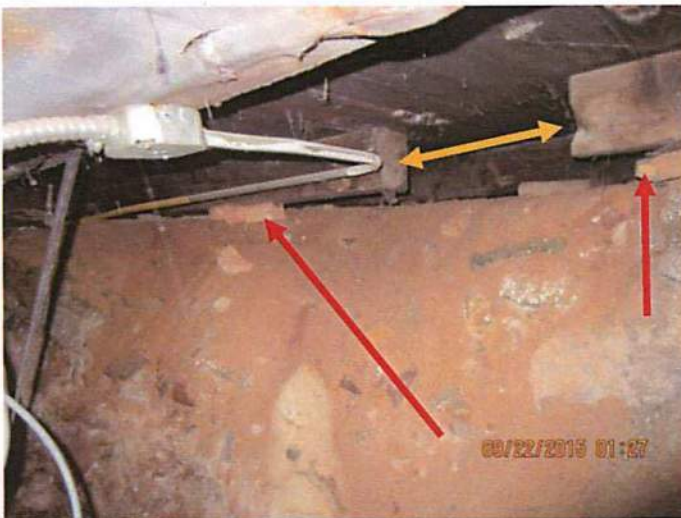
**Photo 3** The red arrows show improperly installed shims are blocking to level the floor above. Not permitted on dirt. The yellow arrow shows the removal of floor joist, this is consistent throughout the floor area

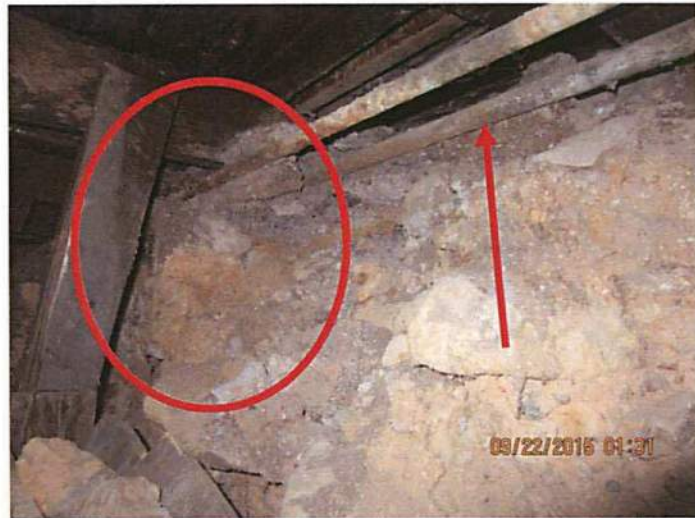
**Photo 4** The red circle shows movement of the rubble foundation and decay of the floor joist members resting directly on top of the rubble. The red arrow shows decay of water lines used to heat the structure

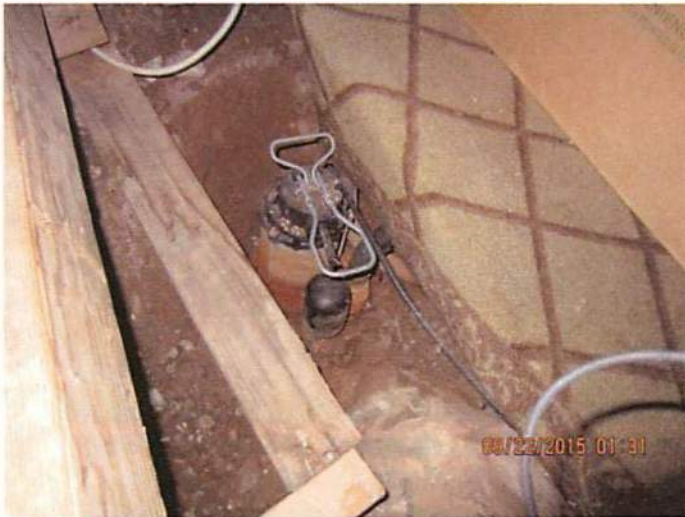
**Photo 5** A sump was installed to remove water from the area but was not properly maintained and currently is not in working condition

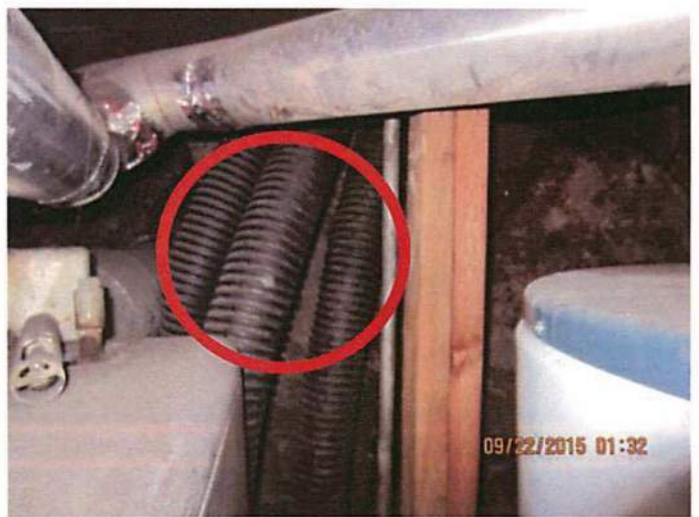
**Photo 6** A drainage system was improperly installed and permitted to drain directly on top of the dirt floor causing decay, mold and erosion

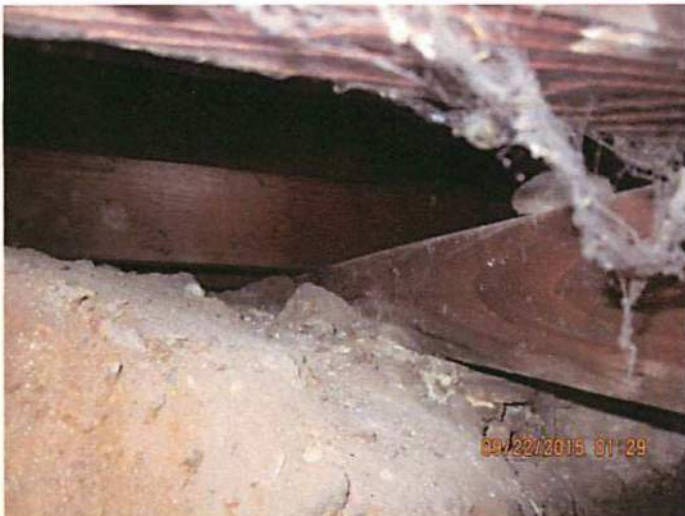
**Photo 7** The floor joist of the structure are resting directly on top of dirt and rubble. Not permitted under building codes

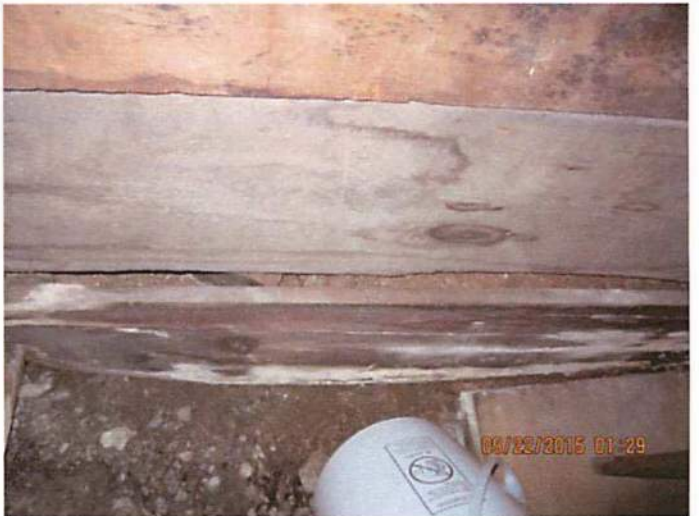
**Photo 8** Wood backing being used to prevent rubble from filling the storage area. Backing is failing and decayed. Serious mold and water concerns

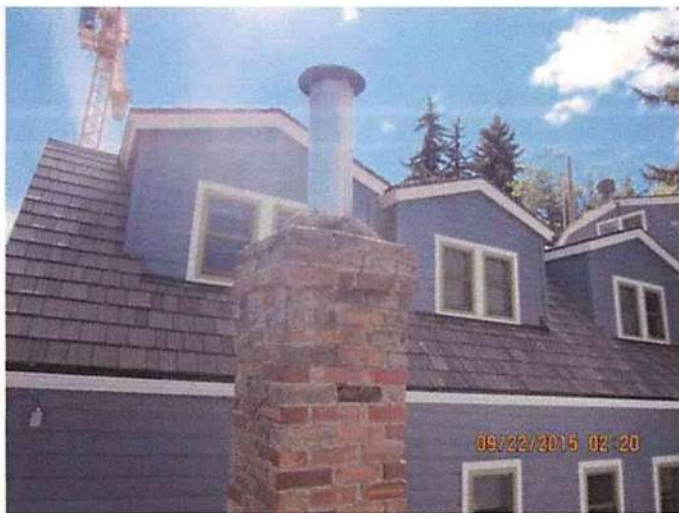
**Photo 1** The chimney shows signs of decay and instability. To be removed or evaluated by a structural engineer

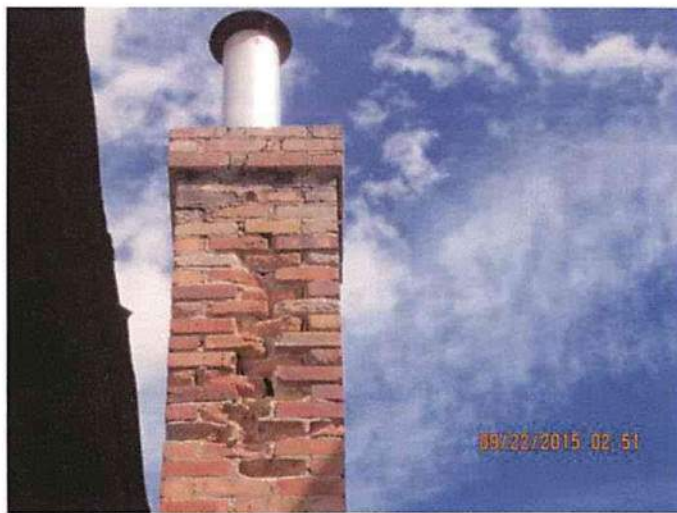
**Photo 2** Structural brick has decayed or is deteriorated in such a way is may fail

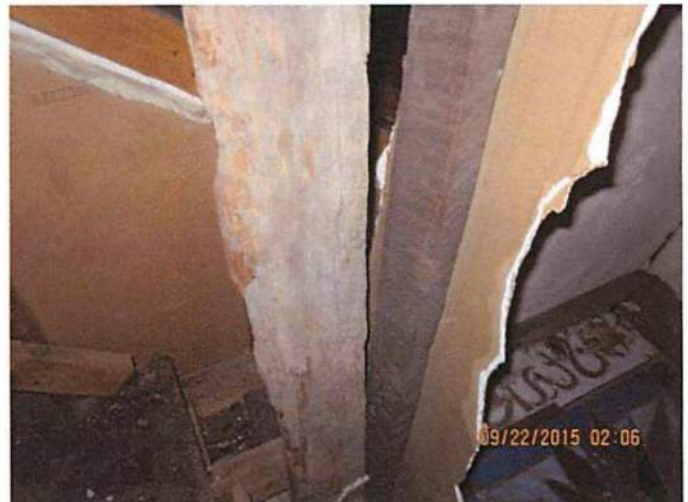
**Photo 4** Structural members not properly supported

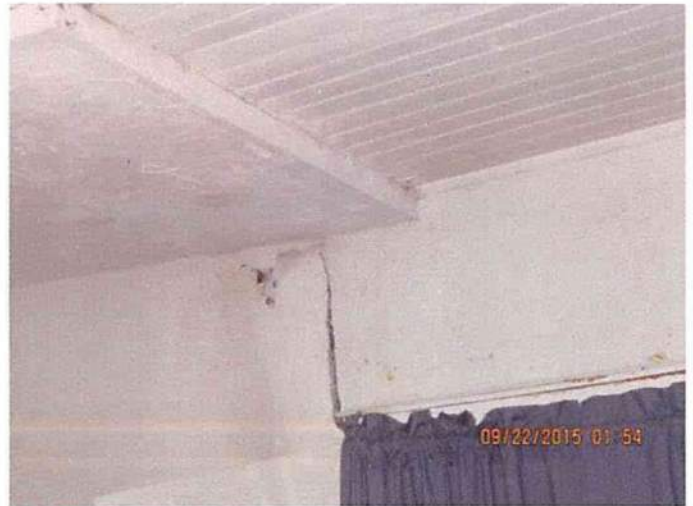
**Photo 12** Structural separation in second floor bedroom. Consistent with missing point loads and missing foundation

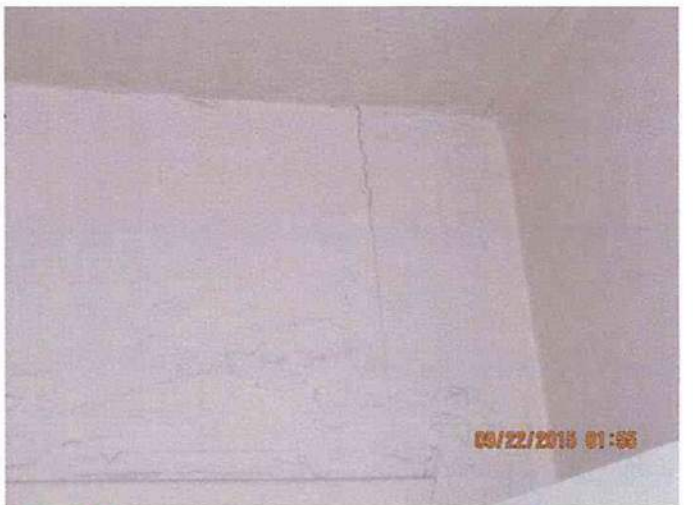
**Photo 14** Structural separation in second floor bedroom. Consistent with missing point loads and missing foundation

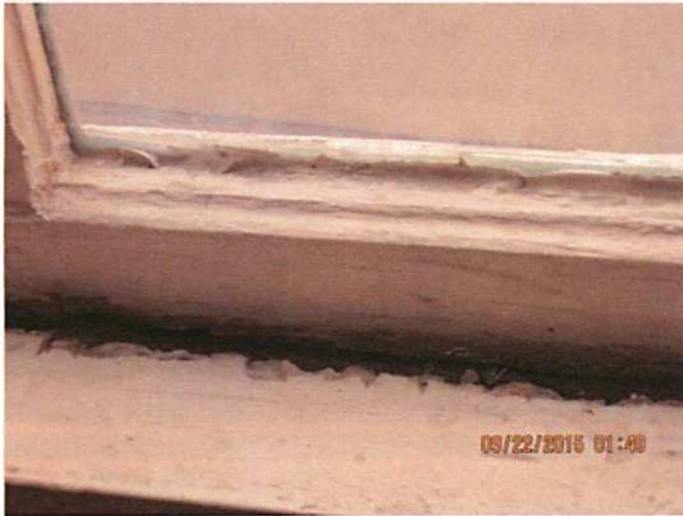
**Photo 17** Several windows on the second floor have separated and have been nailed shut. This is consistent with wracked and warped walls due to structural stability of the building

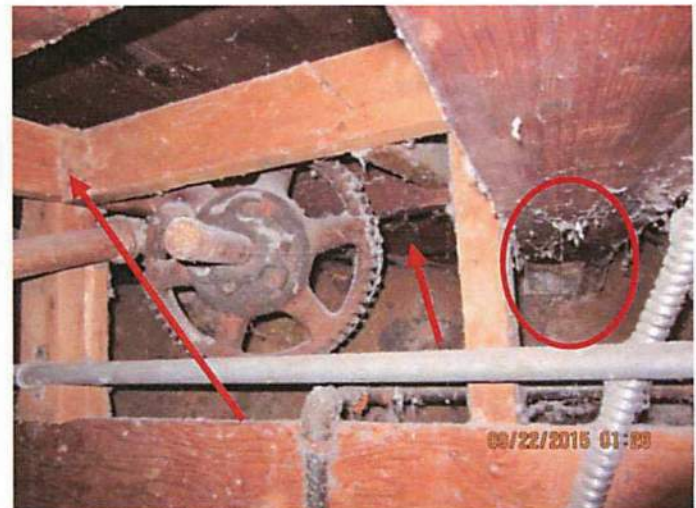
**Photo 22** Floor joist bearing directly on dirt. Shims and bracing added for support. Improperly installed

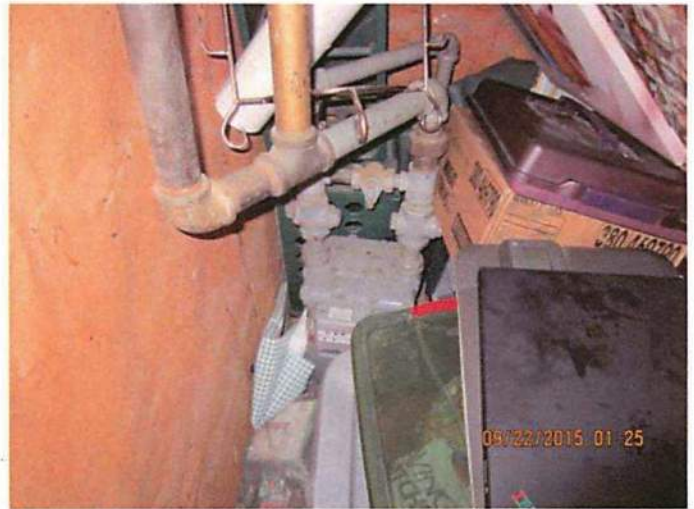
**Photo 2** Gas meter is located in a hidden room with possible improper connections to the building. The room is located in the front of the deli between the entry doors

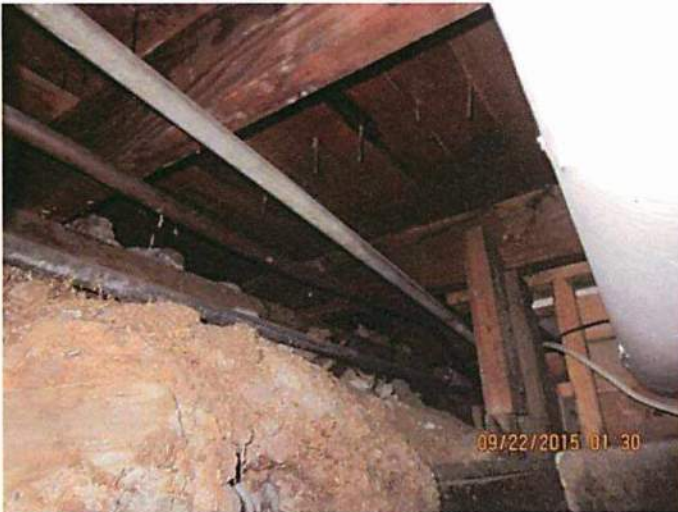
**Photo 3** There are numerous pipes consisting of potable water, heating water lines and gas lines that are in direct contact with soils and not properly secured. Decay and deterioration of piping is noted throughout the underground area

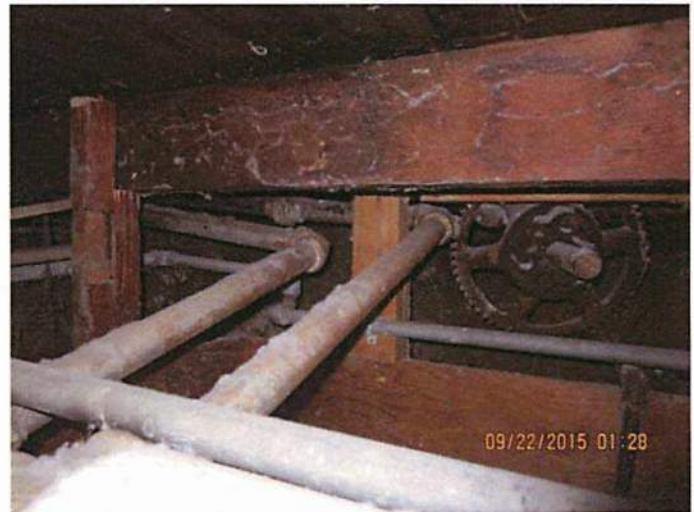
**Photo 4** Unsecured gas lines, unknown valves that are not properly maintained or marked

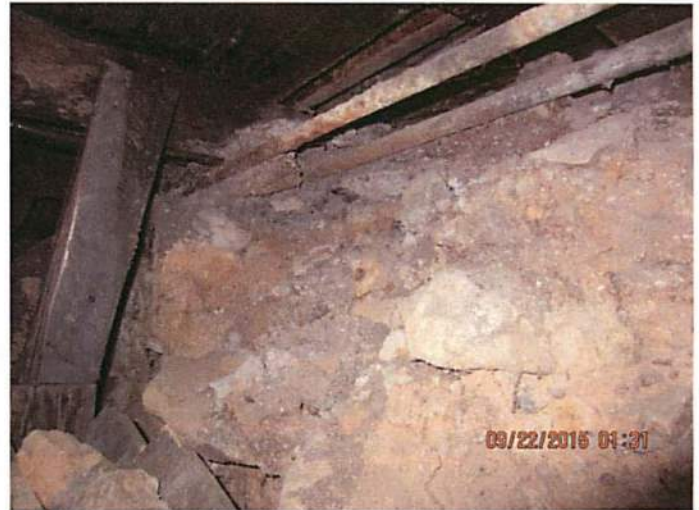
**Photo 6** Water lines used for the heating of the building are damaged by decay and deterioration. Erosion and sloughing of the rubble foundation. Severe stability concerns for the structure

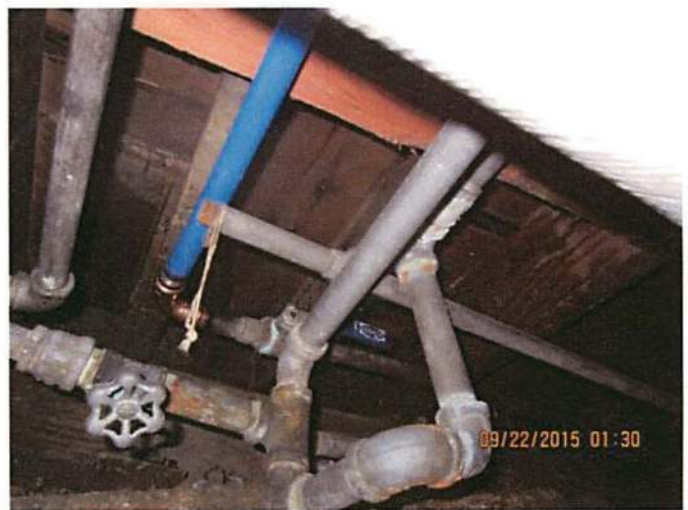
**Photo 8** Improperly installed plumbing repairs. Ends not properly capped. Copper to galvanized requires a brass coupler

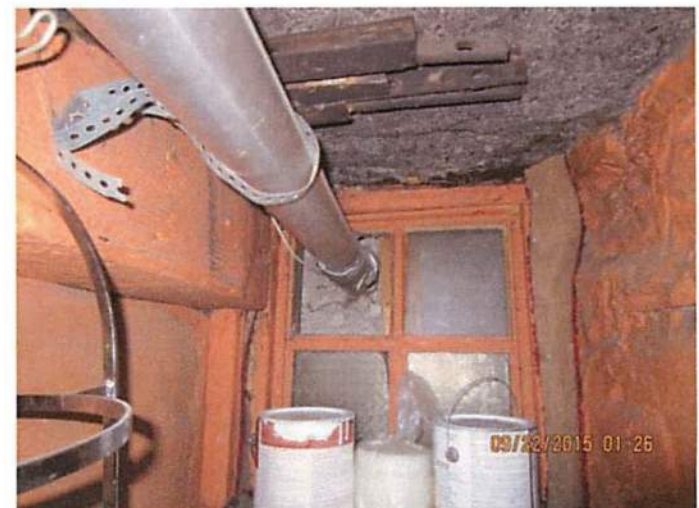
**Photo 10** Vent line for hot water heater exceeds the maximum length. Possible carbon dioxide (co2) concerns. Located in deli

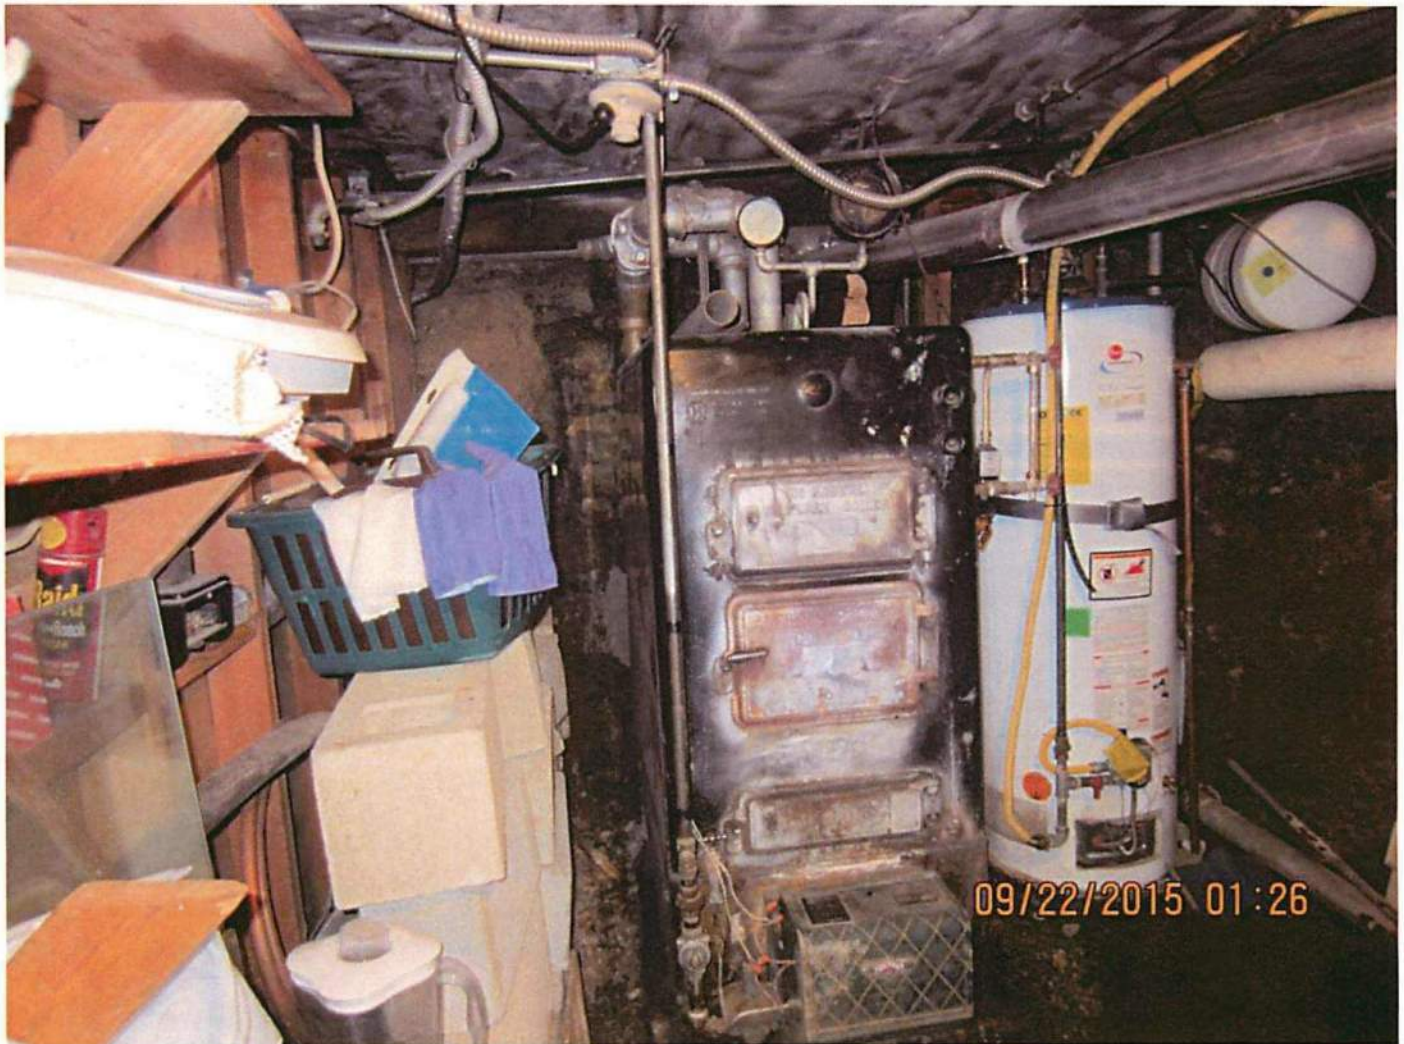
**Photo 11** The building is being heated by a 1930's era boiler that has been converted from coal/wood to natural gas. The boiler has no current state boiler inspection tags and required by state law to be inspected annually. It is advised the state boiler be notified for a immediate safety check on the boiler. The gas line that feeds the boiler is unsafe and should be terminated .

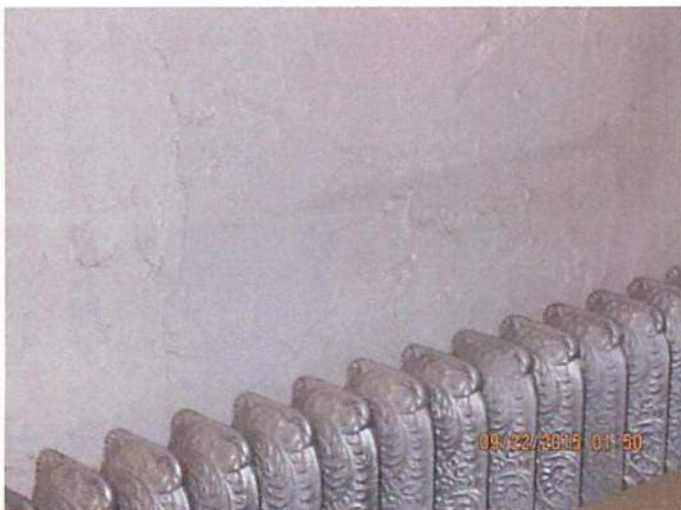
**Photo 12** Example of the radiator heating system that uses the boiler to heat the building

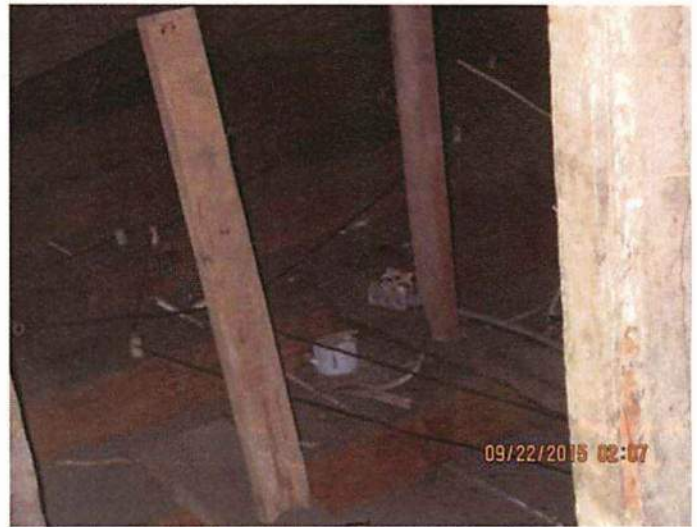
**Photo 18** General inspections noted that the knob and tube is most likely active

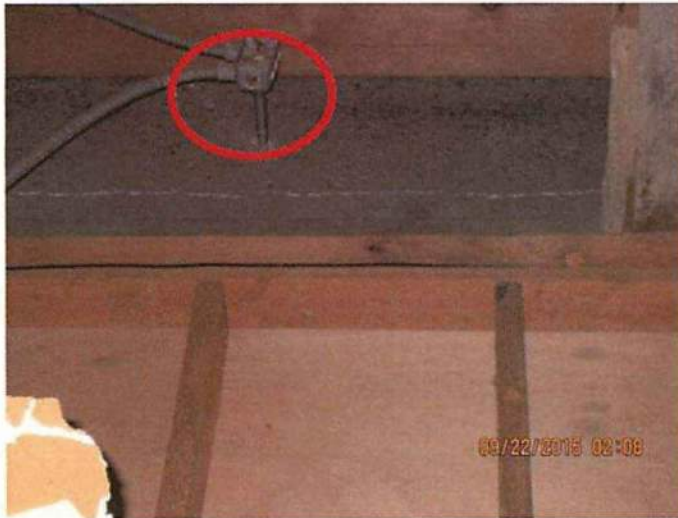
**Photo 18** Open electrical boxes noted throughout the building. Electrocutation hazard, fire hazard. Located in attic

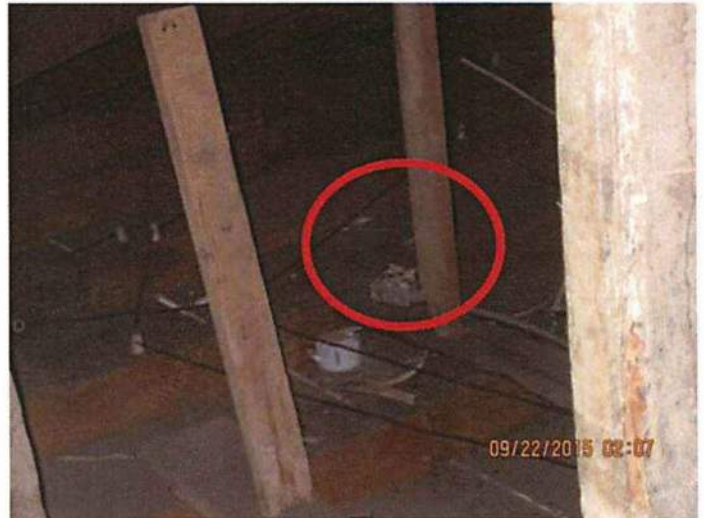
**Photo 19** Open electrical boxes noted throughout the building. Electrocutation hazard, fire hazard. Located in attic

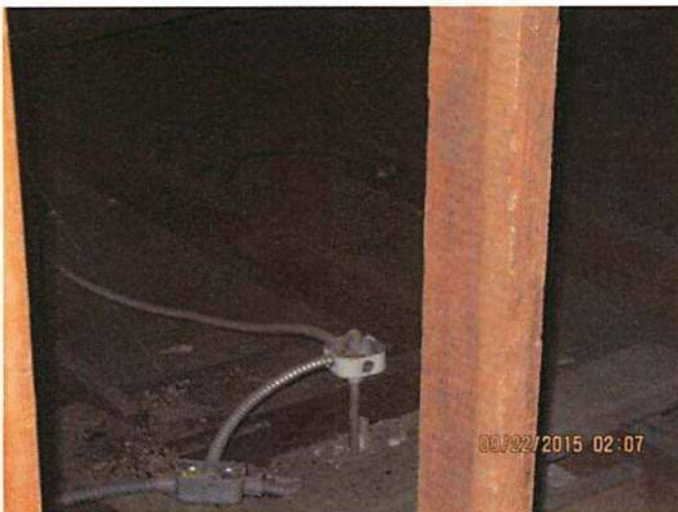
**Photo 20** Open electrical boxes noted throughout the building. Electrocutation hazard, fire hazard. Located in attic

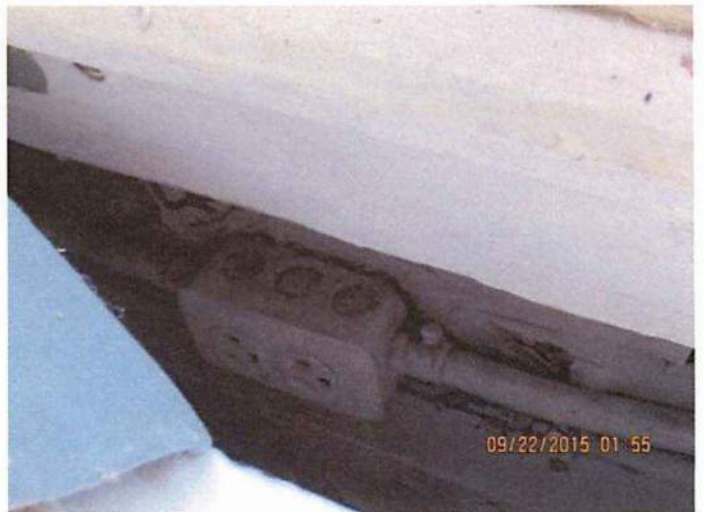
**Photo 21** Outlets located under windows that are damaged. Moisture and decay surrounds the electrical outlet

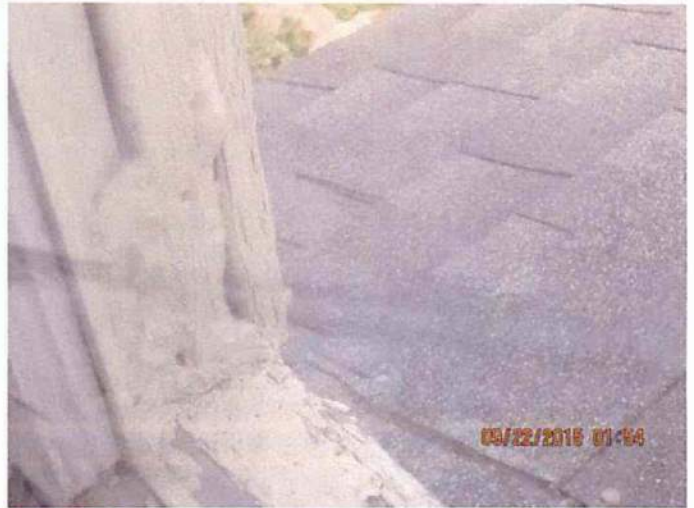
**Photo 23** Decay and deterioration noted throughout the building, cause appears to be lack of proper maintenance and infiltration of water from damaged roof

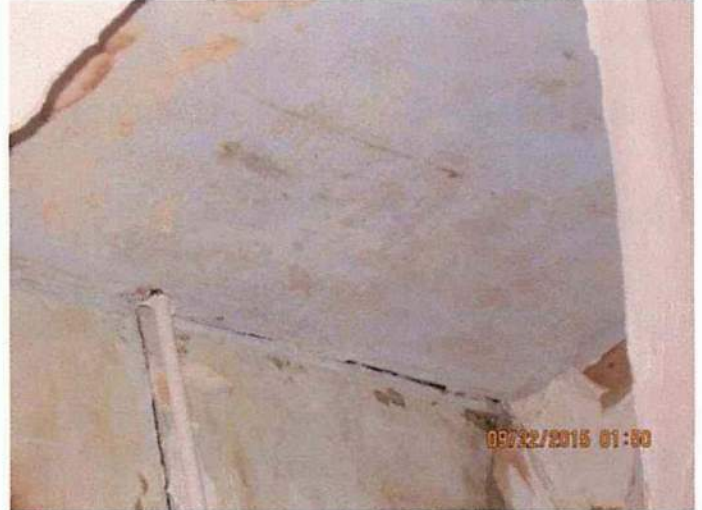
**Photo 25** Decay and deterioration noted throughout the building, cause appears to be lack of proper maintenance and infiltration of water from damaged roof

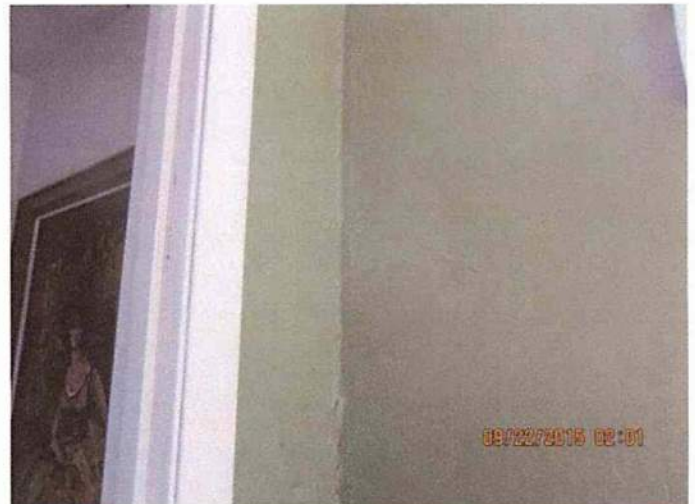
**Photo 27** Water damage and structural concern behind wall

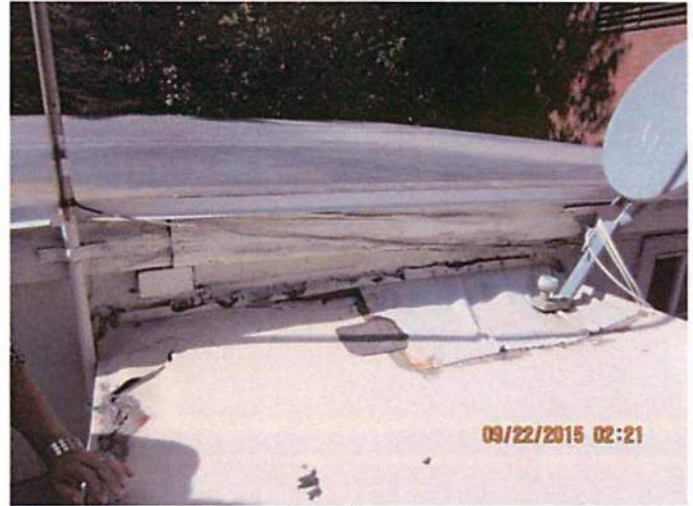
**Photo 29** Roof appears to have been recently repaired but some areas are damaged and show signs of possible water infiltration

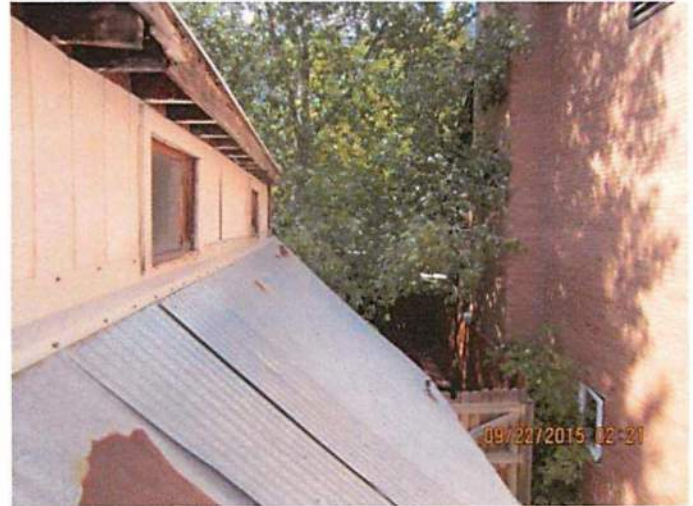
**Photo 31** Roof shows sign of decay and rot damage, soffit and fascia are missing, possible location of water infiltration

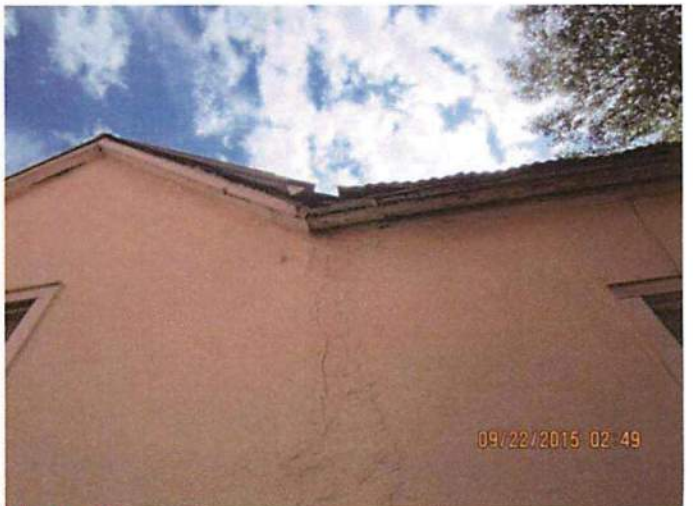
**Photo 33** Structural concerns possibly related to the drainage from the roof

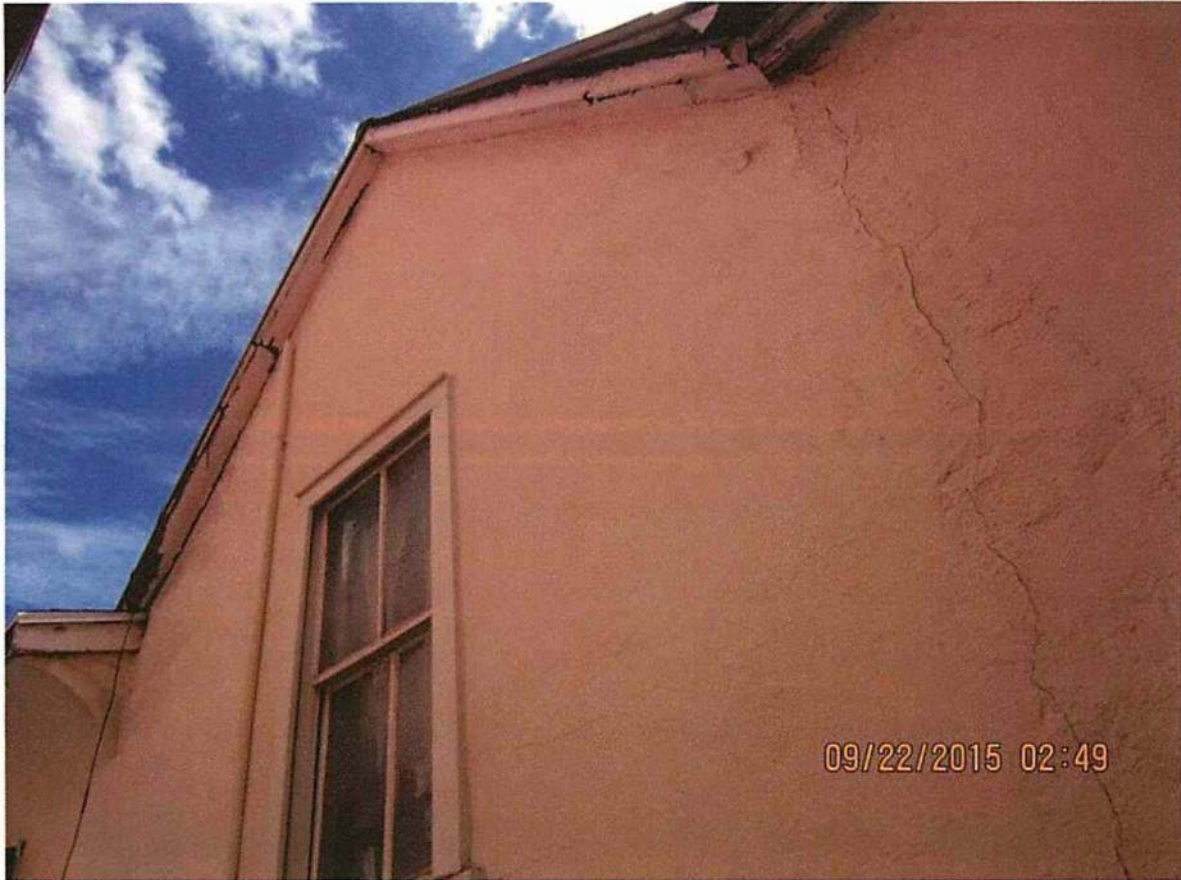
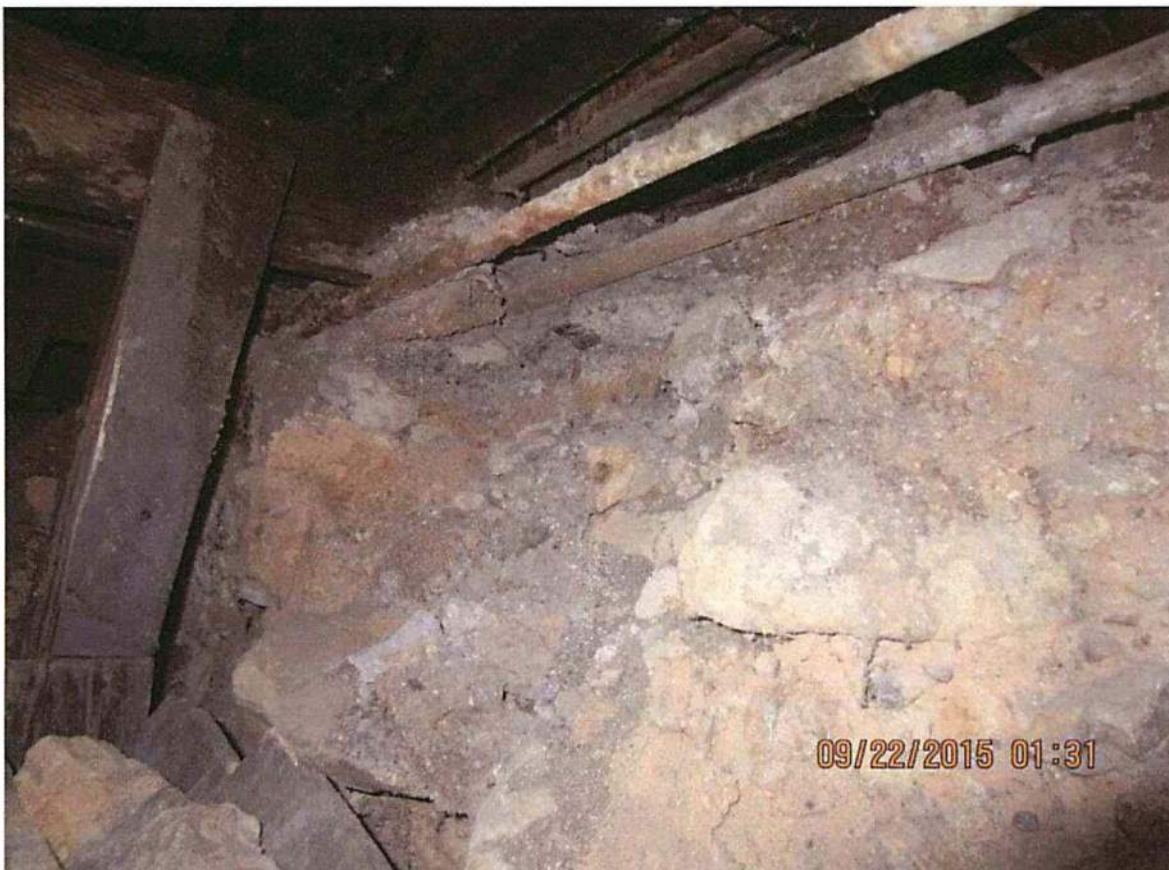
**Photo 34** The "above and "below" photos represent the continuation of a structural crack that is consistent with a rubble and dirt foundation. Structural deviations are difficult to see on wood framed construction. At least 30 of the building is wood framed

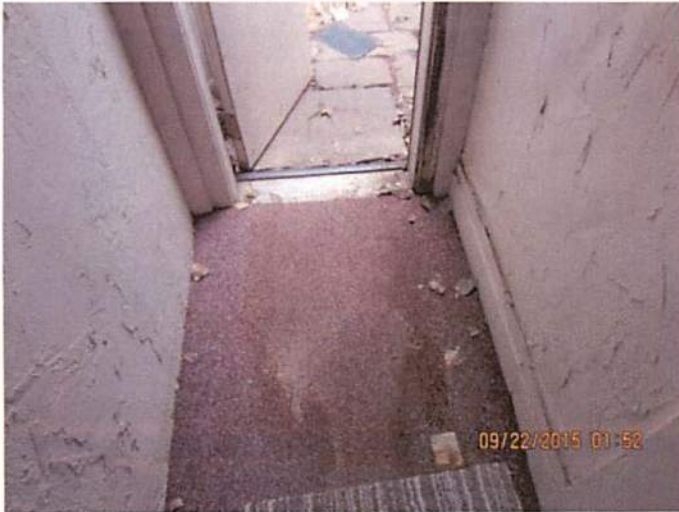
**Photo 35** Egress from the back of the dwelling serving 50% of 8 units or 22 occupants cannot be used. Gates are locked to prevent escape and no safe access to the front of the building is provided. Limited egress, direct violation of the fire code for egress requirements for type R-3 buildings and occupant load

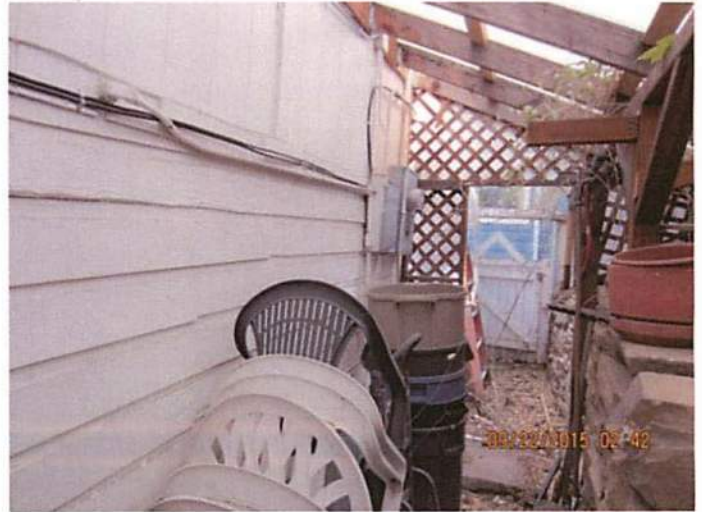
**Photo 36** Egress path rear of building. No access to safe location

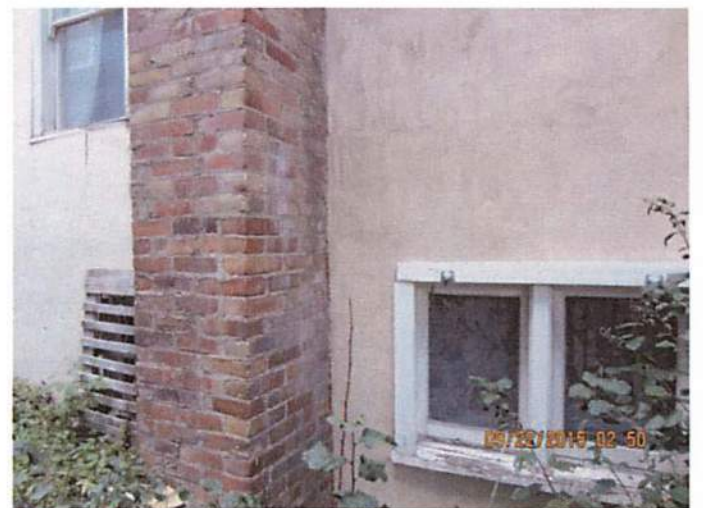
**Photo 40** Egress path from other side of building. No safe access to main street
