**PARK CITY MUNICIPAL CORPORATION
HISTORIC PRESERVATION BOARD MEETING
MARSAC MUNICIPAL BUILDING
COUNCIL CHAMBERS
445 MARSAC AVENUE
PARK CITY, SUMMIT COUNTY, UTAH
MINUTES OF JUNE 4, 2025**

**PRE-DEMOLITION/RENOVATION INSPECTION
FOR ASBESTOS, LEAD, UNIVERSAL,
HAZARDOUS AND TOXIC WASTES**

**The Centennial House
176 Main Street
Park City, Utah 84060**

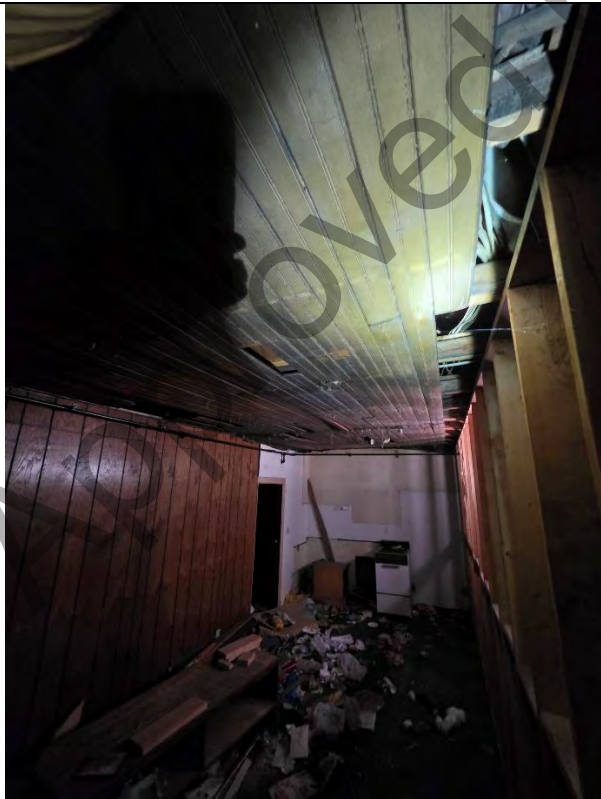
Green wood ceiling positive for lead

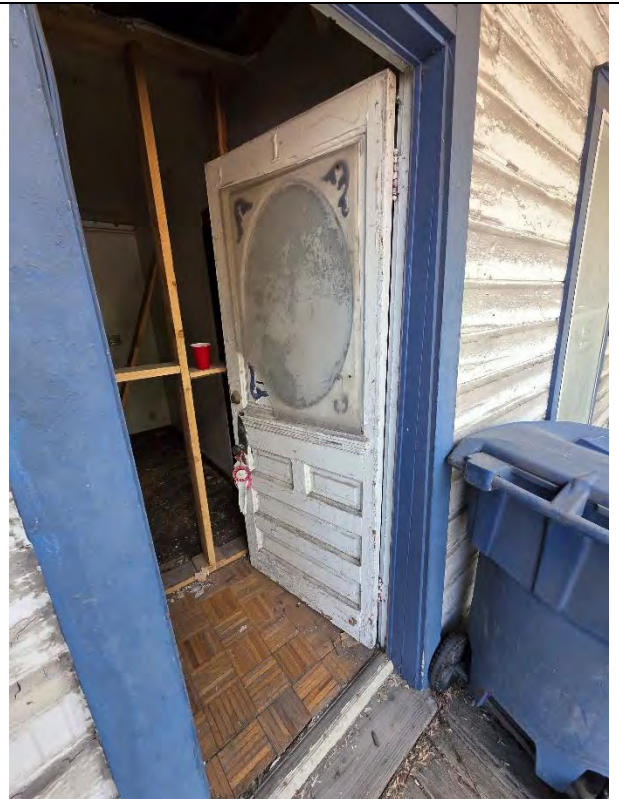
Lead exterior door, siding and door frame

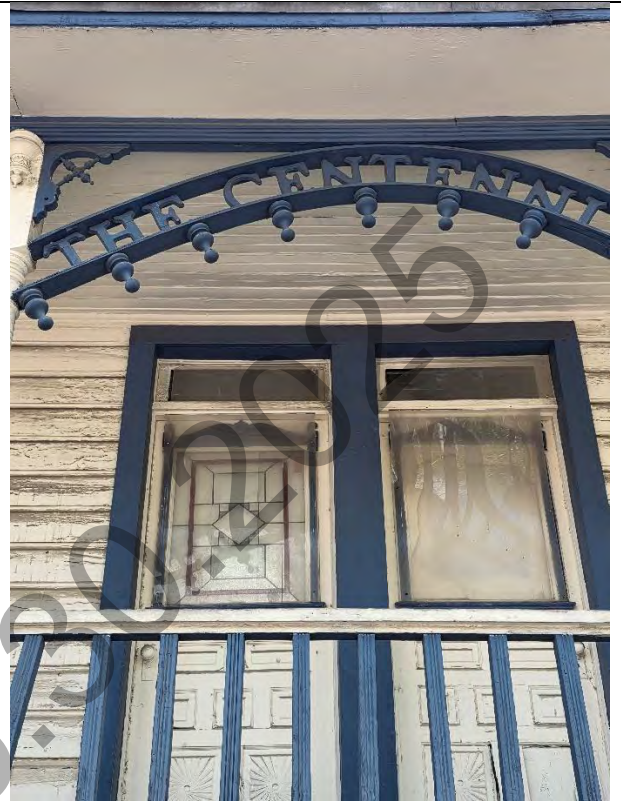
Exterior window frame, stair stringers and trim

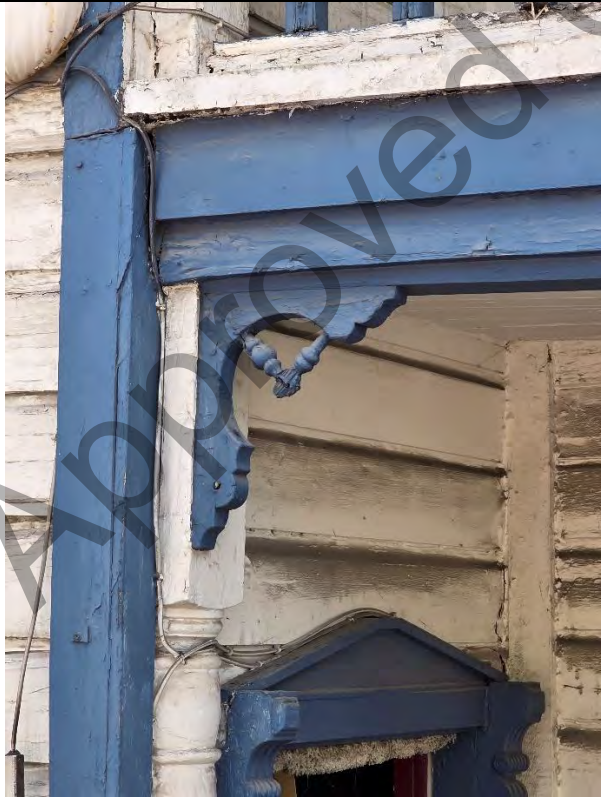
Lead exterior trim

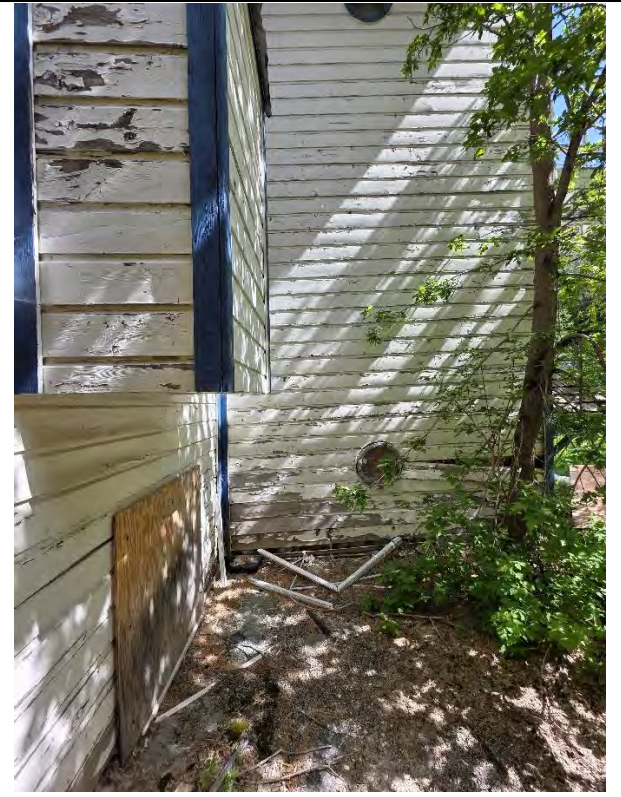
Lead exterior siding and trim

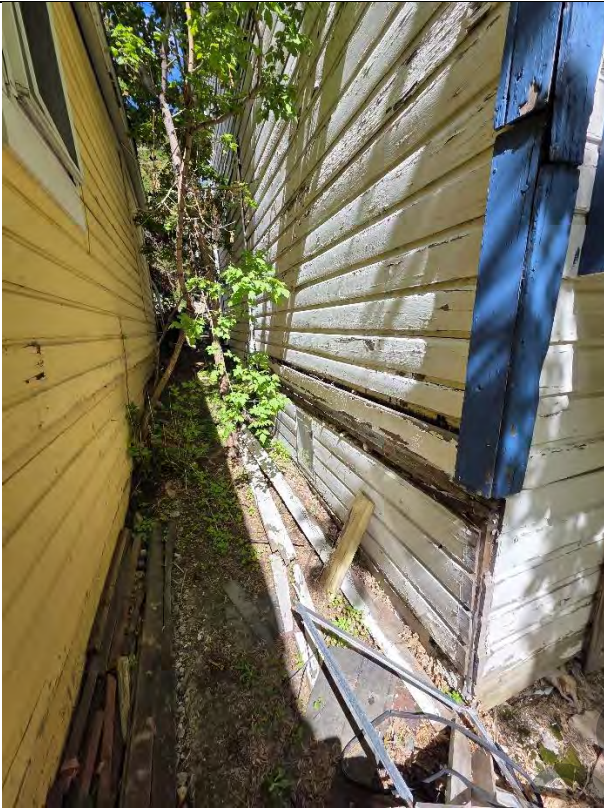
Lead exterior siding and trim

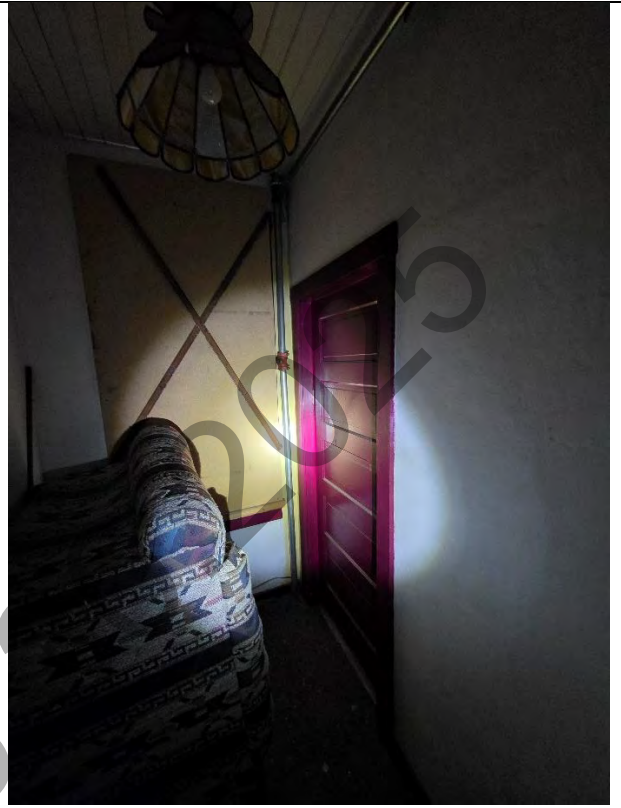
Lead interior door and frame

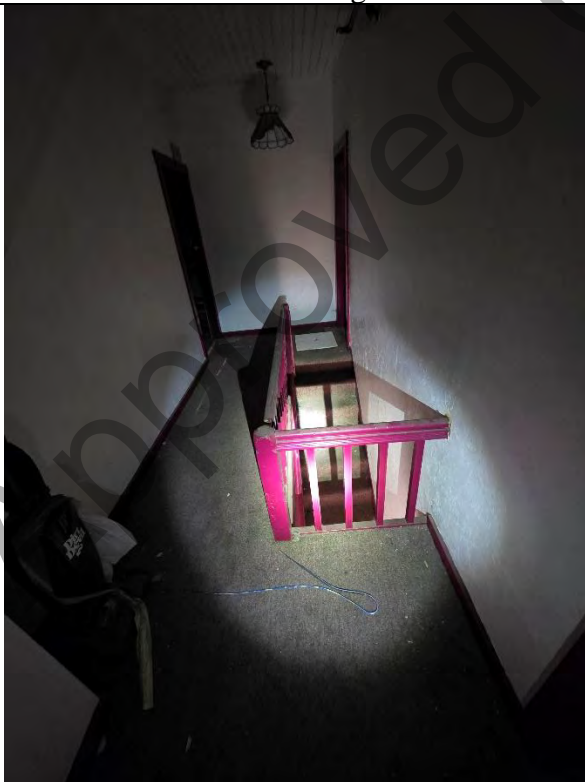
Lead stairwell components positive for lead

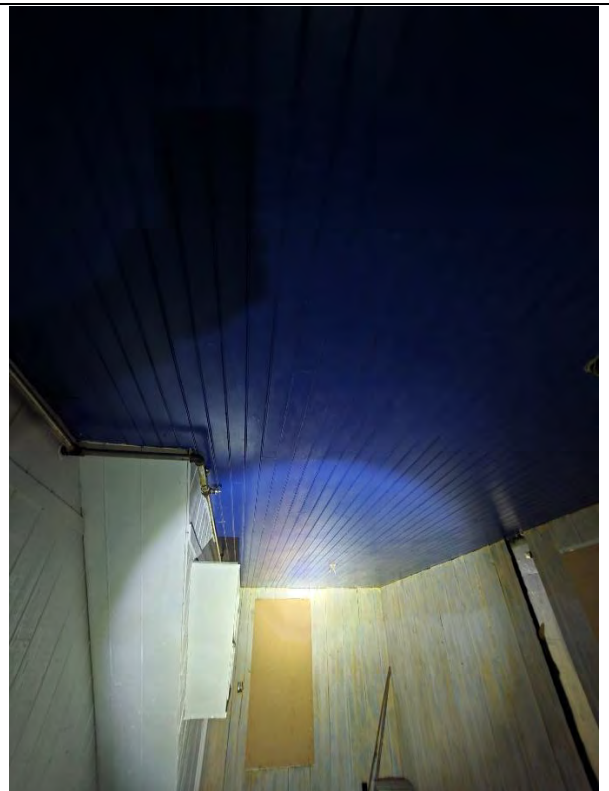
Blue wood ceiling positive for lead

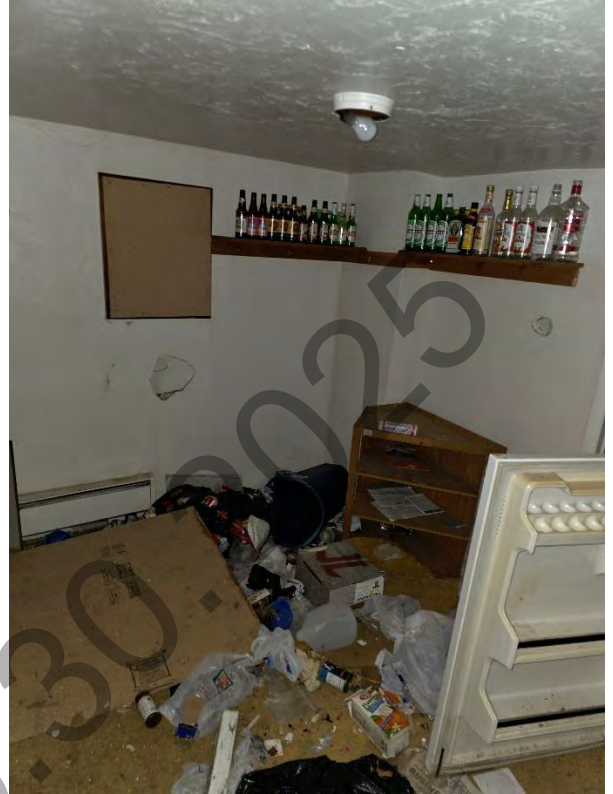
Basement Kitchen area garbage old food

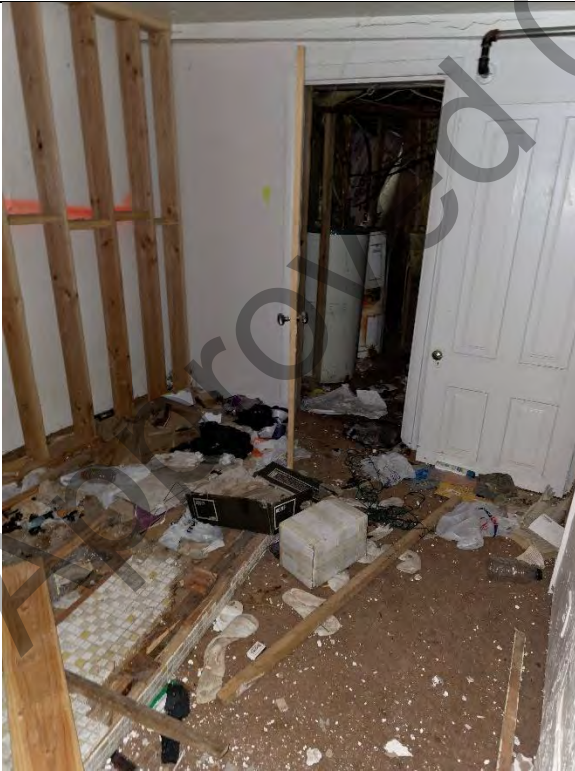
Basement South Apartment NW Bedroom with dead raccoon and garbage

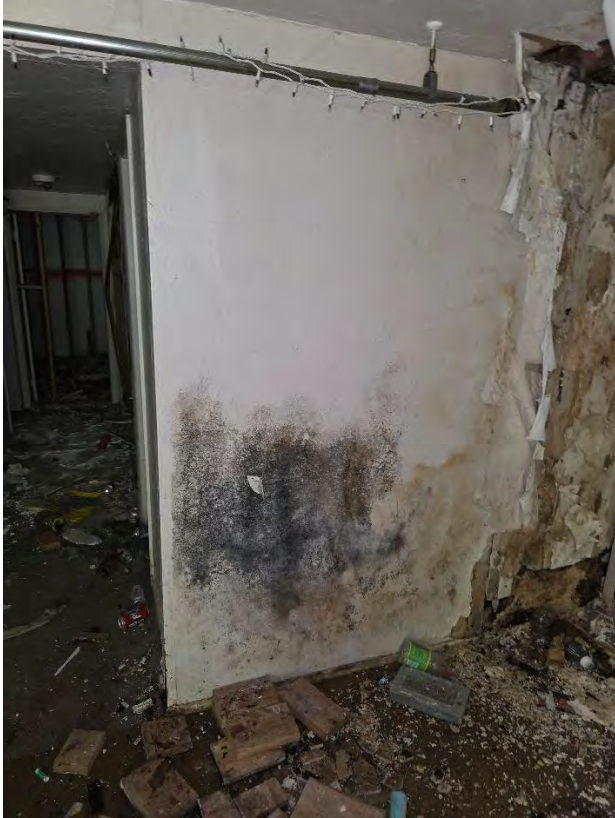
Basement South Apartment visible mold growth,
animal feces and garbage

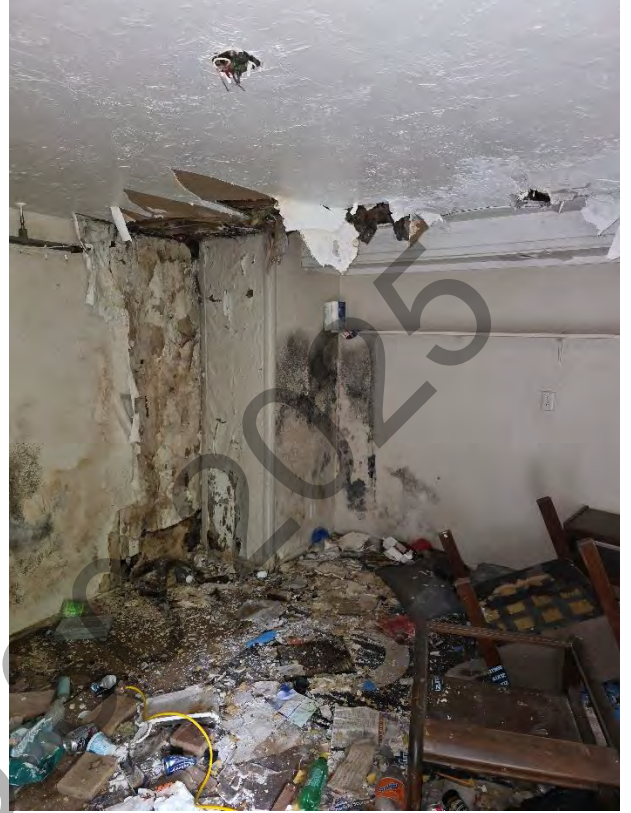
Basement South Apartment visible mold growth,
animal feces, three dead raccoons and garbage

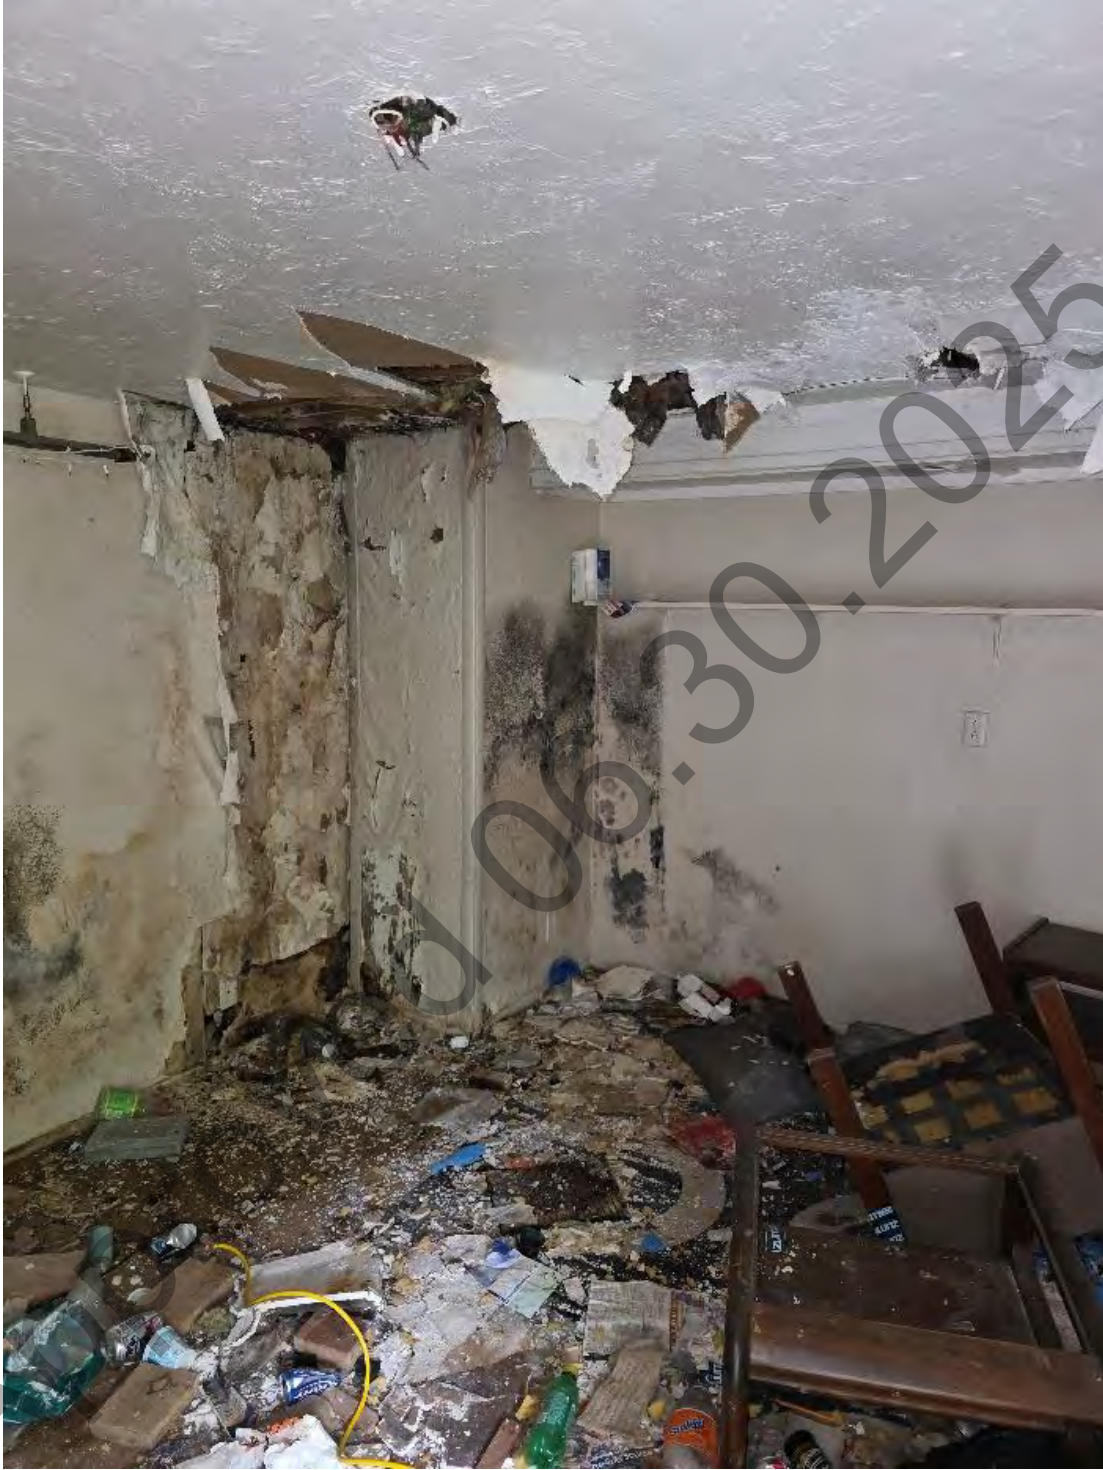
South Basement Apartment Living Room – Three (3) dead raccoons, feces, visible mold on all walls within the basement area.

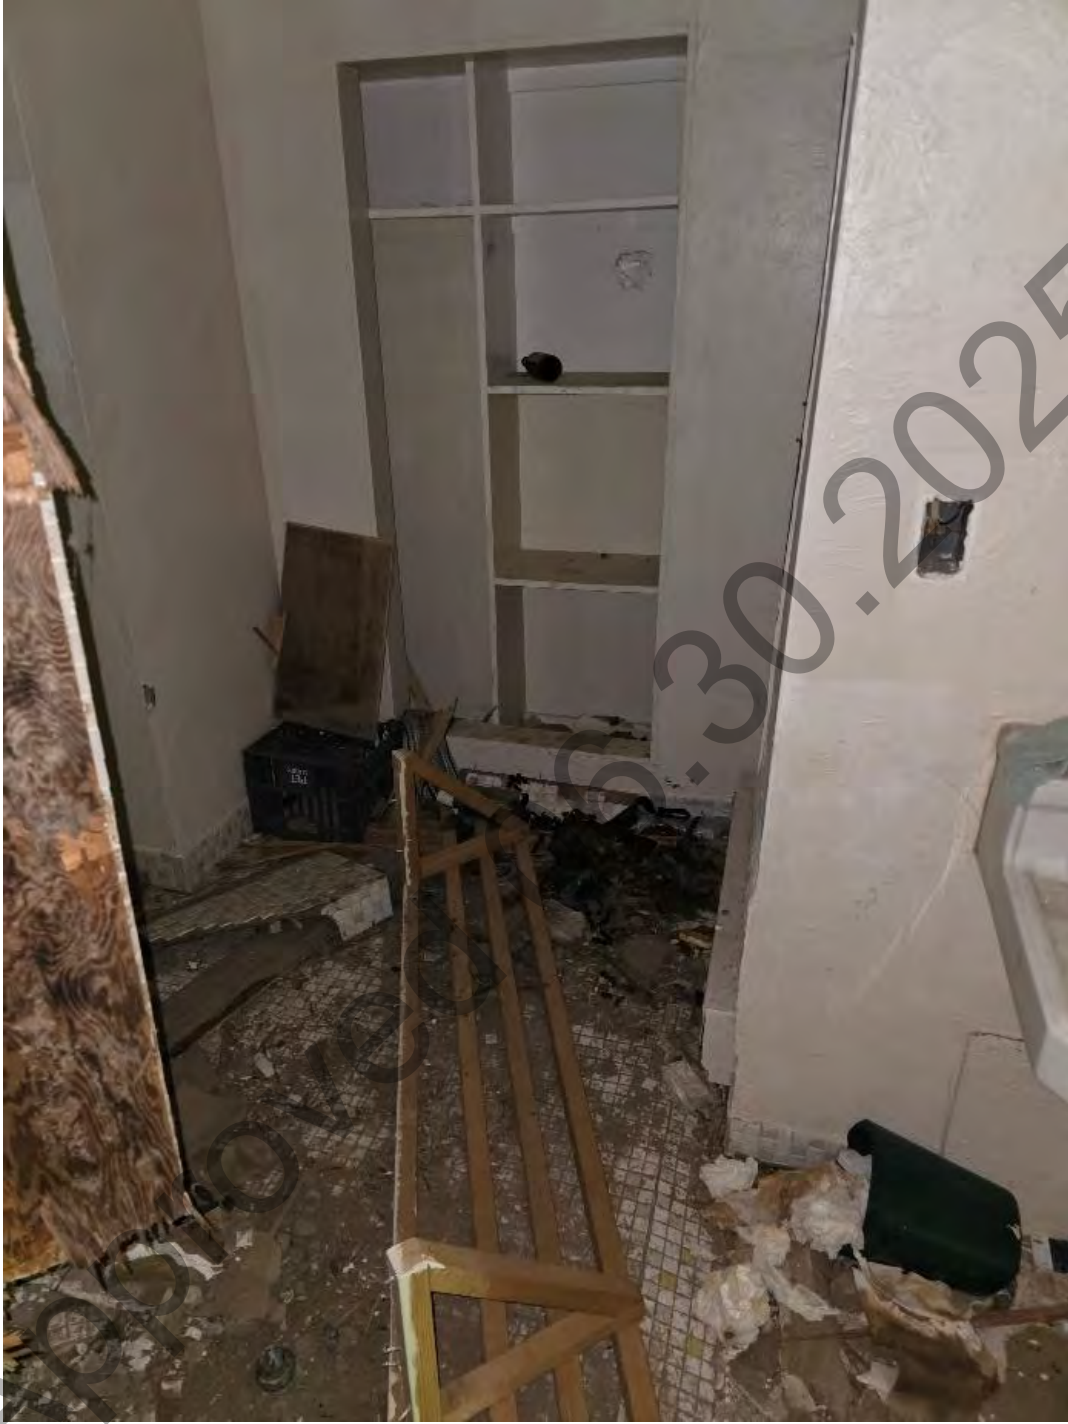
Visible mold growth on sheetrock wall Basement South Apartment Bathroom.

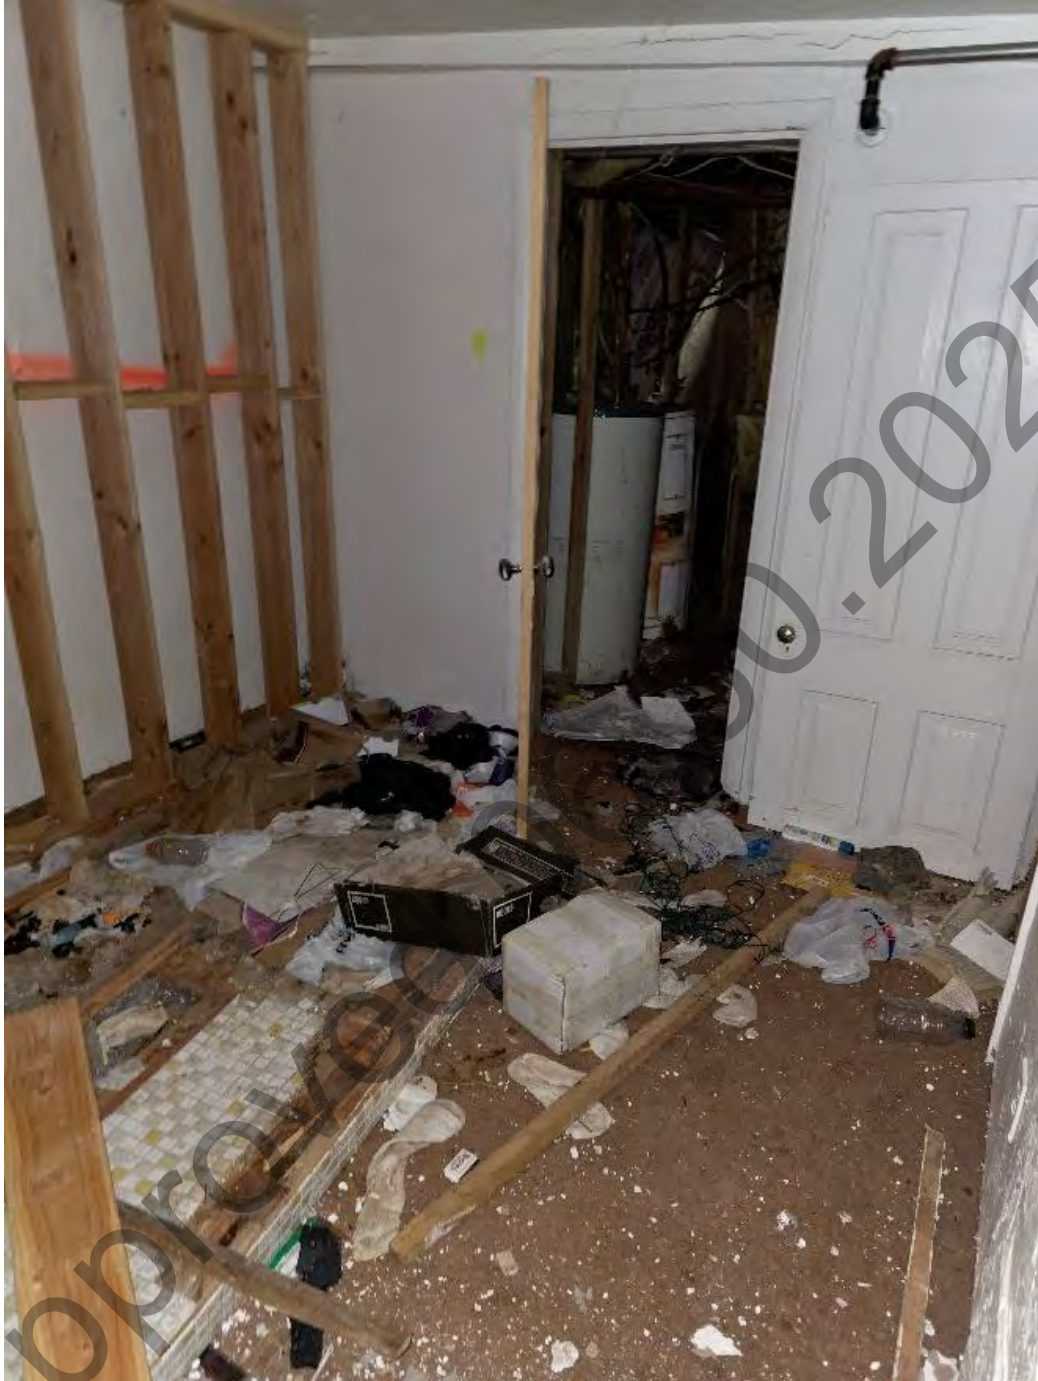
Visible mold growth with dead raccoon and feces throughout room.

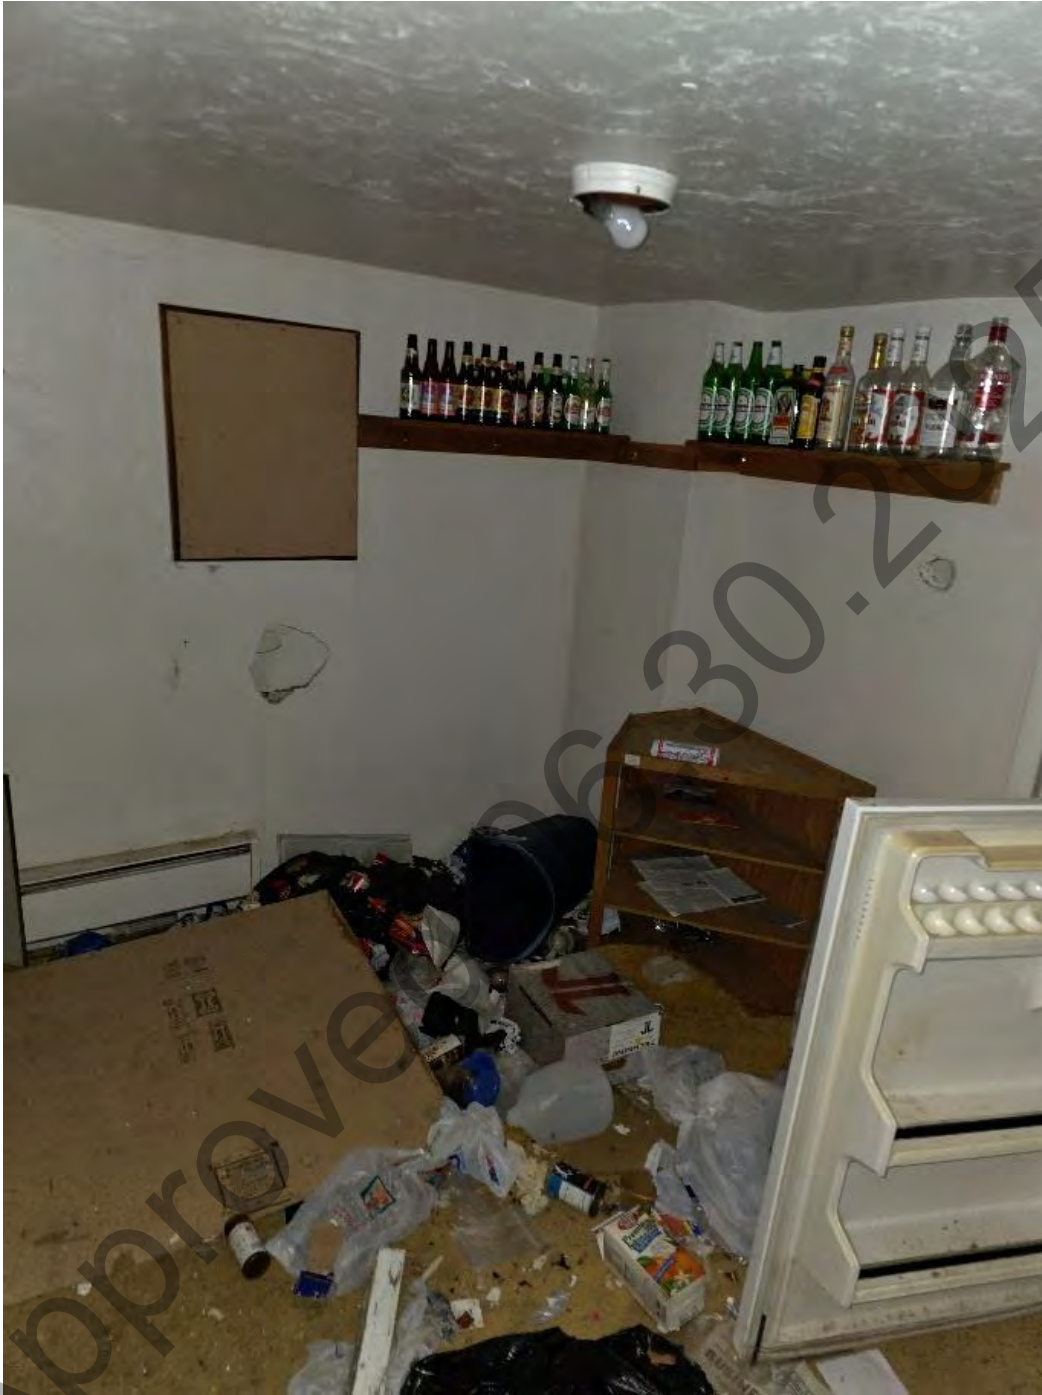
Basement South Apartment Kitchen with visible mold growth and feces.
