**PARK CITY HISTORIC PRESERVATION BOARD MEETING  
SUMMIT COUNTY, UTAH  
November 6, 2019**

- 6.A. 526 Park Avenue – Historic District Design Review  
Historic Preservation Board Review for Material Deconstruction of a Significant Historic Structure – The Applicant is Proposing to Rehabilitate and Restore a Historic Structure back to its Original Use as a Garage. Applicant is Proposing to Impact the Following Materials Including Non-Historic Railroad Tie Retaining Walls; Non-Historic Covered Entry and Patio; Non-Historic Exterior Stairs; Non-Historic Stone Retaining Walls; Post-1929 Concrete Foundation; Post-1929 Floor Structure with Modern Upgrades; Post-1929 Original Roof Pitch and Shape; Post-1968 West Wall used to Cover Original Garage Doors; Non-Historic Wood Shingle Siding; Non-Historic Front (West) Porch; Post-1968 Rear (East) Enclosed Deck; Post-1995 Skylight Window; and Non-Historic Windows and Doors Replacement. PL-18-03966

PARK CITY MUNICIPAL CORPORATION  
HISTORIC PRESERVATION BOARD  
MINUTES OF OCTOBER 2, 2019

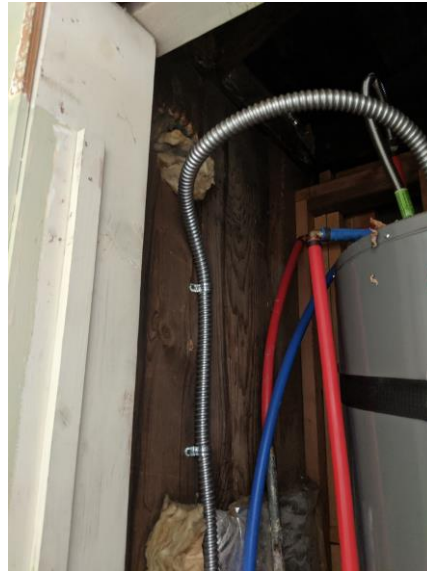
*Interior vertical wood material*

The Applicant has not yet completed an exploratory demolition, but a staff Site visit on July 22, 2019 proved that vertical wood siding exists within a closet of the existing Structure. See image below from Site visit.

All Historic material on or within the Structure, will be saved where possible. The Applicant proposes to structurally stabilize the existing Structure by adding new framing members on the interior. The existing foundation is minimal and has not been adapted to the slope of the Site. The Applicant is proposing to lift the Structure to install a new foundation. New structural members will be added to the existing framed Structure to meet structural loads; existing structural members will be inspected and repaired or replaced as needed. The wood framed walls on the interior of the Structure, separating the interior into different rooms, will be demolished to prepare the interior to be used as a garage and storage.

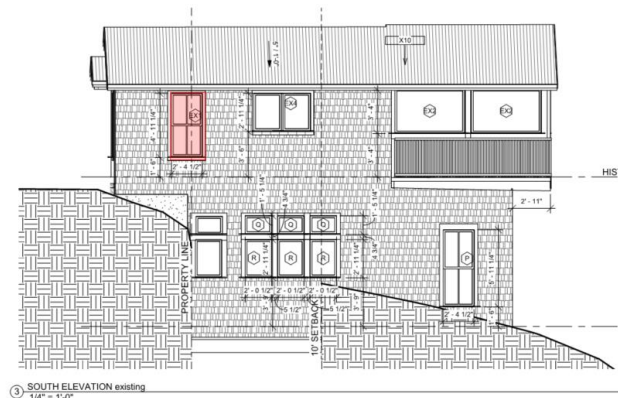
There is a total of one (1) Historic wood window and eighteen (18) contemporary windows on the Structure. The contemporary windows include both wood and aluminum frames. The Physical Conditions Report notes they vary in condition from fair to poor. Staff finds that there may be an opportunity to salvage and re-use the existing Historic wood window (on the south side of the Structure – pictured below in red), if it is able to be rehabilitated.

*#4. An independent window evaluation specialist will assess and report on the existing window conditions and outline options for rehabilitation or replacement in satisfaction of the Planning Director.*

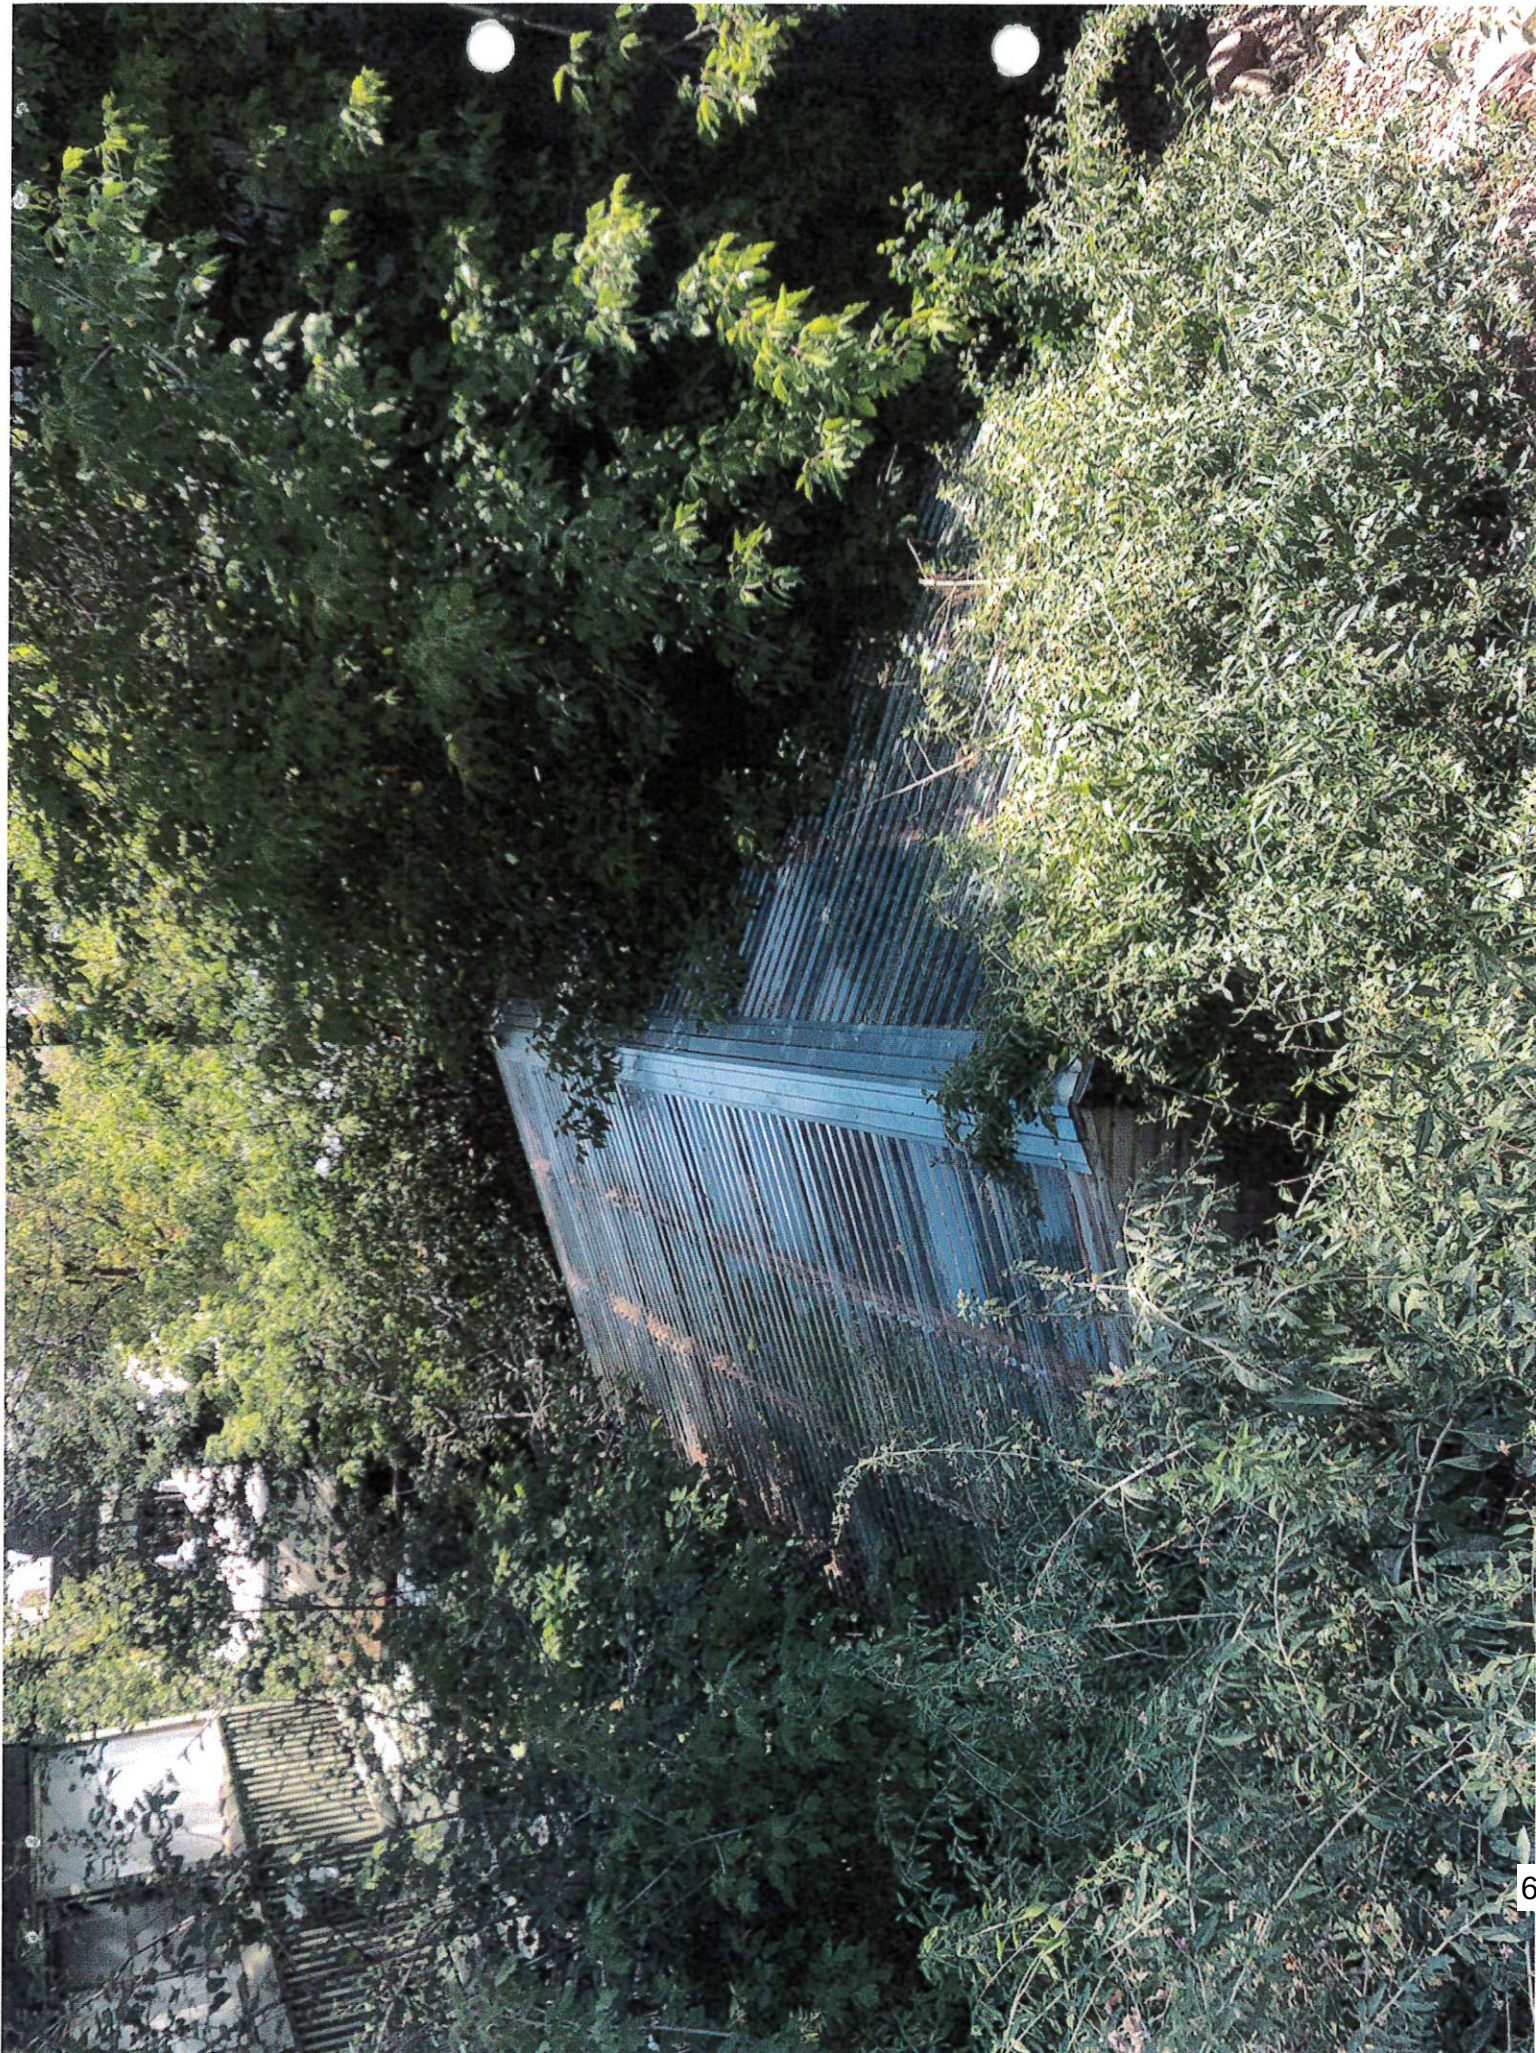
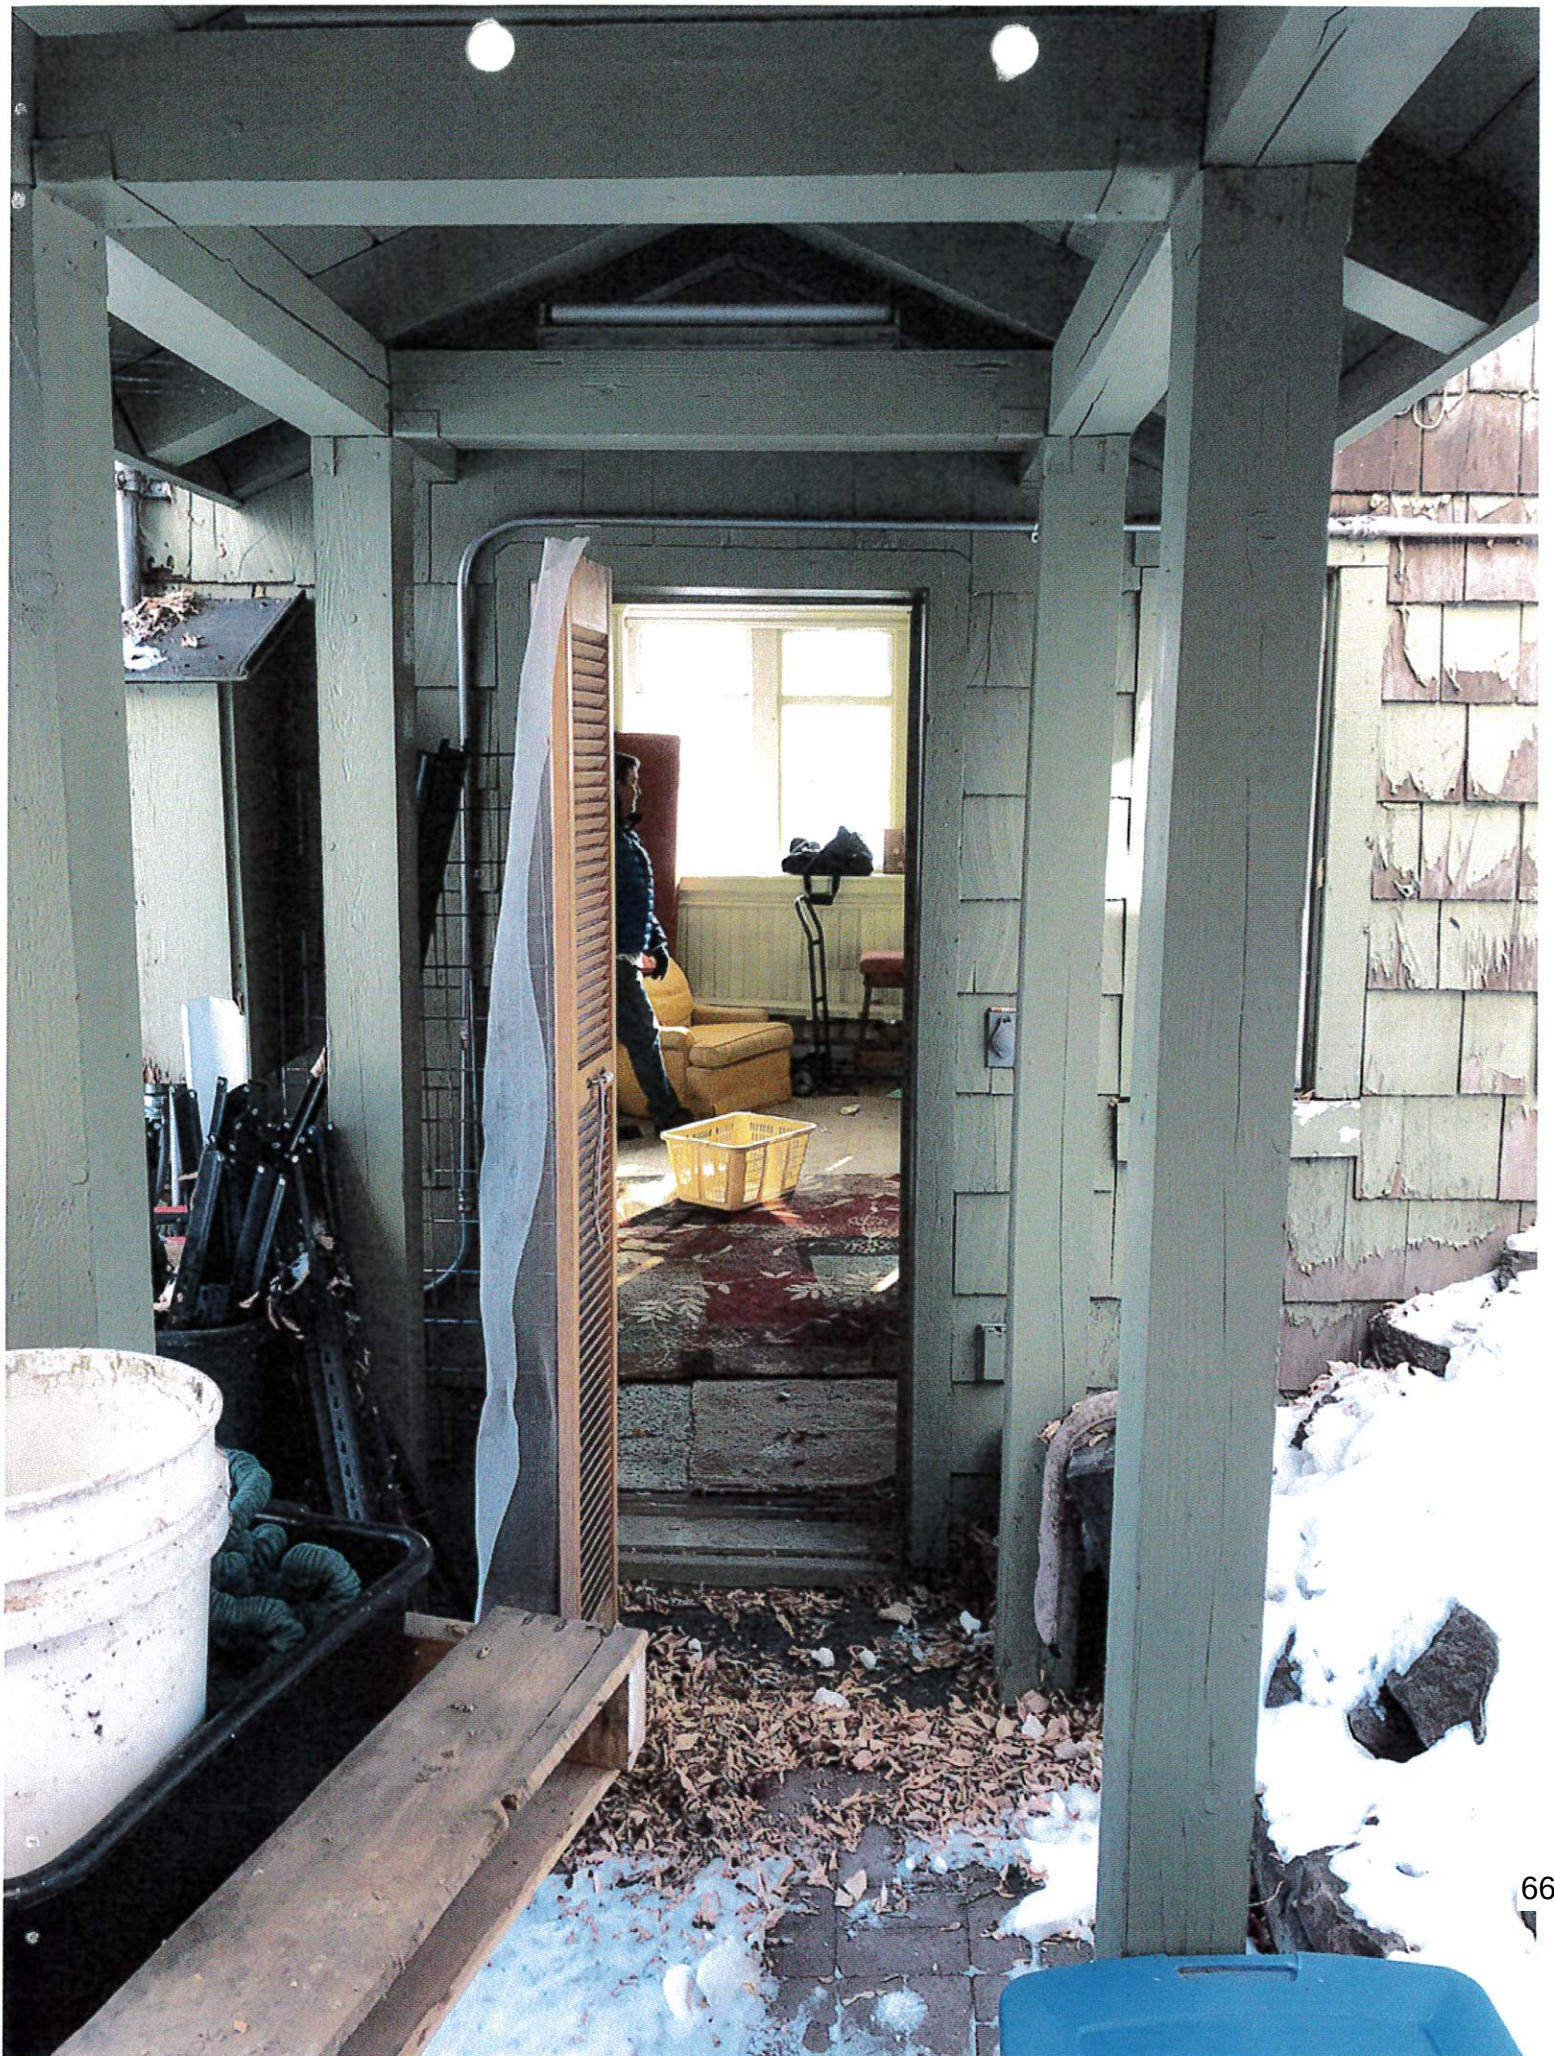
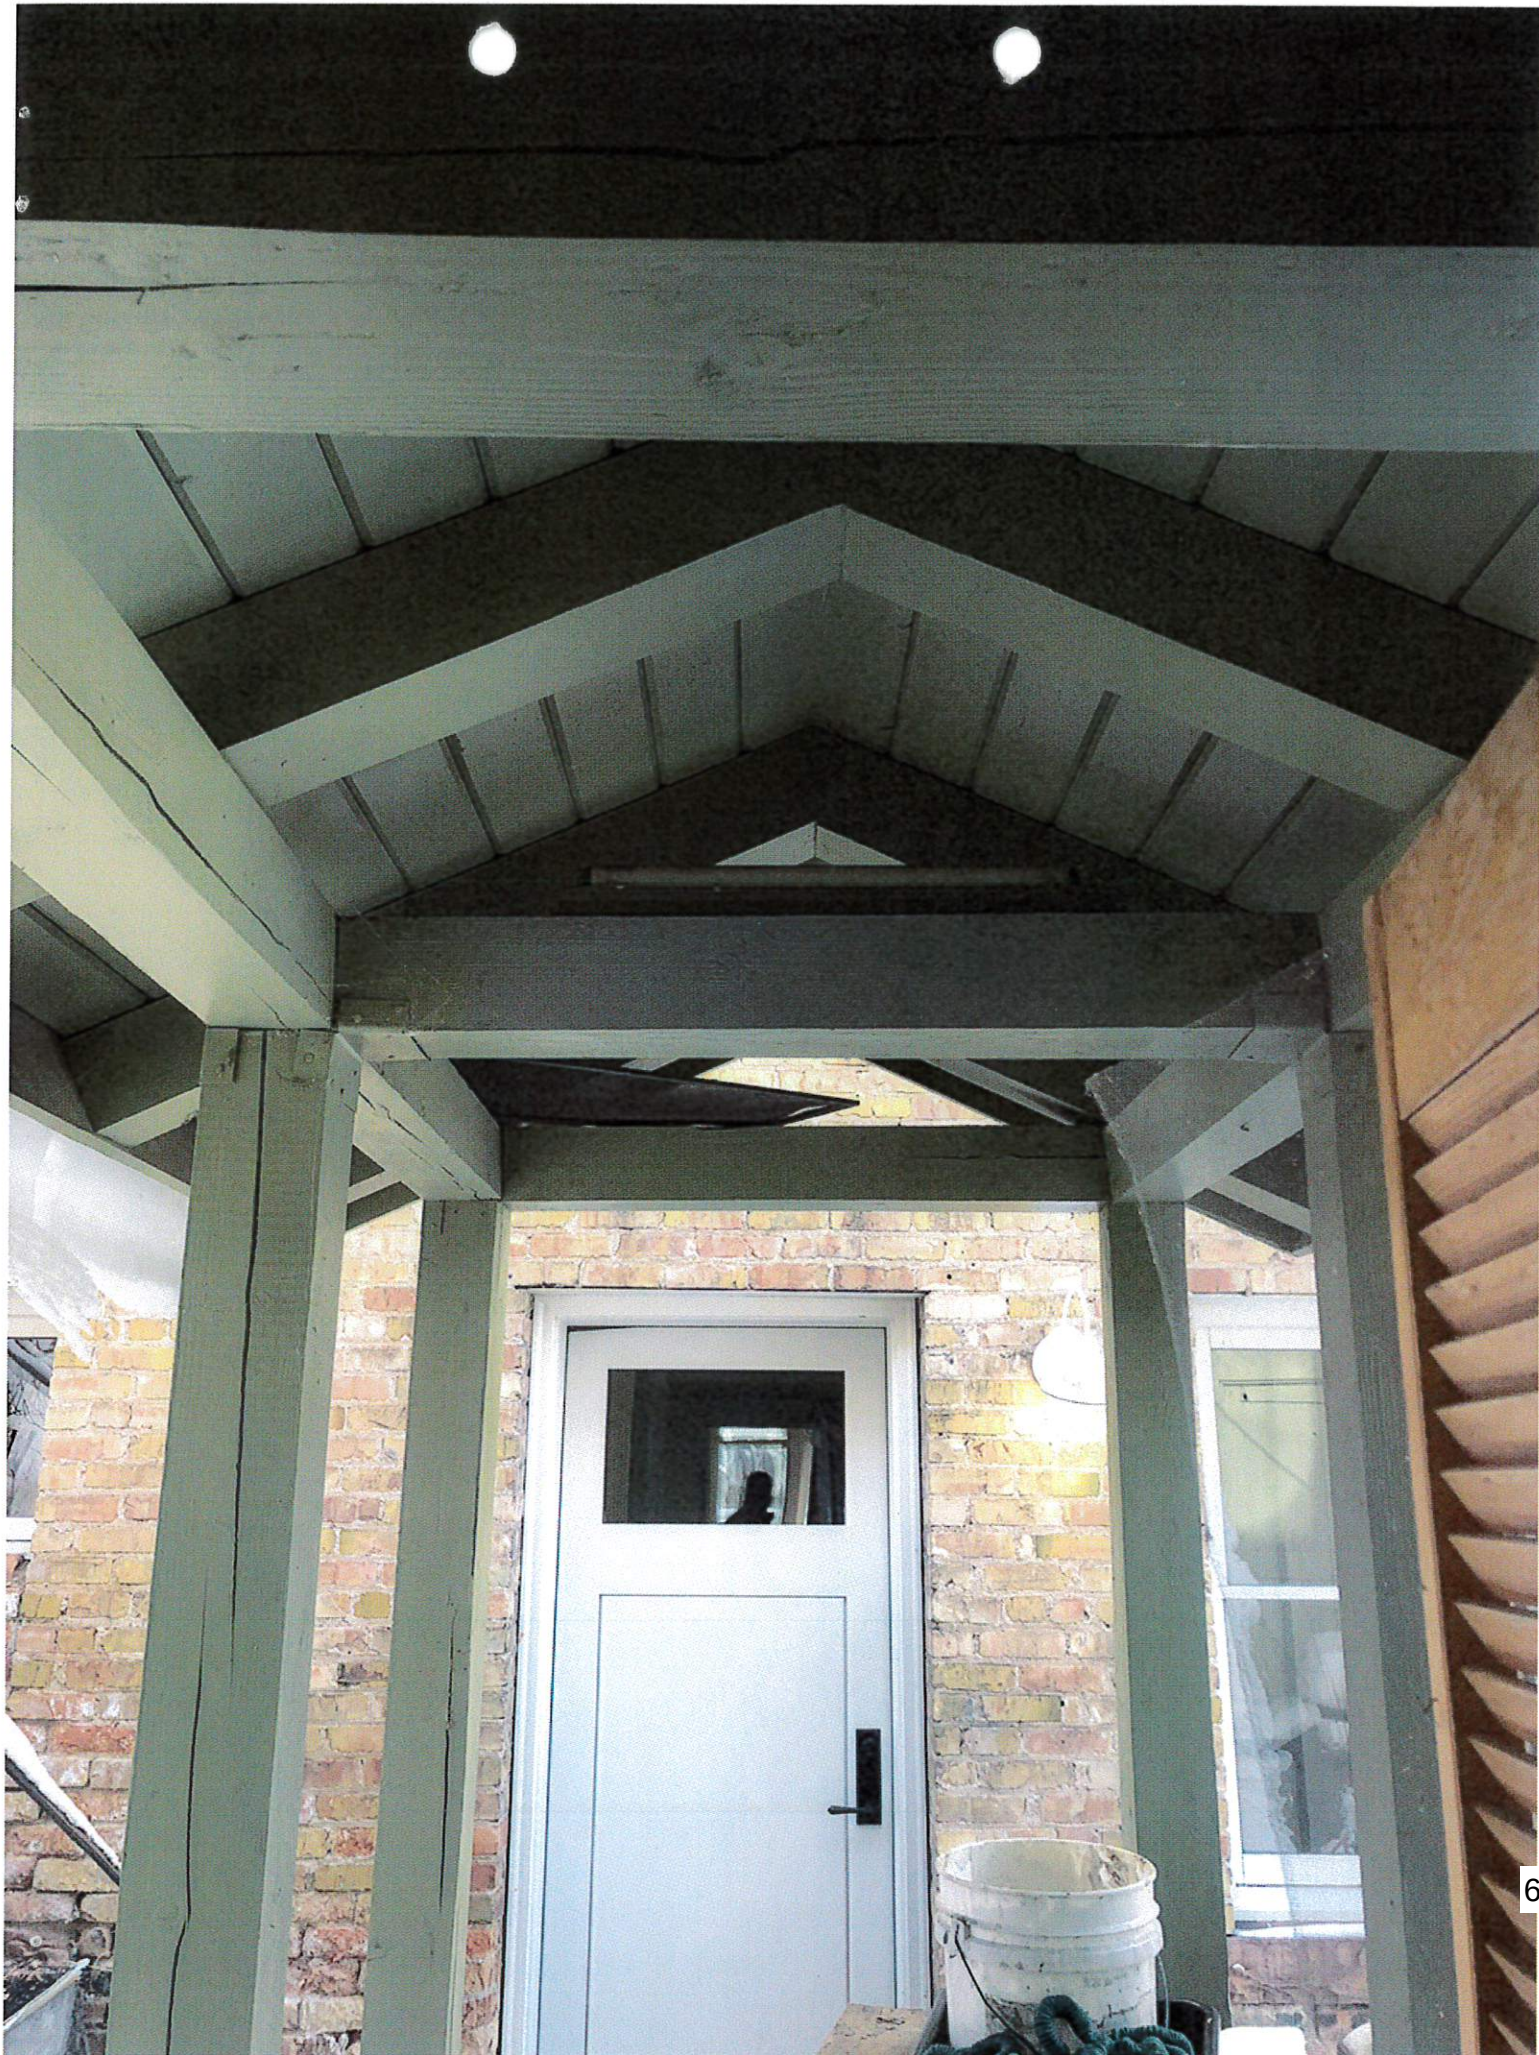
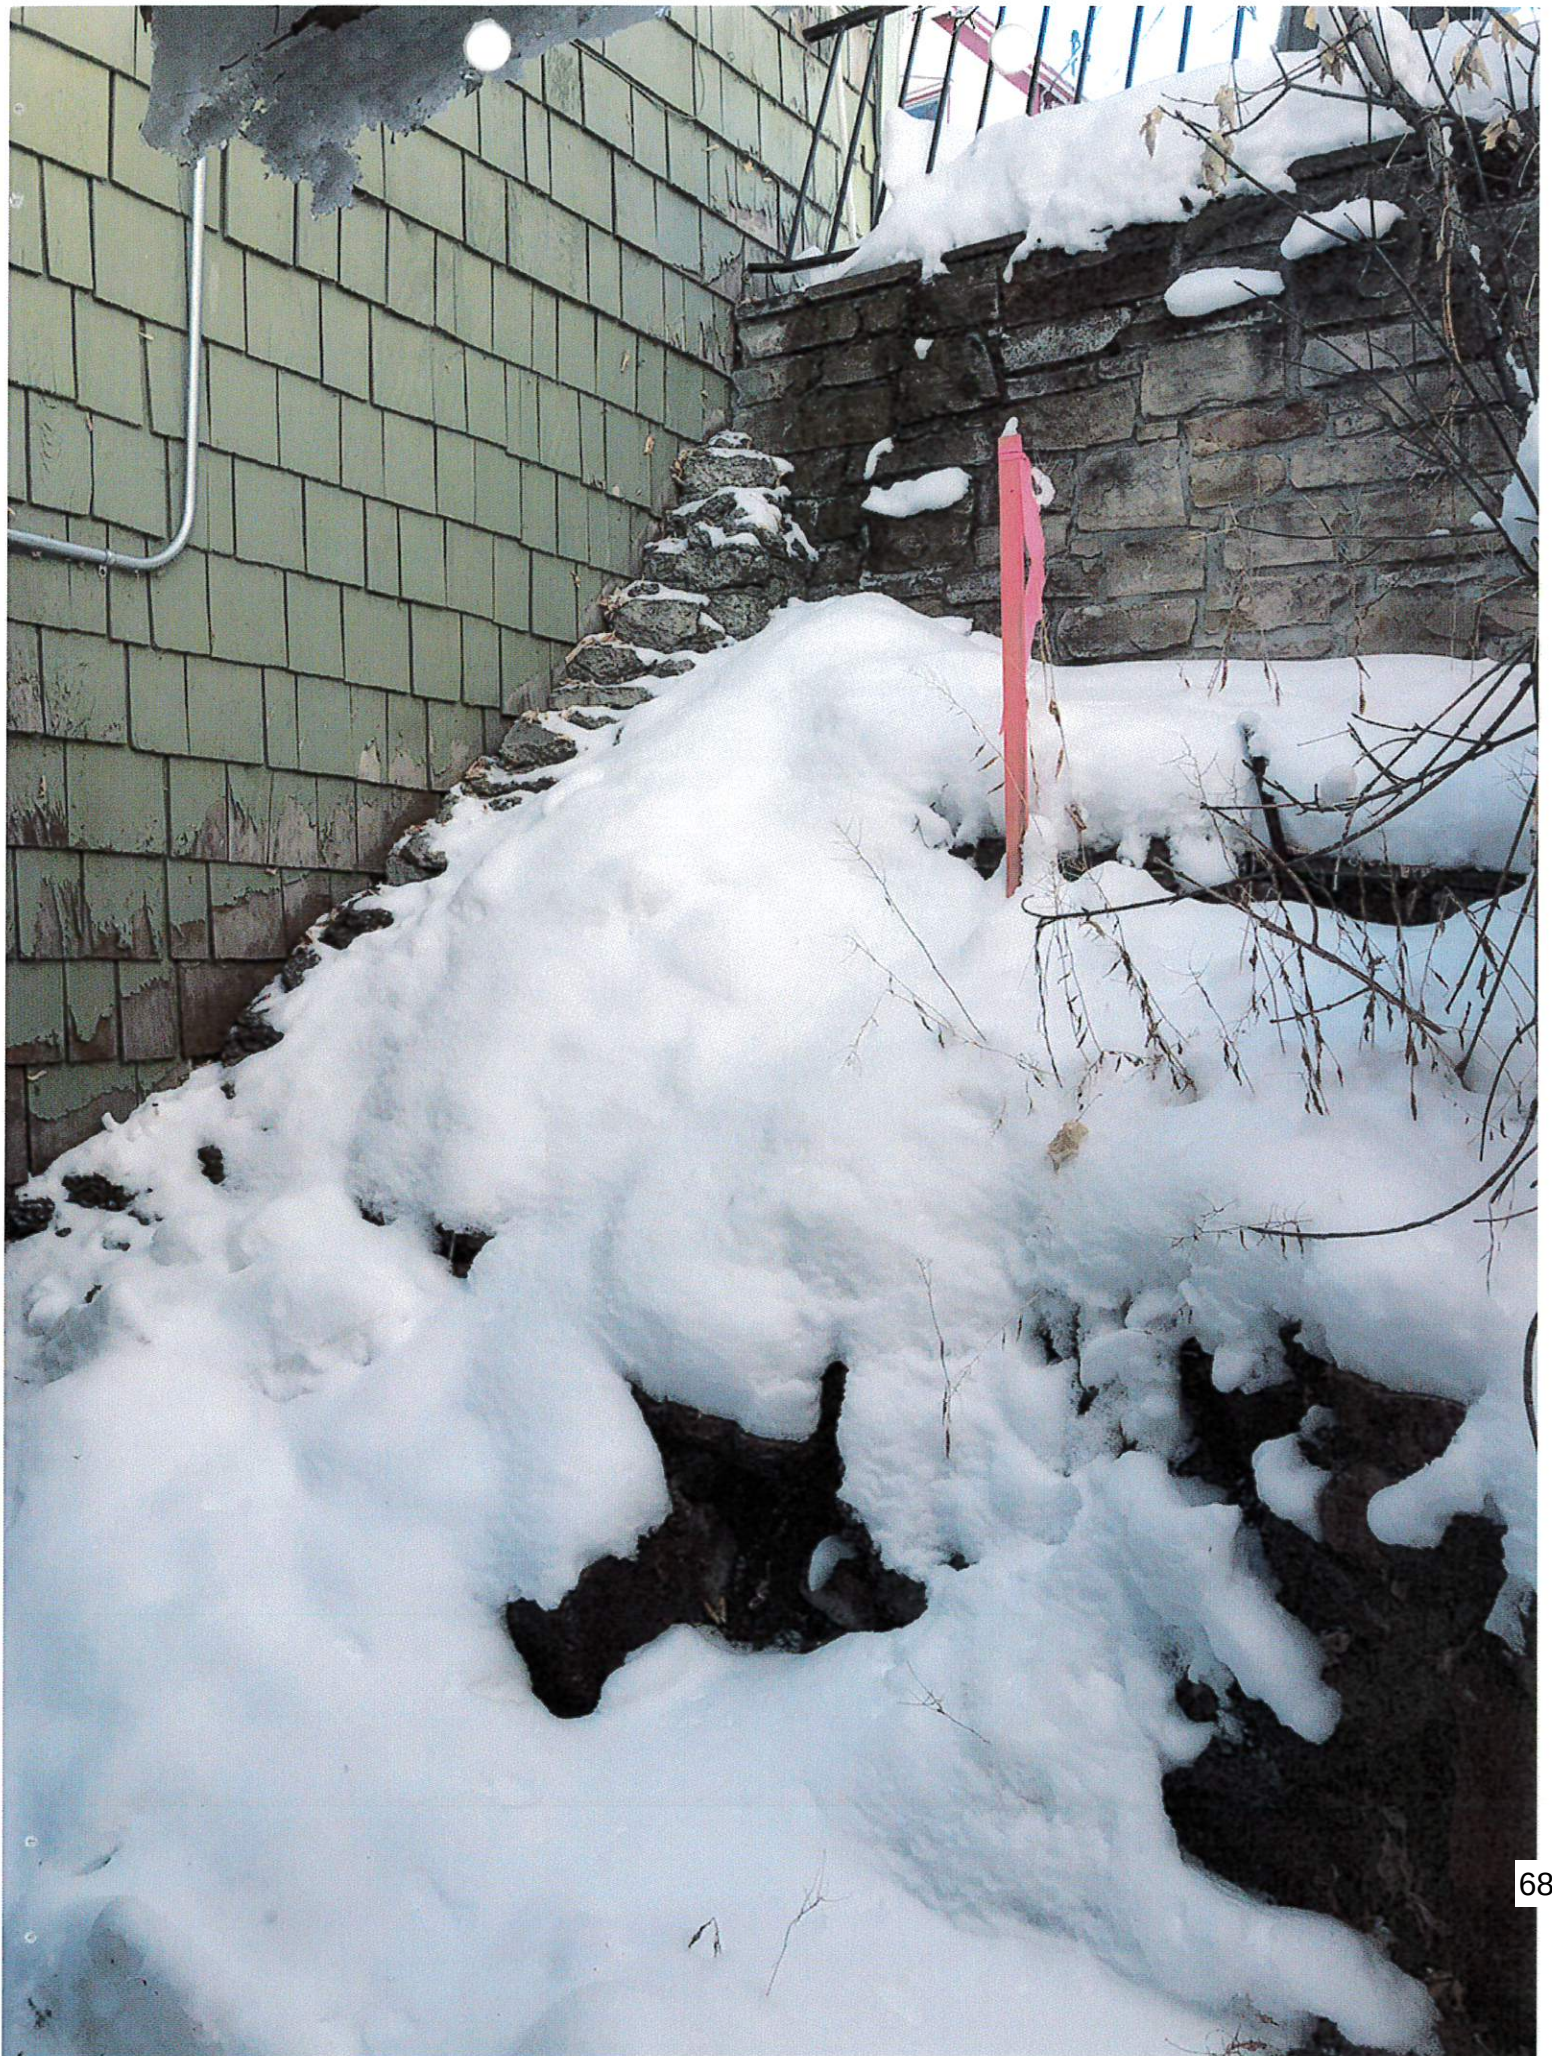
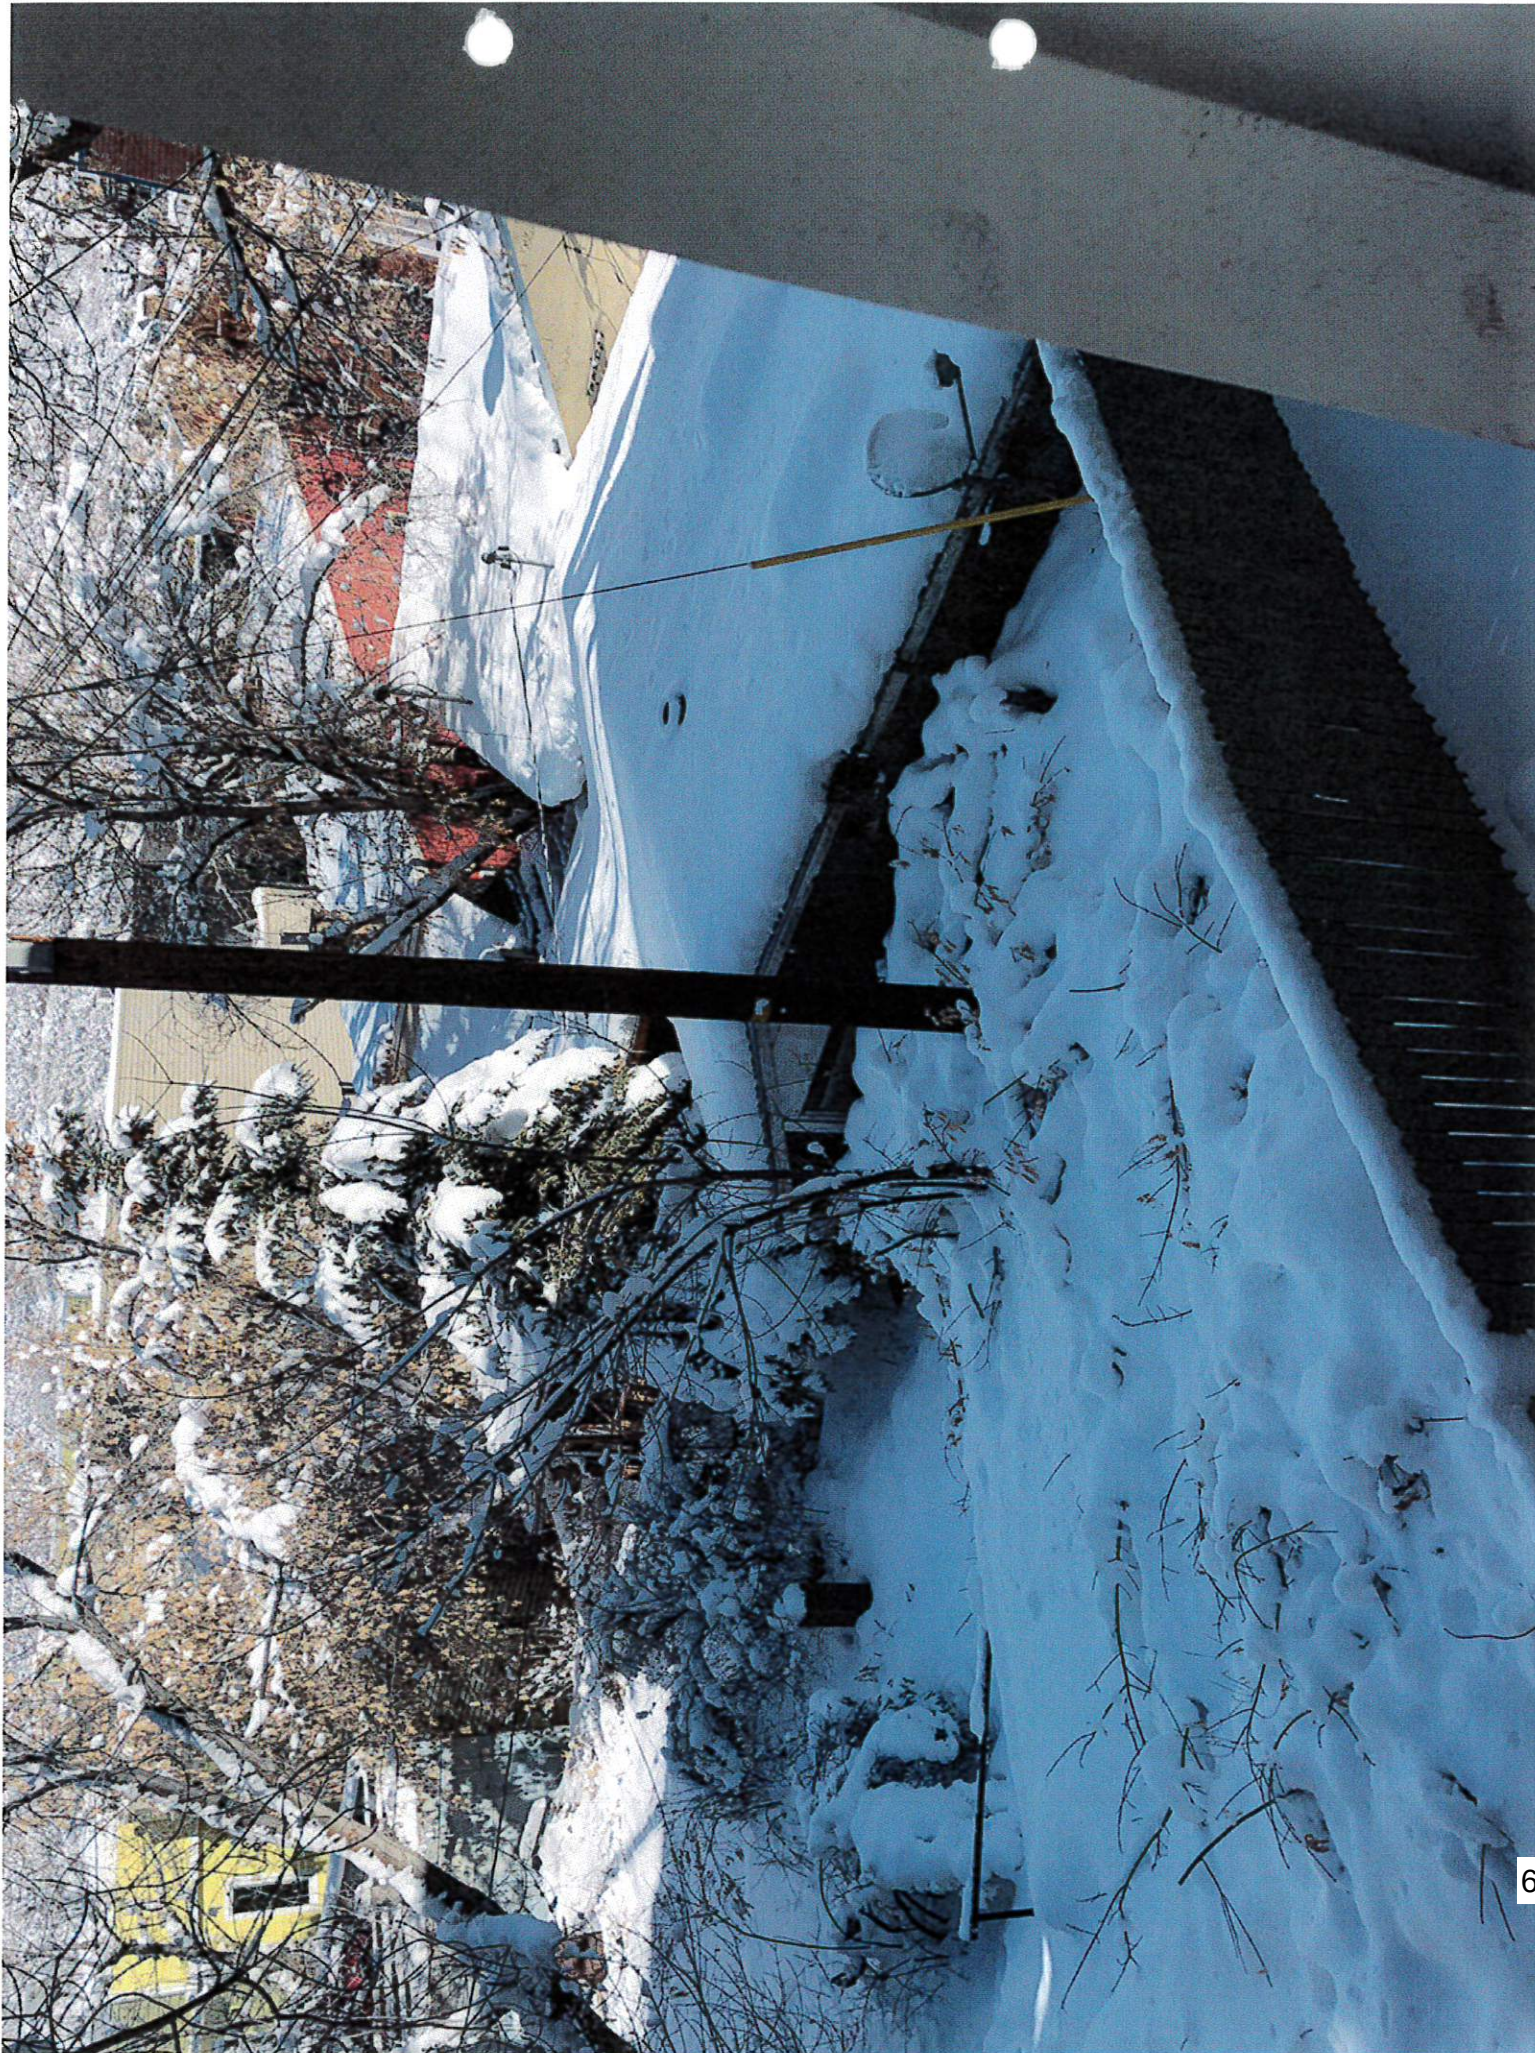
Photo Numbers: 1, 2, 3, 4, 5 Illustration Numbers: Survey, A1.01

| Greenhouse is a temporary, non-foundation, non-permitted structure to be removed<br>Cover over concrete walk is non compliant and will be removed.<br>Slope will be stabilized with stepped retaining walls under 4'.<br>Overhead power lines and poles will be installed in new easement along property line. |

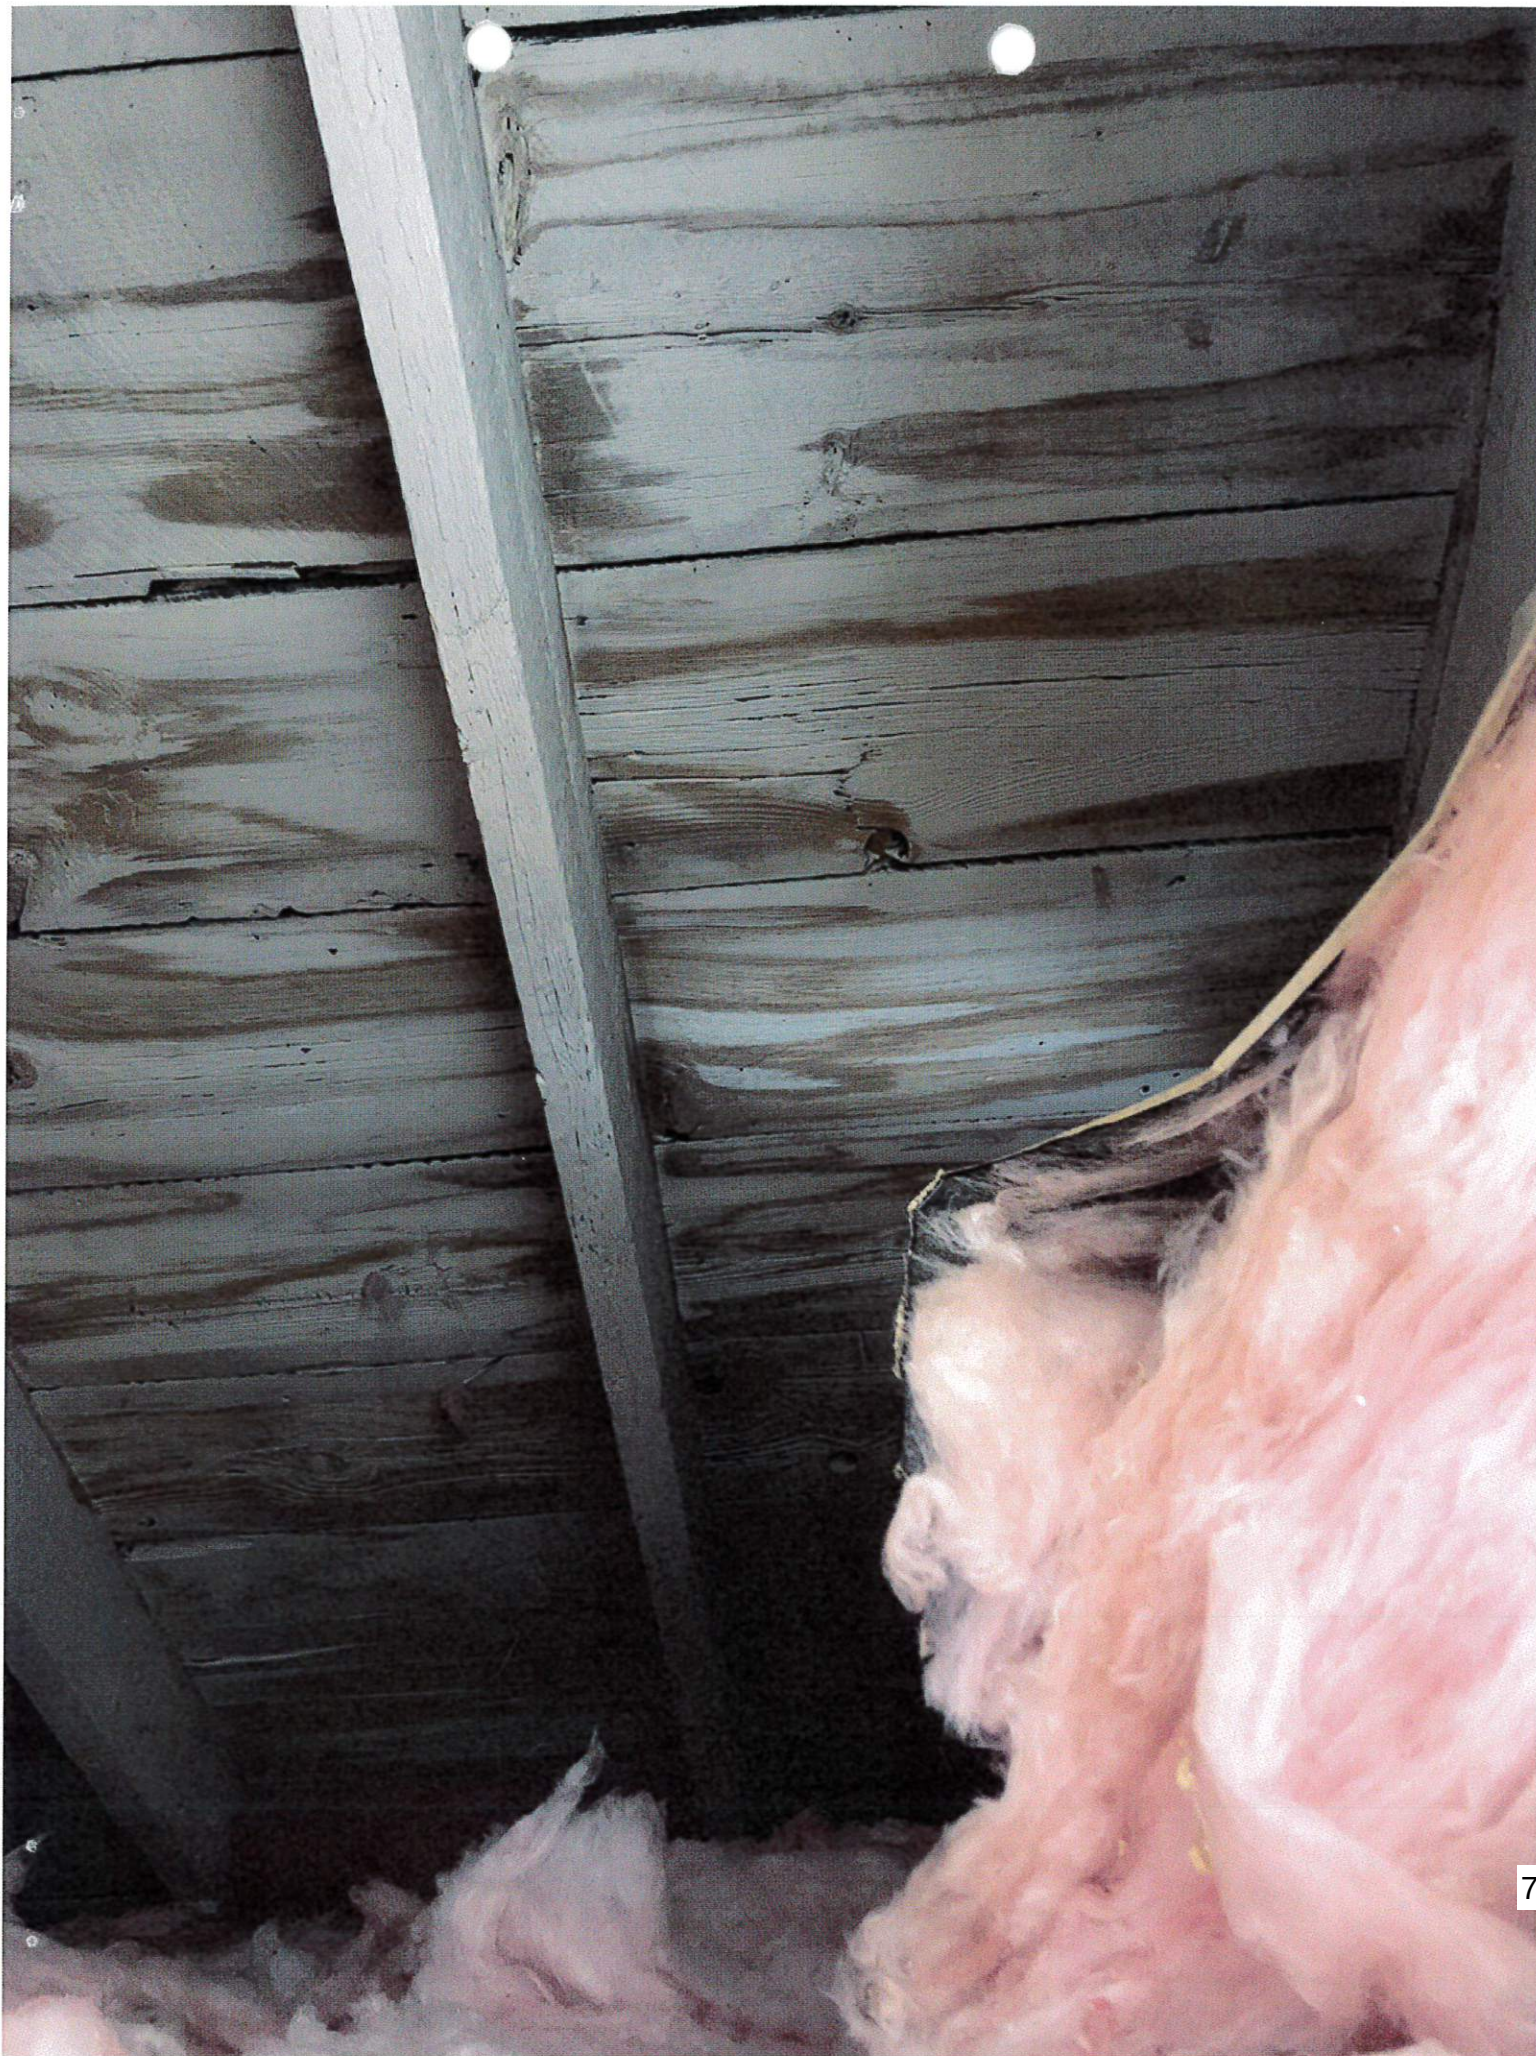
Photo Numbers: 6 Illustration Numbers: \_\_\_\_\_

Foundation is not adapted to slope and makes framing vulnerable to rot.  
Floor structure not suited to current vehicle weight and will be reinforced  
Roof framing trusses need to be reinforced to meet current requirements.
