**PARK CITY HISTORIC PRESERVATION BOARD MEETING  
SUMMIT COUNTY, UTAH  
November 6, 2019**

- 6.A. 526 Park Avenue – Historic District Design Review  
Historic Preservation Board Review for Material Deconstruction of a Significant Historic Structure – The Applicant is Proposing to Rehabilitate and Restore a Historic Structure back to its Original Use as a Garage. Applicant is Proposing to Impact the Following Materials Including Non-Historic Railroad Tie Retaining Walls; Non-Historic Covered Entry and Patio; Non-Historic Exterior Stairs; Non-Historic Stone Retaining Walls; Post-1929 Concrete Foundation; Post-1929 Floor Structure with Modern Upgrades; Post-1929 Original Roof Pitch and Shape; Post-1968 West Wall used to Cover Original Garage Doors; Non-Historic Wood Shingle Siding; Non-Historic Front (West) Porch; Post-1968 Rear (East) Enclosed Deck; Post-1995 Skylight Window; and Non-Historic Windows and Doors Replacement. PL-18-03966

PARK CITY MUNICIPAL CORPORATION  
HISTORIC PRESERVATION BOARD  
MINUTES OF OCTOBER 2, 2019

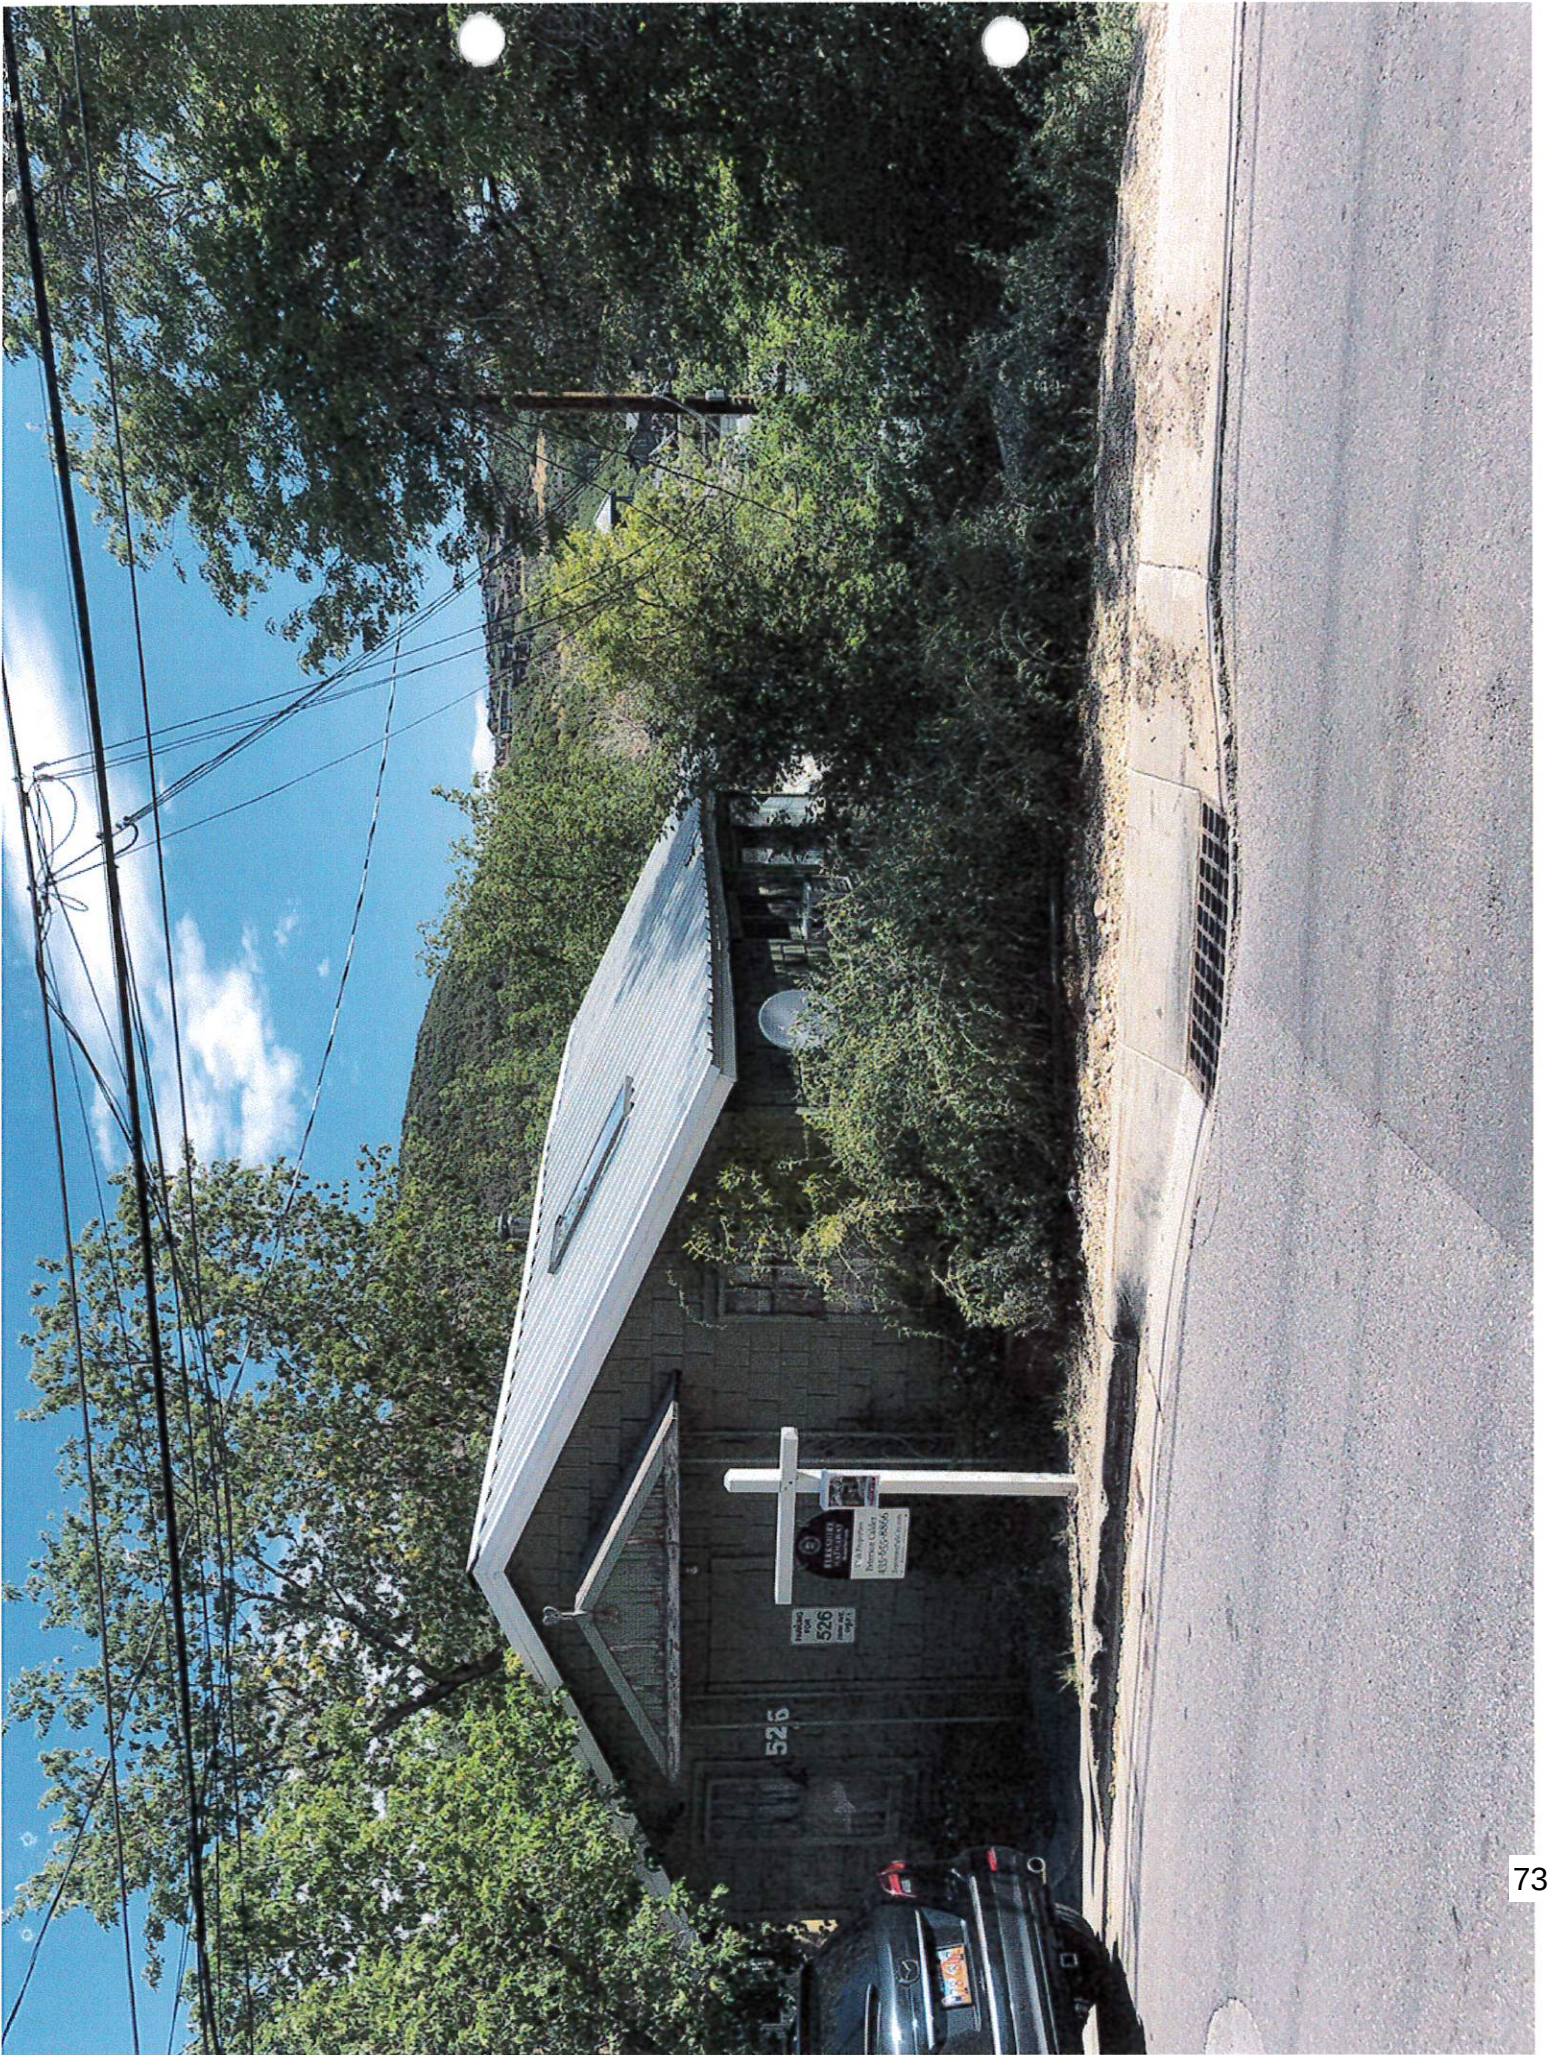
Photo Numbers: 7 Illustration Numbers: E2.03, E3.01

| Main roof is not up to par with historic metal systems<br>Porch roof is non-historic and conflicts with historic garage use. |

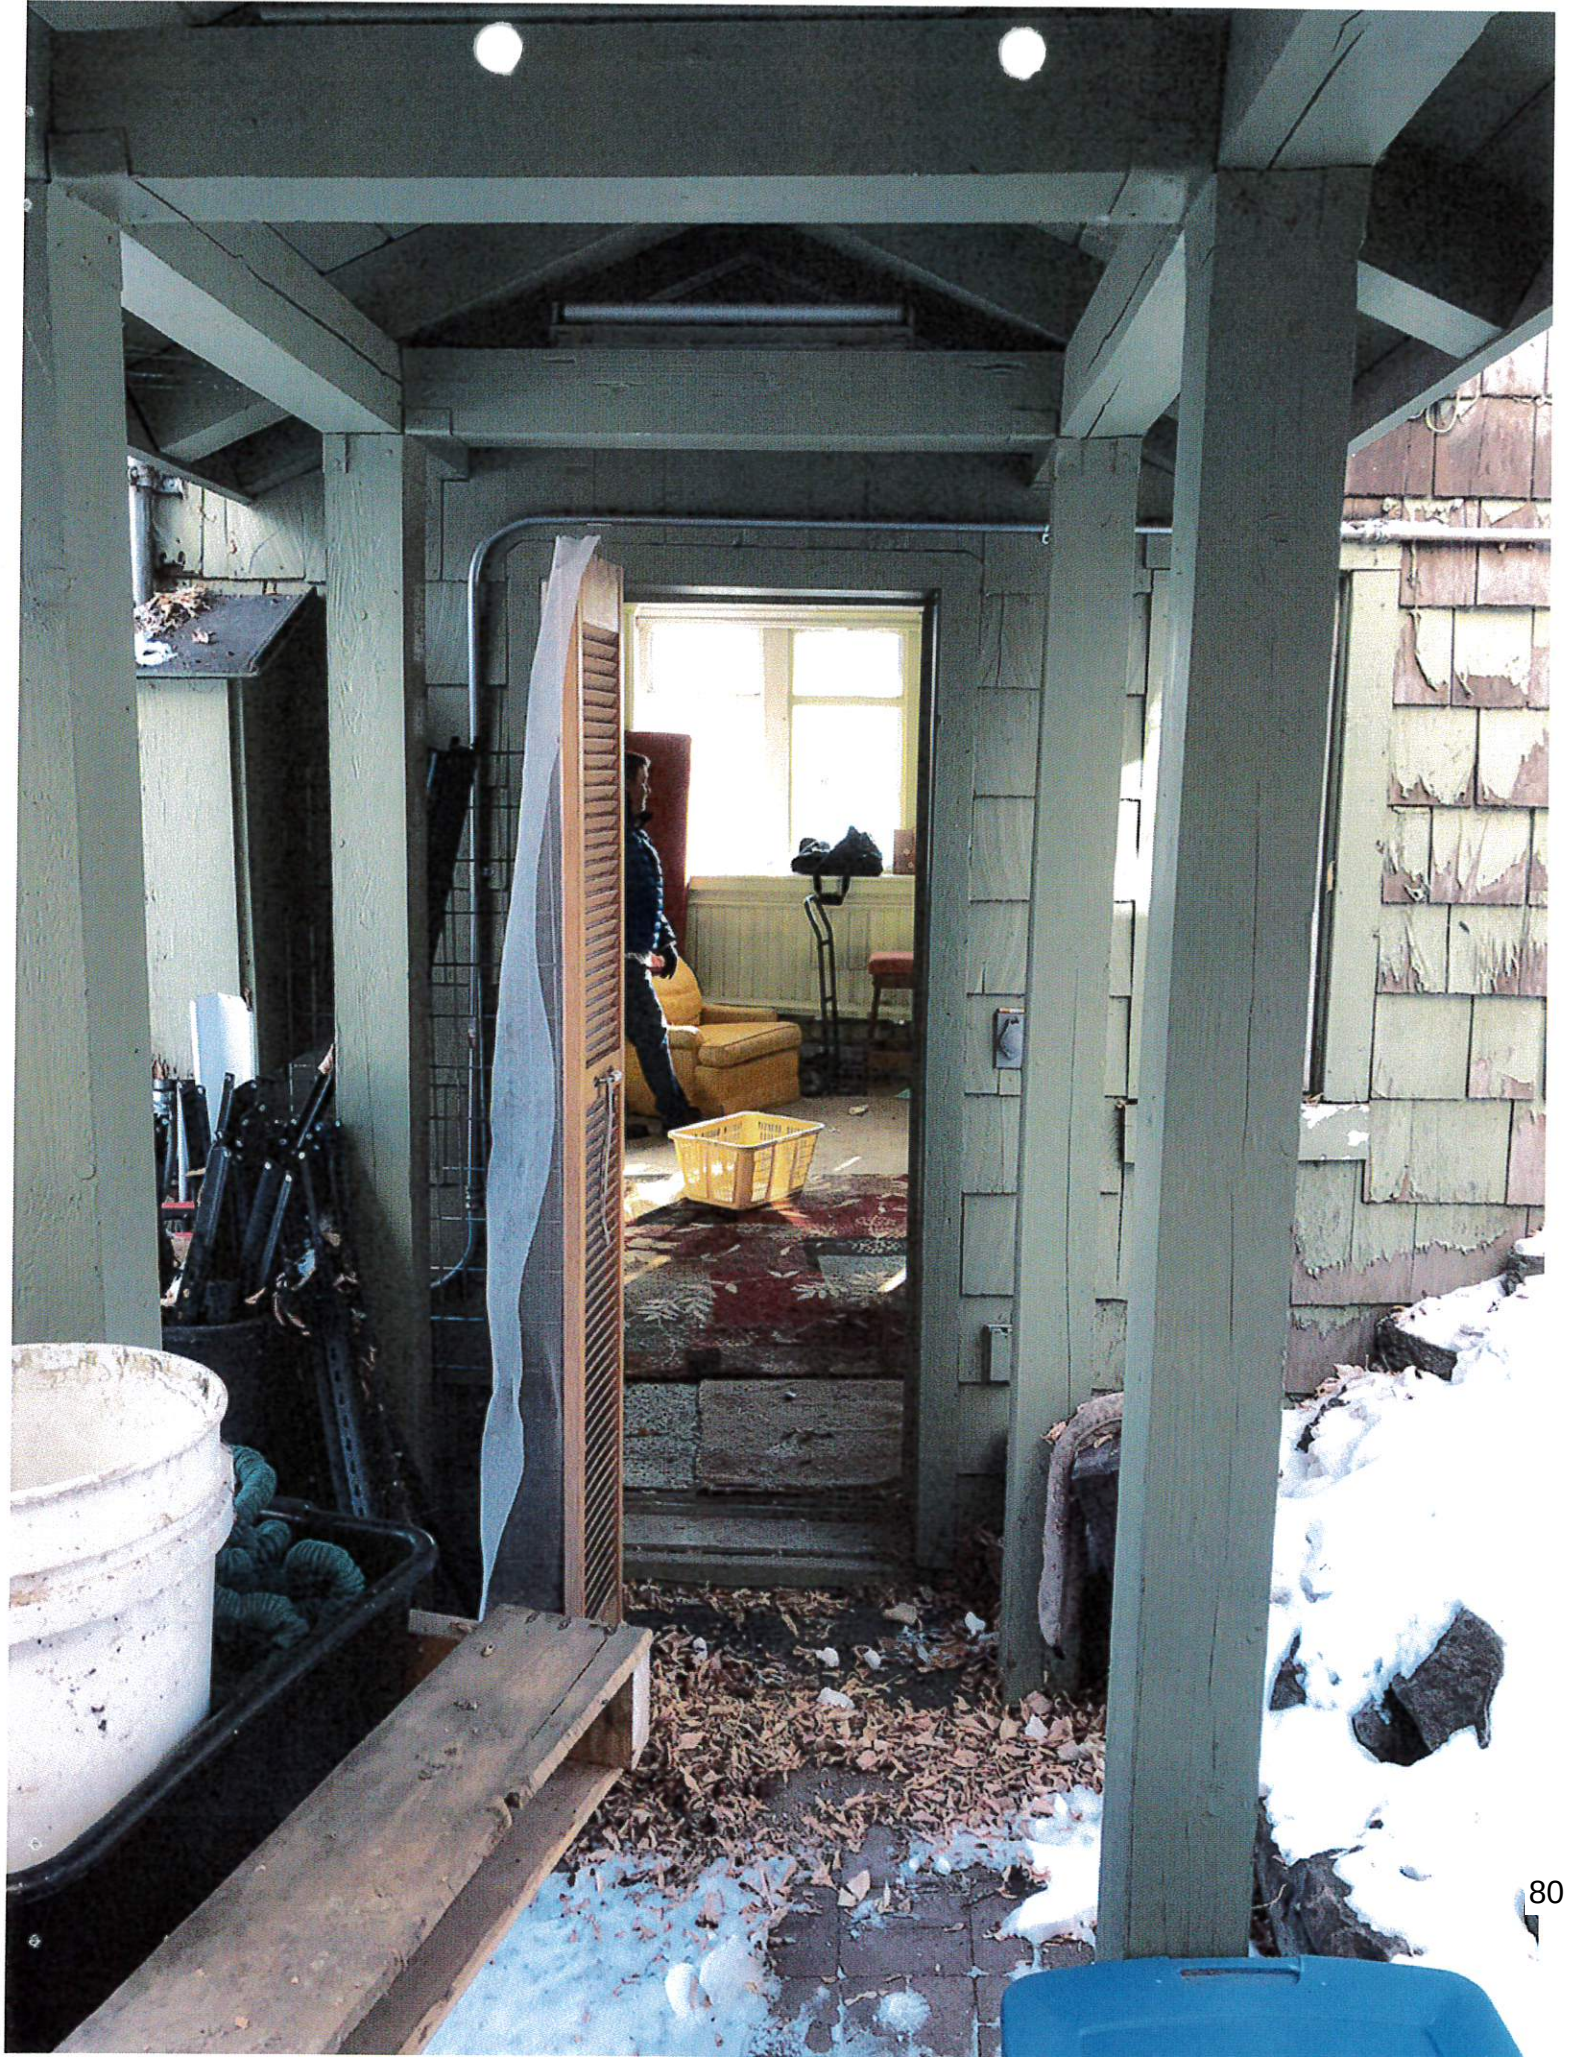
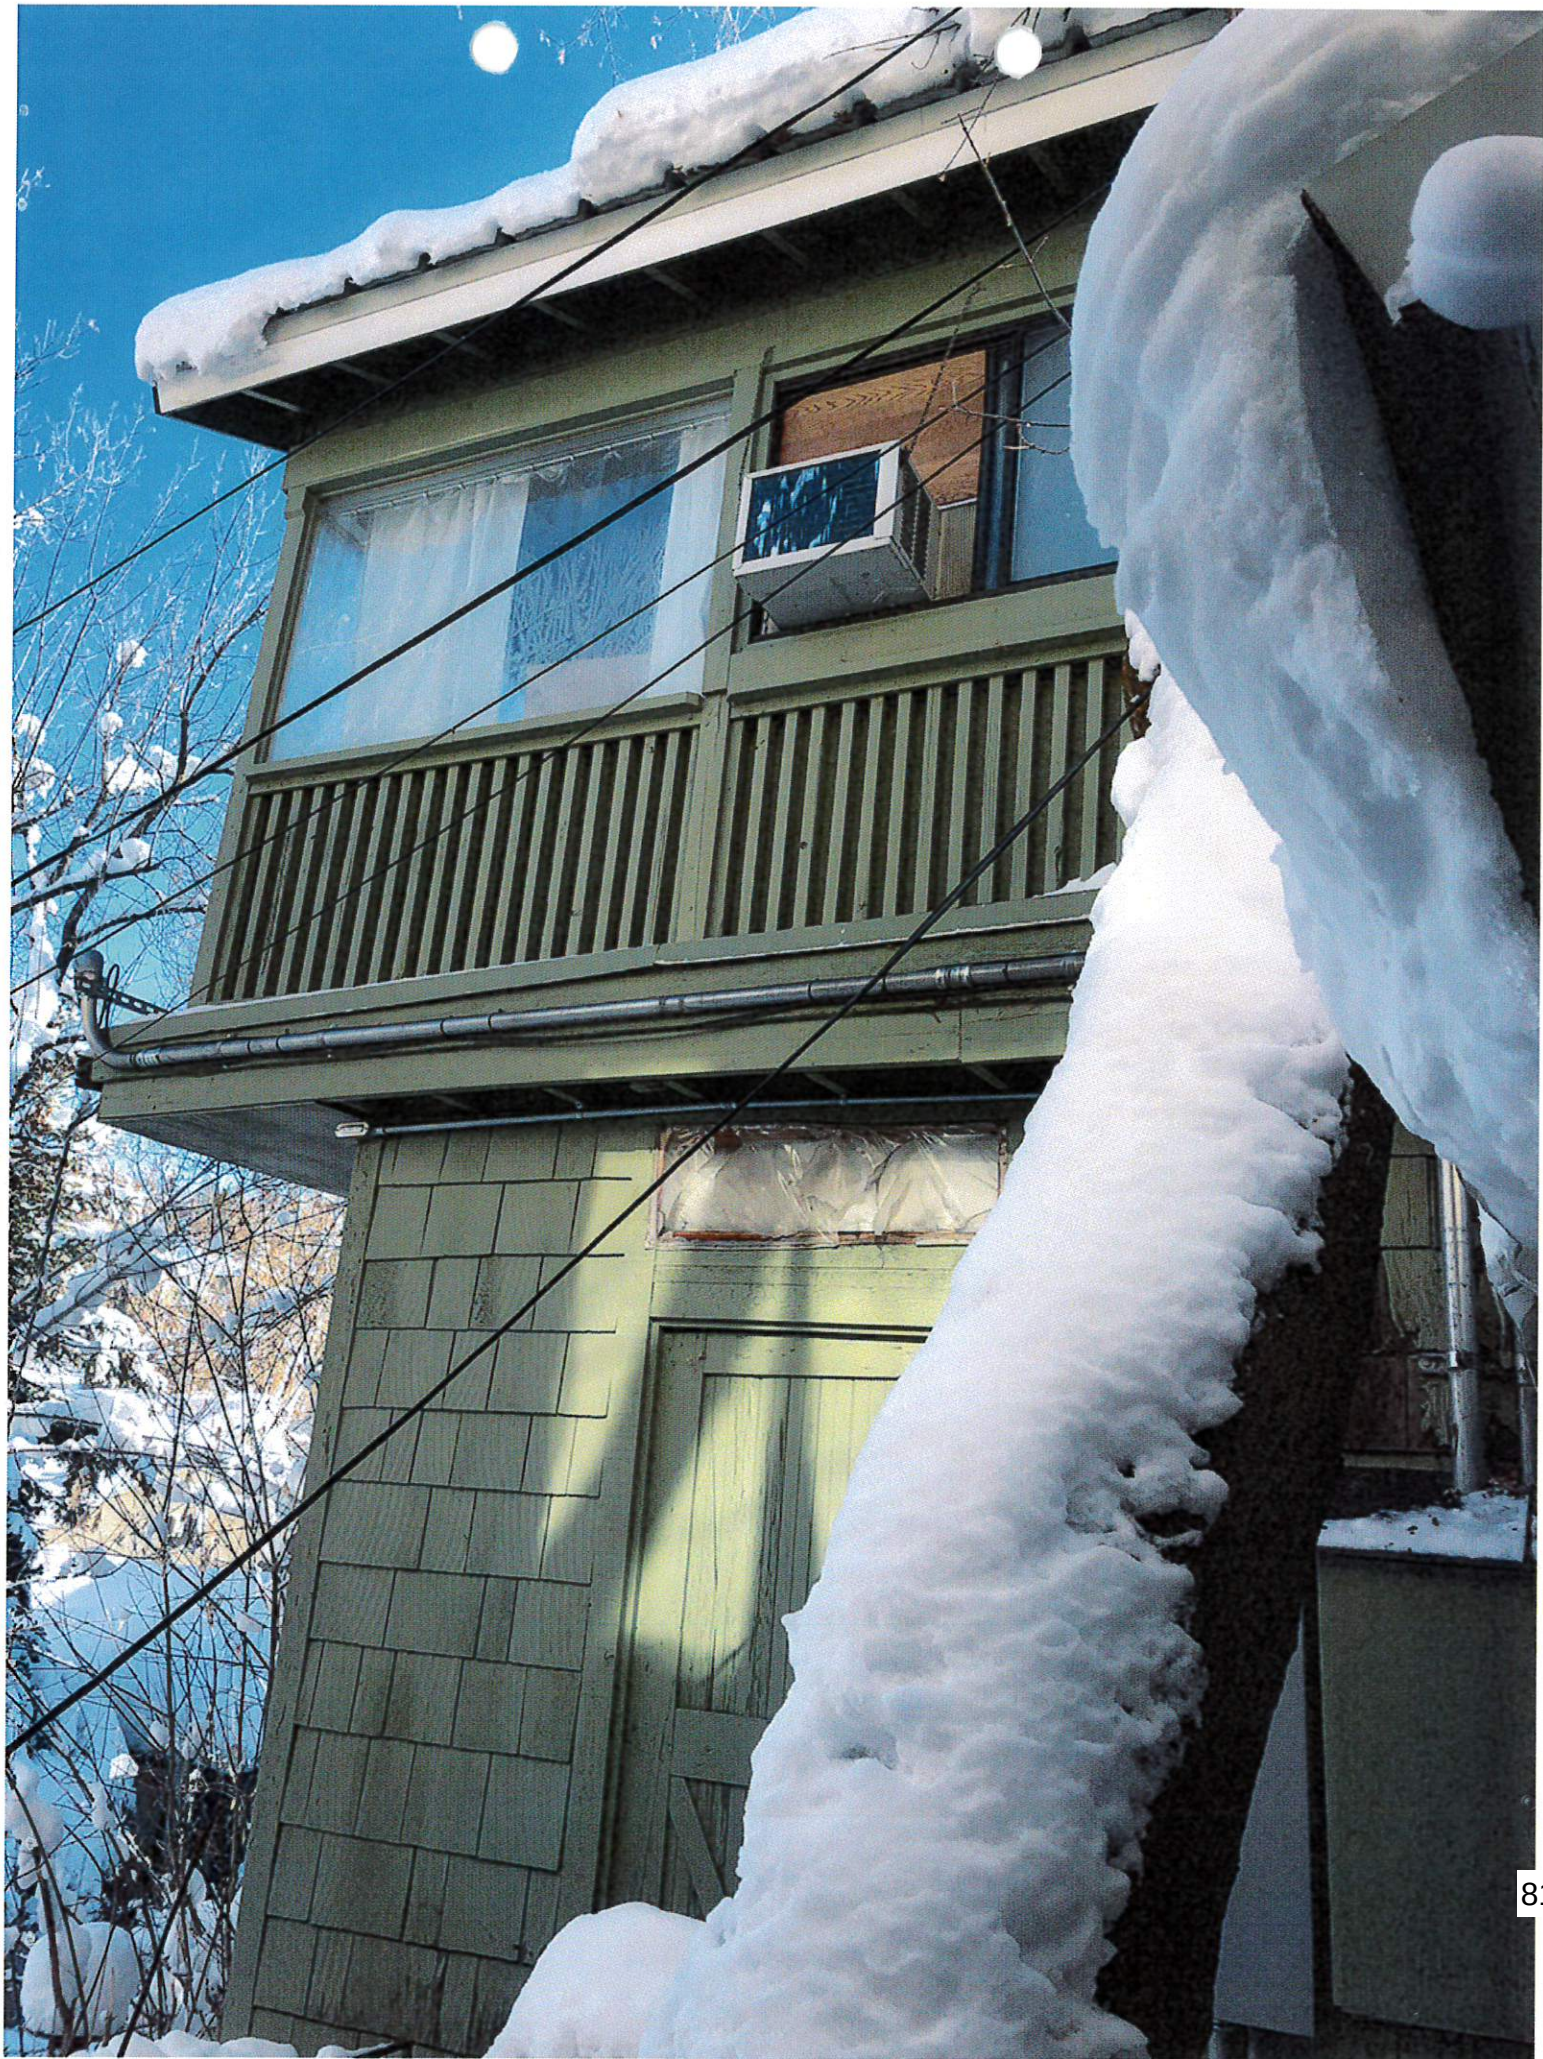
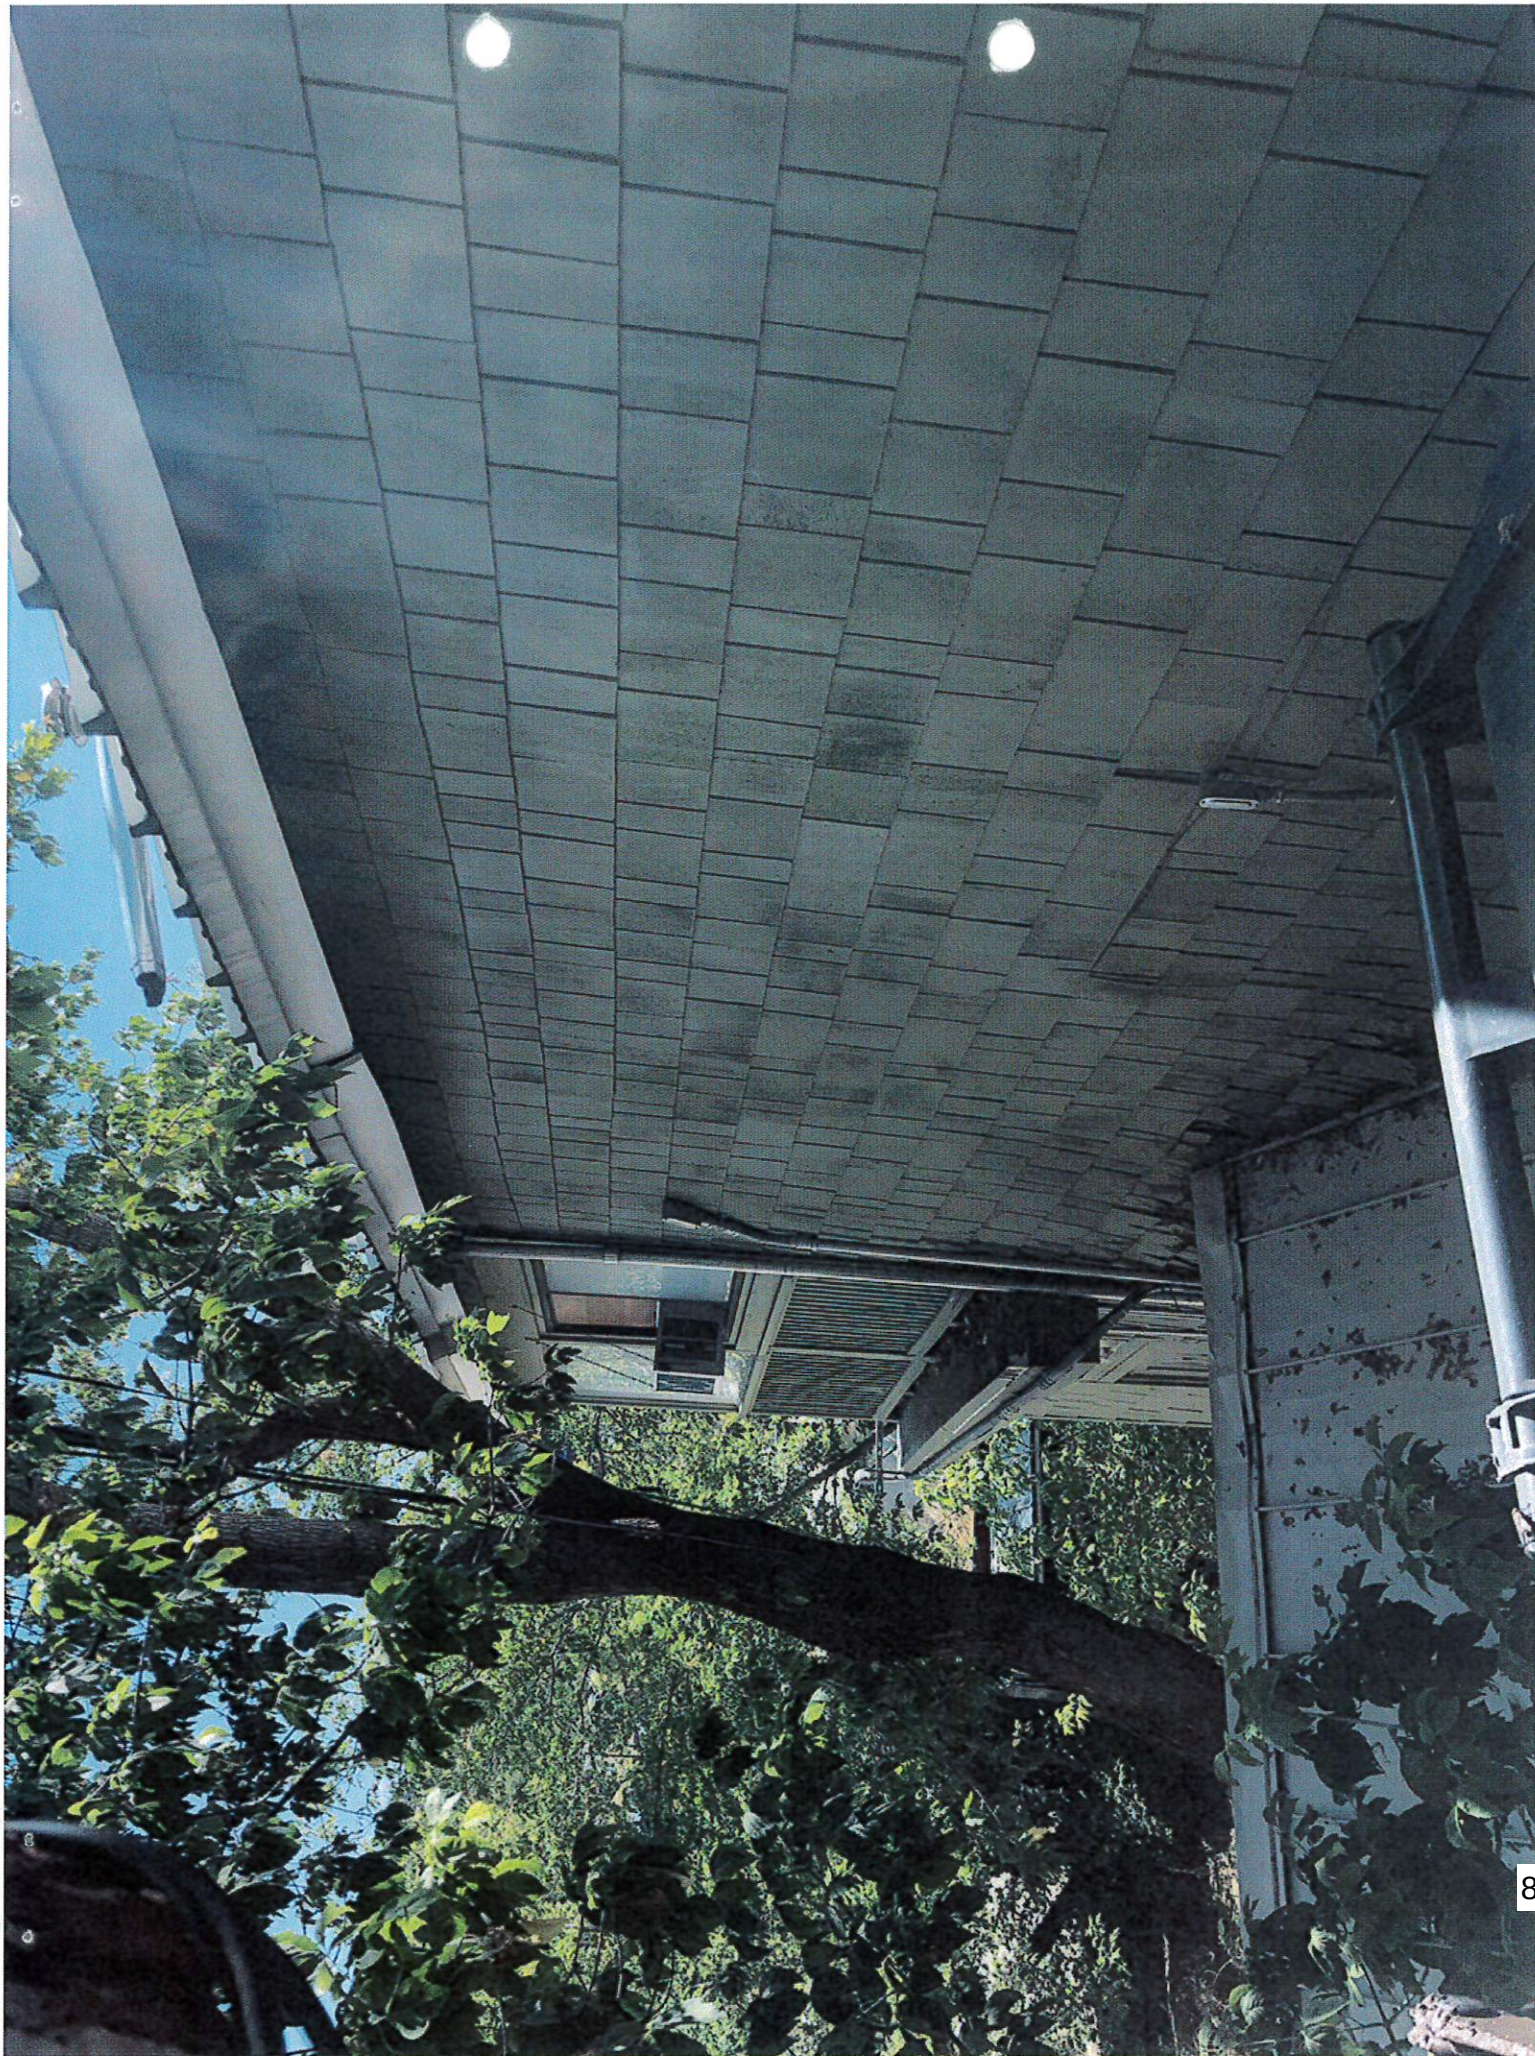
Photo Numbers: 2, 8, 15 Illustration Numbers: E3.01

non-historic shingles siding

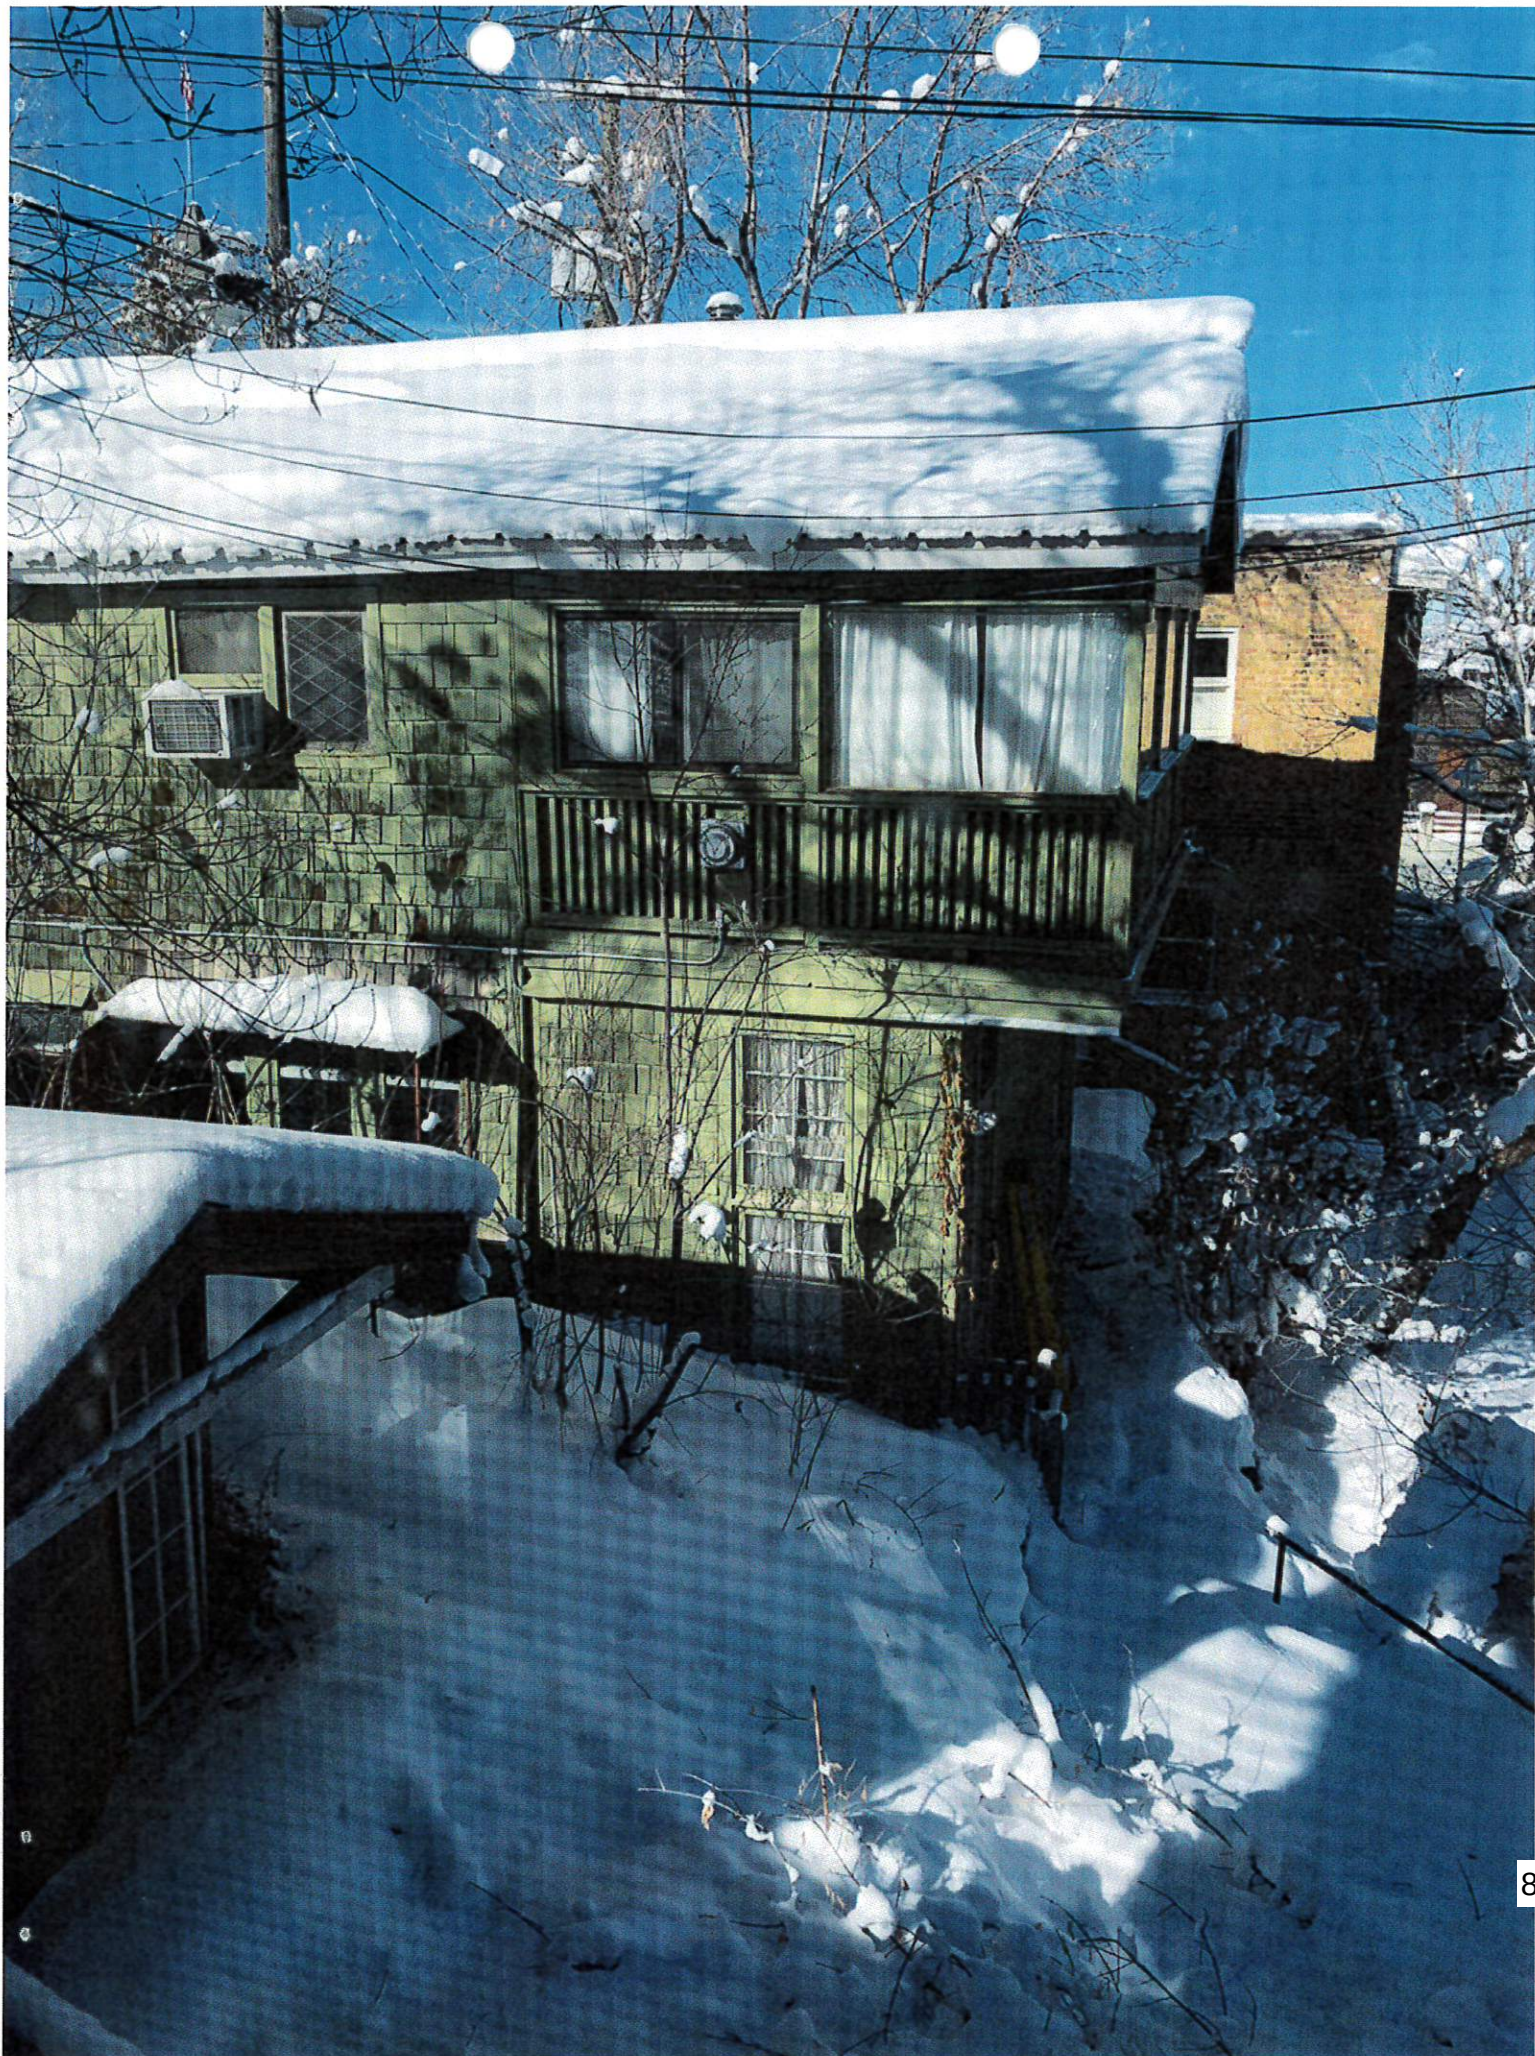
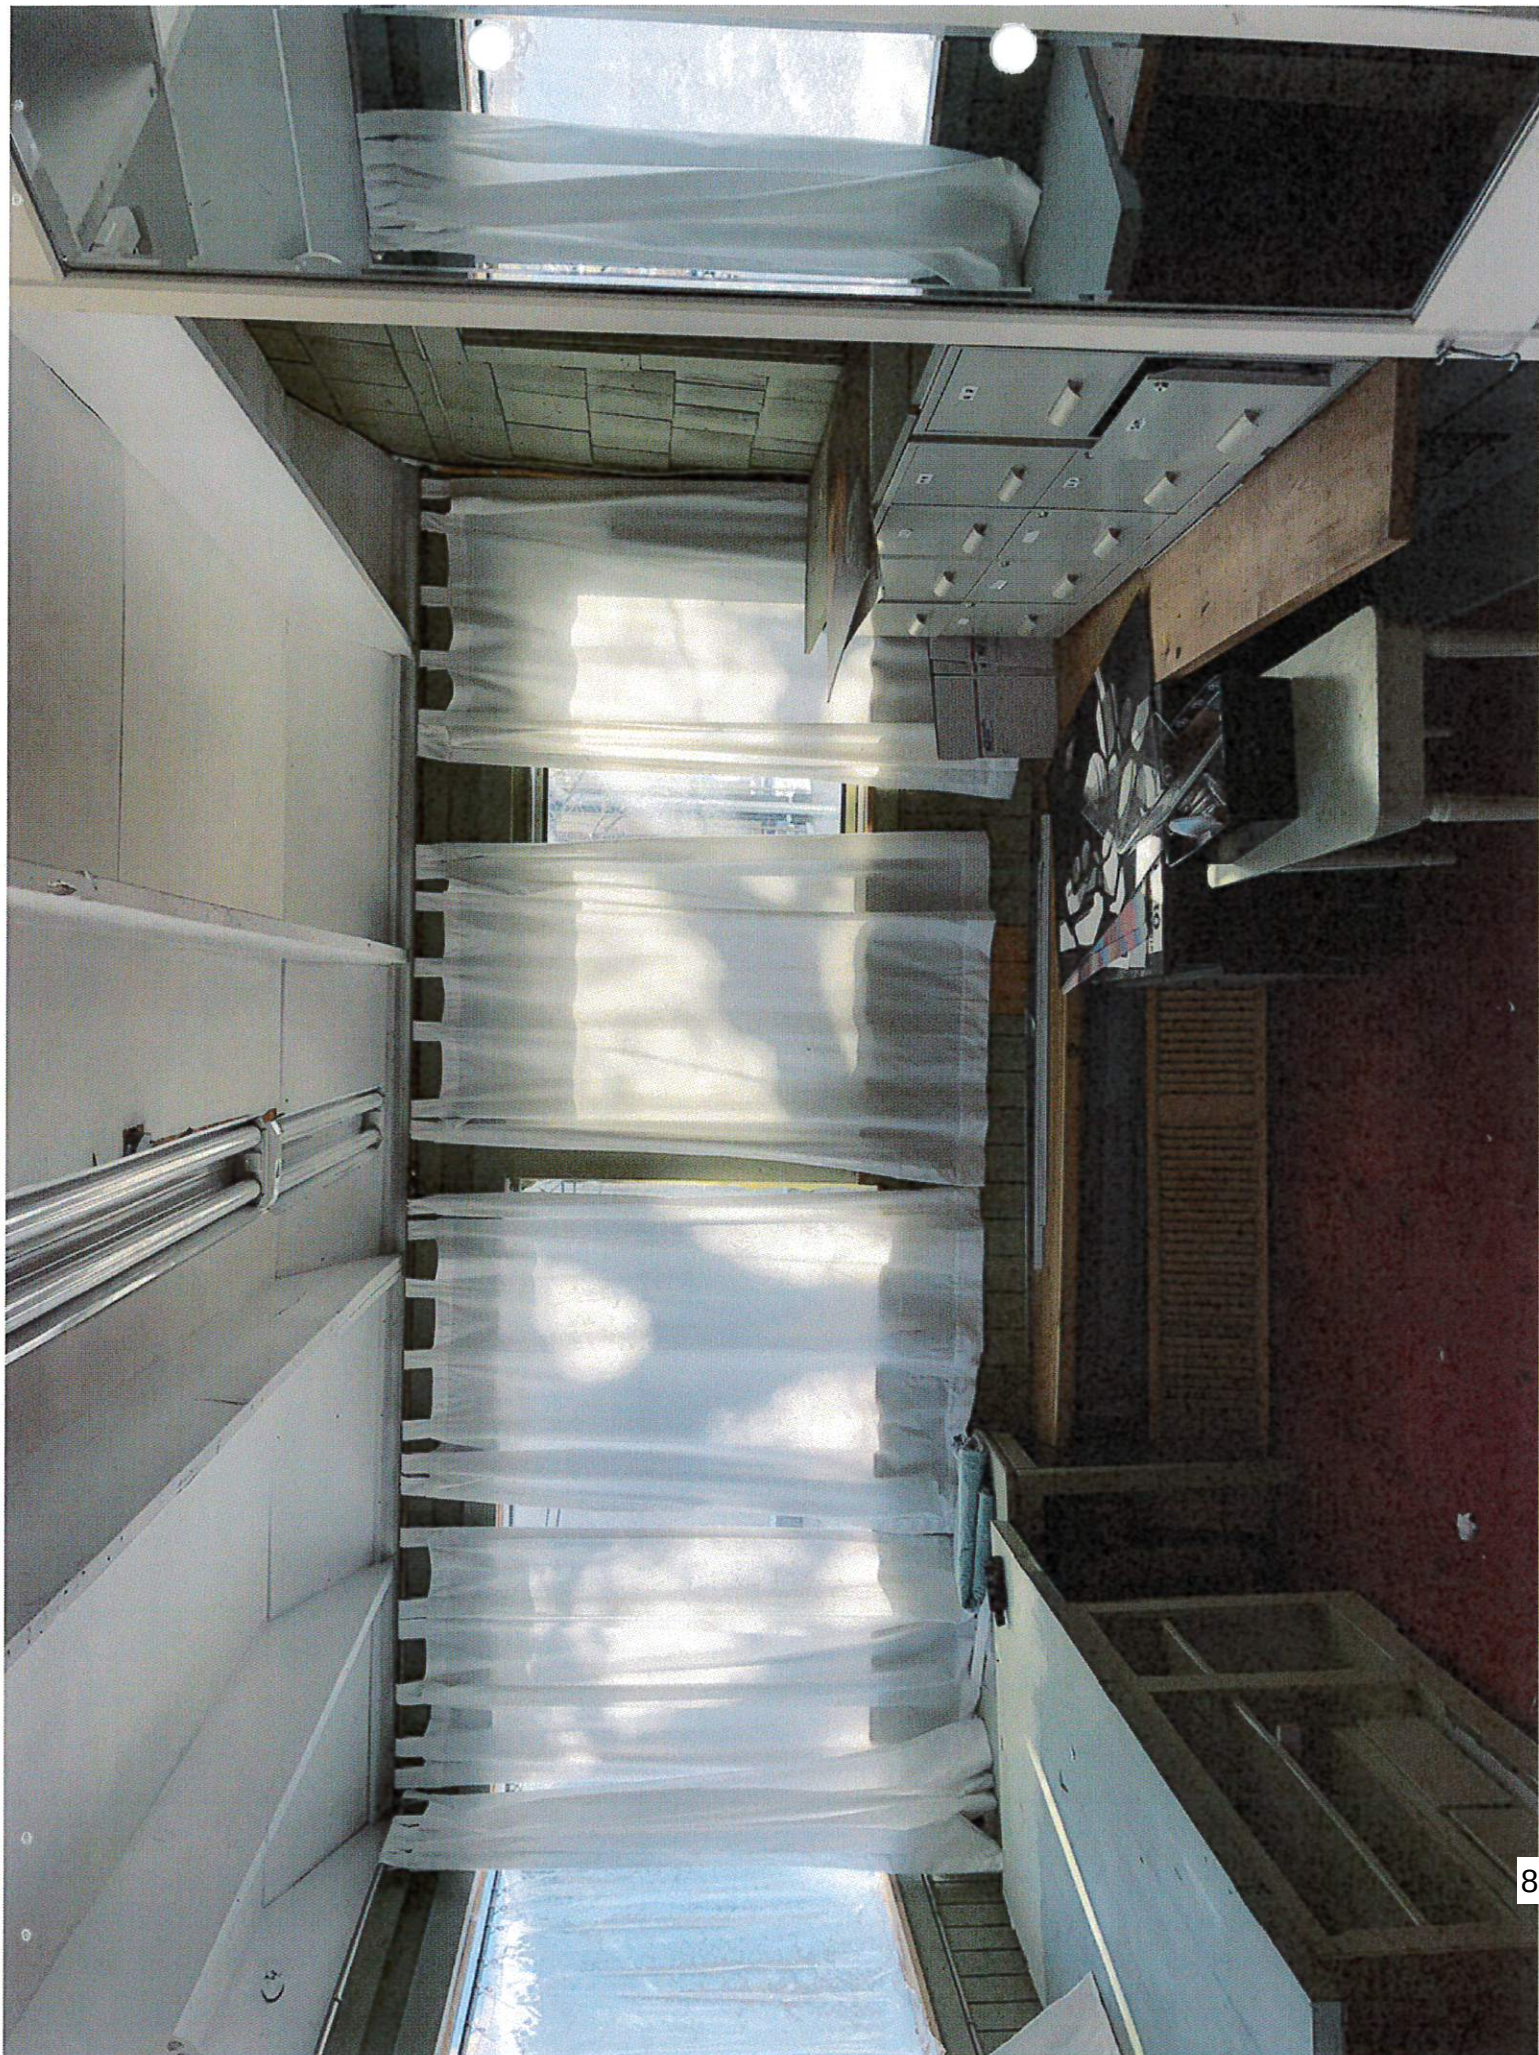
Photo Numbers: 11. 12 Illustration Numbers: E3.01

enclosing wall and windows are in poor shape and need replacing with more historic scale windows.
