**PARK CITY HISTORIC PRESERVATION BOARD MEETING  
SUMMIT COUNTY, UTAH  
November 6, 2019**

- 6.A. 526 Park Avenue – Historic District Design Review  
Historic Preservation Board Review for Material Deconstruction of a Significant Historic Structure – The Applicant is Proposing to Rehabilitate and Restore a Historic Structure back to its Original Use as a Garage. Applicant is Proposing to Impact the Following Materials Including Non-Historic Railroad Tie Retaining Walls; Non-Historic Covered Entry and Patio; Non-Historic Exterior Stairs; Non-Historic Stone Retaining Walls; Post-1929 Concrete Foundation; Post-1929 Floor Structure with Modern Upgrades; Post-1929 Original Roof Pitch and Shape; Post-1968 West Wall used to Cover Original Garage Doors; Non-Historic Wood Shingle Siding; Non-Historic Front (West) Porch; Post-1968 Rear (East) Enclosed Deck; Post-1995 Skylight Window; and Non-Historic Windows and Doors Replacement. PL-18-03966

PARK CITY MUNICIPAL CORPORATION  
HISTORIC PRESERVATION BOARD  
MINUTES OF OCTOBER 2, 2019

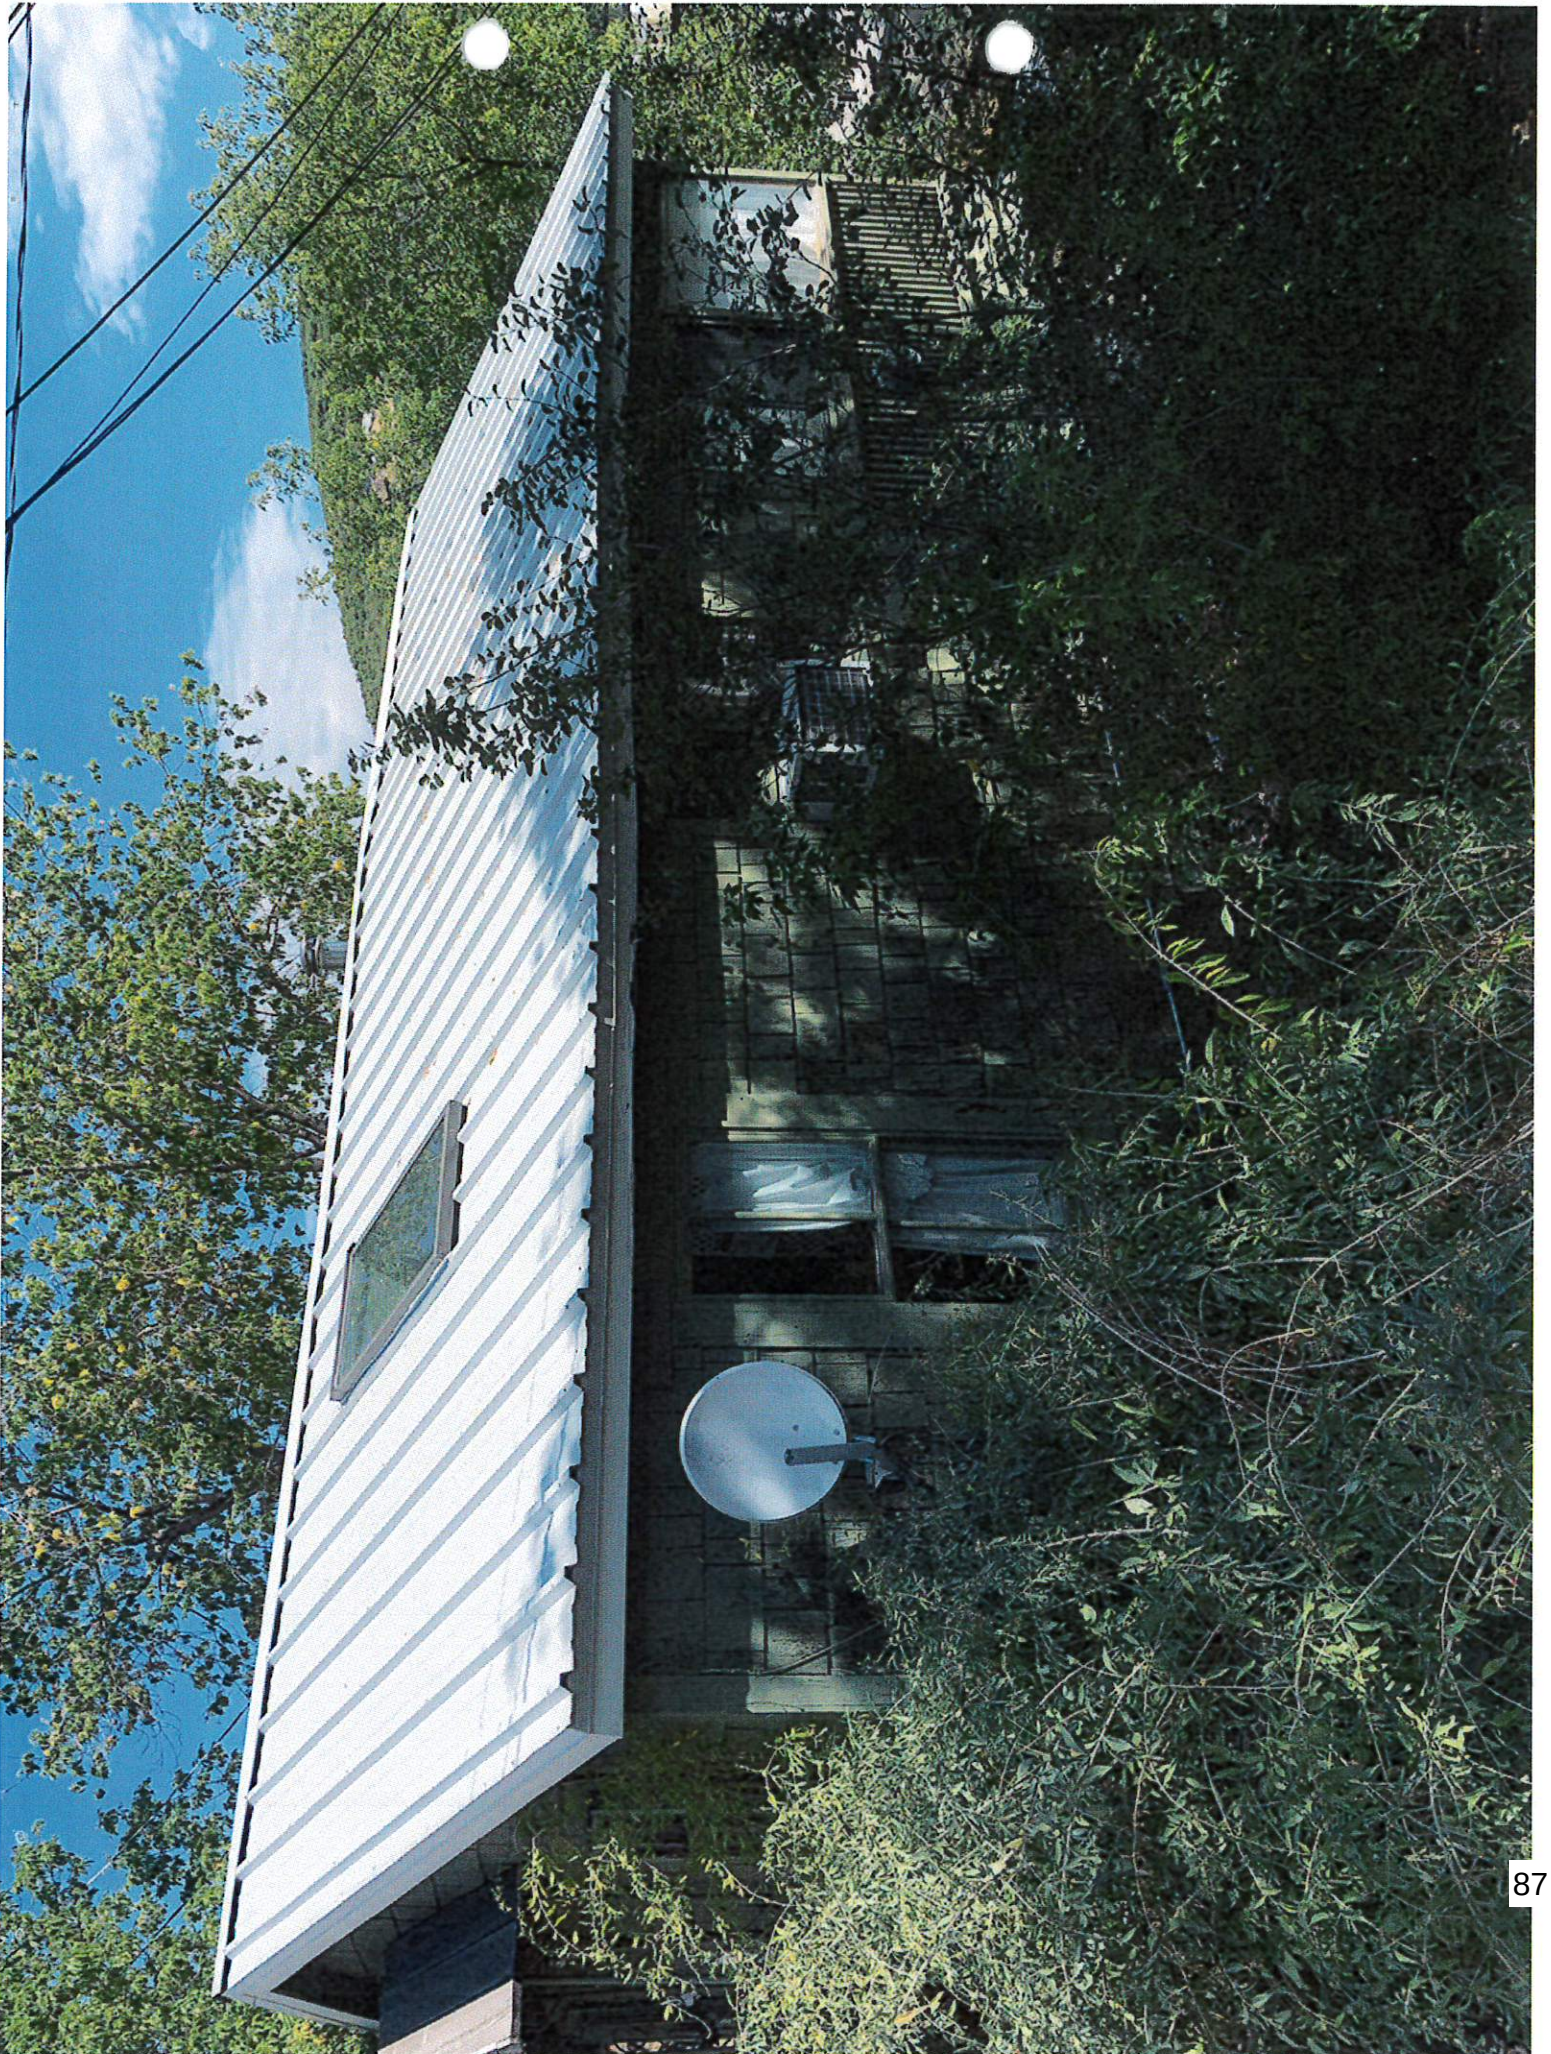
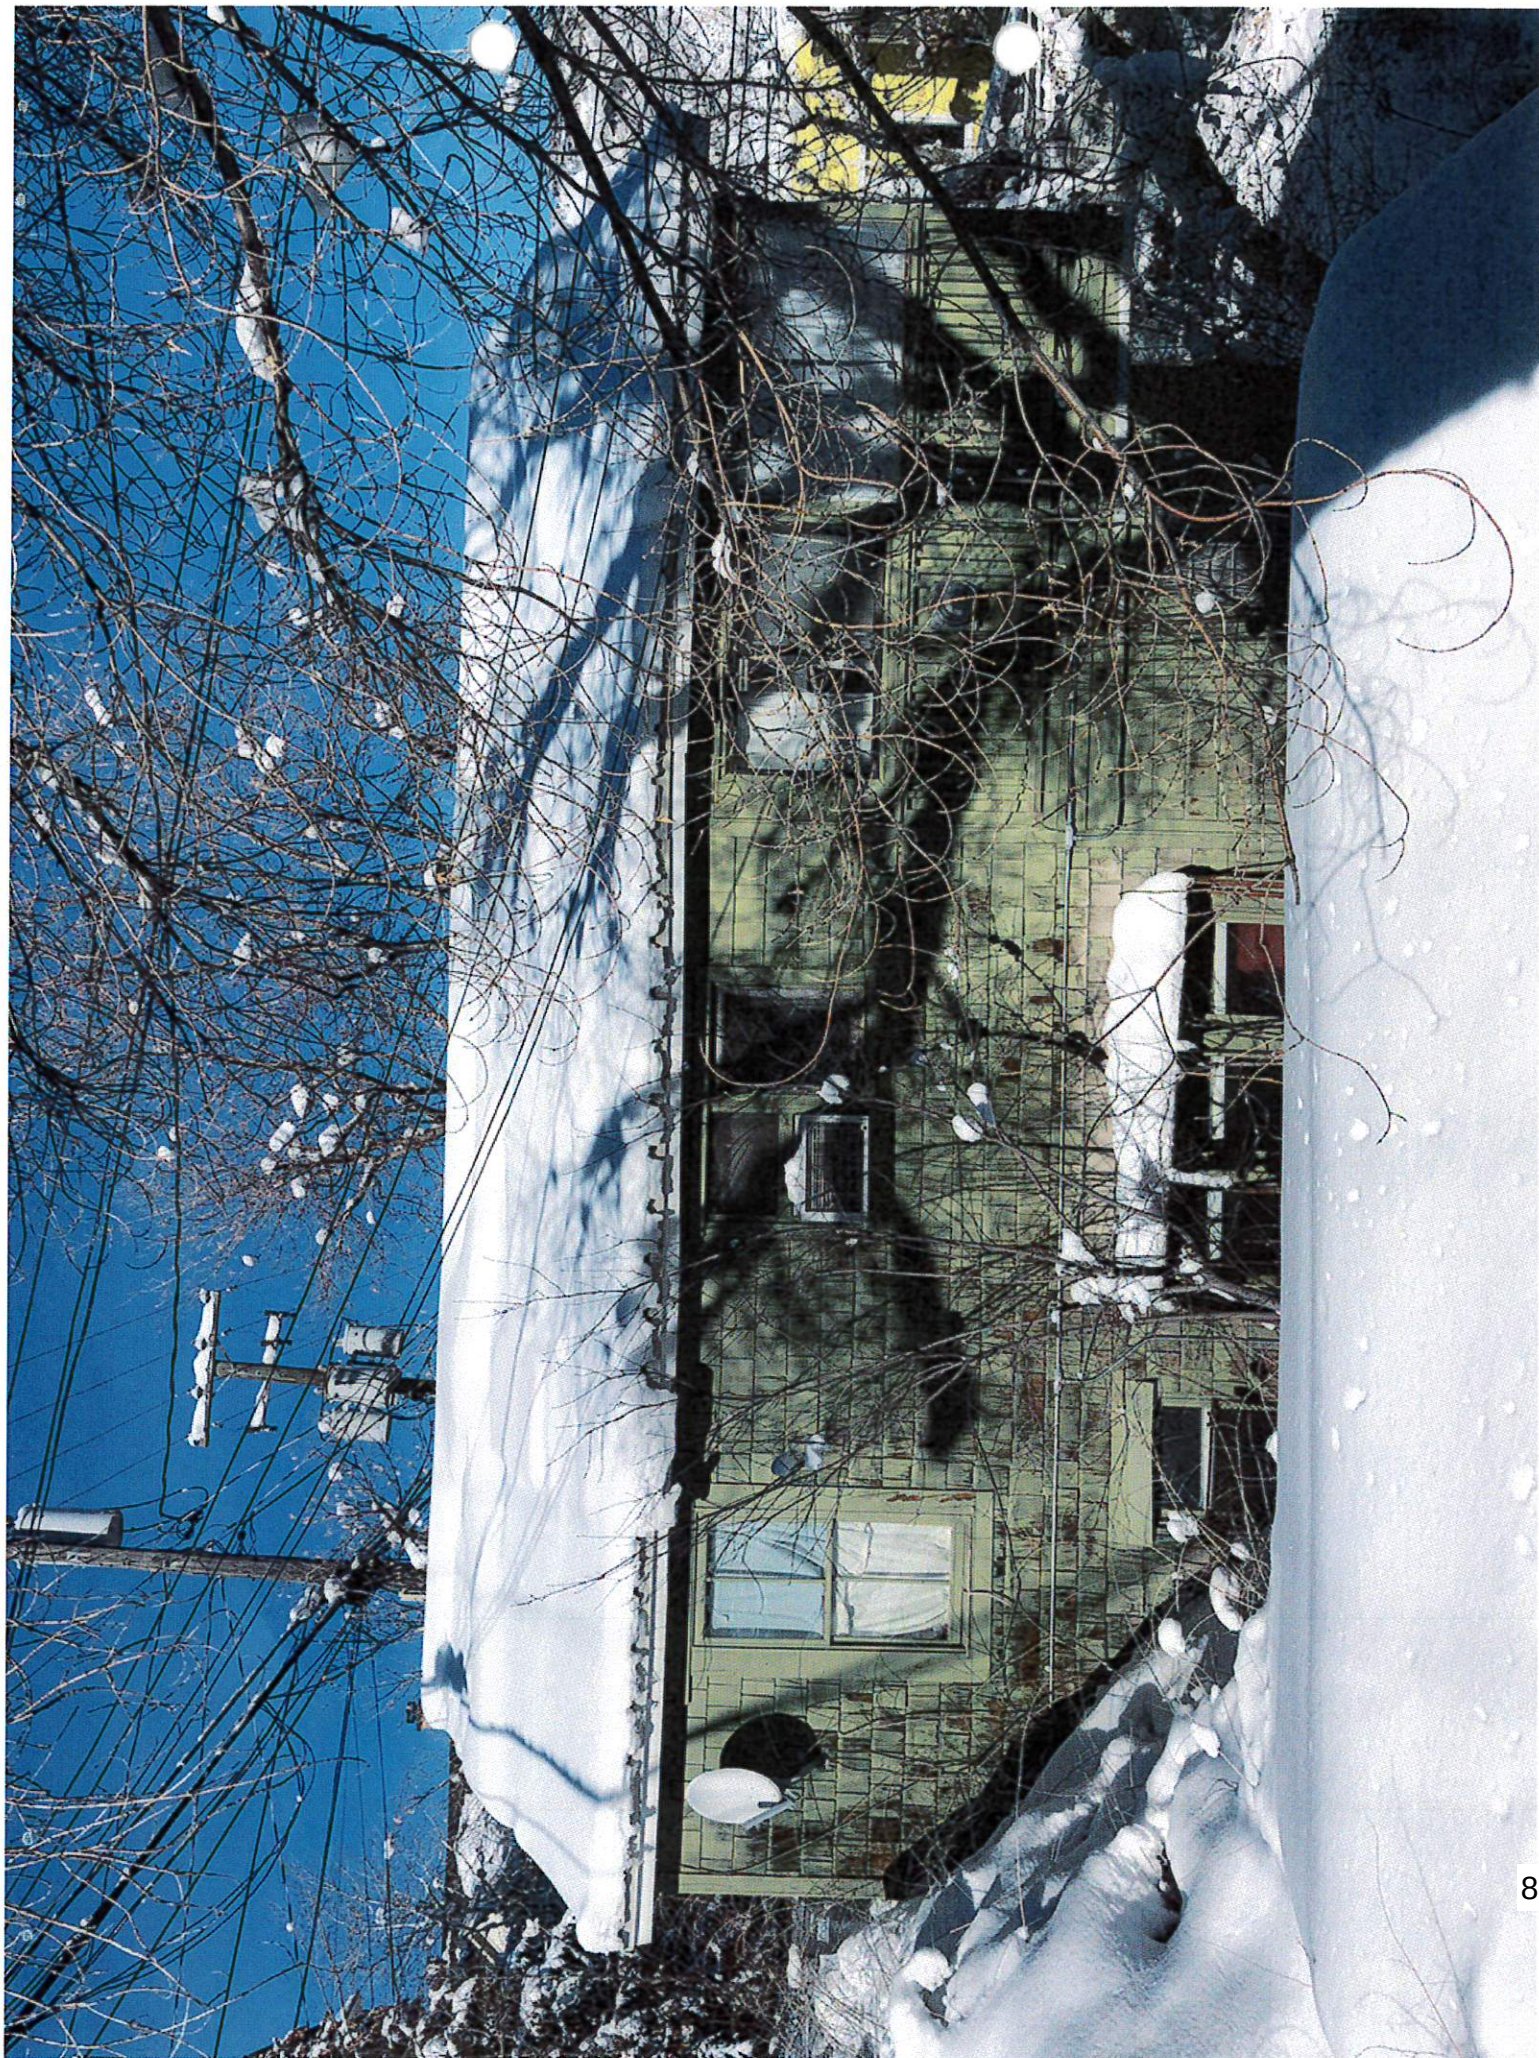
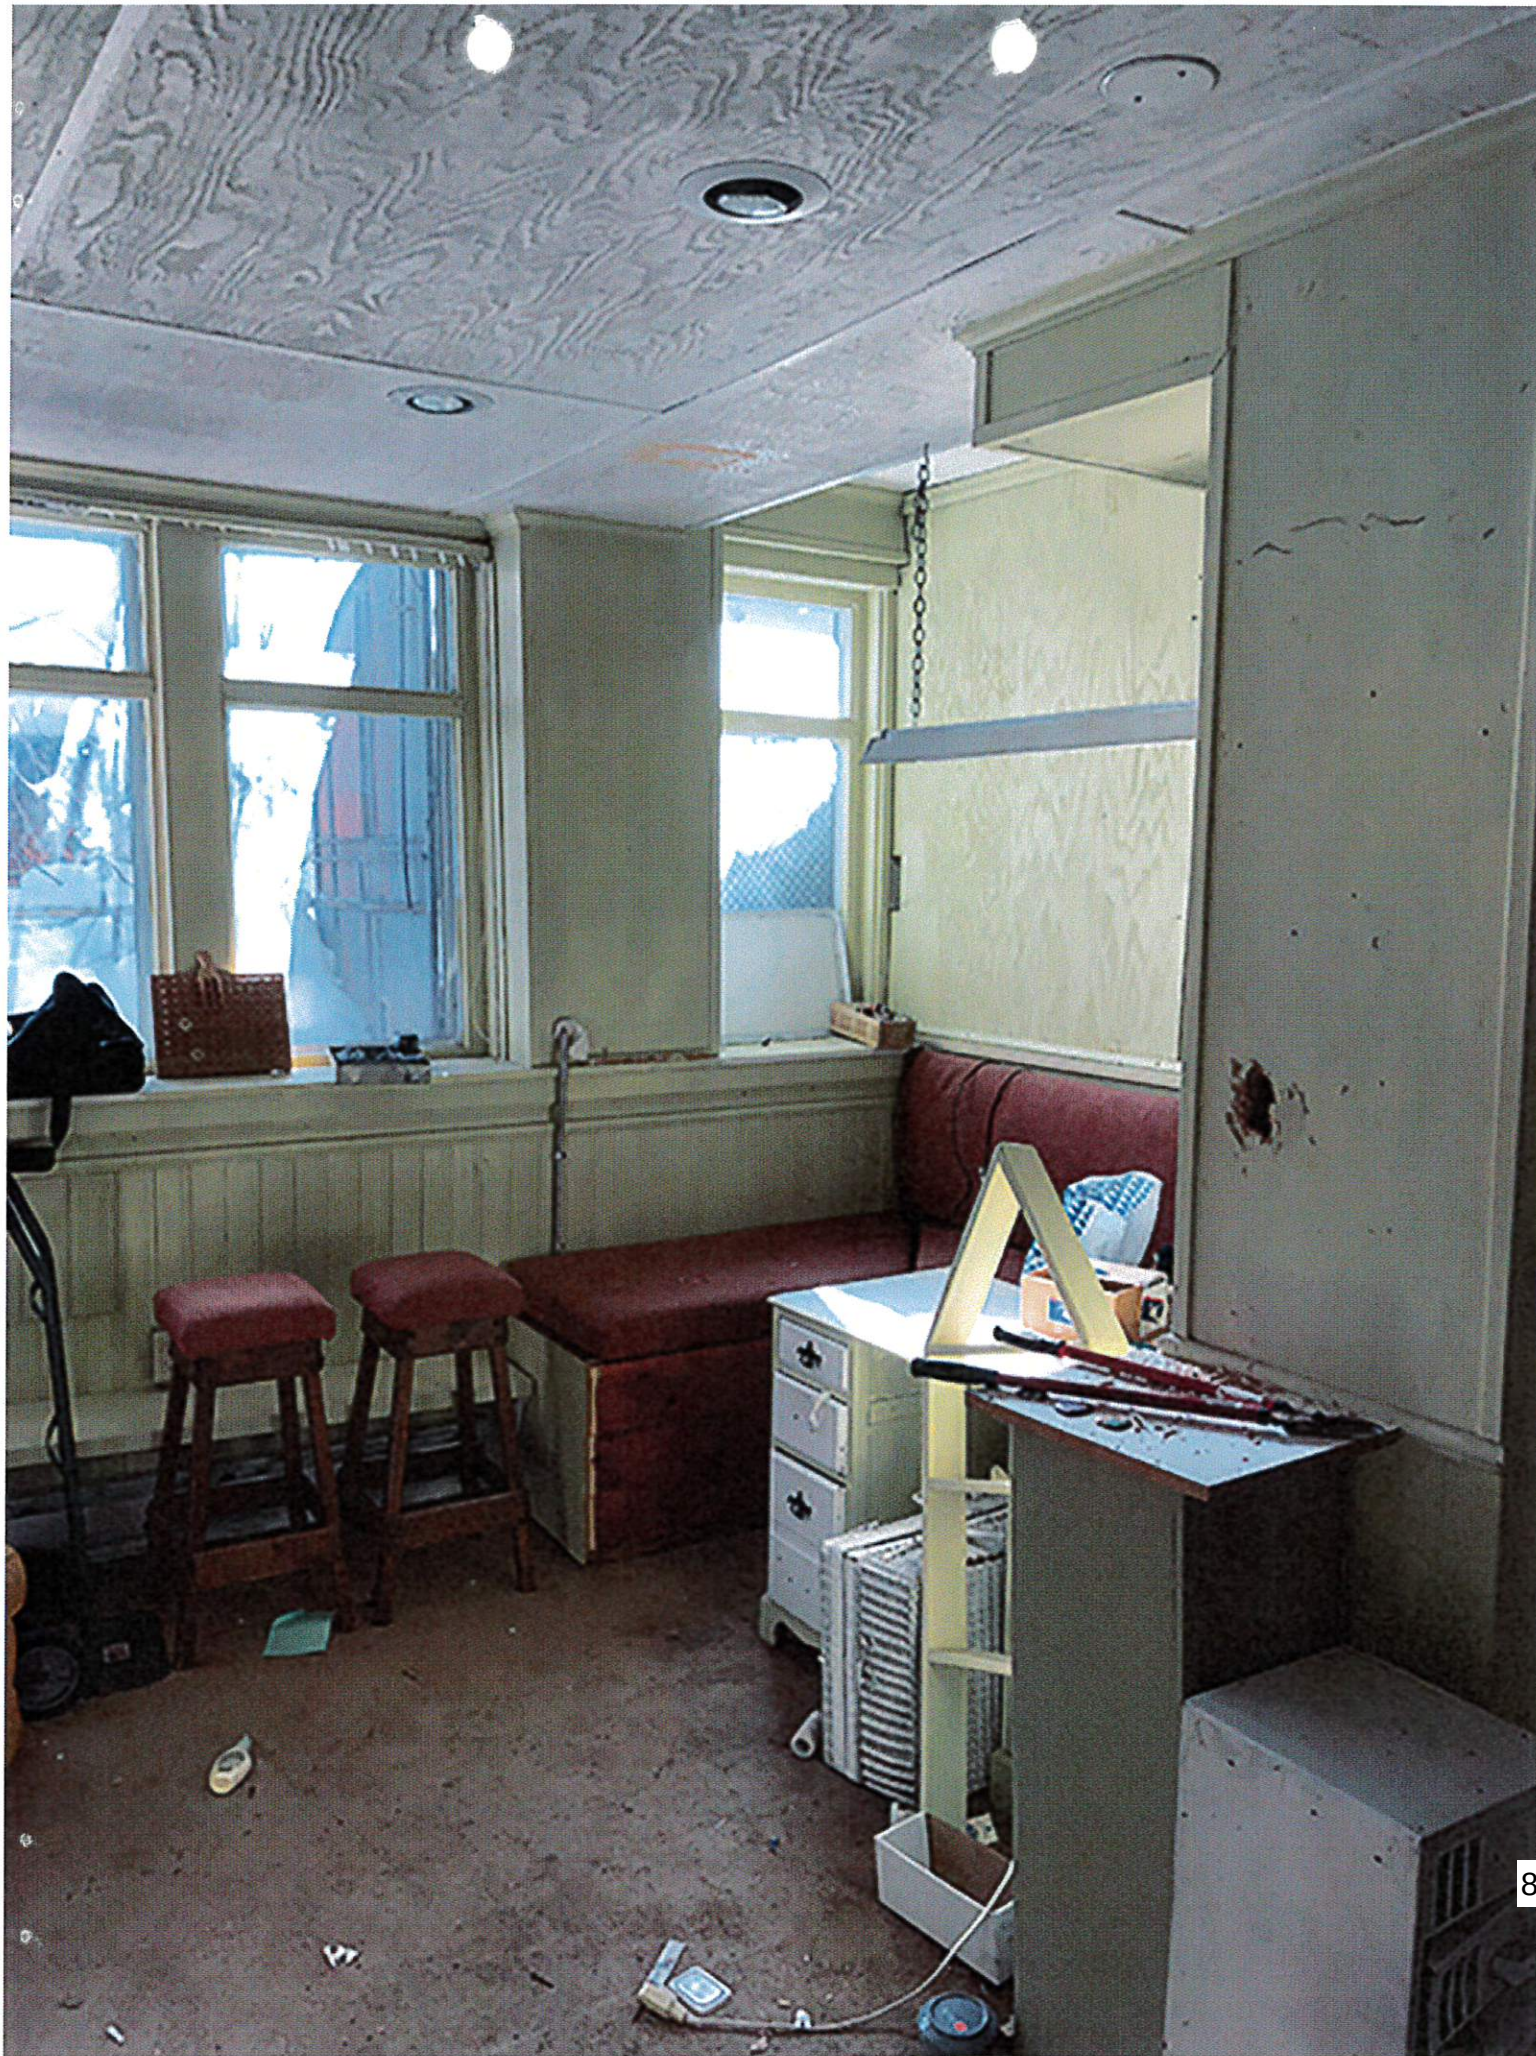
Photo Numbers: 13, 14, 16 Illustration Numbers: E3.01

non-historic siding

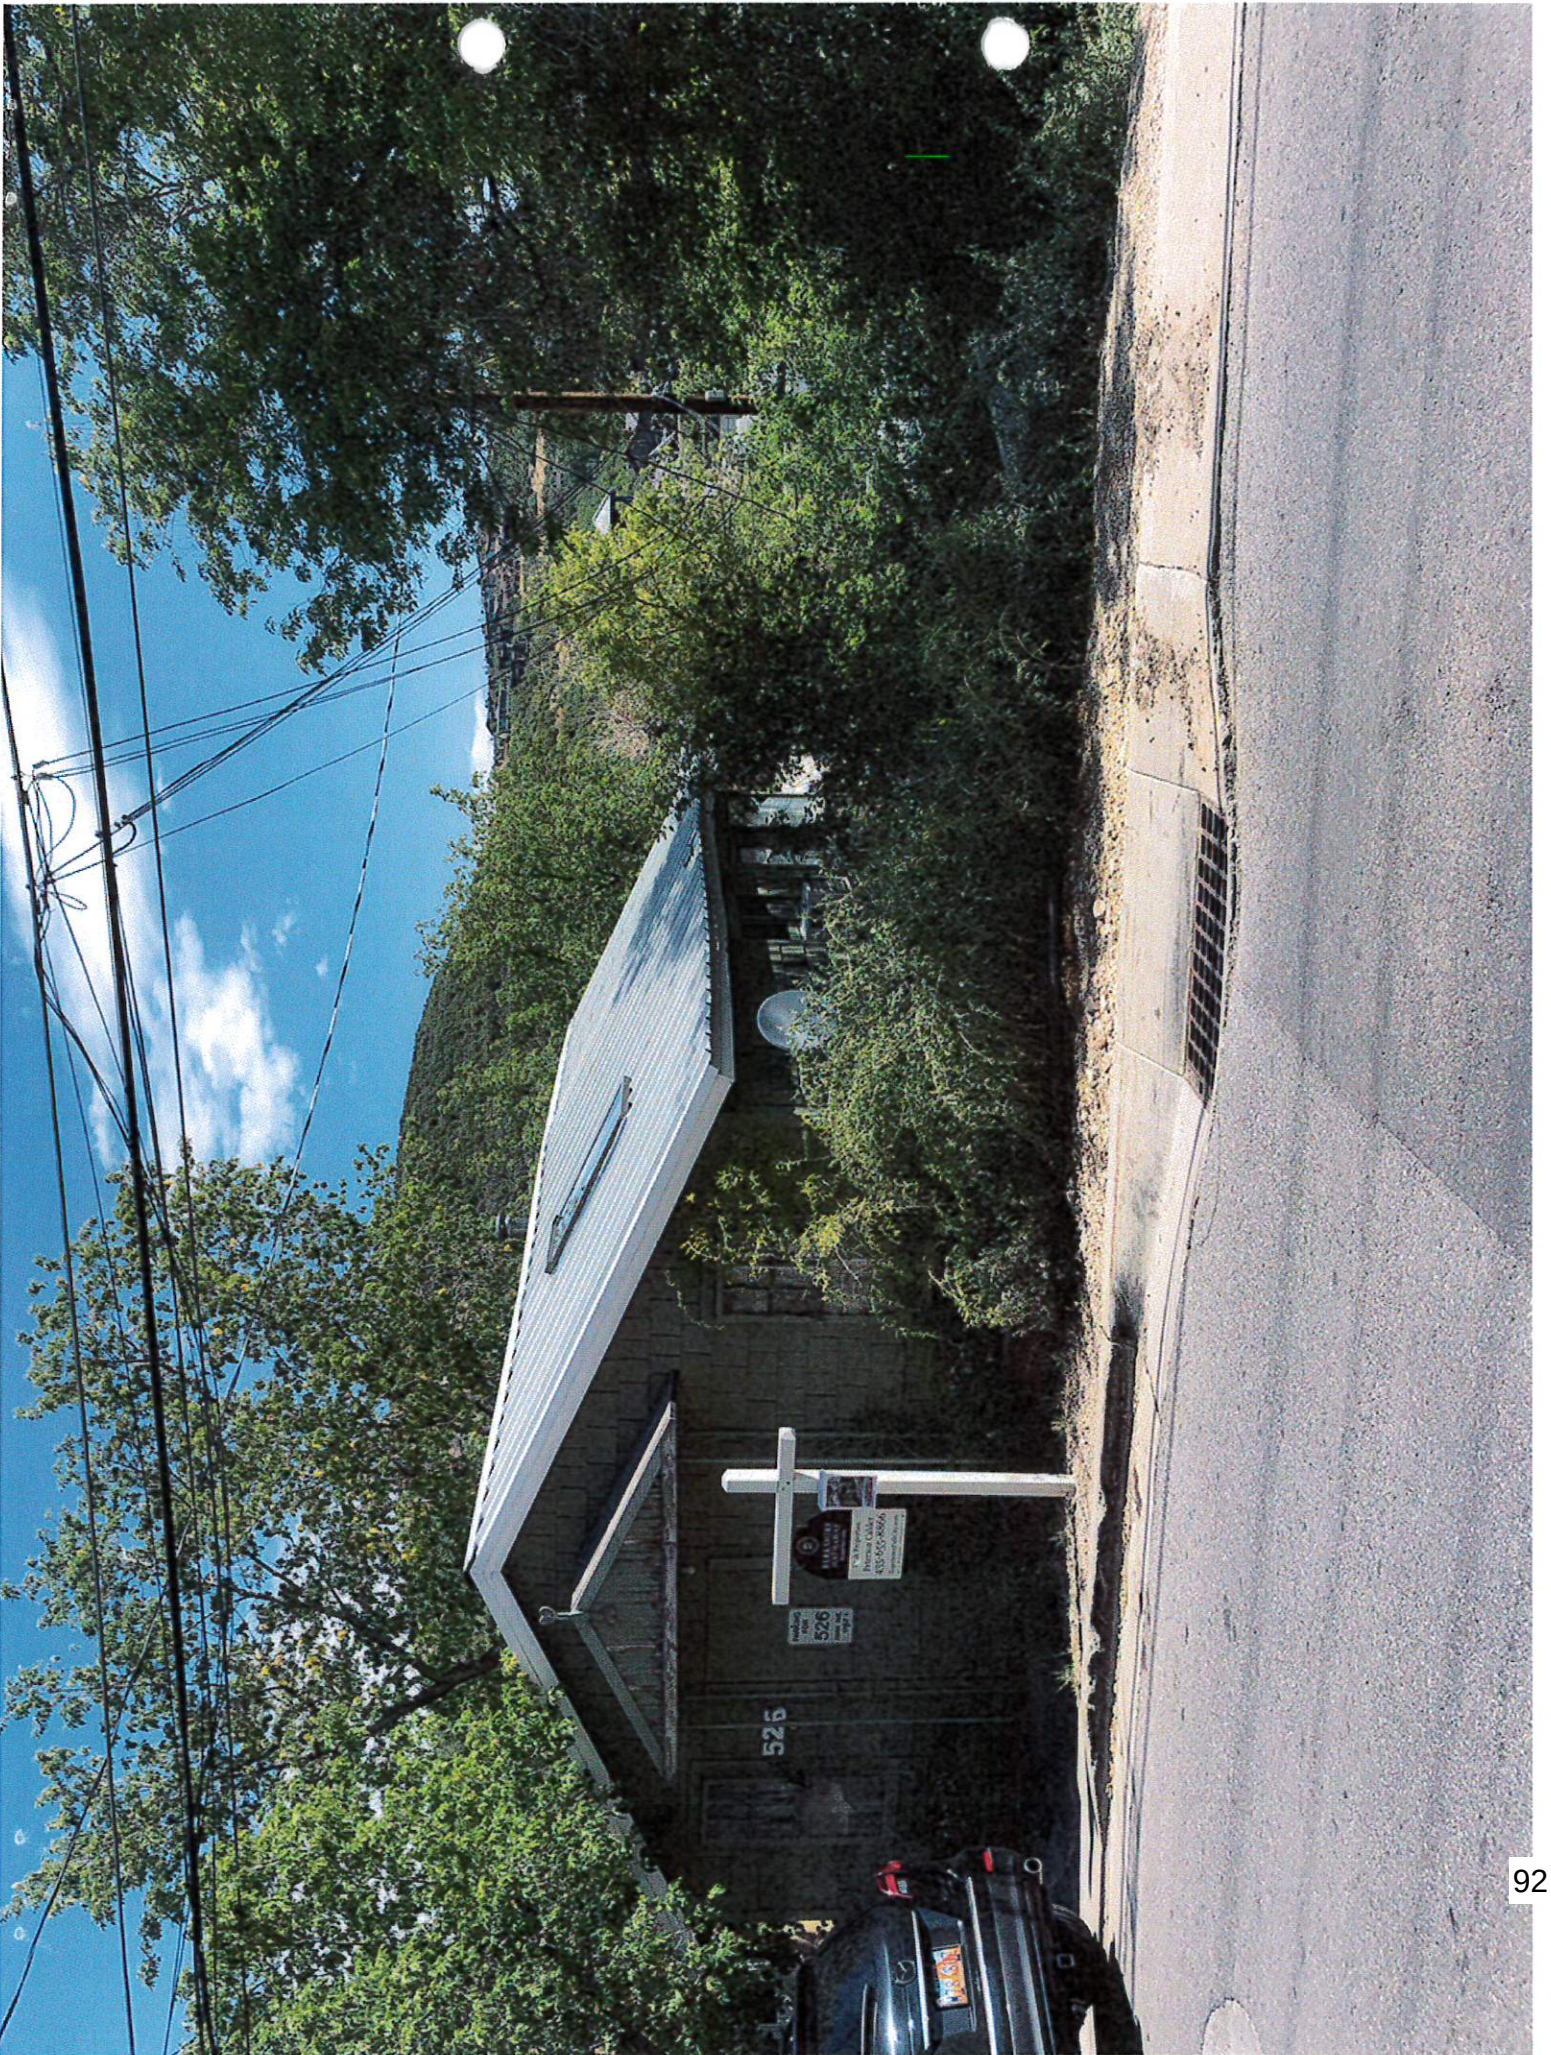
Photo Numbers: 10 Illustration Numbers: E3.01

| non-historic and too small for use. Needs to be removed to restore garage doors. |

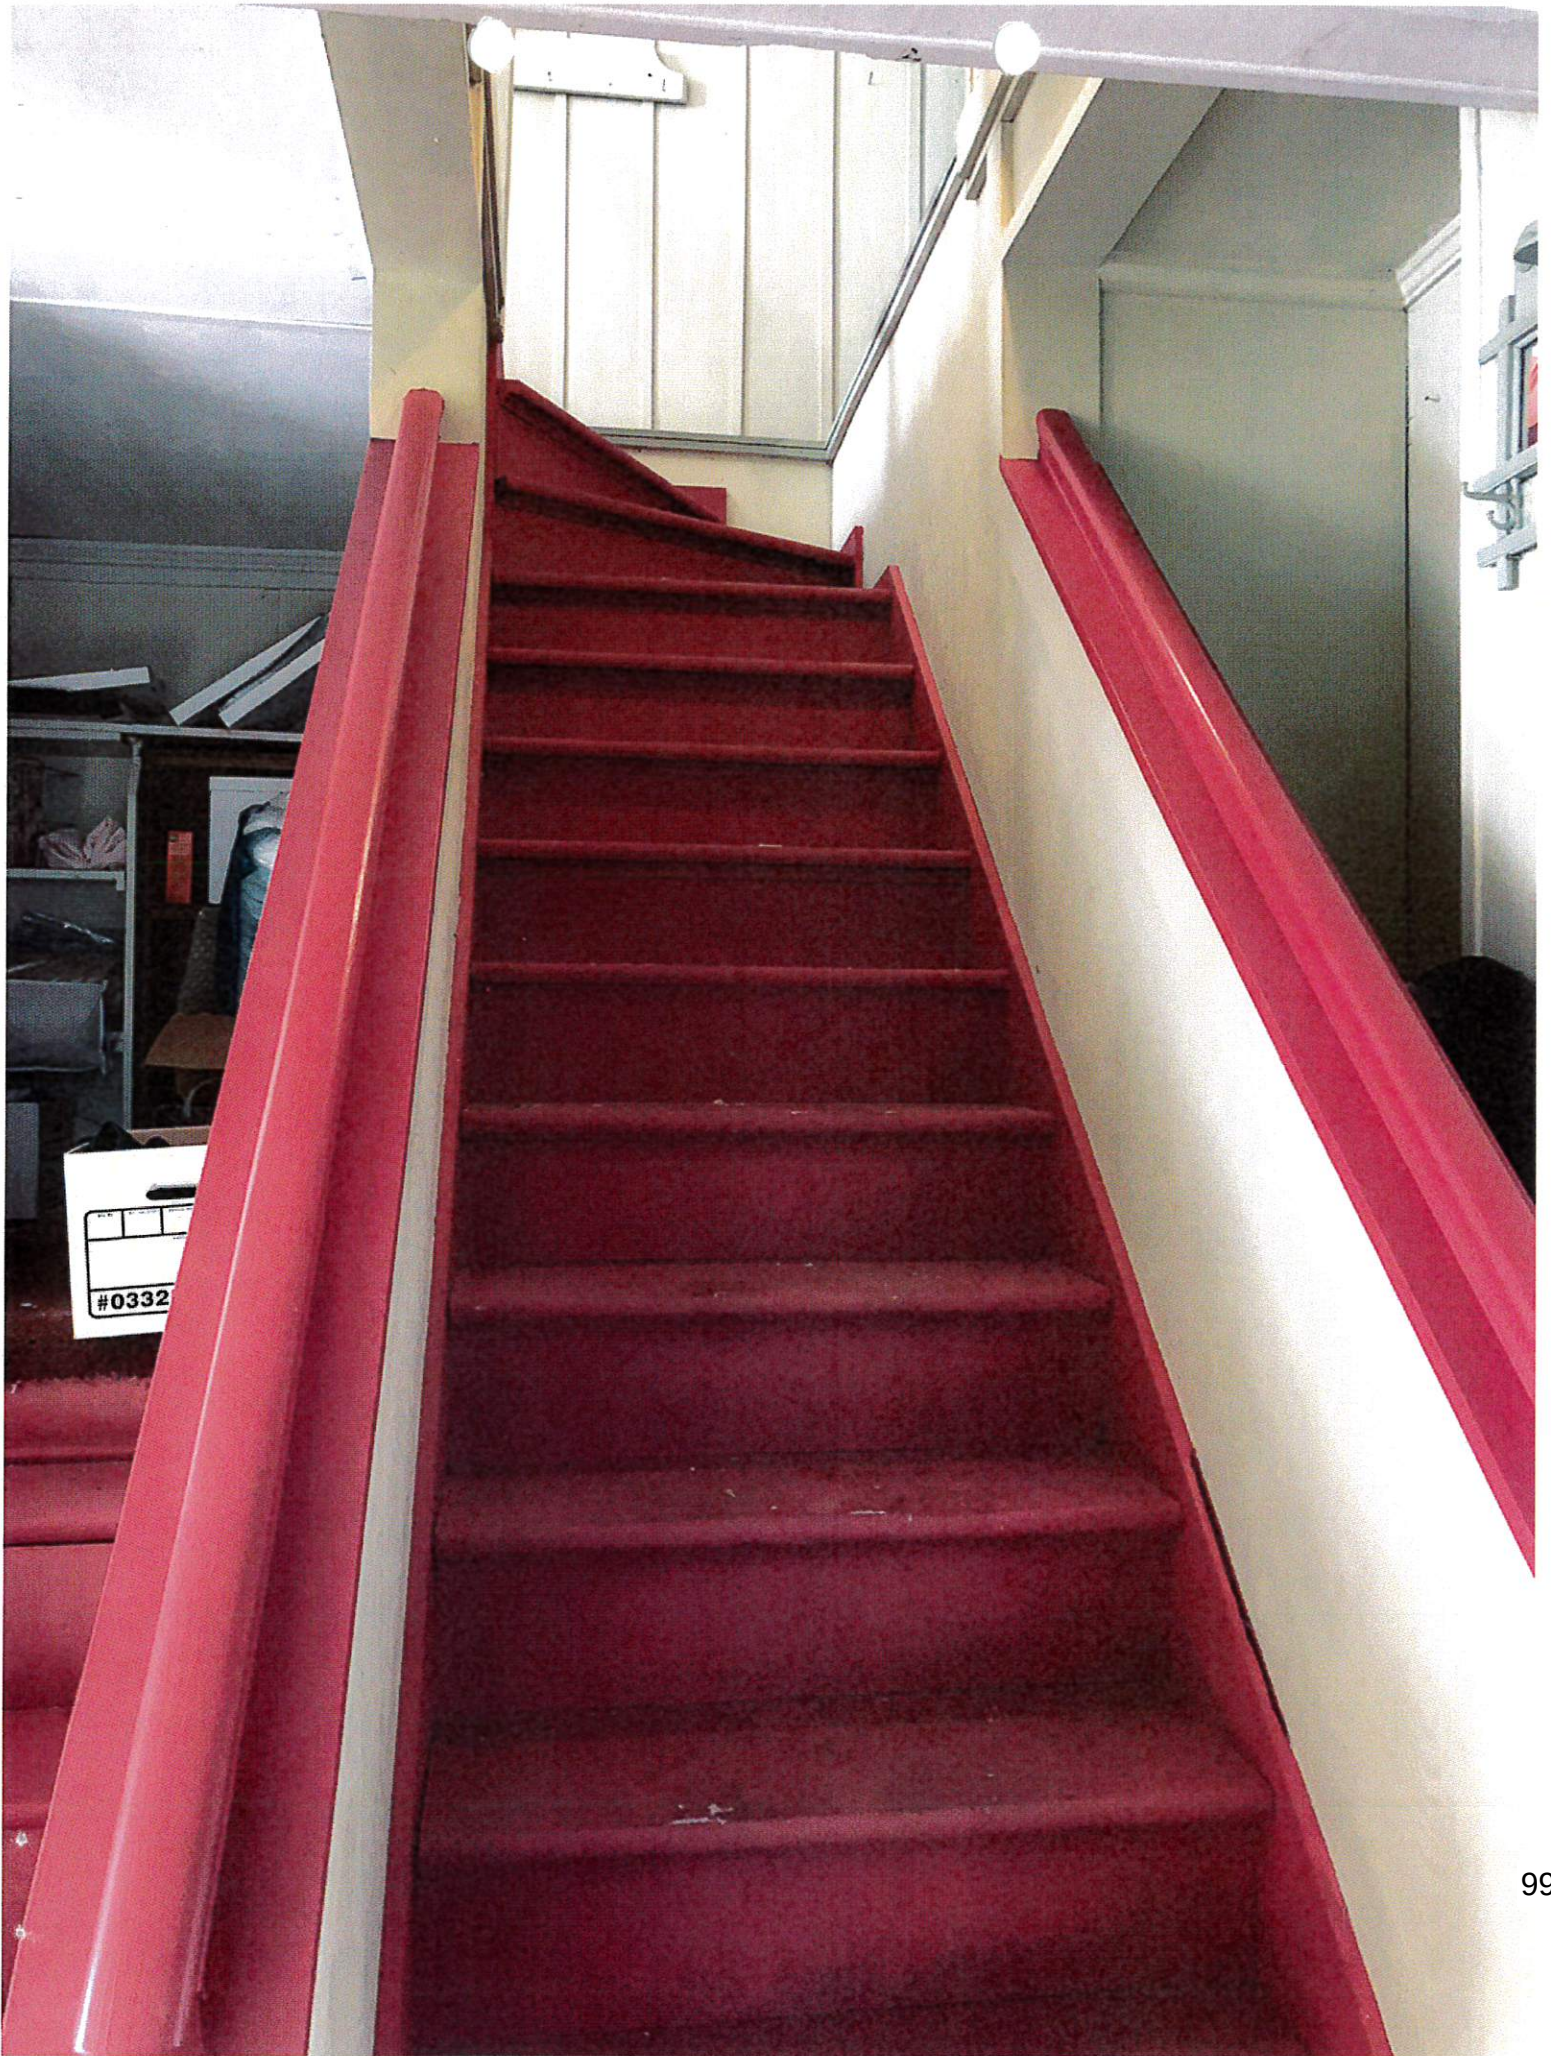
Photo Numbers: 17 Illustration Numbers: E2.01, E2.02

| too narrow and steep. not original, not part of restored us as garage |
