**PARK CITY MUNICIPAL CORPORATION  
HISTORIC PRESERVATION BOARD  
CITY COUNCIL CHAMBERS  
November 2, 2016**

## **AGENDA**

227 Main Street (Star Hotel) – Determination of Significance

**Physical Conditions Report  
Internal Demolition Report  
227 Main Street - Star Hotel  
Submitted by Westlake Land, LLC**

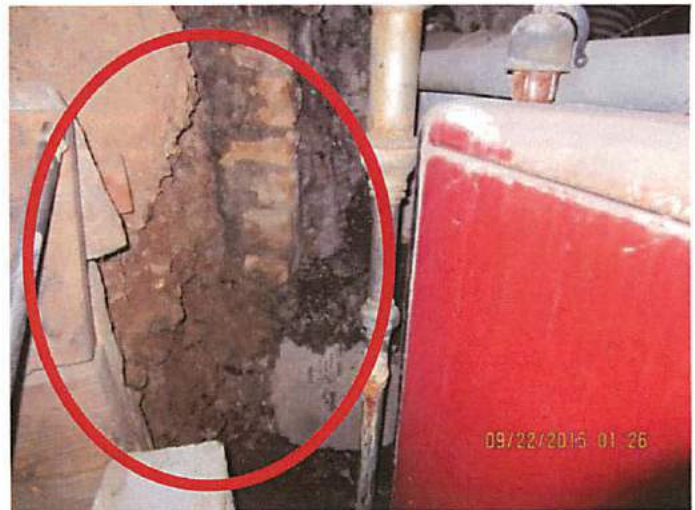
**Photo 1** The structure has no concrete or stable foundation. The foundation consists of rubble, dirt and loose stone matter.

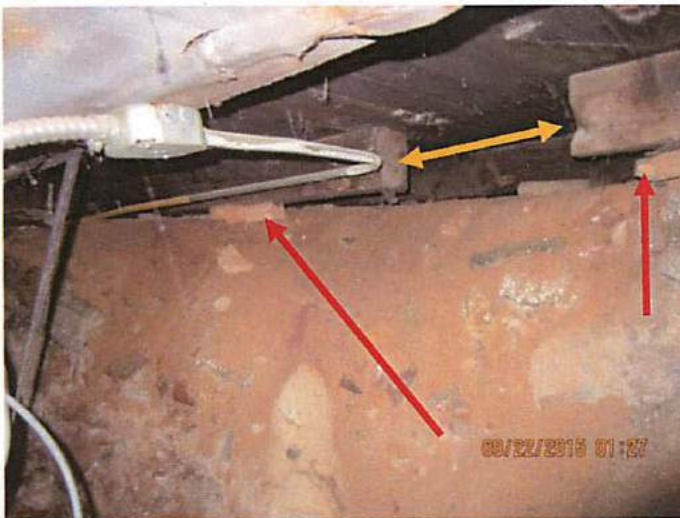
**Photo 2** Decay of the rubble foundation due to water infiltration

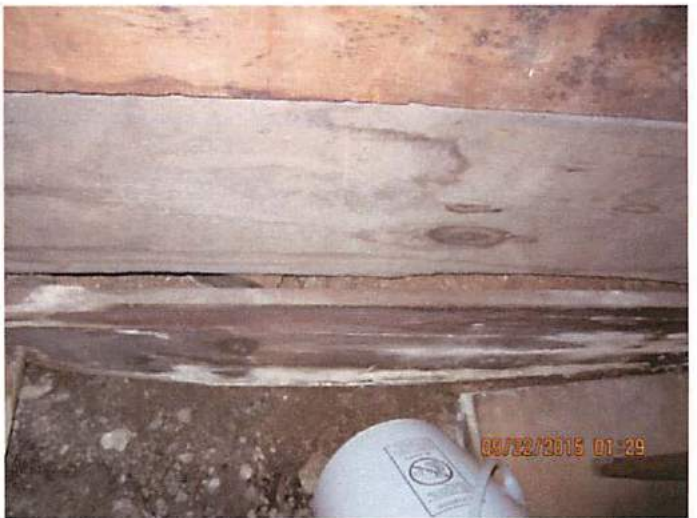
**Photo 7** The floor joist of the structure are resting directly on top of dirt and rubble. Not permitted under building codes

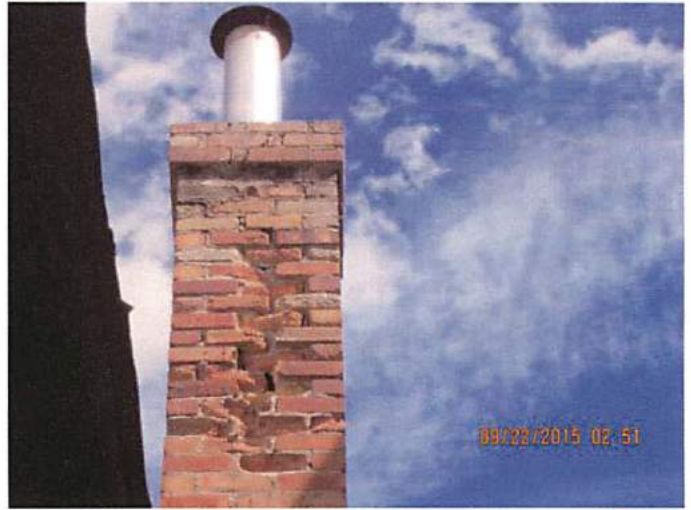
**Photo 1** The chimney shows signs of decay and instability. To be removed or evaluated by a structural engineer

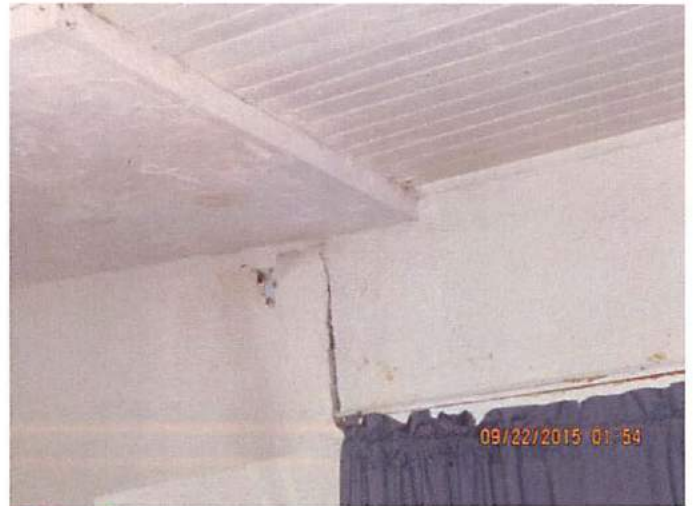
**Photo 11** Noted settling around the bathroom window on the second floor. Consistent with improperly installed support beam on third floor.

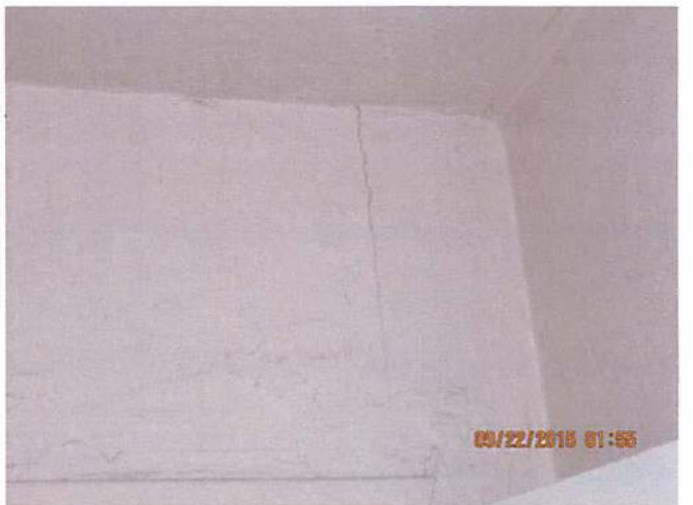
**Photo 13** Structural separation in second floor bedroom. Consistent with missing point loads and missing foundation

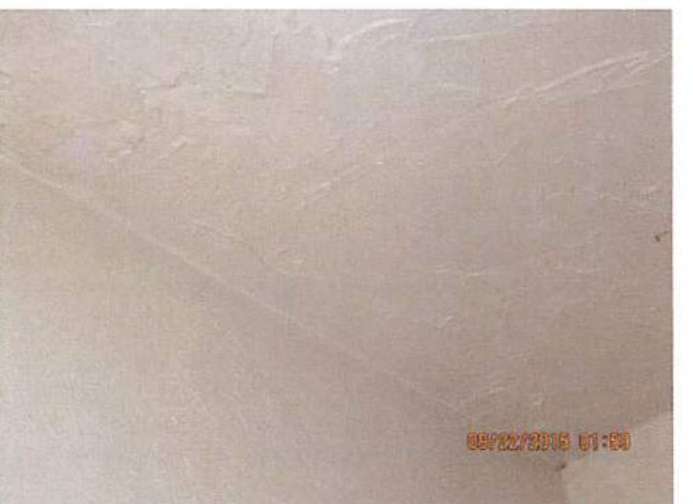
**Photo 15** Structural separation in second floor bedroom. Consistent with missing point loads and missing foundation

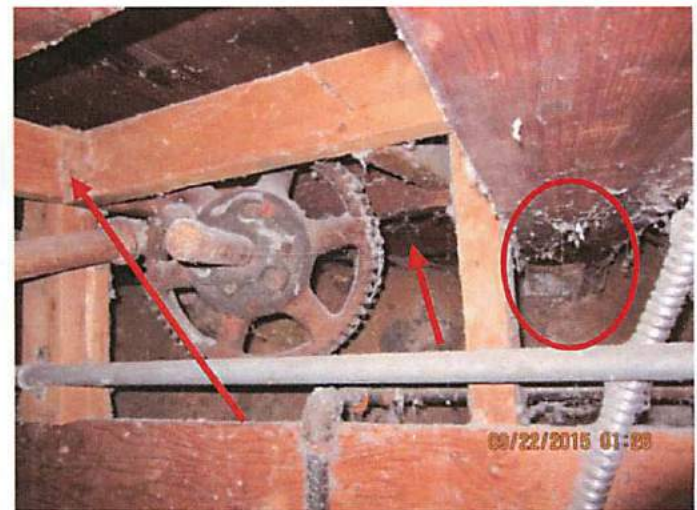
**Photo 21** Floor joist are bearing directly on top of soils. This is not permitted by code

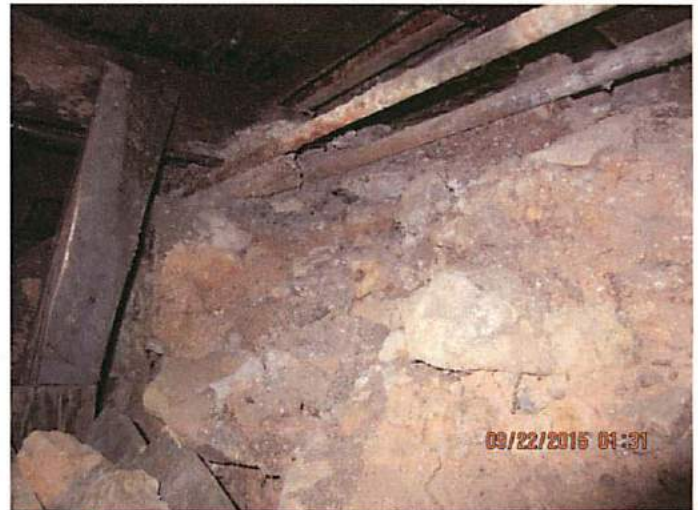
**Photo 6** Water lines used for the heating of the building are damaged by decay and deterioration. Erosion and sloughing of the rubble foundation. Severe stability concerns for the structure

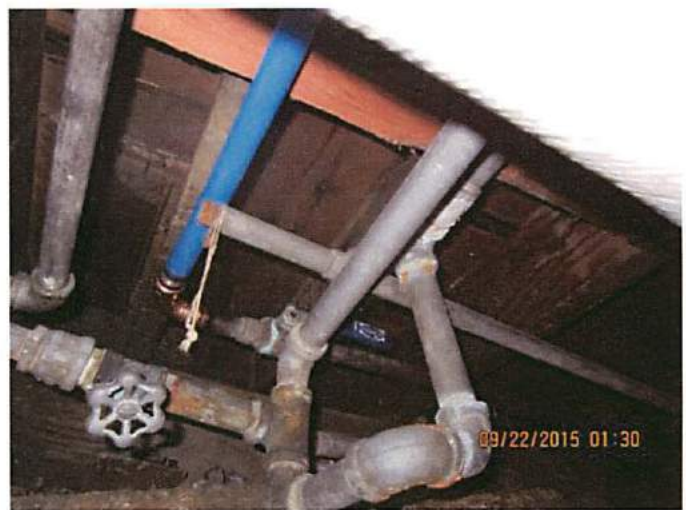
**Photo 8** Improperly installed plumbing repairs. Ends not properly capped. Copper to galvanized requires a brass coupler

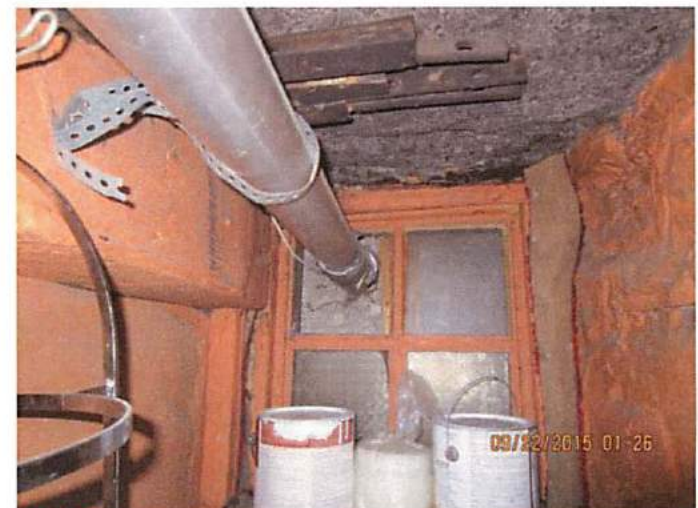
**Photo 10** Vent line for hot water heater exceeds the maximum length. Possible carbon dioxide (co2) concerns. Located in deli

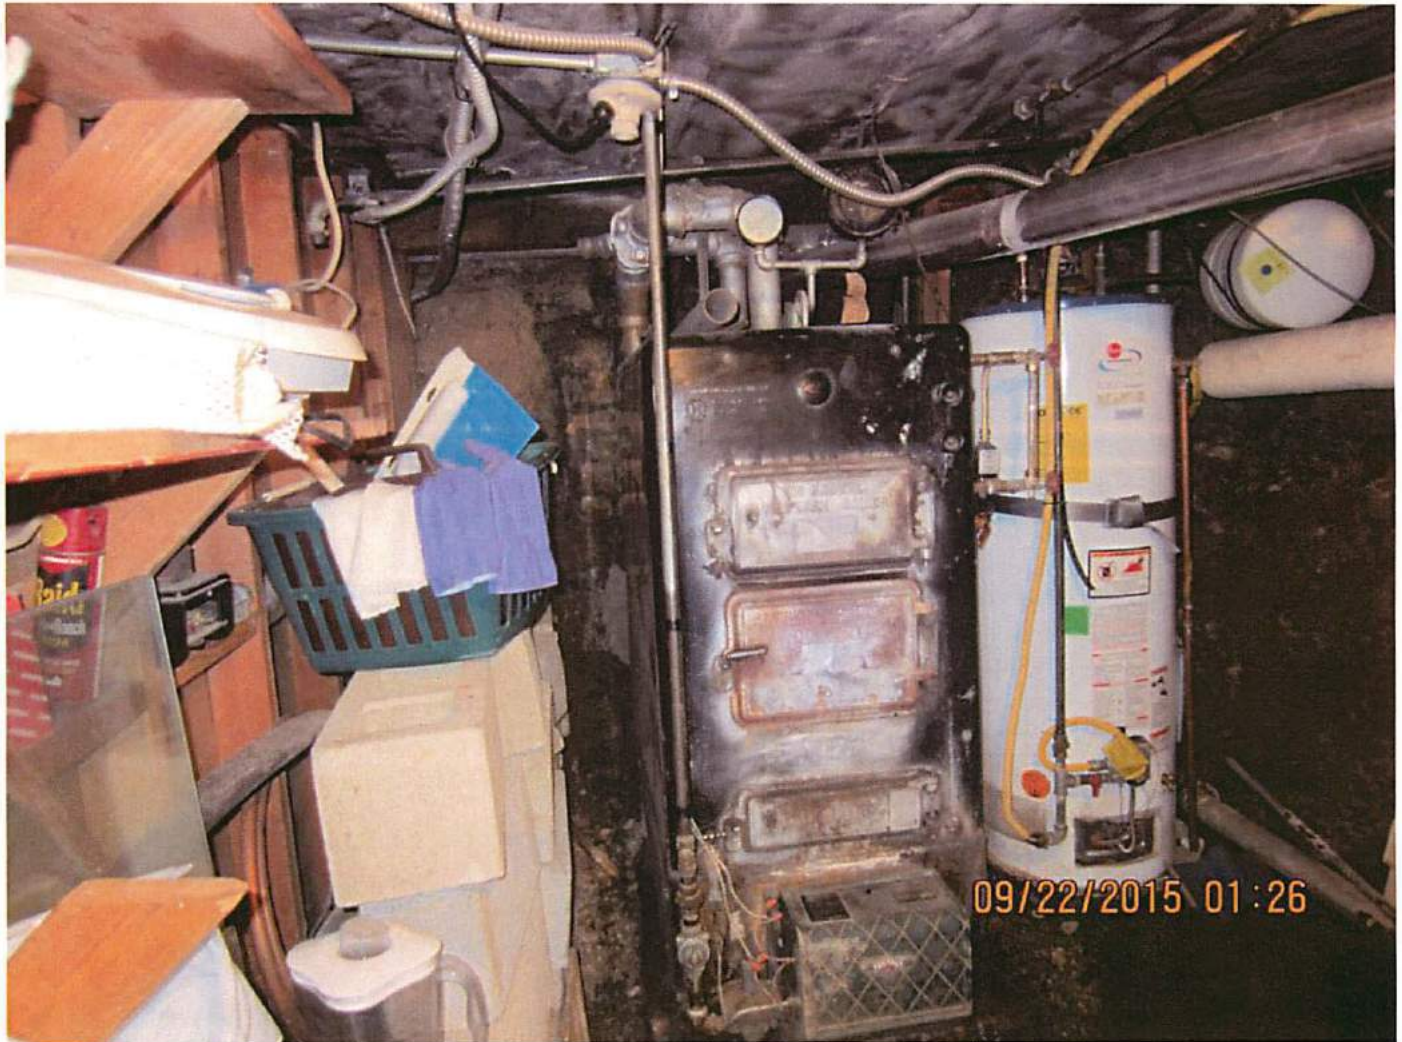
**Photo 11** The building is being heated by a 1930's era boiler that has been converted from coal/wood to natural gas. The boiler has no current state boiler inspection tags and required by state law to be inspected annually. It is advised the state boiler be notified for a immediate safety check on the boiler. The gas line that feeds the boiler is unsafe and should be terminated .

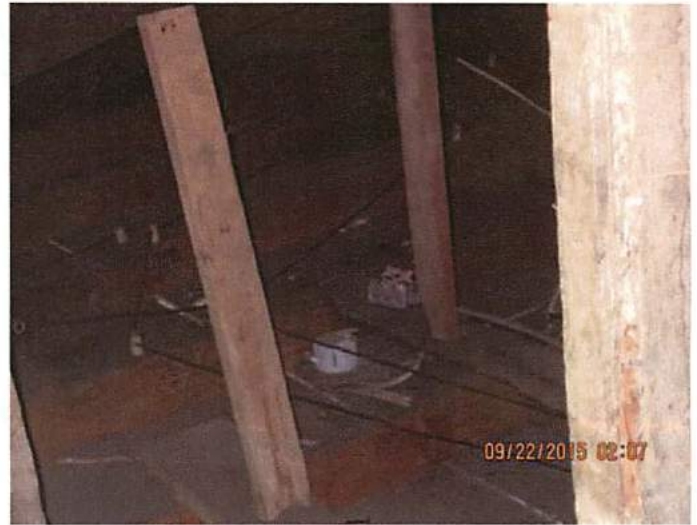
**Photo 18** General inspections noted that the knob and tube is most likely active

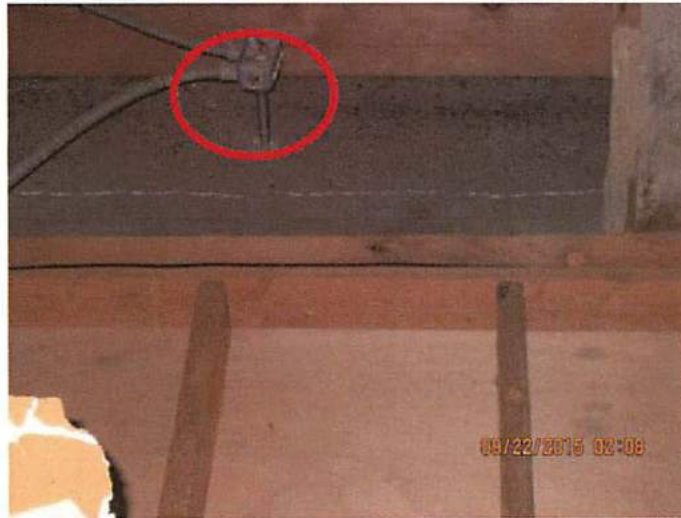
**Photo 18** Open electrical boxes noted throughout the building. Electrocutation hazard, fire hazard. Located in attic

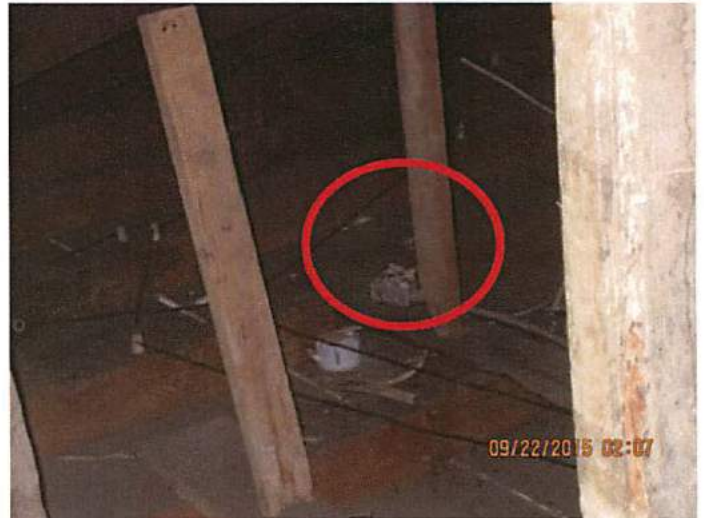
**Photo 19** Open electrical boxes noted throughout the building. Electrocutation hazard, fire hazard. Located in attic

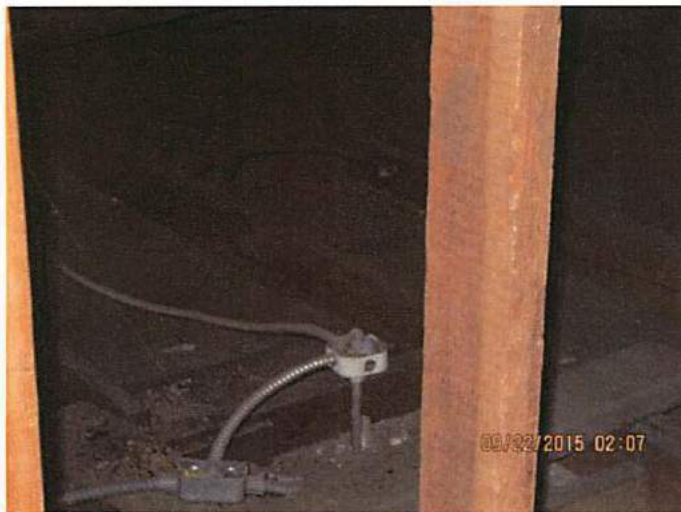
**Photo 20** Open electrical boxes noted throughout the building. Electrocutation hazard, fire hazard. Located in attic

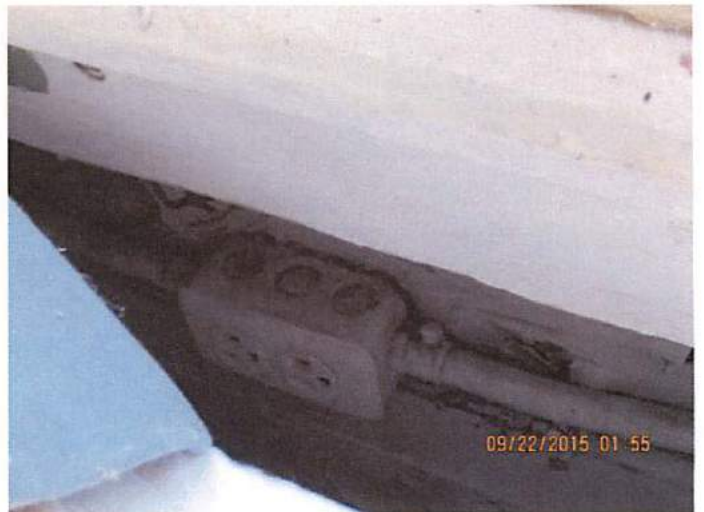
**Photo 21** Outlets located under windows that are damaged. Moisture and decay surrounds the electrical outlet

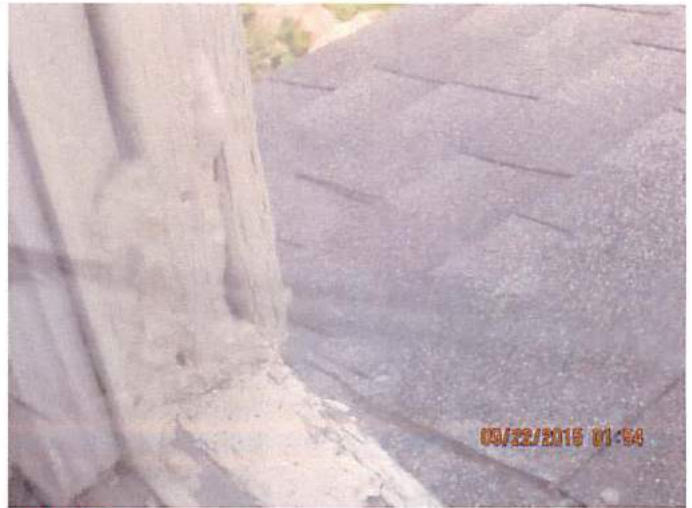
**Photo 23** Decay and deterioration noted throughout the building, cause appears to be lack of proper maintenance and infiltration of water from damaged roof

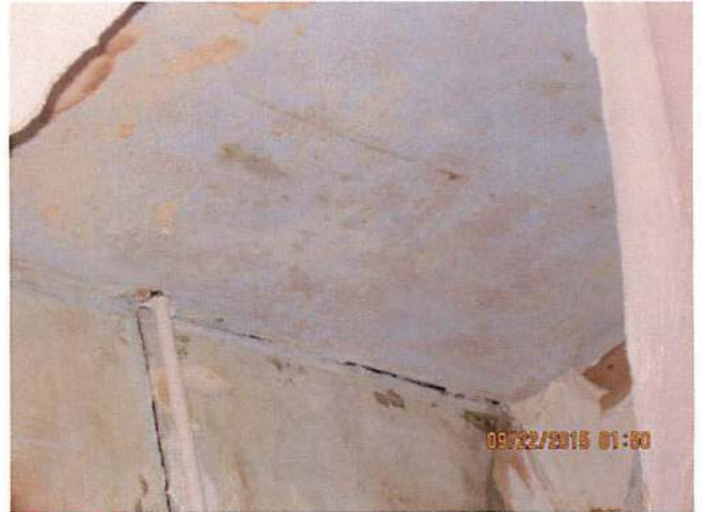
**Photo 25** Decay and deterioration noted throughout the building, cause appears to be lack of proper maintenance and infiltration of water from damaged roof

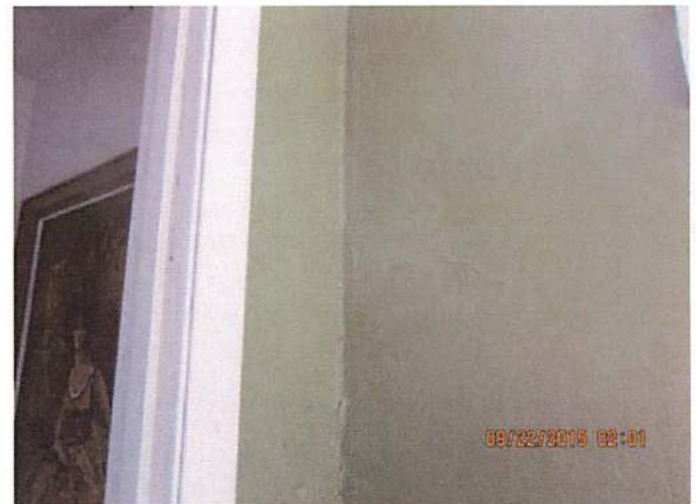
**Photo 27** Water damage and structural concern behind wall

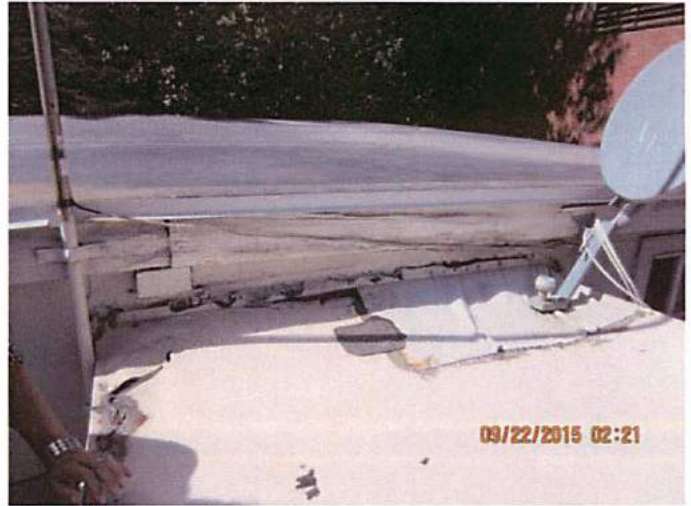
**Photo 29** Roof appears to have been recently repaired but some areas are damaged and show signs of possible water infiltration

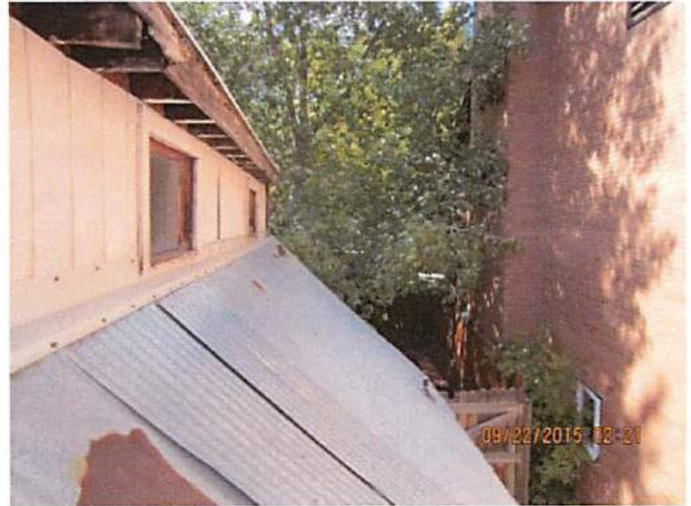
**Photo 31** Roof shows sign of decay and rot damage, soffit and fascia are missing, possible location of water infiltration

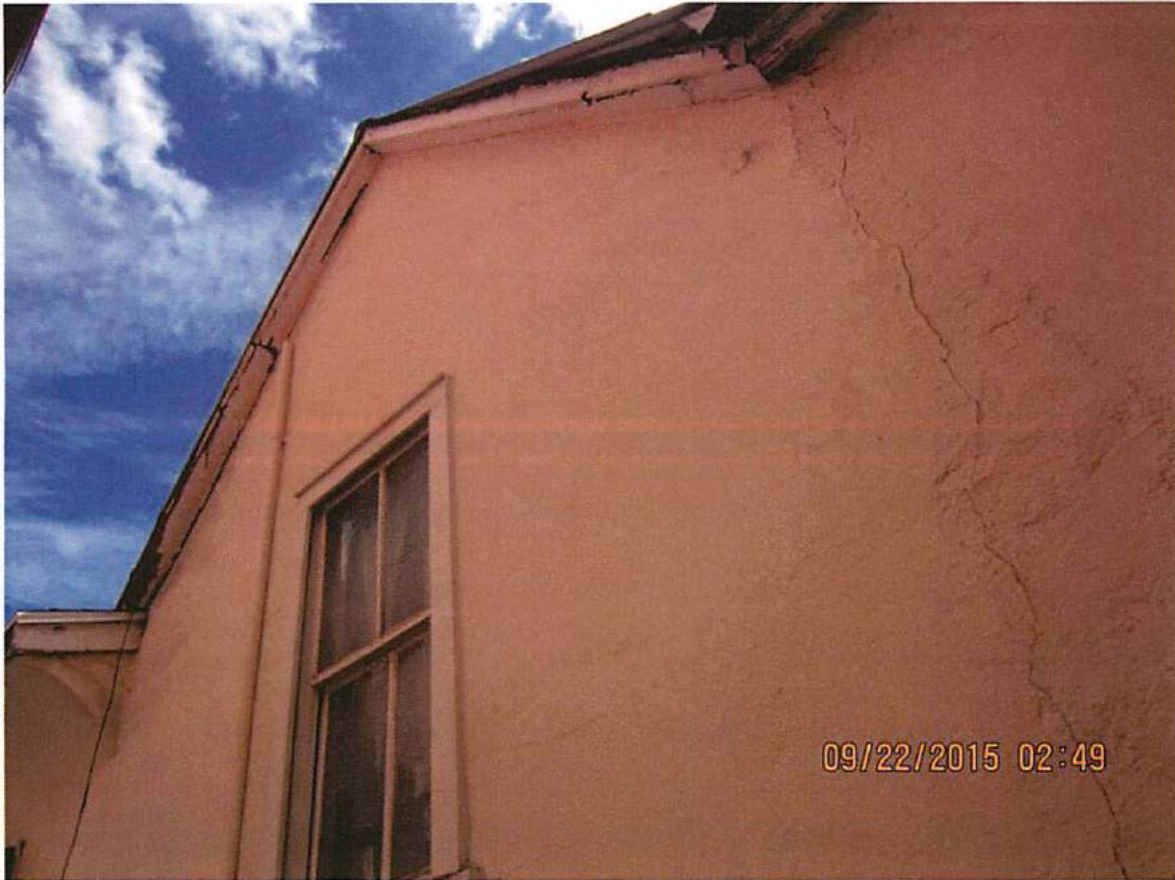
**Photo 34** The "above and "below" photos represent the continuation of a structural crack that is consistent with a rubble and dirt foundation. Structural deviations are difficult to see on wood framed construction. At least 30 of the building is wood framed

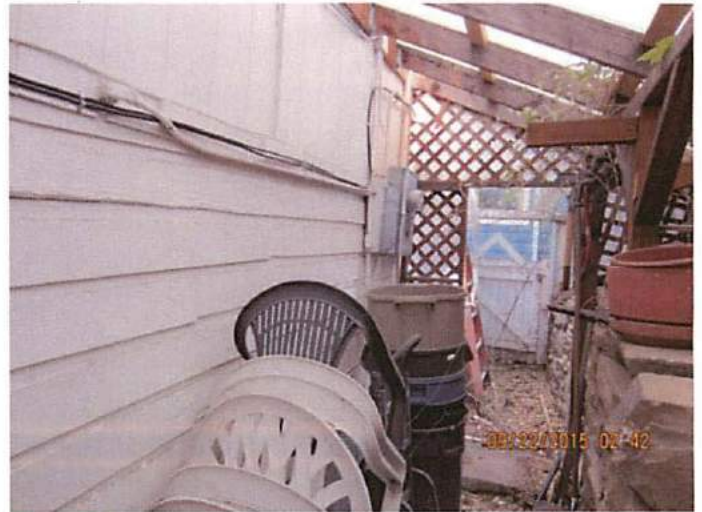
**Photo 36** Egress path rear of building. No access to safe location
