**PARK CITY MUNICIPAL CORPORATION  
HISTORIC PRESERVATION BOARD  
CITY COUNCIL CHAMBERS  
May 16, 2018**

1021 Park Avenue –Historic District Design Review – Material Deconstruction on Landmark Site. The applicant is proposing to impact a portion of the rear (west) elevation for a new addition, modifications to historic window and door openings. The house was approved to be reconstructed through the Historic District Design Review (HDDR) process in 2016.

115 Sampson Avenue – HDDR Material Deconstruction and Reconstruction – The applicant is proposing to reconstruct the historic house designated as “Significant” on the City’s Historic Sites Inventory. In addition the applicant will be removing existing non-historic parking pad along with its associated wood staircases and railroad tie retaining wall; non-historic stacked stone retaining walls and 1990s wood slat fences; post-1947 addition on the west elevation and an underground root cellar; rebuilding the historic pyramid roof and dormers; reconstructing the existing masonry chimney; raising the house 2 feet to pour a new foundation; reconstructing the historic ca.1900 wraparound porch on the east and south elevations; replacing t

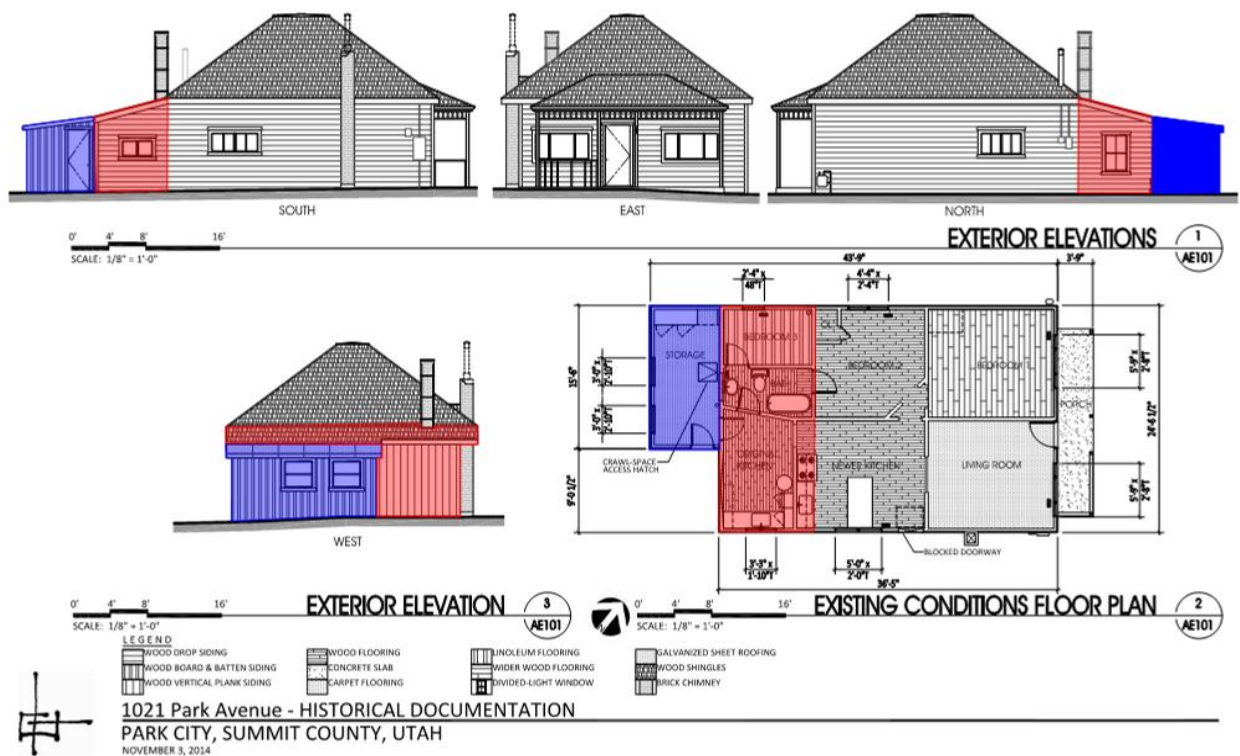
*This photograph shows the condition of the two additions in 2014. The additions had begun to pull away from the original pyramid-shaped roof and had significantly deteriorated due to inadequate foundations.*

These later additions were lien-to additions that had been haphazardly added to the west elevation of the historic house. Overtime, they had been significantly altered to create useable living space. Staff found that these later additions do not contribute to the historic integrity or historical significance of the structure or site and do not need to be reconstructed.

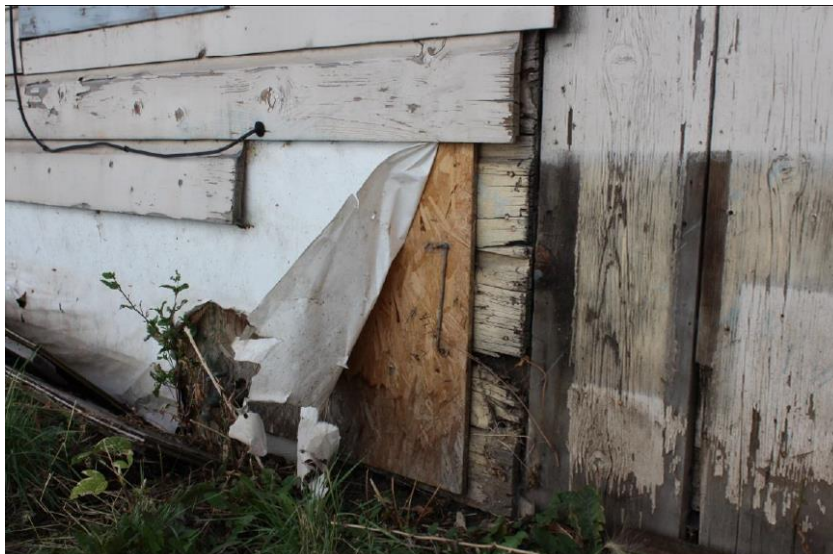
The exterior walls had been clad with layers of asbestos shingles, plywood, and non-historic wood siding by 2013. The layers of siding were in disrepair and had deteriorated significantly. The applicant was required to salvage those pieces of the original wood drop novelty siding that could be restored; however, the amount of material salvaged was limited due the overall deteriorated state of the building.

*Layers of siding present at the time of the deconstruction in 2013*

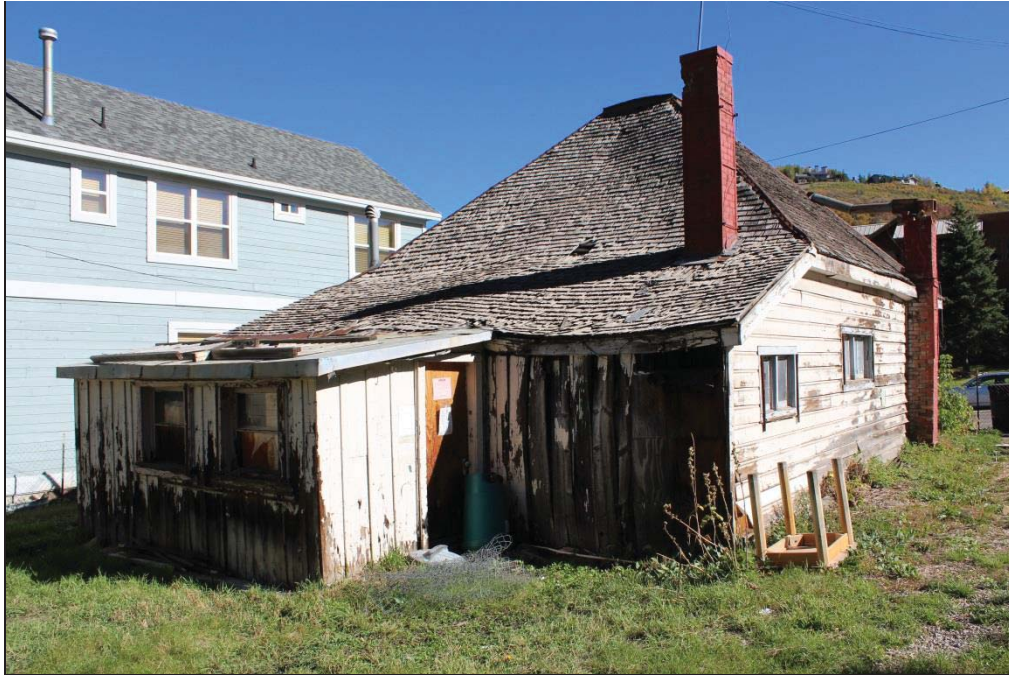
**B.1. ROOF:** Poor condition of west side of main building, Additions 1 and 2, facing northeast.

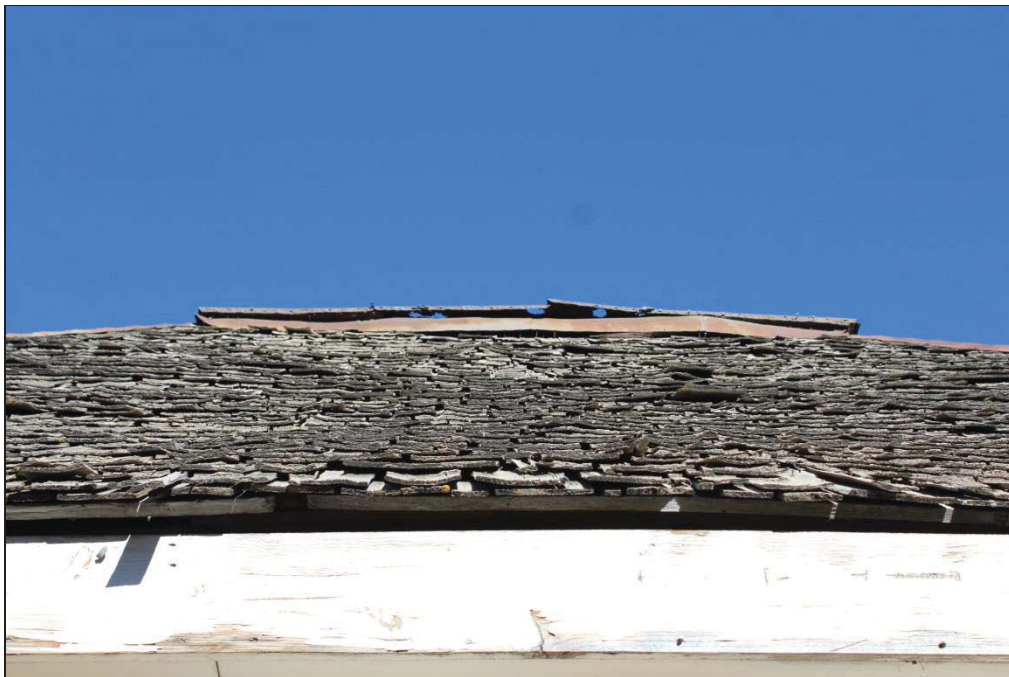
**B.1. ROOF:** Corroded and detached metal roof cap at top of hipped roof.

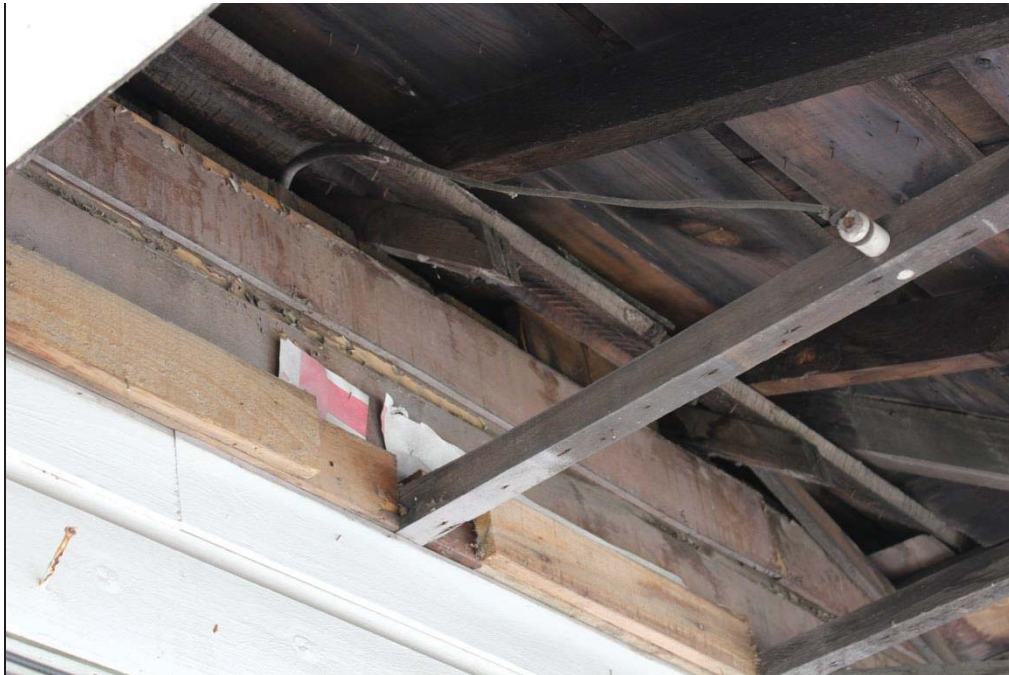
### B.2. EXTERIOR WALL – PRIMARY FAÇADE: Under porch roof, original dark-painted siding visible beneath c. 1995 white siding.

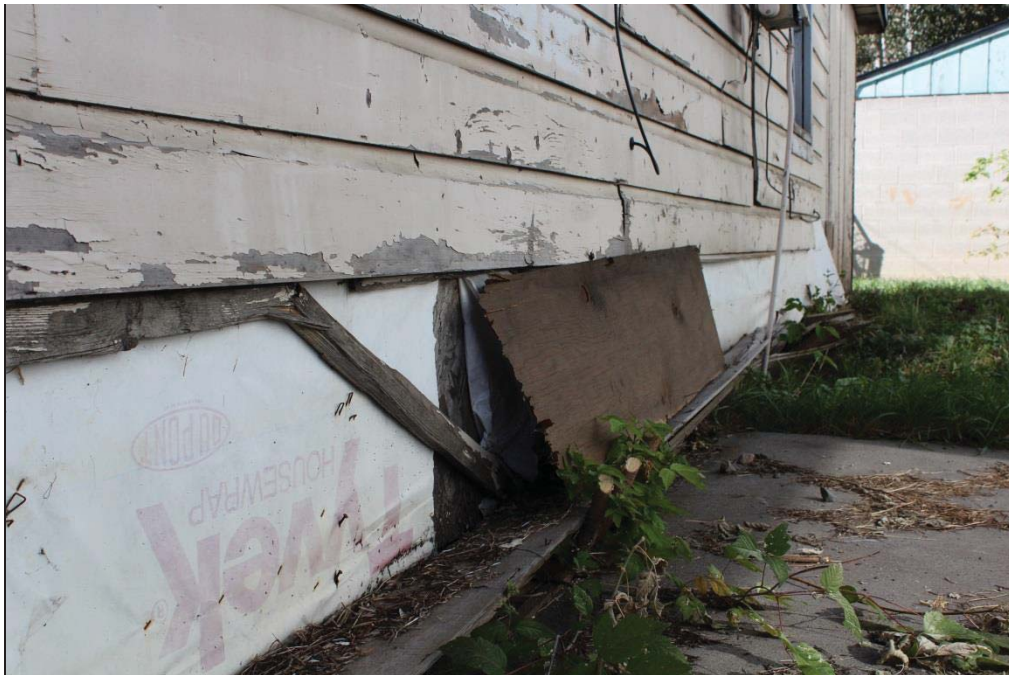
### B.3. EXTERIOR WALL – SECONDARY FAÇADE 1: North wall, poor condition at wall base, facing west.

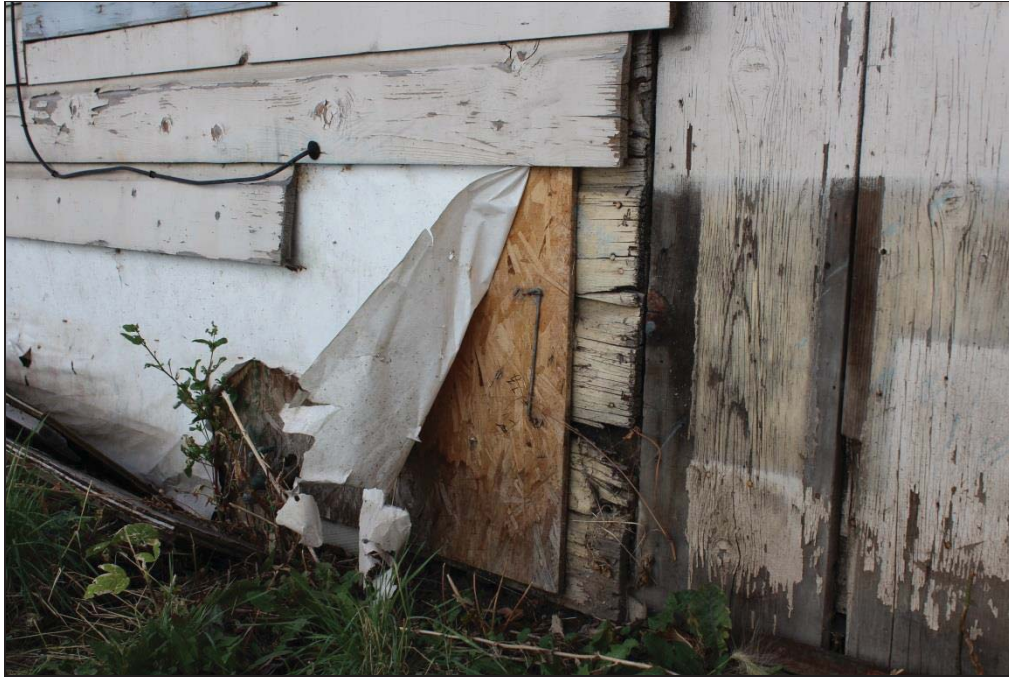
**B.3. EXTERIOR WALL – SECONDARY FAÇADE 1:** North wall, original siding in fair/poor condition beneath particleboard, Tyvek, new siding; shadow marks showing batten locations on Add. 2.

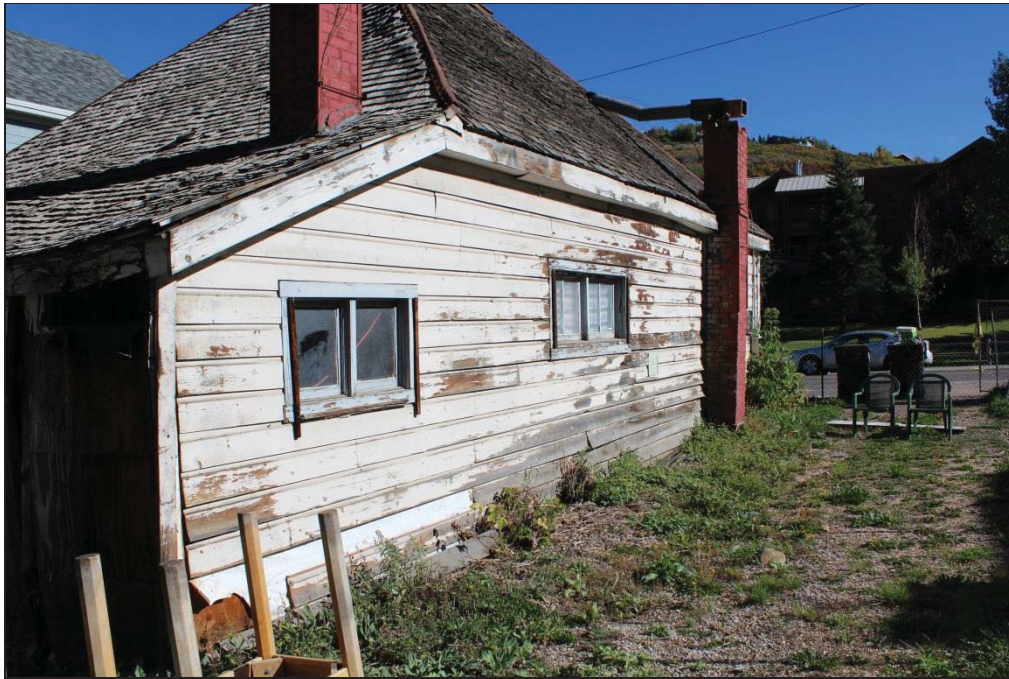
**B.4. EXTERIOR WALL – SECONDARY FAÇADE 2:** South wall, facing northeast. Note detached siding, paint loss.

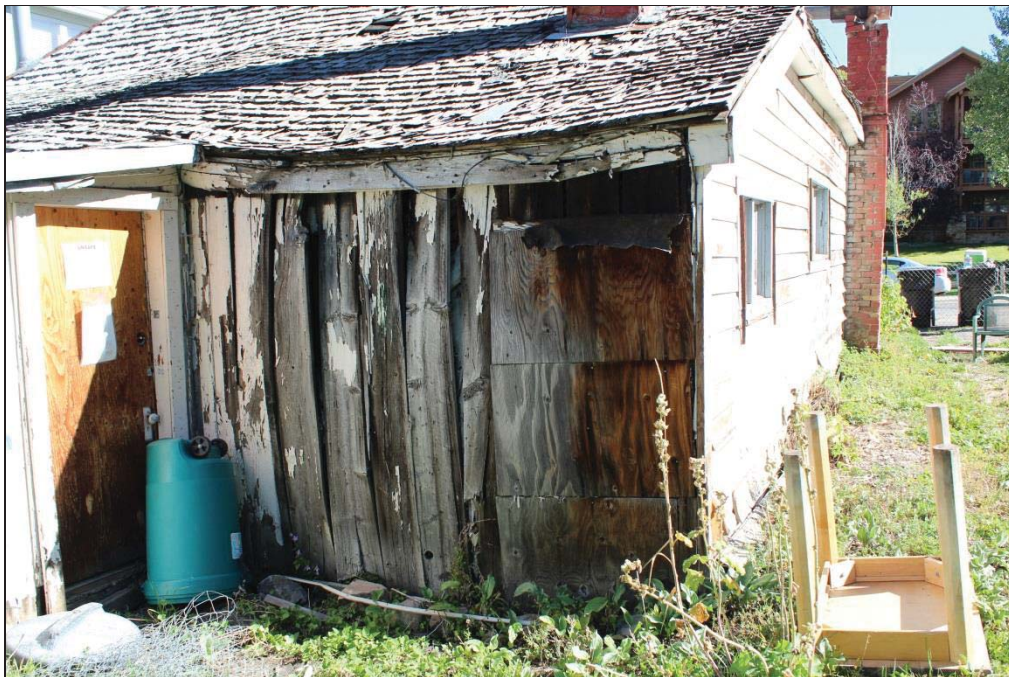
**B.4. EXTERIOR WALL – REAR FAÇADE:** West side, detail of Addition 1, facing east. Note single-wall construction, very poor condition.

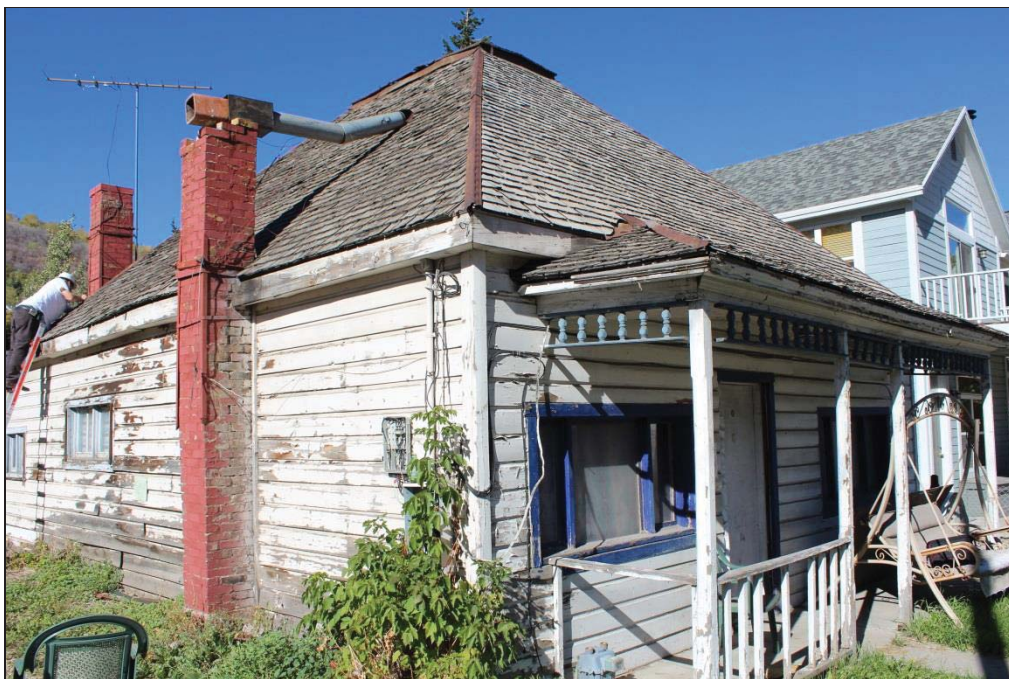
**B.10. MECHANICAL SYSTEM:** Second brick chimney abutting south wall of house, facing northwest. Note displacement and toppled stovepipe.

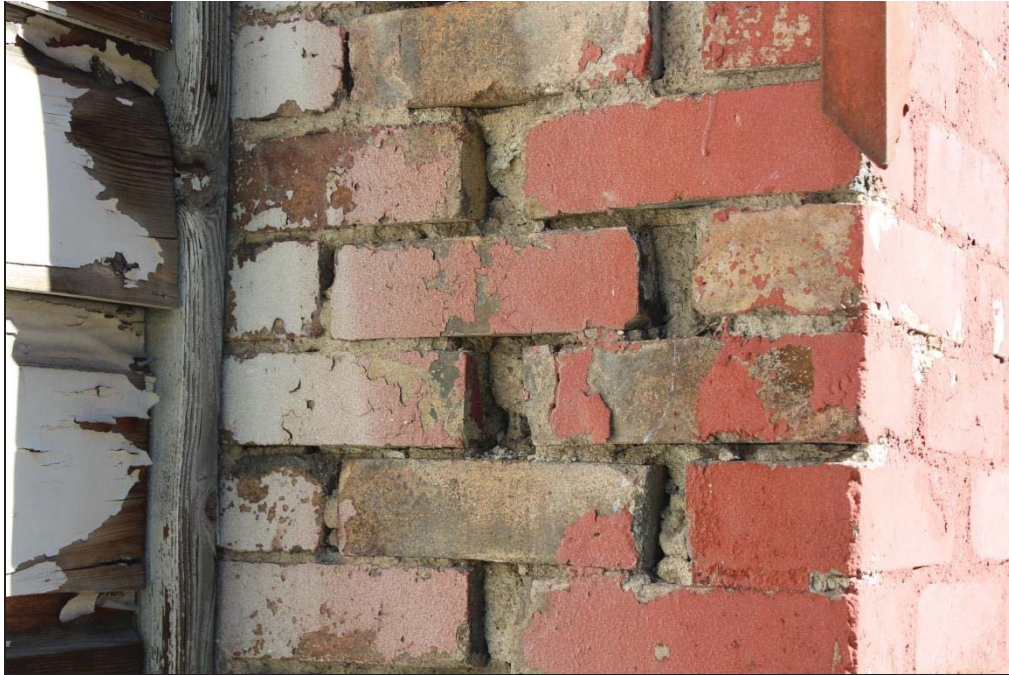
**B.10. MECHANICAL SYSTEM:** Mortar loss on west side of second brick chimney, facing east.

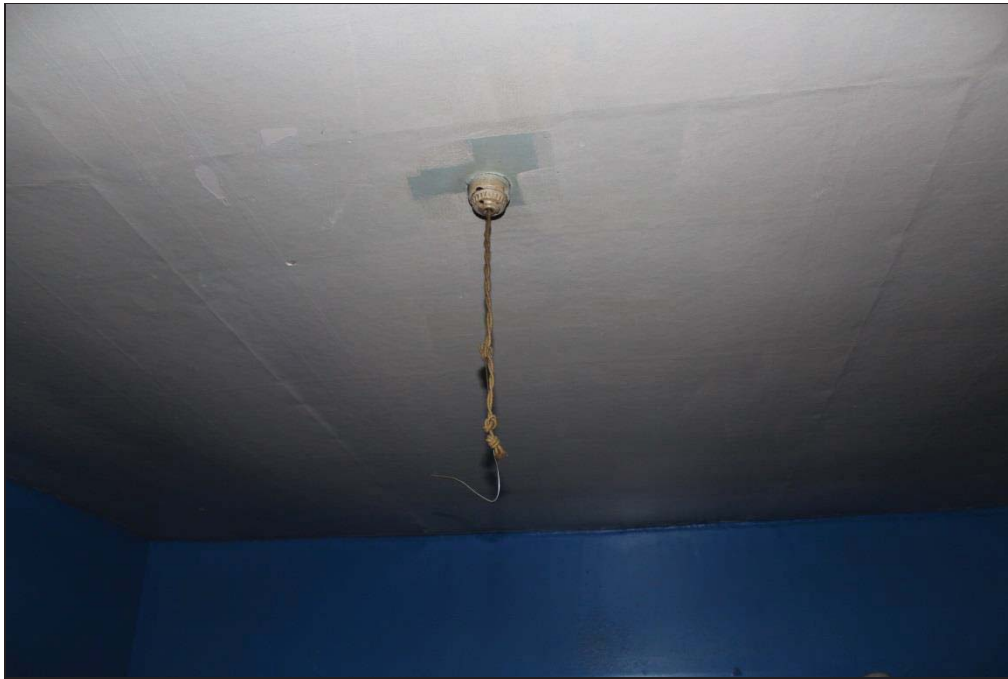
**B.11. ELECTRICAL SYSTEM:** Ceiling fixture connected to cloth-covered wiring on interior. See also B.7. showing porcelain knob for older knob-and-tube wiring system.

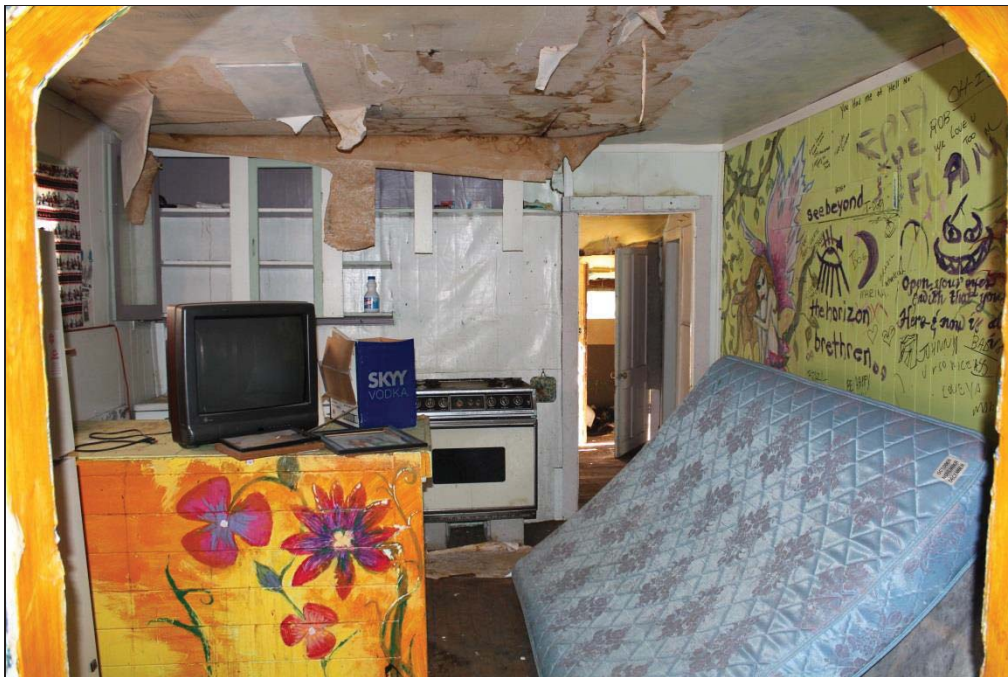
**B.12. STRUCTURAL SYSTEM:** Water damage in ceiling, southwest room of original building, indicating likely damage to roof members, facing west. See B.1. for photos indicating cracked or broken rafters and B.3. for damage at wall base and therefore likely at floor sill and joist ends.

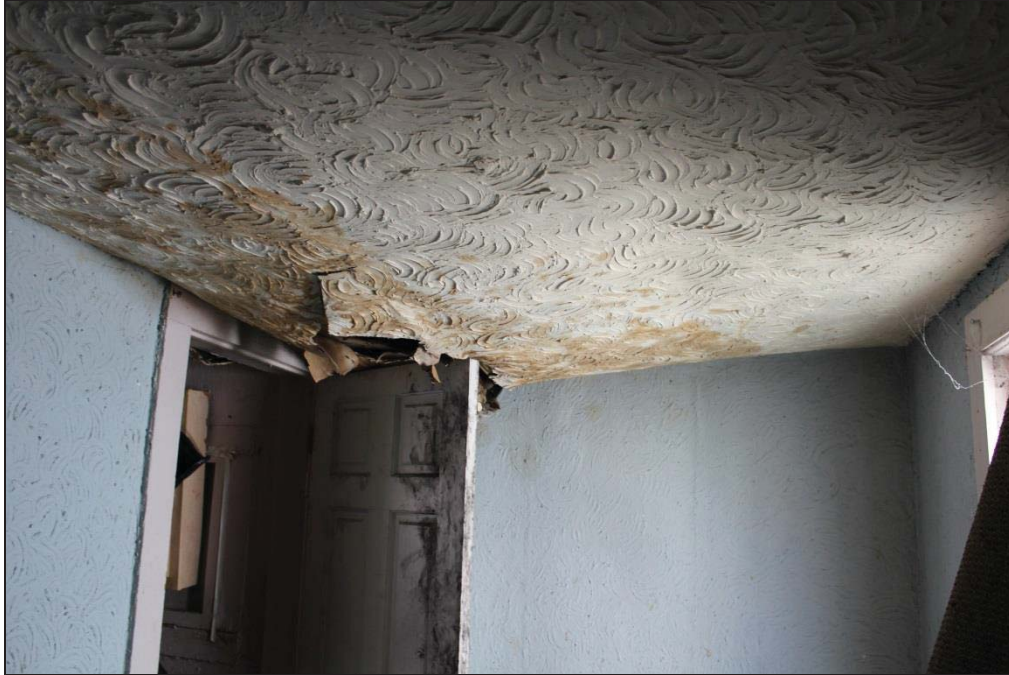
**B.12. STRUCTURAL SYSTEM:** Water damage in north end of Addition 1 ceiling, facing west.

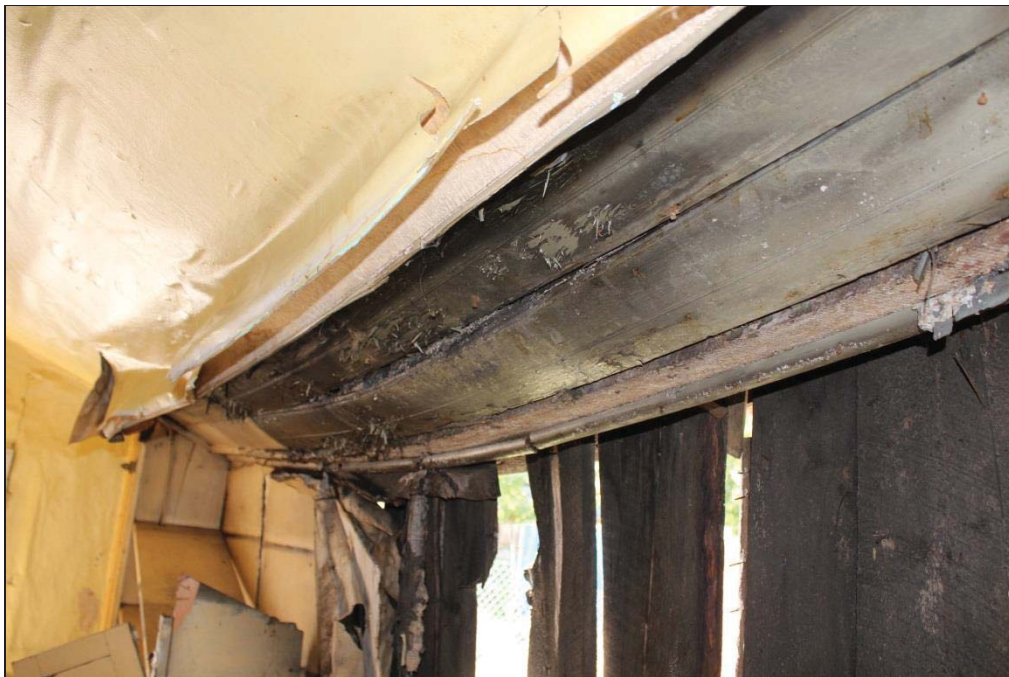
**B.12. STRUCTURAL SYSTEM:** Water damage to south end of Addition 1 ceiling paper (painted yellow), underlying original board finish, and original vertical-board wall, facing southwest.

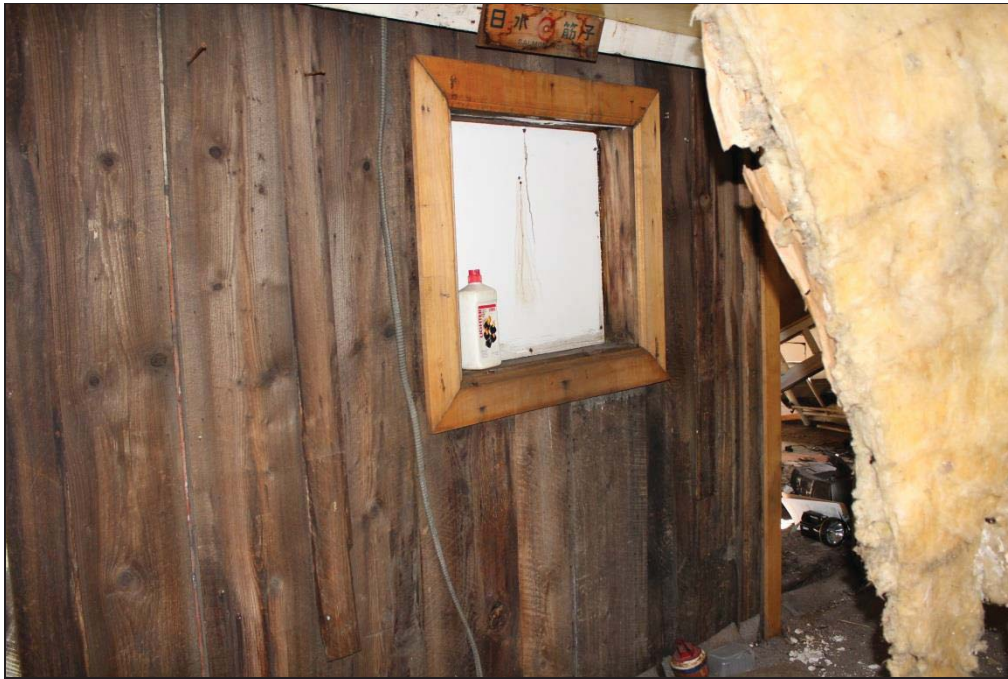
**B.12. STRUCTURAL SYSTEM:** Original vertical-board wall in good condition on west interior side of Addition 2, facing southeast.

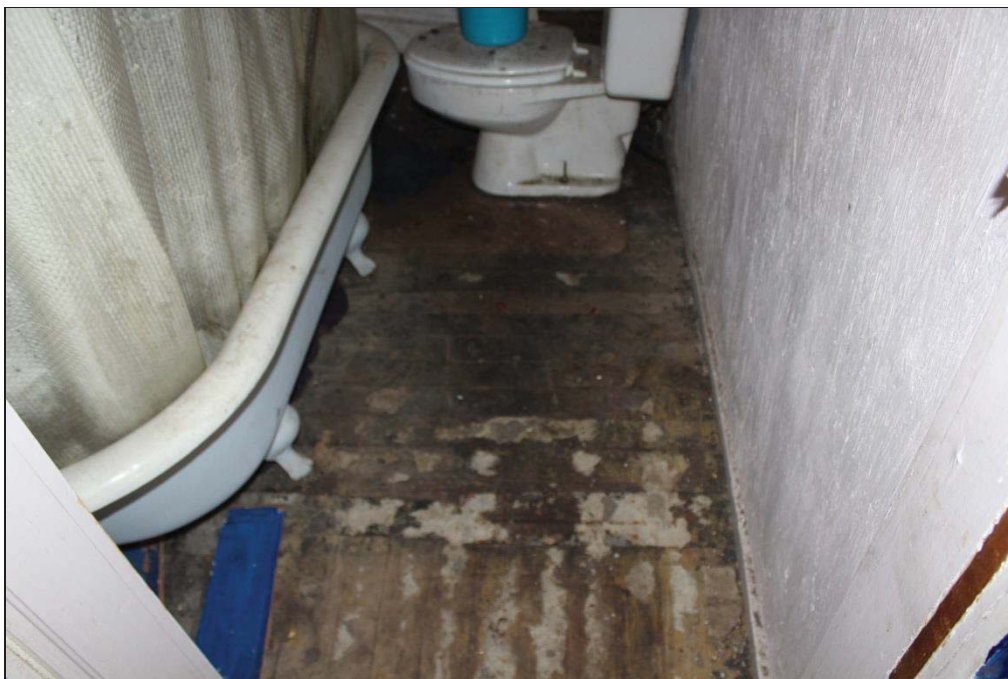
**B.12. STRUCTURAL SYSTEM:** Water damage in bathroom floor of Addition 1, indicating likely damage or rot in underlying floor joists.

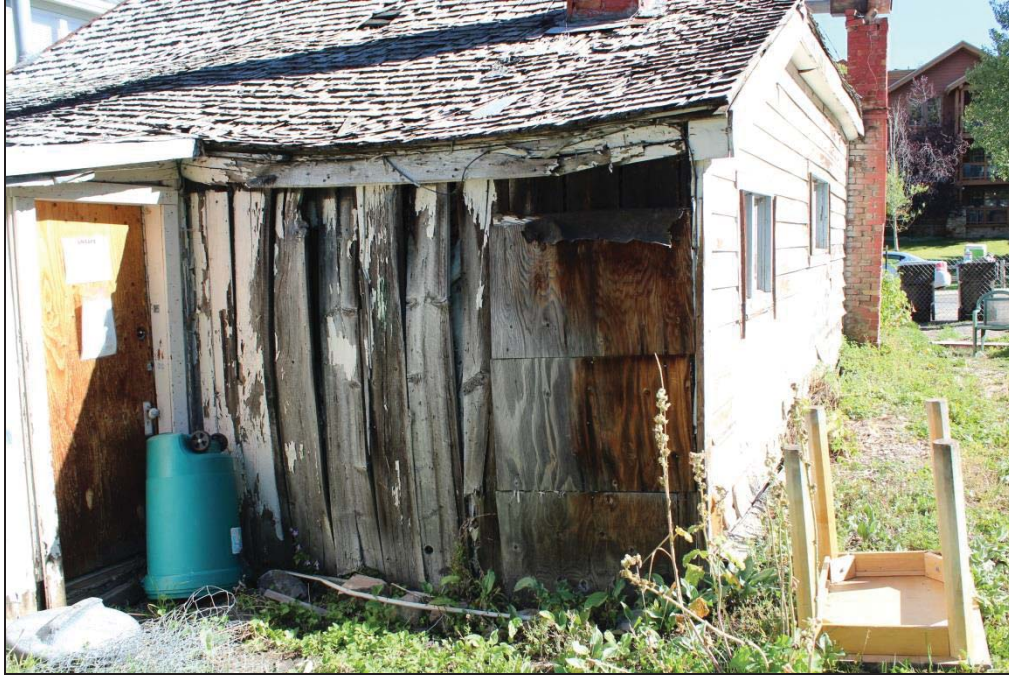
**C.3. TRIM:** Ca. 1990s boxed eave along south wall of house and original fascia/horizontal nailer for wall boards on west side of Addition 1 (in very poor condition), facing northeast.

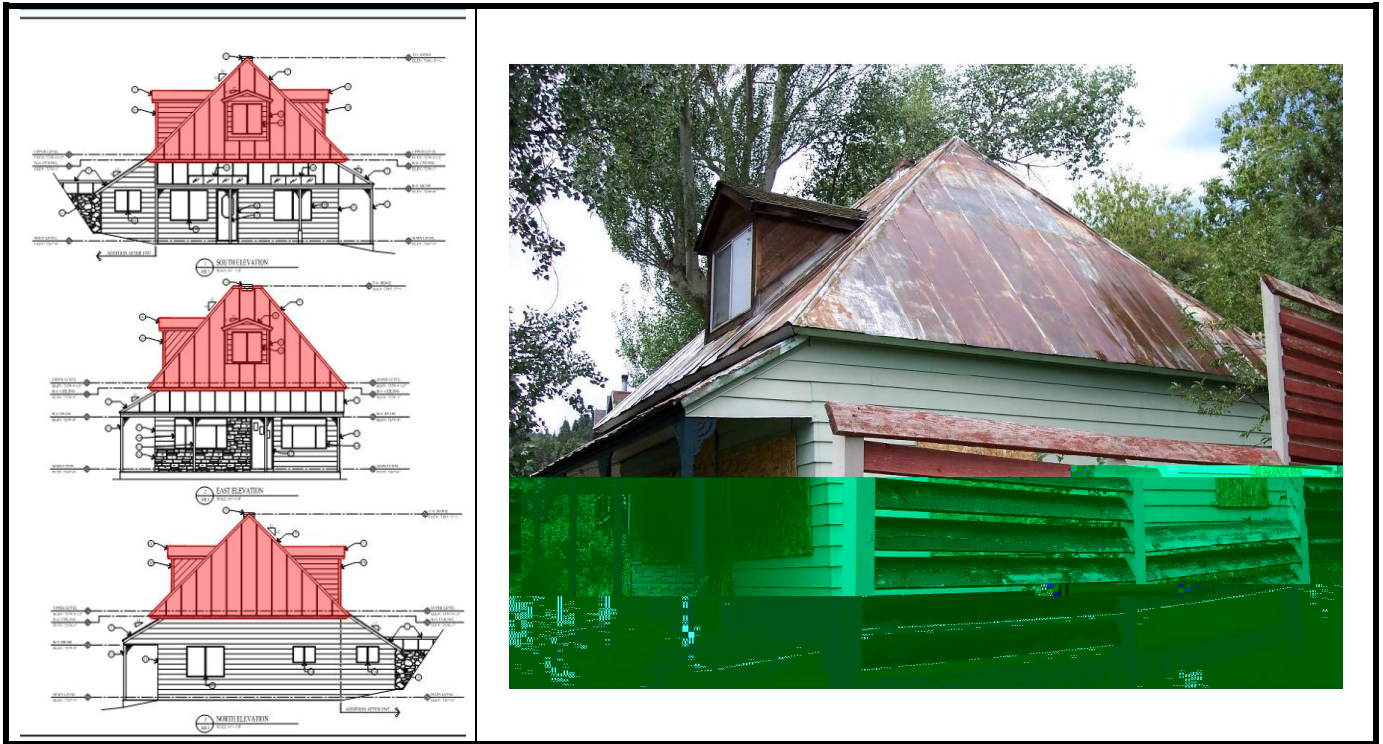
In 2018, Structural Engineer Henry Shen provided an analysis of the roof structure (Exhibit E). In his report, he finds that the existing roof joists consist of 2 inch by 6 inch structural members that span 8 to 12 feet. The 8 foot joists are operating at 28% capacity and the 12 foot joists are operating at 18%. The existing roof deck is 1x wood plank installed perpendicular to the existing joists. It does not have any capacity of shear diaphragm value. The extent of repairs needed to stabilize the roof and the need to panelize the historic house make reconstructing the original pyramid roof form the best alternative.

The applicant is proposing to reconstruct the roof form. He proposes to construct dormers on all four (4) sides of the pyramid roof. Staff finds that the reconstruction of the roof and dormers on the east side of the roof are part of the restoration of the original roof form; the new dormers on the north and south sides of the roof will be incorporated into the roof form in a manner that is consistent with other historic houses. Staff is working with the applicant to ensure that the dormers are consistent in mass and scale to those that were seen historically.

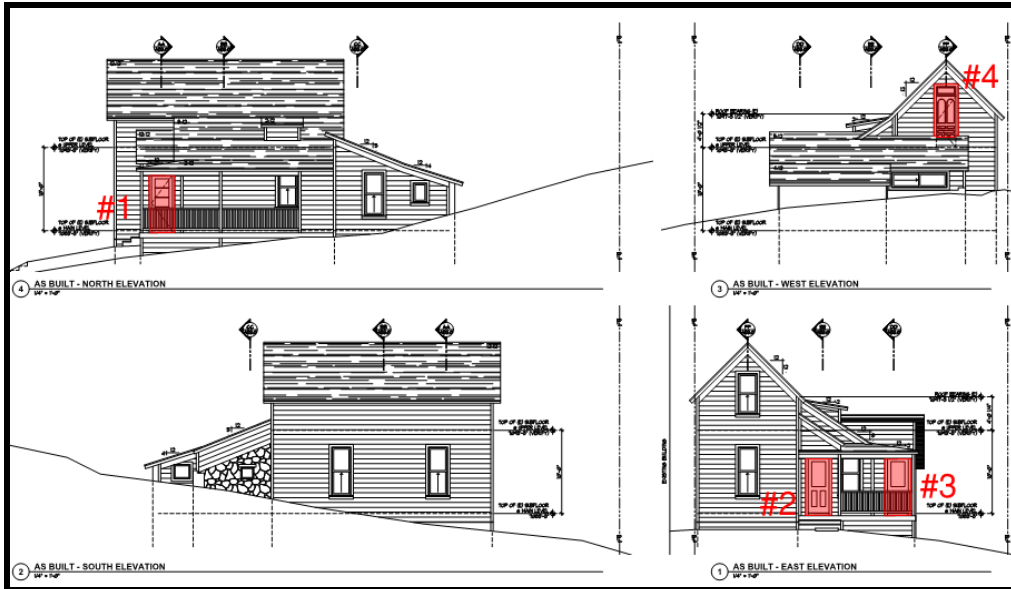
Staff finds that these doors are in varying degrees of disrepair due to age and general wear and tear. Staff finds that replacement may be necessary in order to restore the historic wood paneled doors; however, any replacements should be made in-kind. Staff has added the following Condition of Approval to address the replacement:
