**PARK CITY MUNICIPAL CORPORATION  
HISTORIC PRESERVATION BOARD  
CITY COUNCIL CHAMBERS  
May 2, 2018**

945 Norfolk Avenue – HDDR Material Deconstruction– The applicant is proposing to remove existing improvements in the front yard such as the non-historic stone retaining walls in the front yard, stairs and decks in the south side yard, and a c.1990 rock retaining walls in the backyard; reconstruct the historic c.1896 roof form and c.1990 wood shake roofing materials; reconstruct two c.1896 chimneys; reconstruct c.1997 basement; reconstruct c.1983 reconstructed front porch; replace c.1900 front door and two non-historic doors; replace 12 total historic wood windows.

PL-17-03686 43  
*Planner Grahn*

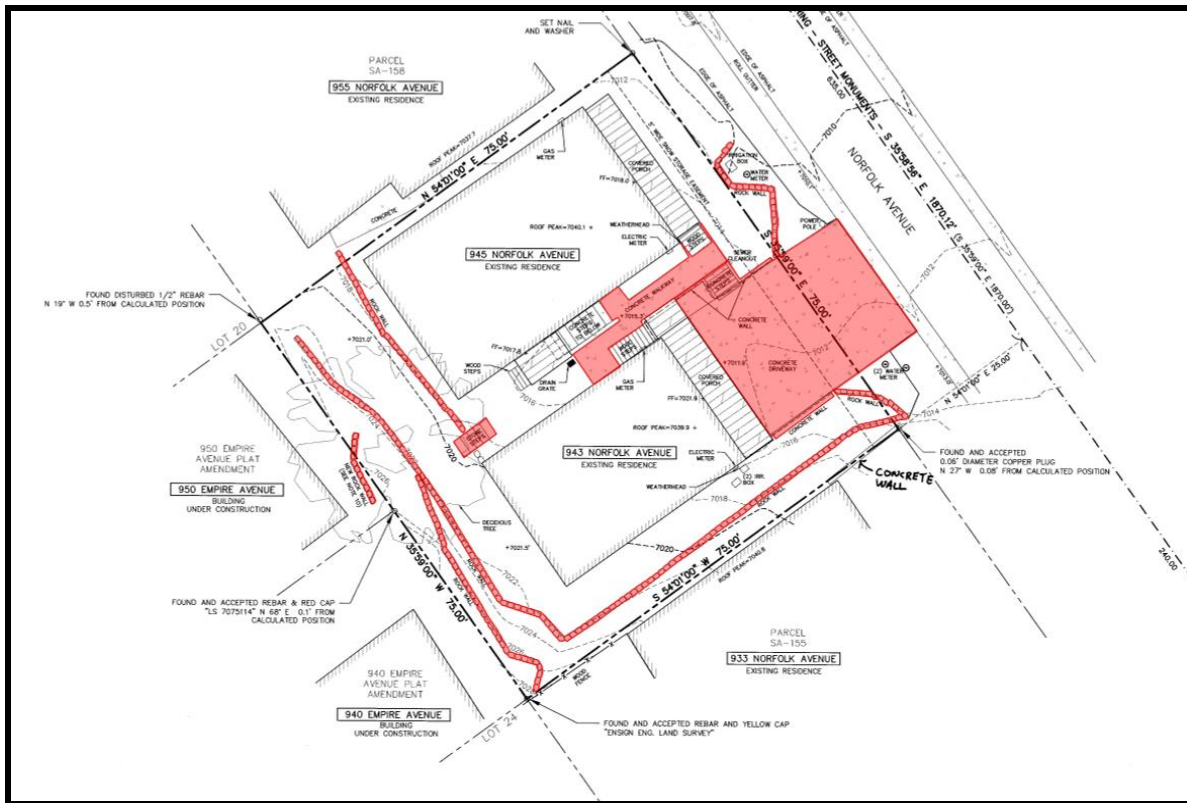
These improvements have been highlighted in red in the following site map.

Staff finds that these improvements to the site are not historic and do not contribute to the historic integrity or historical significance of the site. Further, the proposed work to remove these improvements mitigates any impact to the visual character of the neighborhood, the historical significance of the building, and the architectural integrity of the building.

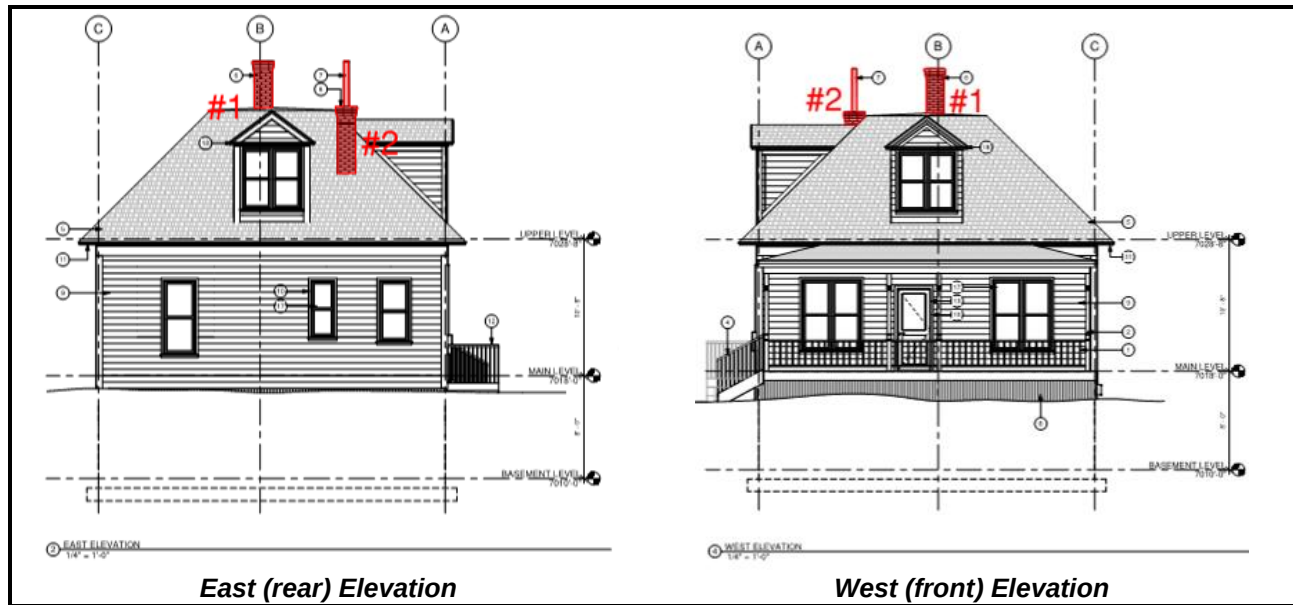
The chimneys are identified and highlighted in red below.

Because the front chimney (#1) is unreinforced masonry and does not meet building code, it will need to be rebuilt. The applicant has proposed a new fireplace in the living room that will be vented through the reconstructed chimney in the same location that it is today. Staff finds that the proposed Material Deconstruction of the front chimney is necessary for its restoration.

Because the second chimney (#2) is on the rear (west) elevation, is not visible from the right-of-way, and is in poor condition, staff finds that this chimney can be removed without compromising the historic integrity of the Landmark house. Further, the salvaged bricks from the second chimney can be used to repair and reconstruct the historic chimney on the front of the house. Staff finds the proposed scope of work mitigates any impacts that will occur to the historical significance of the building and will not impact the architectural integrity or structural stability of the historic building.

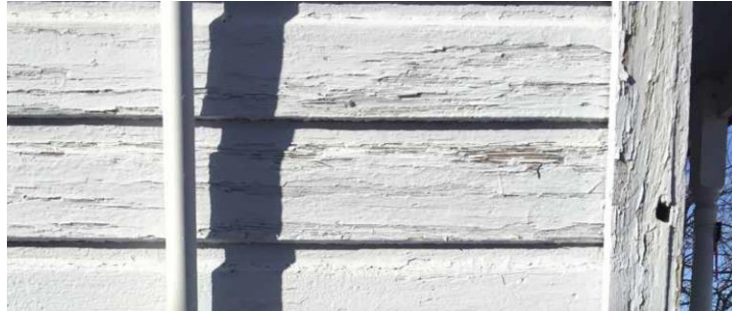
Exterior walls are in good condition, minus some deterioration of siding materials, particularly at the bottoms of the wall. The applicant proposes to repair defects where necessary, but the historic siding can largely remain in place and intact. Staff finds that any Material Deconstruction necessary to repair the siding is necessary for its restoration.

*Close-up of siding condition.*

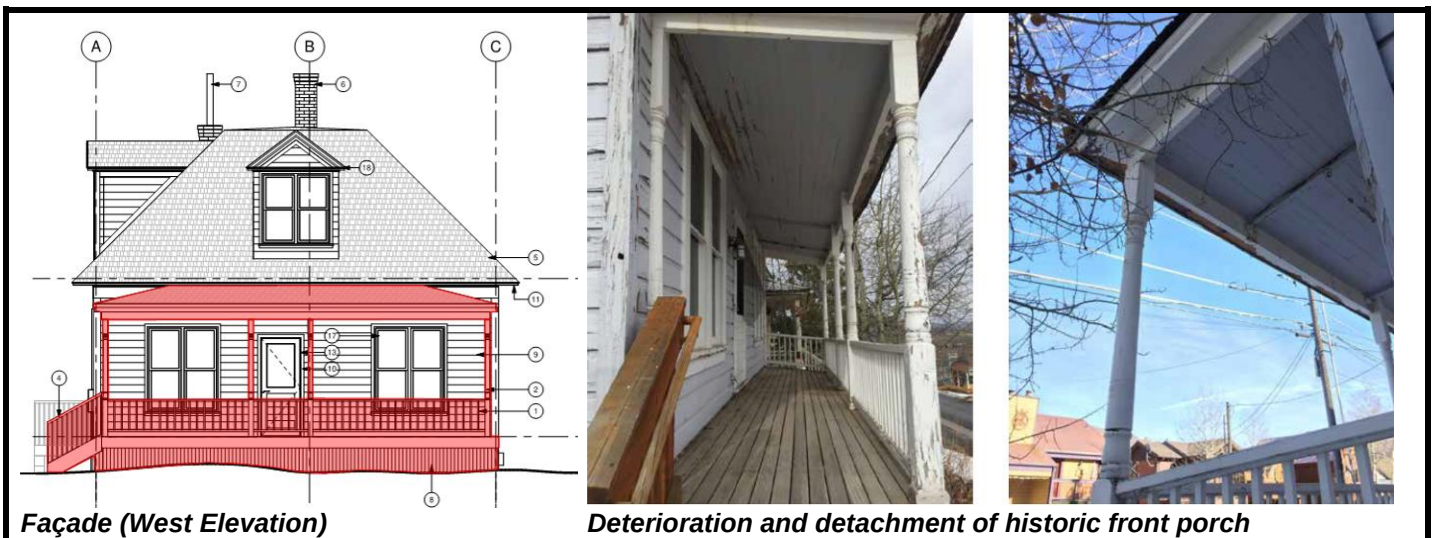
The porch is in fair condition. The deck and roof are currently sagging substantially toward the street, demonstrating a lack of structural integrity. The bottom of the porch posts show signs of deterioration and do not meet the bearing capacity of the roof. The trim and porch ceiling also show signs of deterioration and likely require replacement.

The applicant is proposing to reconstruct the entire front porch. On the south elevation, the porch steps will be removed and a new central staircase on the façade will be constructed; this new central staircase will replicate the staircase seen in the historic c.1941 tax photograph. Because the existing railings do not match the original lattice-inspired railing shown in the c.1941 tax photograph and the railing does not meet International Building Code (IBC) requirements, the applicant has proposed a taller railing to meet IBC requirements. The new railing will reconstruct the original lattice-inspired porch railings. New posts will be constructed that are modified in their profile slightly to ensure that the railing does not meet the post at a decorative turn. The new porch posts will also ensure IBC requirements for structural supports. Staff finds that the proposed Material Deconstruction on the porch is necessary for its restoration.

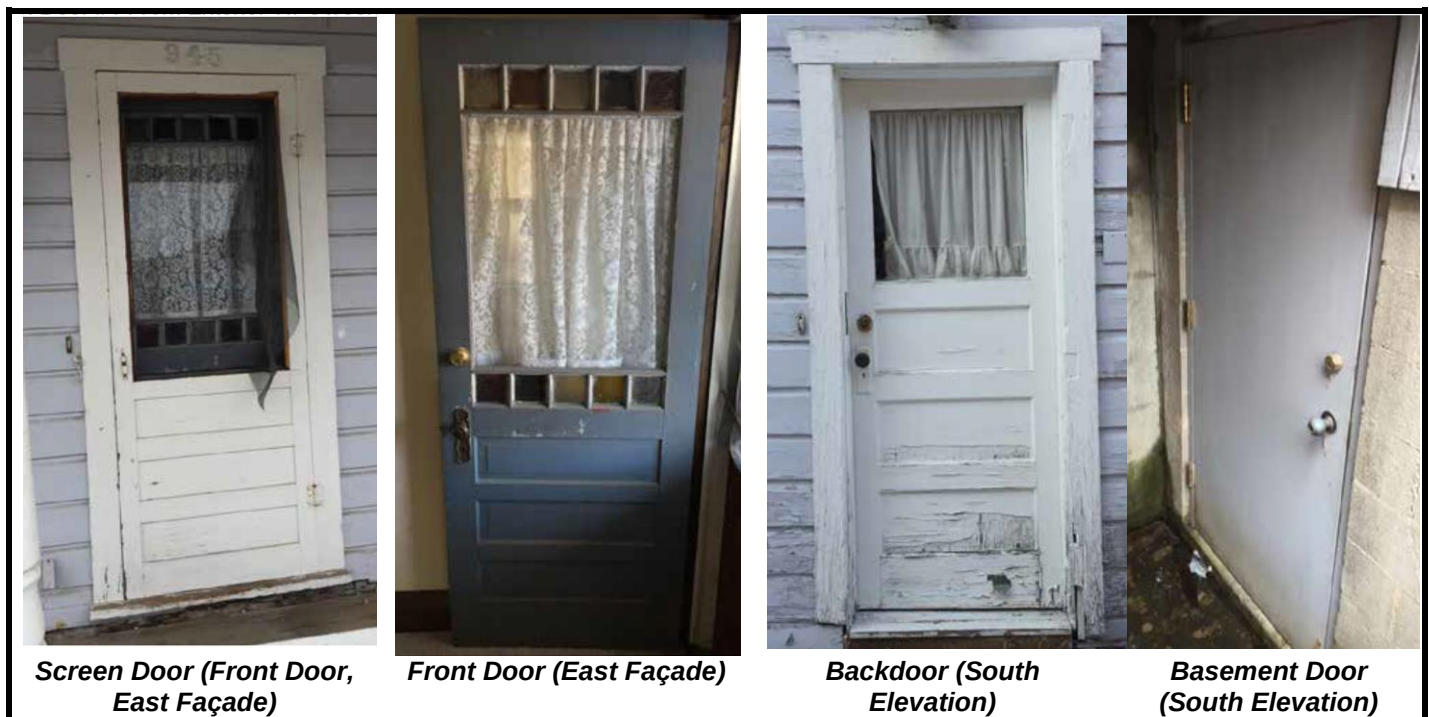
There are three existing doors on this historic house. The front door is in fair condition, but is no longer energy efficient and shows signs of deterioration. It has

been shielded by an original screen door; however, this door is warped, deteriorated, and the screen is damaged. The backdoor on the south elevation is also in fair condition and also shows signs of wood rot and paint deterioration. The third door is a contemporary steel door on the basement level.

The applicant is proposing to remove the historic doors and reconstruct these doors with new low-e tempered glass. The applicant will replace the contemporary steel basement door with a new wood door. Staff finds that the proposed Material Deconstruction is necessary in order to restore the historic house. In order to ensure that the historic details are accurately recreated, staff has added the following Condition of Approval:
