**PARK CITY HISTORIC PRESERVATION BOARD MEETING  
SUMMIT COUNTY, UTAH  
June 4, 2025**

**PARK CITY MUNICIPAL CORPORATION  
HISTORIC PRESERVATION BOARD MEETING  
MARSAC MUNICIPAL BUILDING  
COUNCIL CHAMBERS  
445 MARSAC AVENUE  
PARK CITY, SUMMIT COUNTY, UTAH  
MINUTES OF MAY 7, 2025**

# PHYSICAL CONDITIONS REPORT

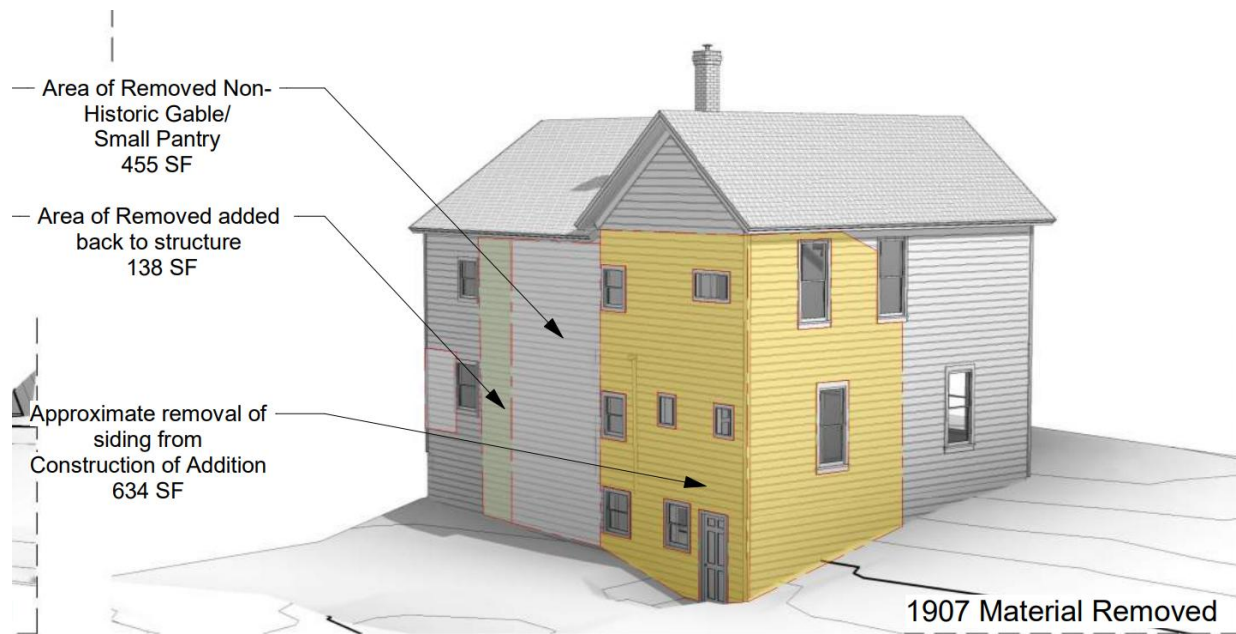
**(III) The Applicant proposes to remove 634 square feet of Historic materials from the rear (north) façade in order to construct the new addition.**

*Figure provided by the Applicant showing the material proposed to be removed to construct the addition.*

As provided in the above Analysis Section I Subsection 3 Staff recommends Conditions of Approval which require that the Applicant take careful steps to document, remove, preserve, and restore the Historic materials proposed to be removed from the Structure. Additional Staff recommends that Condition of Approval 15 be added to require that the Applicant submit an Industrial Hygienist Report that will be used to analyze the materials on the rear (north) façade can be panelized to preserve as many Historic materials as possible.

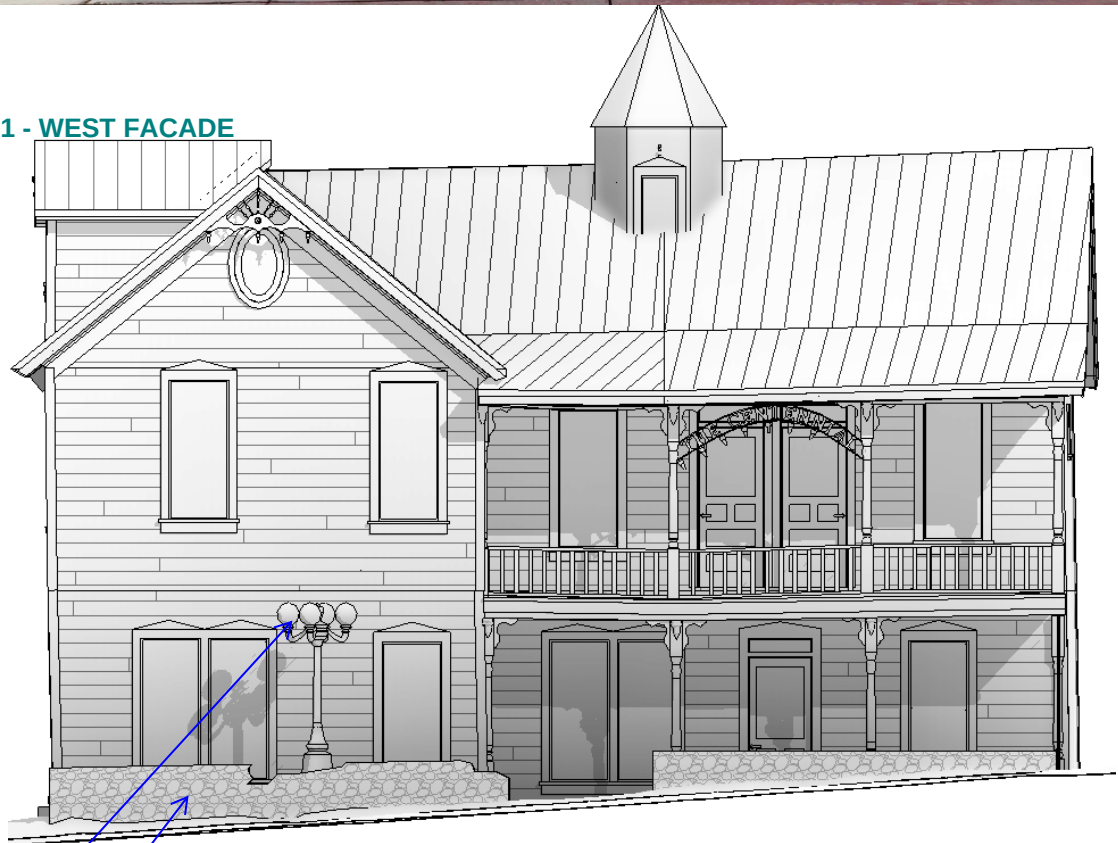
ILLUSTRATION # 1 - WEST FACADE

Non-Historic Light Post

Deteriorating Stone Wall

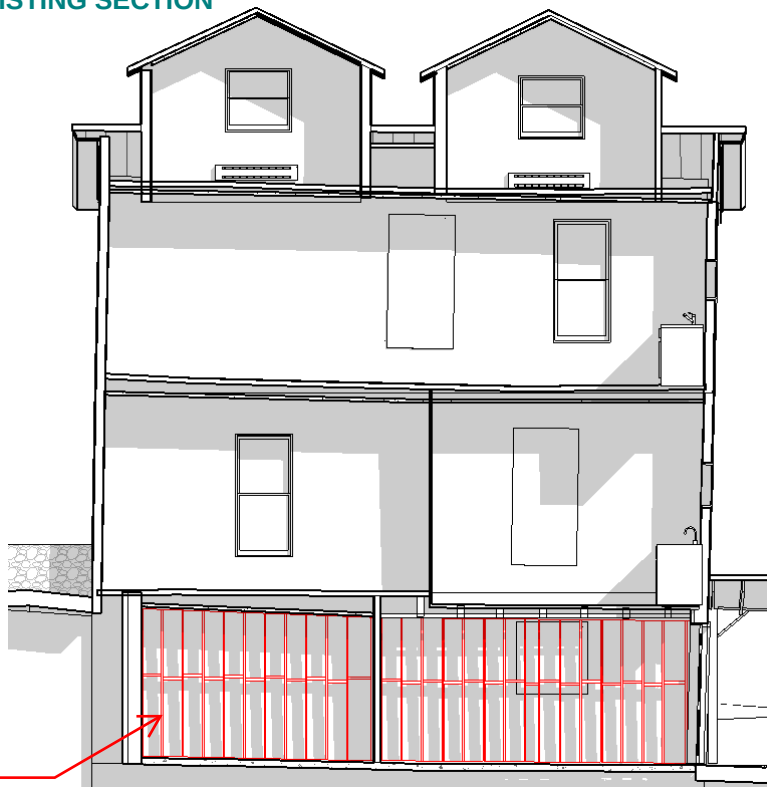
ILLUSTRATION # 2 - EXISTING SECTION

Example of Shoring required  
to support building found in  
as-built drawing set

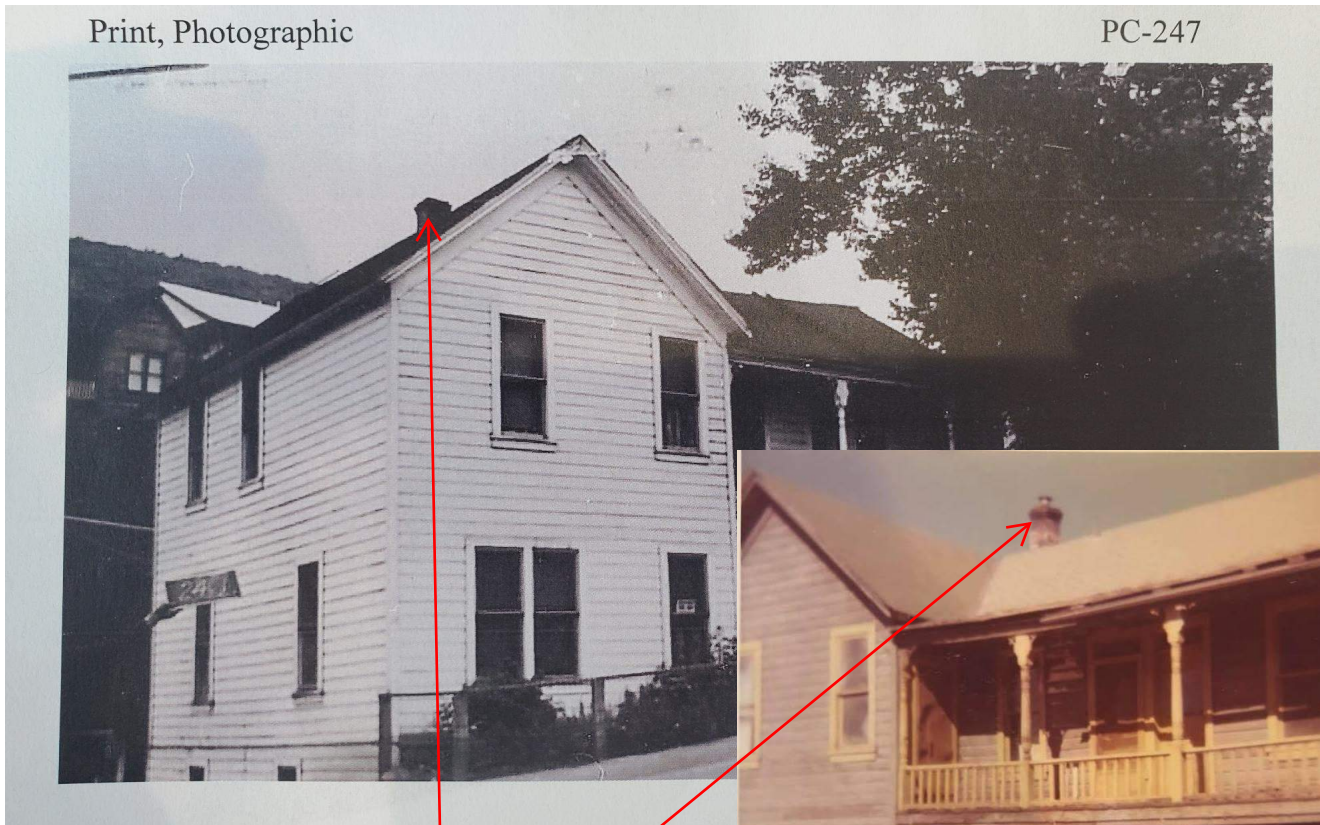
PHOTO #3,4 - CHIMNEY

Former  
Chimney

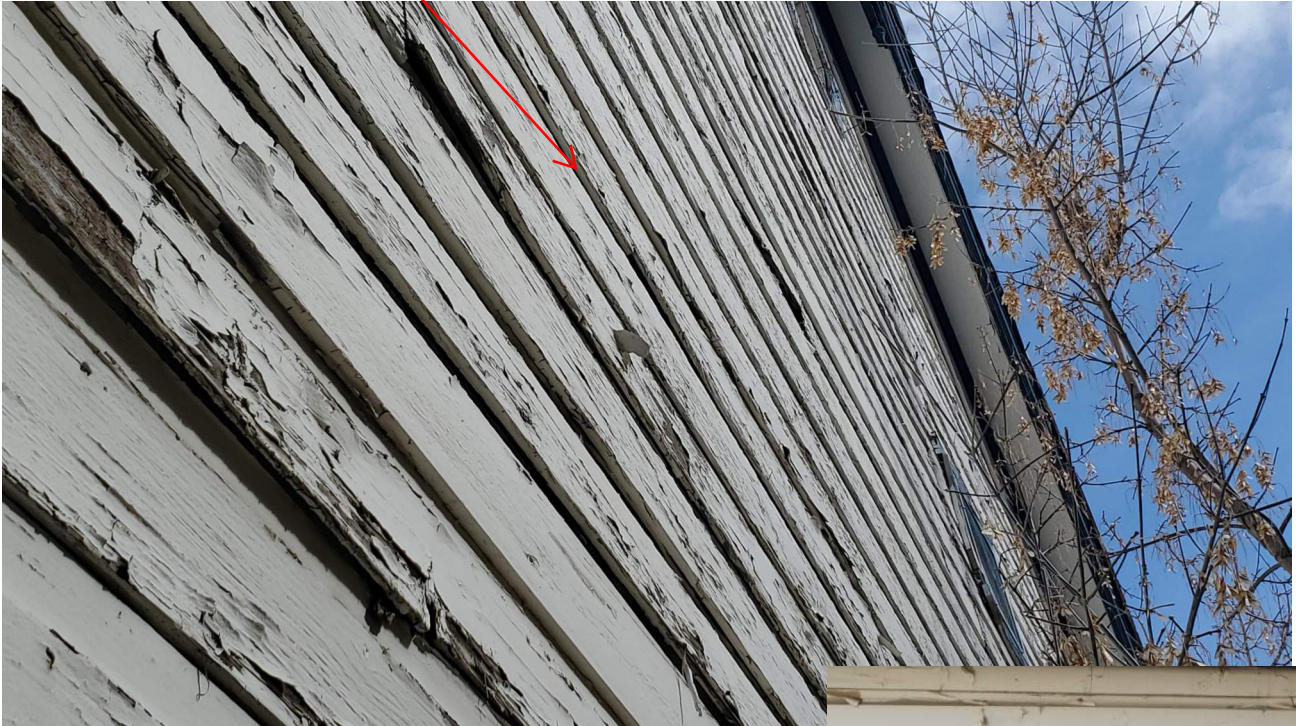
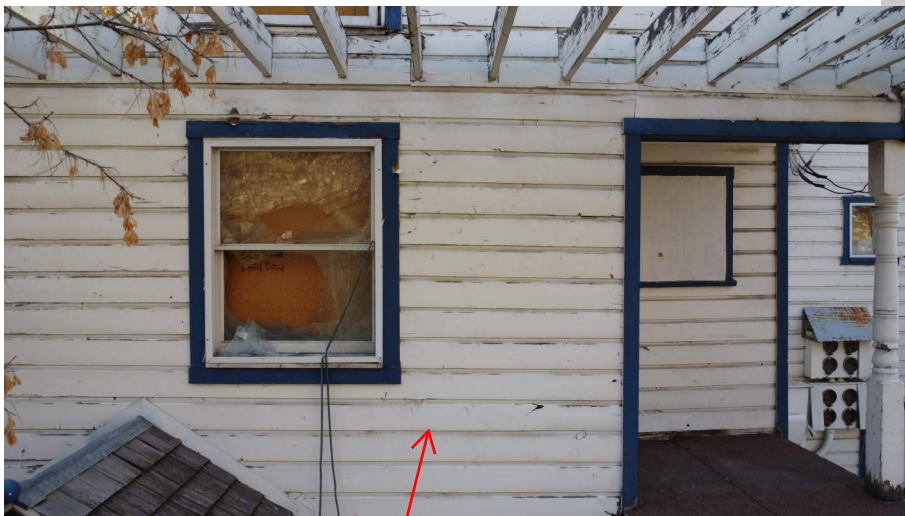
Existing Historic Siding  
on South Facade

Newer Siding on more  
recent addition to 1907  
structure

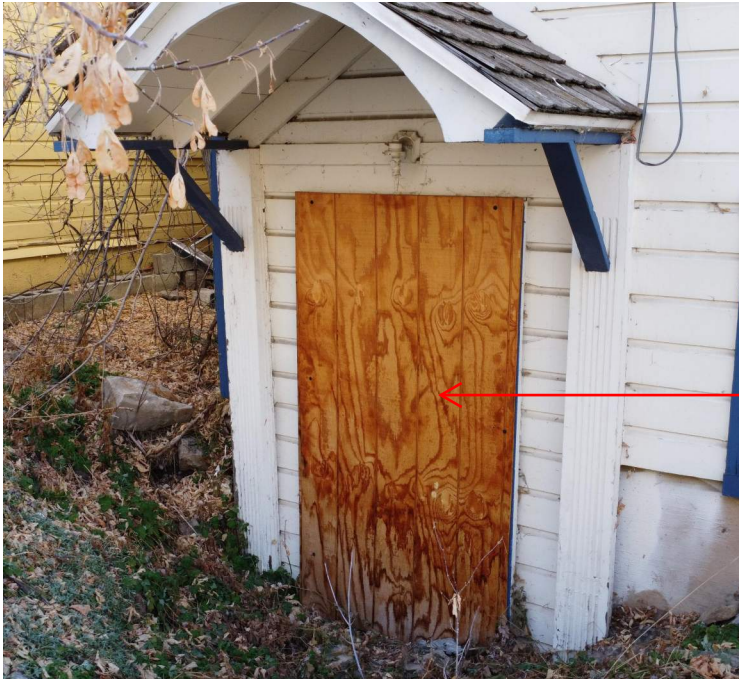
PHOTO #D3, D4

Boarded up door - See door schedule

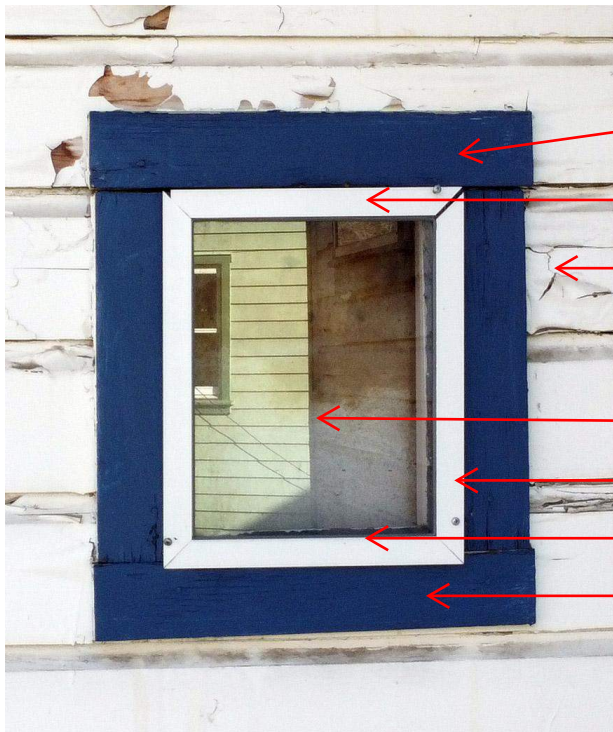
PHOTO #W8

- Head
- Upper Rail
- Jamb
- Single Pane Glazing Missing
- Storm Window Cover
- Lower Rail
- Apron

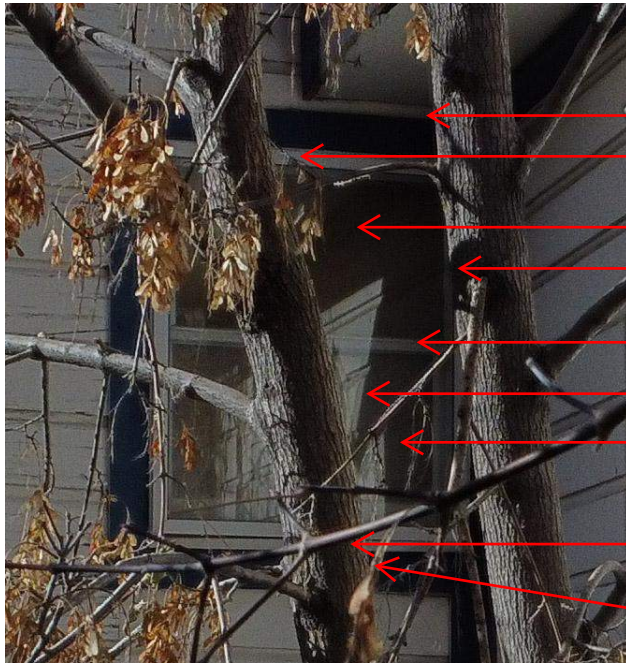
PHOTO #W22

- Head
- Upper Rail
- Upper Sash
- Jamb
- Lower Rail
- Storm Window Cover (Broken)
- Lower Sash
- Sill
- Apron

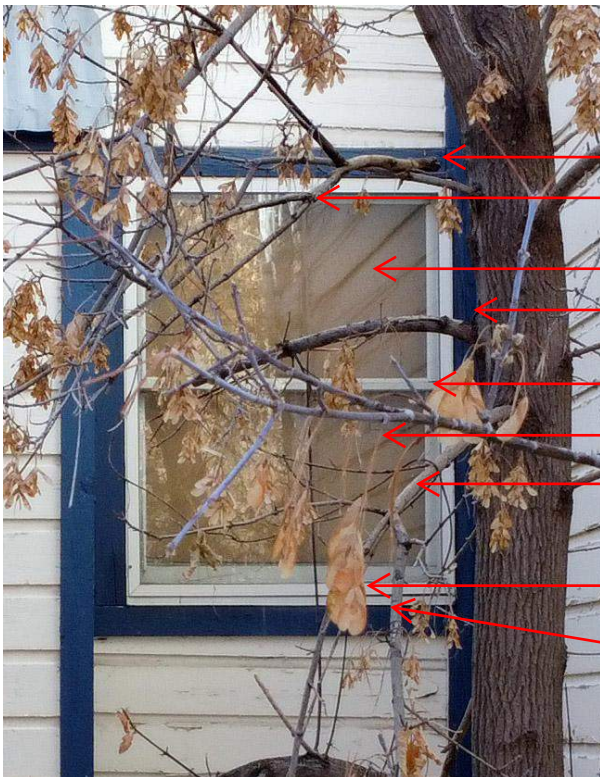
PHOTO #W23

- Head
- Upper Rail
- Upper Sash
- Jamb
- Lower Rail
- Storm Window Cover (Broken)
- Lower Sash
- Sill
- Apron

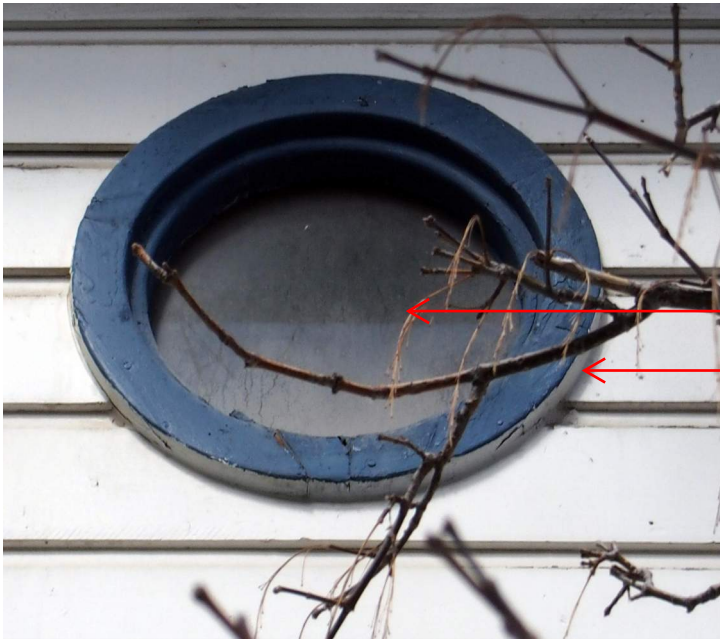
PHOTO #W27

Single Pane Glass (Broken)

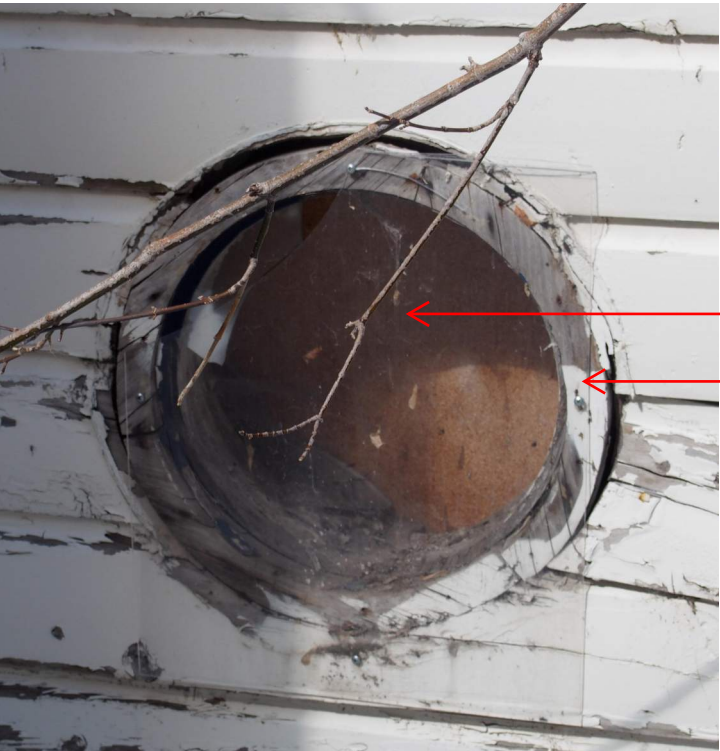
PHOTO #W28 - Update if possible

Single Pane Glass (Broken)
