**PARK CITY MUNICIPAL CORPORATION  
HISTORIC PRESERVATION BOARD  
CITY COUNCIL CHAMBERS  
November 1, 2017**

PARK CITY MUNICIPAL CORPORATION  
HISTORIC PRESERVATION BOARD  
MINUTES OF OCTOBER 4, 2017

### **Summary Recommendation:**

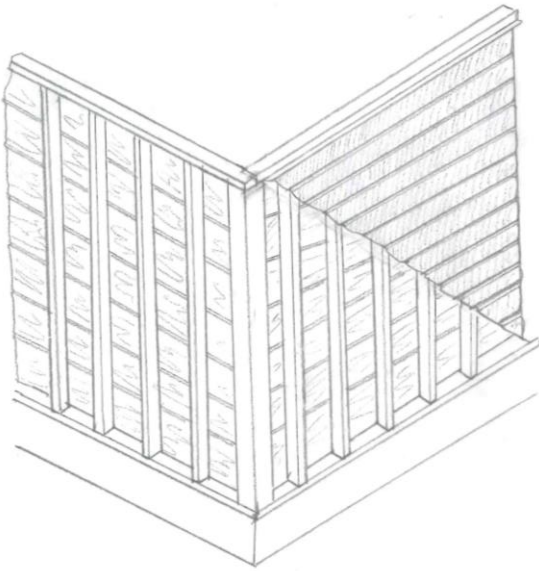
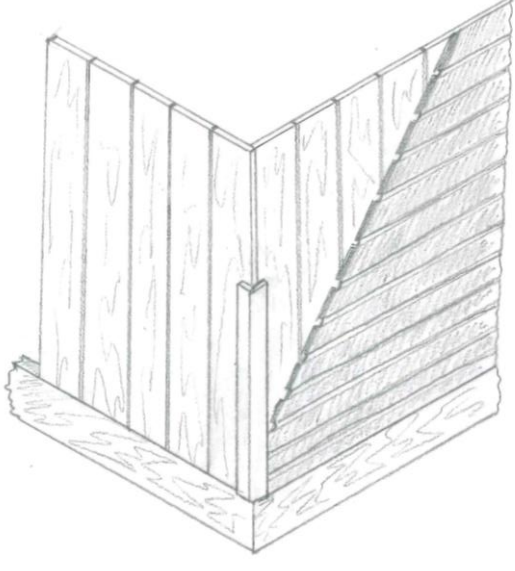
| <p><b>Framed Wall Construction.</b> 632 Deer Valley Loop has framed wall construction. On exterior, the horizontal wood siding is nailed to the studs. On the interior, horizontal wood planks cover the studs. This creates a cavity that was then filled with insulation, containing asbestos.</p> <p><i>Because the individual siding pieces are nailed to the studs on the exterior and the wall structure is in such poor condition, the applicant cannot salvage an entire wall panel the way that they could have if the structure had been built using single-wall construction.</i></p> | <p><b>Single Wall Construction.</b> Most Park City houses constructed during the Mining Era consist of single-wall construction. The walls are comprised of horizontal wood siding on the exterior, attached to vertical wood planks on the interior. With this type of construction, there are no cavities for insulation, and new framed walls were sometimes added on the interior in order to facilitate new insulation. Because there are no corner boards with single-wall construction, the wall panels can generally be detached and disassembled through panelization.</p> |

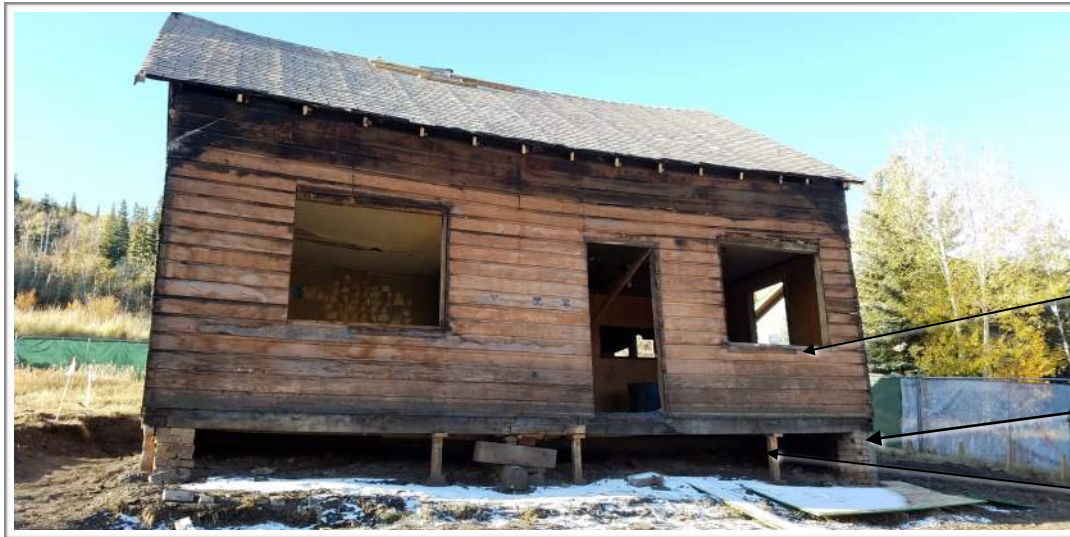
Photo #1: North Elevation - October 10

Window Shadow

Triple Wythe  
Brick Columns

Post-Beam Floor  
Construction

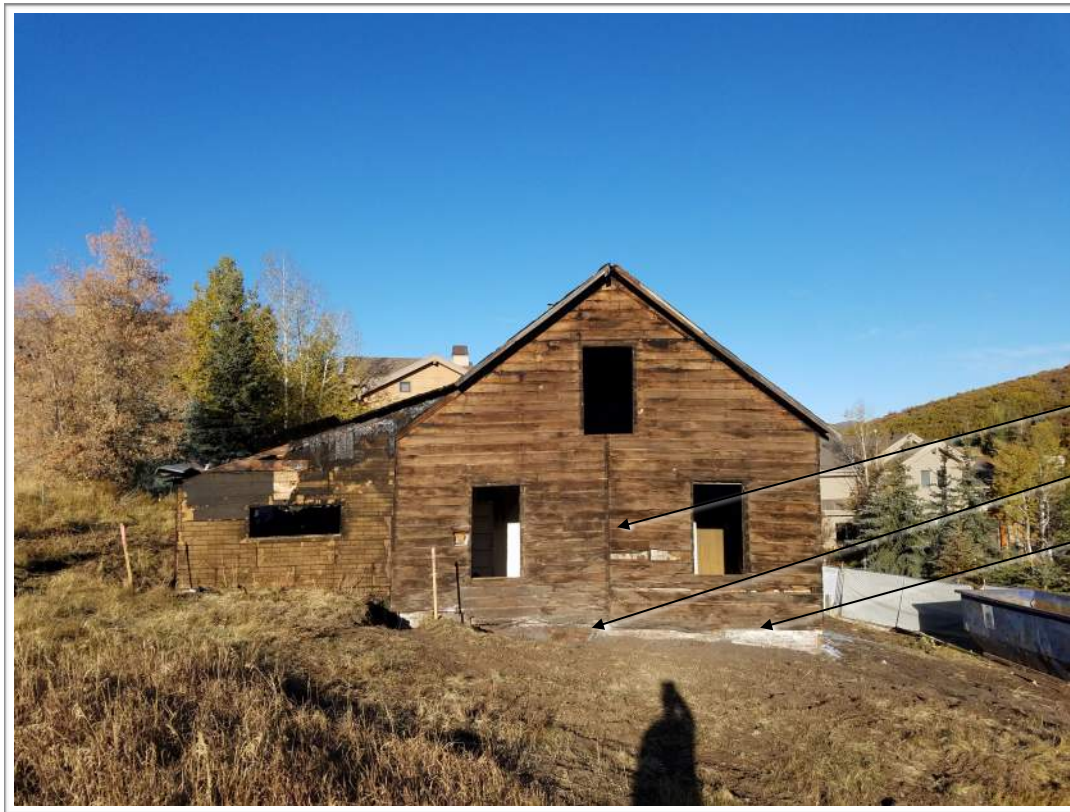
Photo #2: East Elevation - October 10

Vertical Seam

Wood Foundation

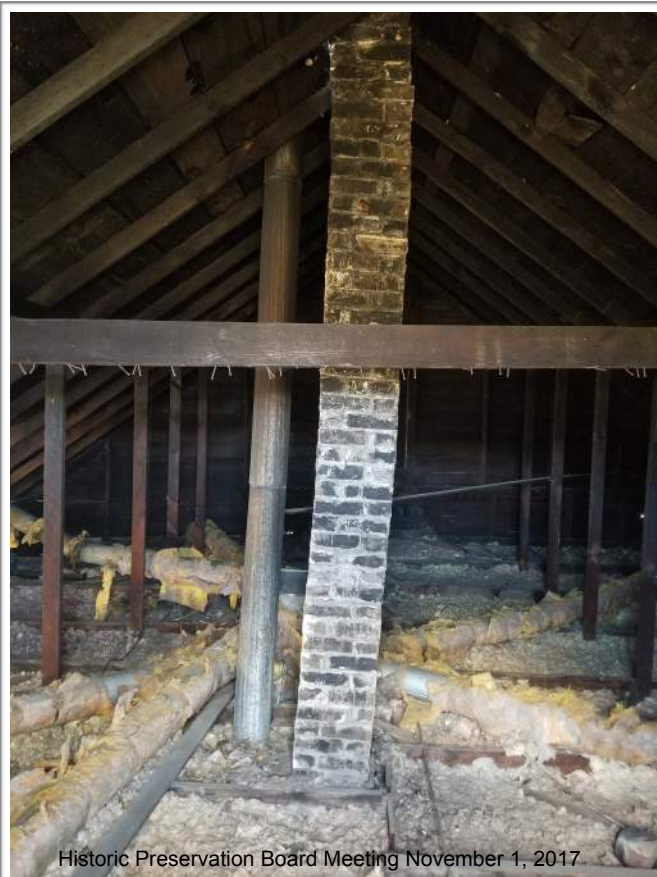
Photo #12 Ash Mixture Exiting Structure

Adding to the building's deficiencies, coal ash and other materials were dumped into the wall cavities from the attic, likely in an effort to introduce insulation into the wall structure. These materials have settled into the base of the wall structure as well as the headers for the windows and doors. The insulation material contains traces of asbestos, which require abatement; however, the poor structural stability of the house prevents those completing the abatement to do so from the interior. Should the interior wall sheathing be removed, the structure will lose its rigidity and possibly collapse. The Chief Building Official and Planning staff met with the applicant's construction team on site on September 28<sup>th</sup>, and staff has confirmed these poor and dangerous conditions (See Exhibit D-Chief Building Official Letter).

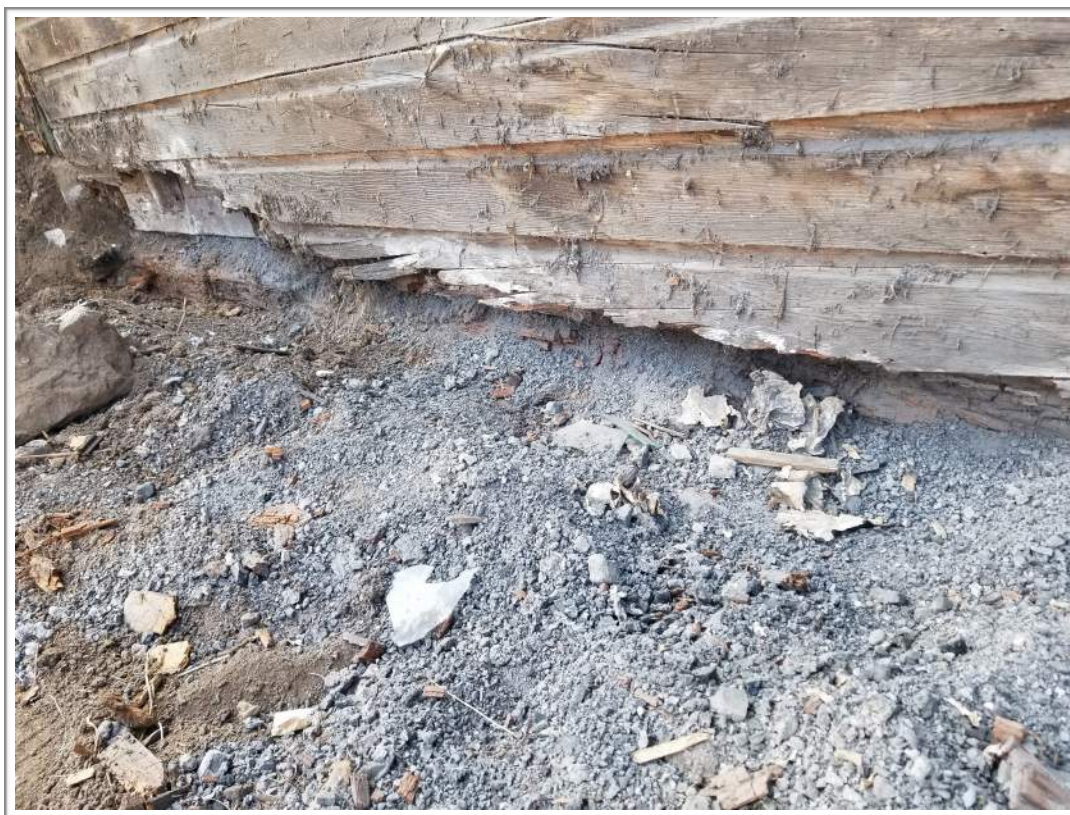
As outlined in the applicant's analysis (Exhibit A), the foundation was ~~hobbled~~ "hobbled together" at best. On the east and west sides of the house, a [single wythe foundation](#) – a wall consisting of a single layer of stacked bricks—was haphazardly added as the grade falls away from the main floor level of the house. The north façade is held up by a post and beam foundation that sags some six inches (6") across the length of the house. The

Photo #13: Deteriorated Foundation and Ash Mixture

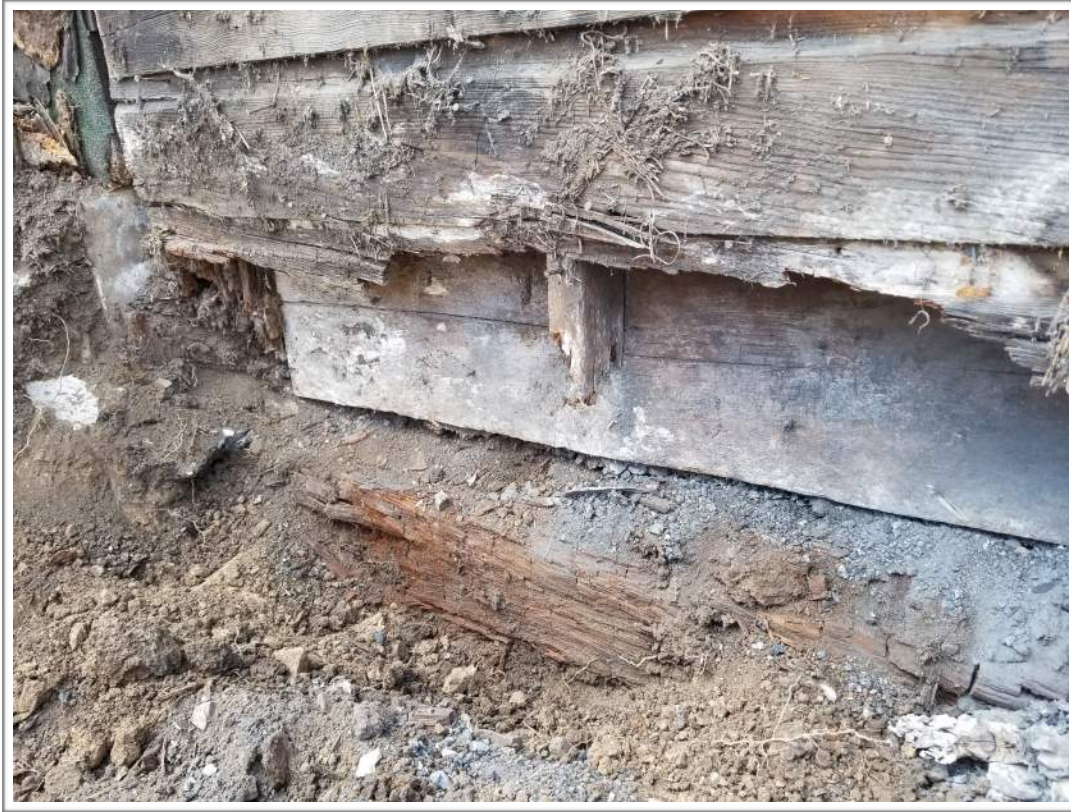
beam under the north wall of the house consists of two large timbers connected by a dovetail rabbet joint; the joint has failed and contributes to the sagging structure. On the south half of the house (original hall-parlor), the wood floor structure sits directly on the dirt. This floor structure is held up by a combination of dirt, rotted wood posts and beams that sit directly on the ground. It is in failing condition.

Photo #14: Deteriorated 6x6 Foundation Beam & Wall Construction

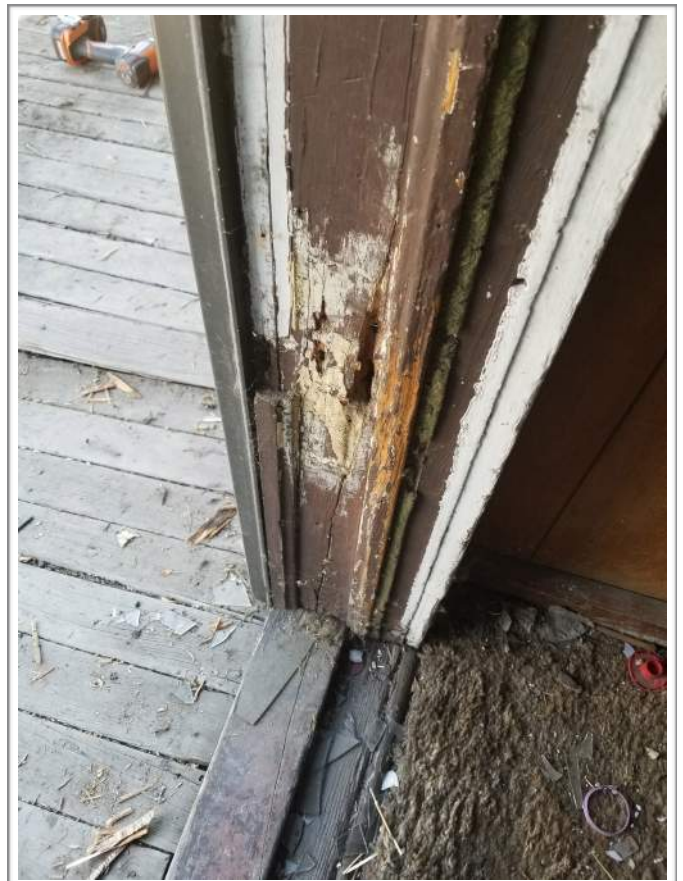
Photo #16: Damaged Door Frame

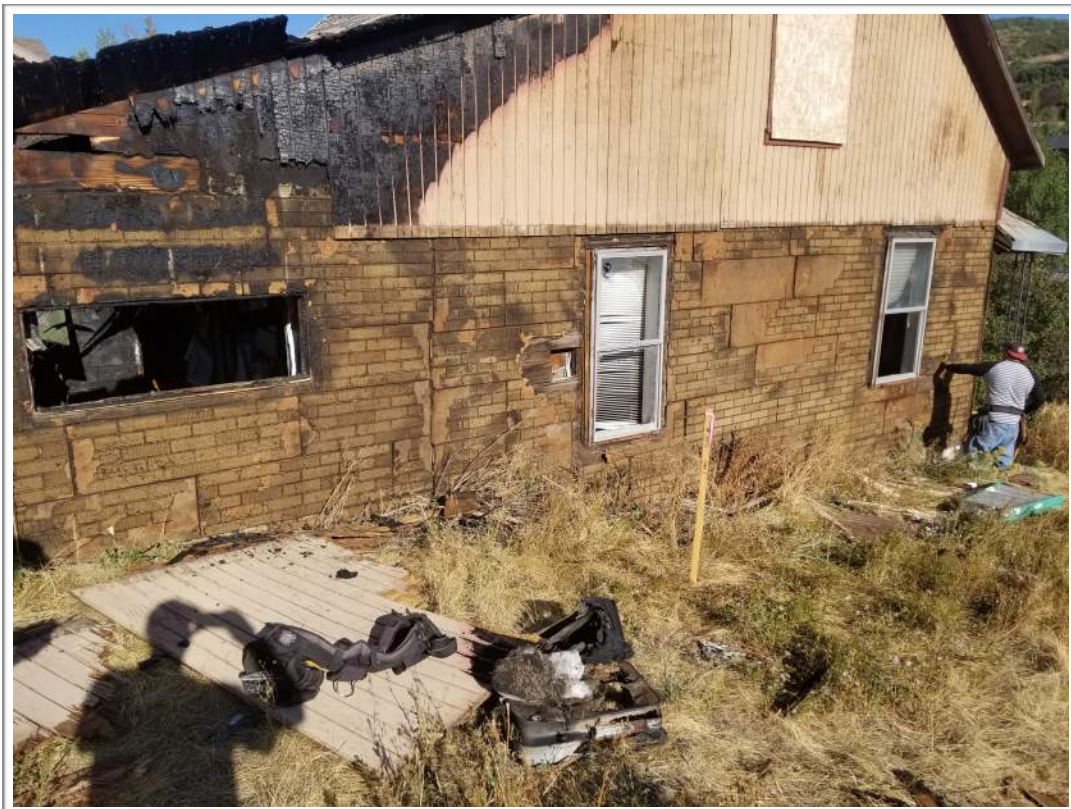
Photo #24 East Elevation Siding Removal

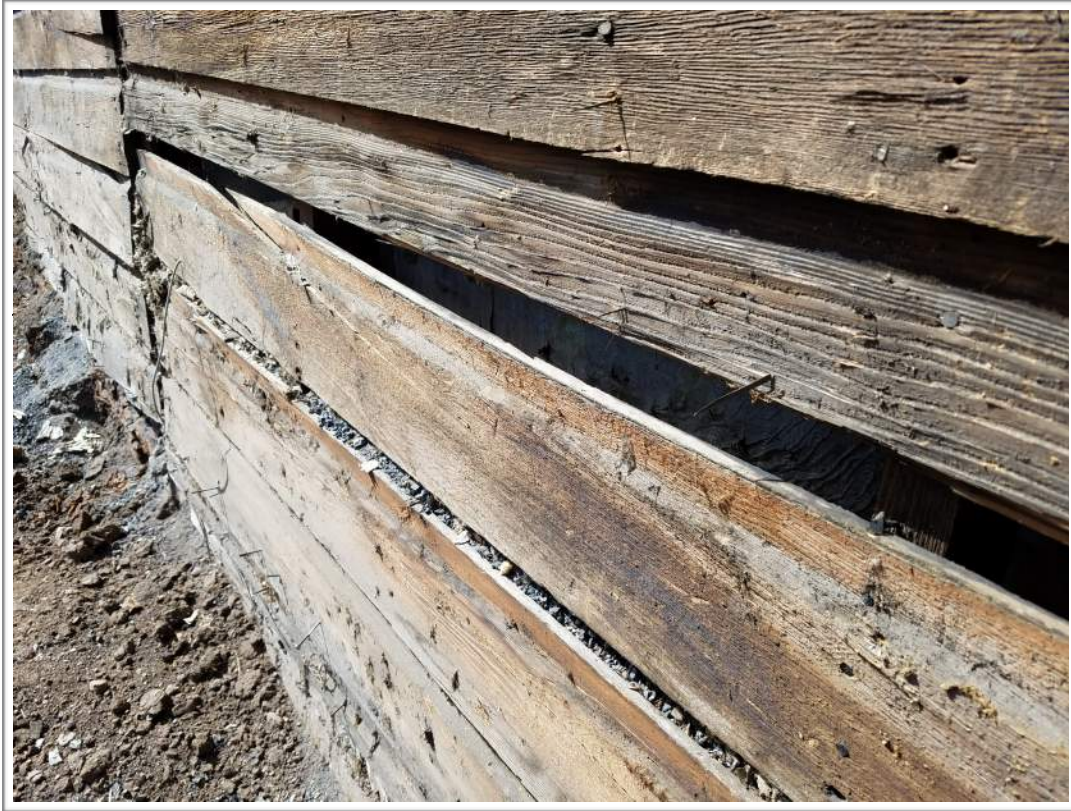
The structure is a hybrid between balloon framing and typical Park City Mining Era single-wall construction. There is no sill plate, which has caused the lower two to three feet of the framing studs to rot. Because of the fire, the wall framing above the top plate is charred in many cases and would not hold new bracing if the walls were panelized. The vertical seam between the original building and north addition has allowed water penetration into the interior structure which has furthered the rot and caused wood rot on the original siding.

Photo #25 East Facade Siding Condition

Siding salvaged from the north, west, and east walls will then be reapplied and restored on the reconstructed house once the HDDR is approved.
