**PARK CITY HISTORIC PRESERVATION BOARD MEETING  
SUMMIT COUNTY, UTAH  
November 1, 2023**

- 6.A. **Historic District Design Guideline Illustrations** - The Historic Preservation Board will Review Draft Amendments to the Standards Adopted in Chapter 15-13: Design Guidelines for Historic Districts and Historic Sites of the Land Management Code.

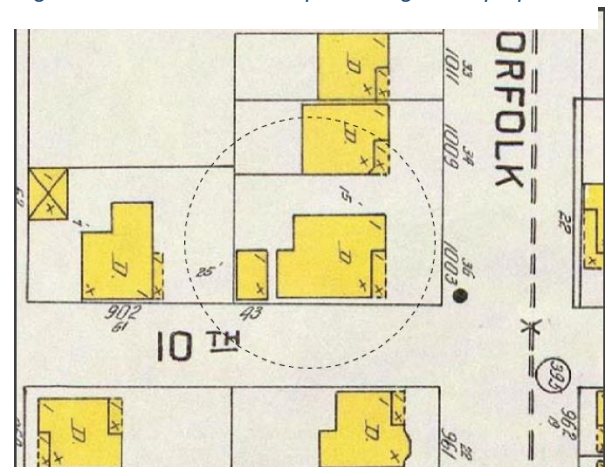
Figure 2: 1900 Sanborn Map showing L-Shape porch

Figure 2: 1907 Sanborn Map showing partially-enclosed porch

On February 3, 2021, the Historic Preservation Board reviewed the Applicant's request to restore 1003 Norfolk Avenue to its c. 1900 form with a finding that the removal of the post-1900 additions was appropriate because it was true to the Structure's original form ([Minutes](#), p. 7). Additionally, the Applicant stated the original roof form had been overbuilt at least twice to accommodate the previous additions and detracted from the historic character of the Structure. The Historic Preservation Board recommended a Condition of Approval that any salvageable historic material be reused on the site

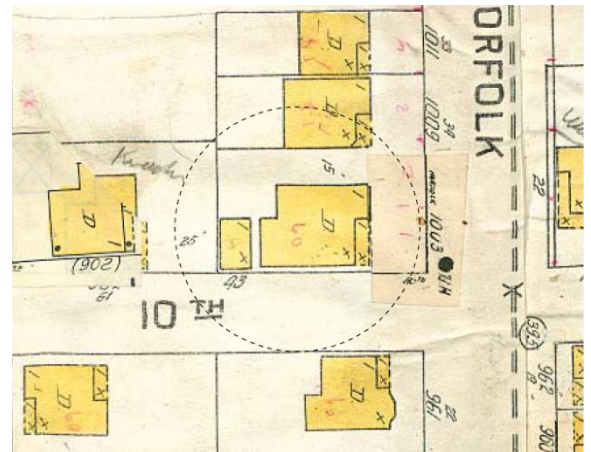
Figure 3: 1941 Sanborn Map

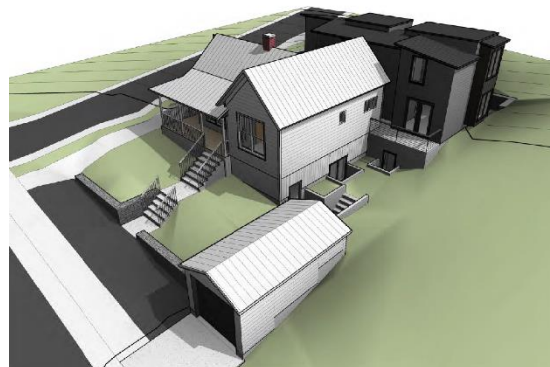
Figure 6: Rendering showing proposed addition and restored 1900 roof form.

Figure 7: As-built roofing plan showing shaded areas proposed to be removed.

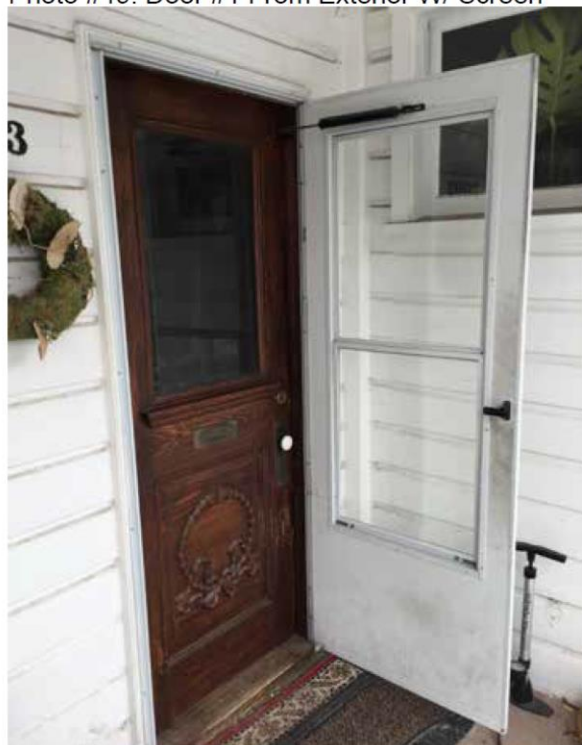
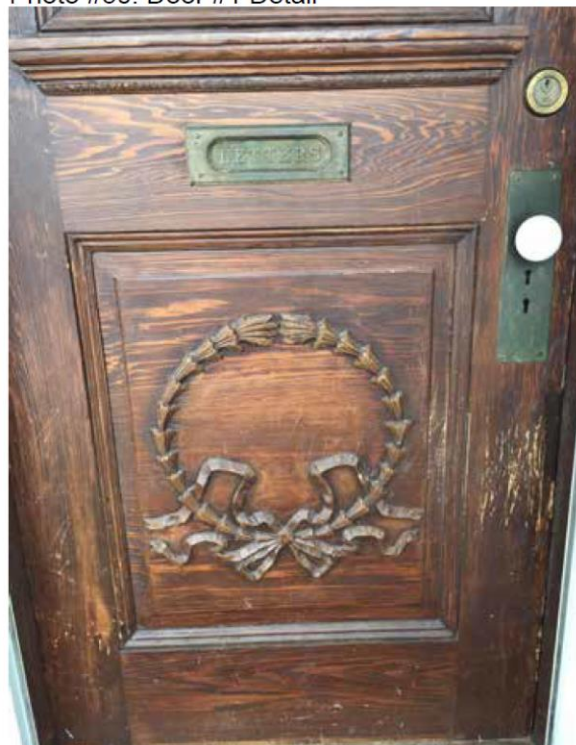
Photo #49: Door #1 From Exterior W/ Screen

*Figure 8: Applicant's photos of existing historic front door (to be replicated).*

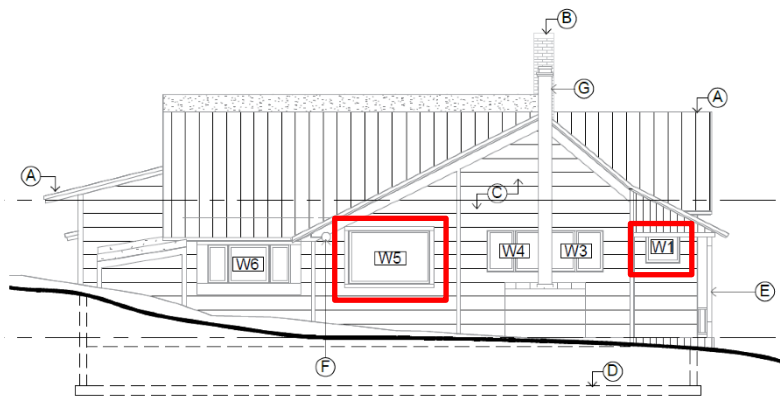
Figure 9: As-builts of southern facade detailing historic window locations.

The Applicant also proposes to replace all 11 windows on the Structure, 7 of which are 50 years old or more (labeled as windows # 1, 2, 5, 7, 9, 10, and 11 (Figures 9-11)). The historic window openings and locations will remain the same. The Applicant's conditions report indicate some of these windows may be inoperable and some components have suffered water damage. Staff recommends Condition of Approval 11 that a determination on the operability and salvageability of these windows be provided to the Planning Department prior to this application proceeding to the Historic District Design Review public hearing.

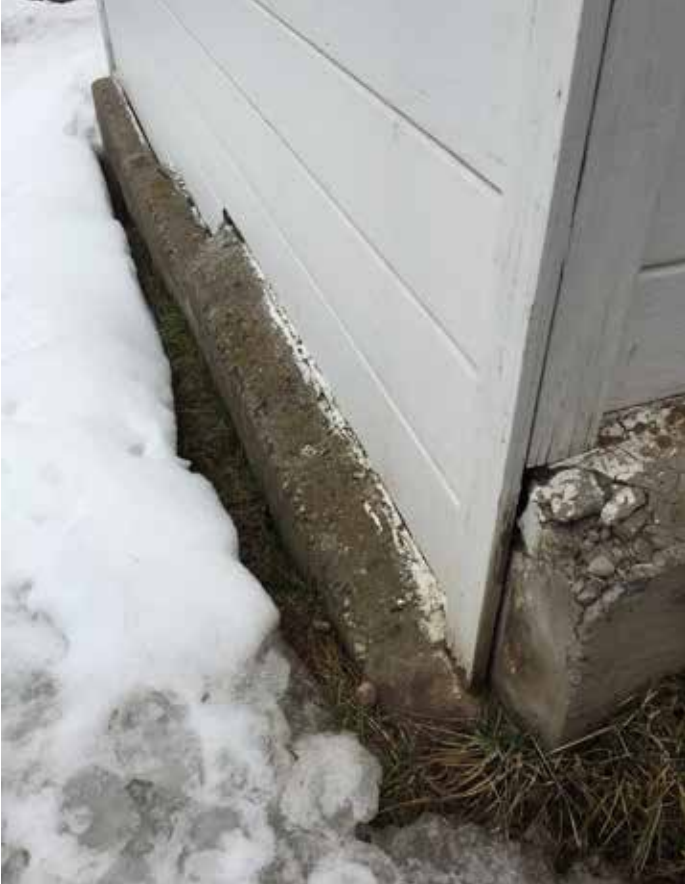
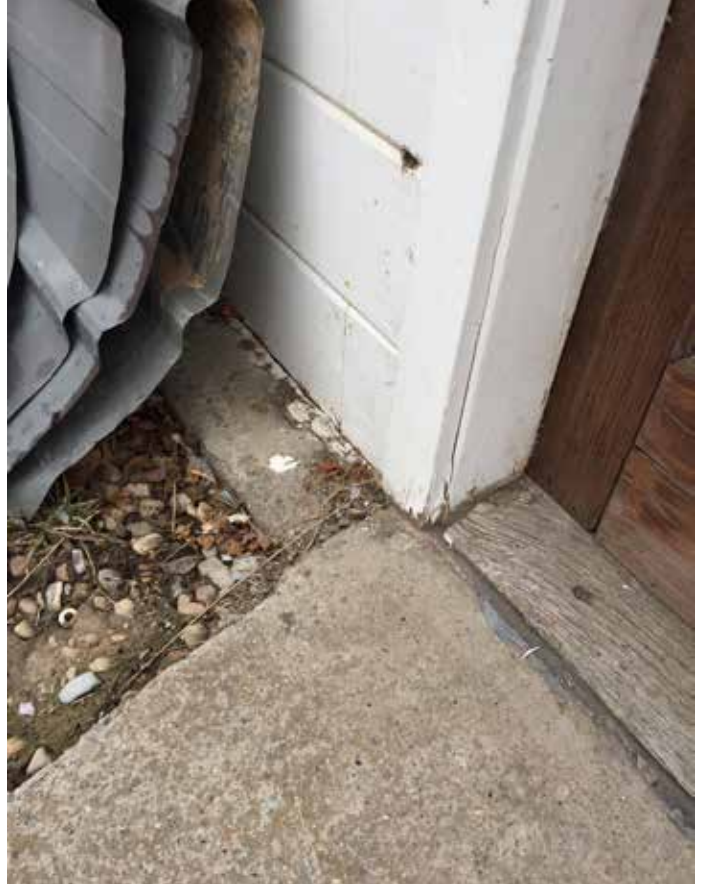
Photo #35: Exposed Foundation At Addition

Photo #36: Exposed Foundation At Addition

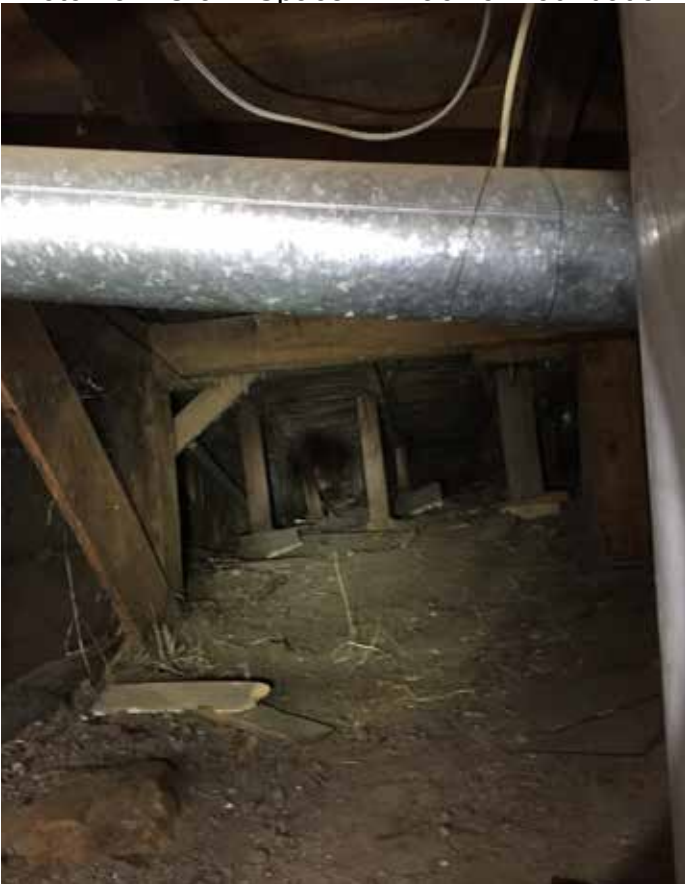
Photo #37: Crawl Space W/ Lack of Foundation

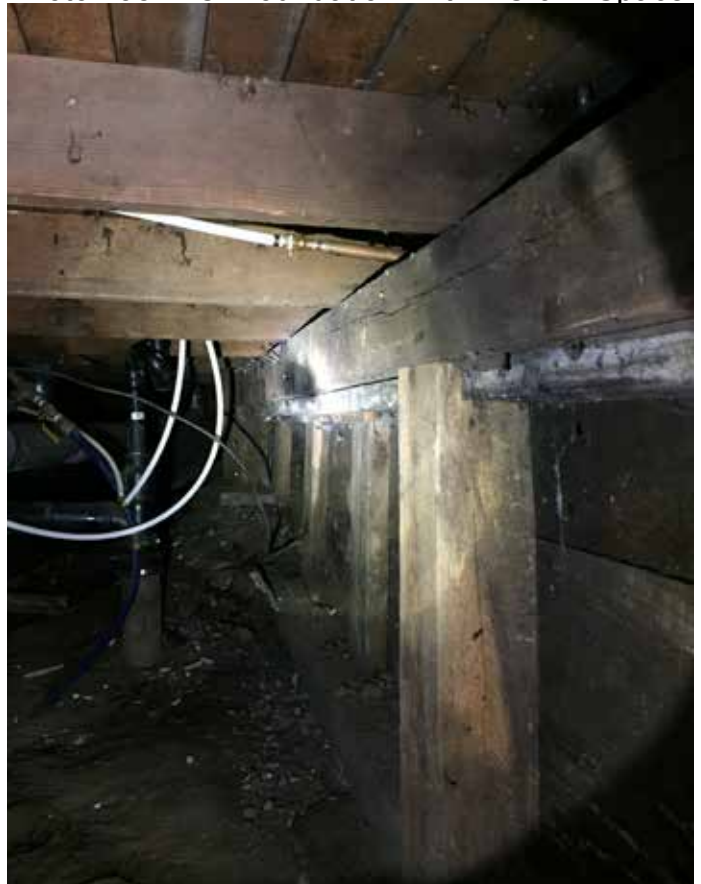
Photo #38: T.O. Foundation Within Crawl Space

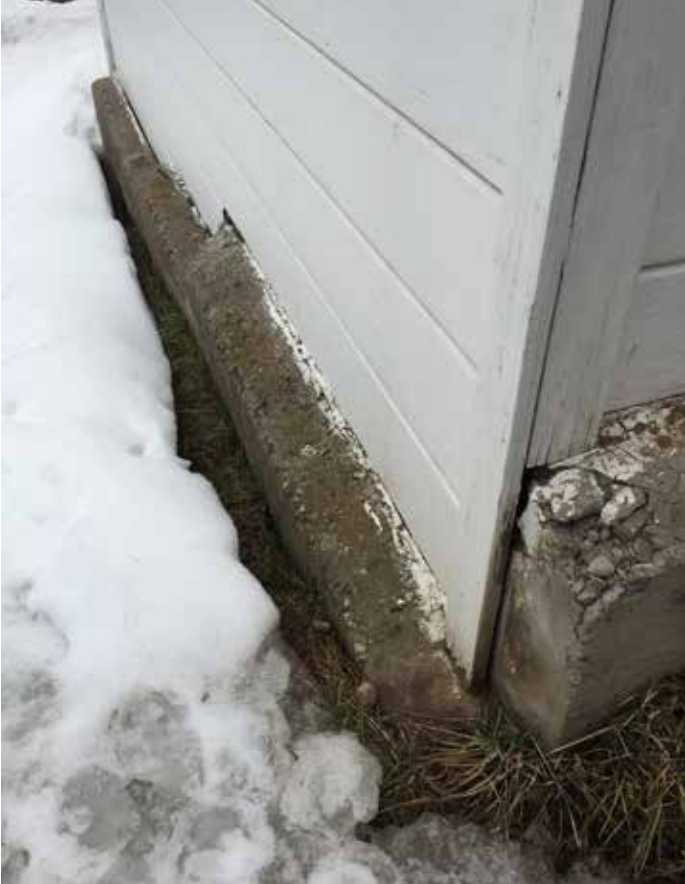
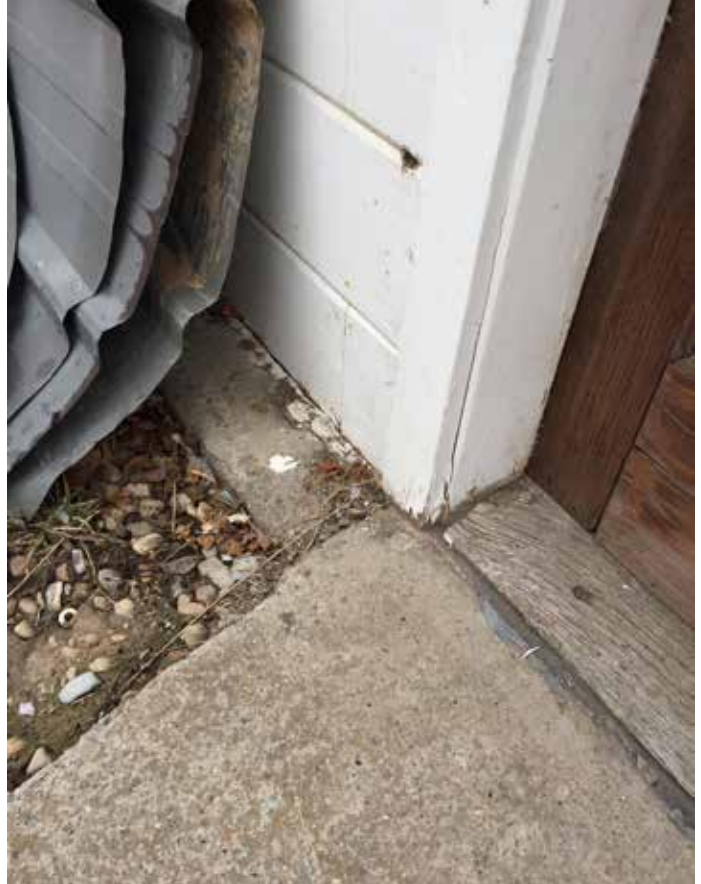
Photo #35: Exposed Foundation At Addition

Photo #36: Exposed Foundation At Addition

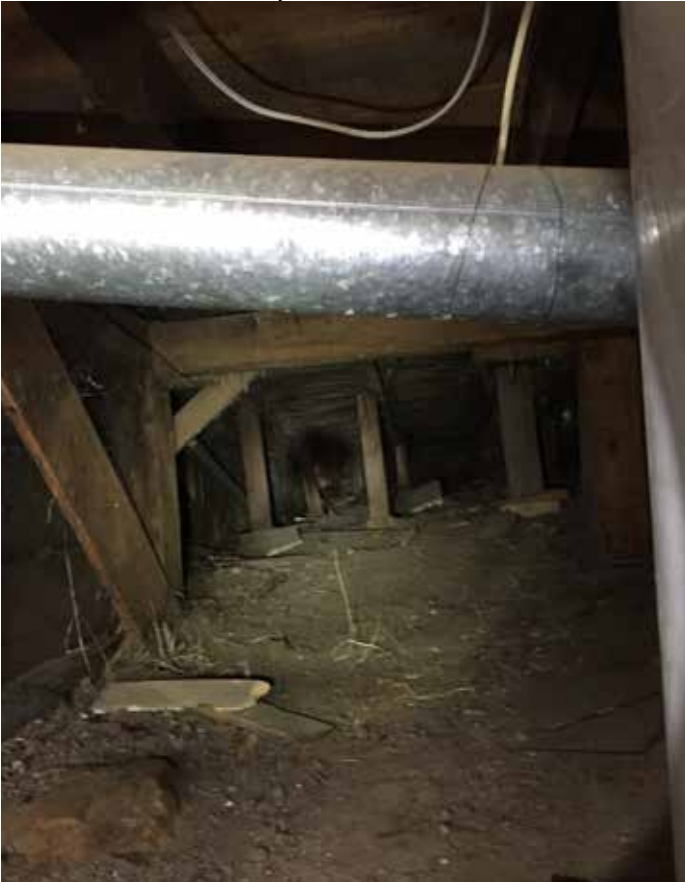
Photo #37: Crawl Space W/ Lack of Foundation

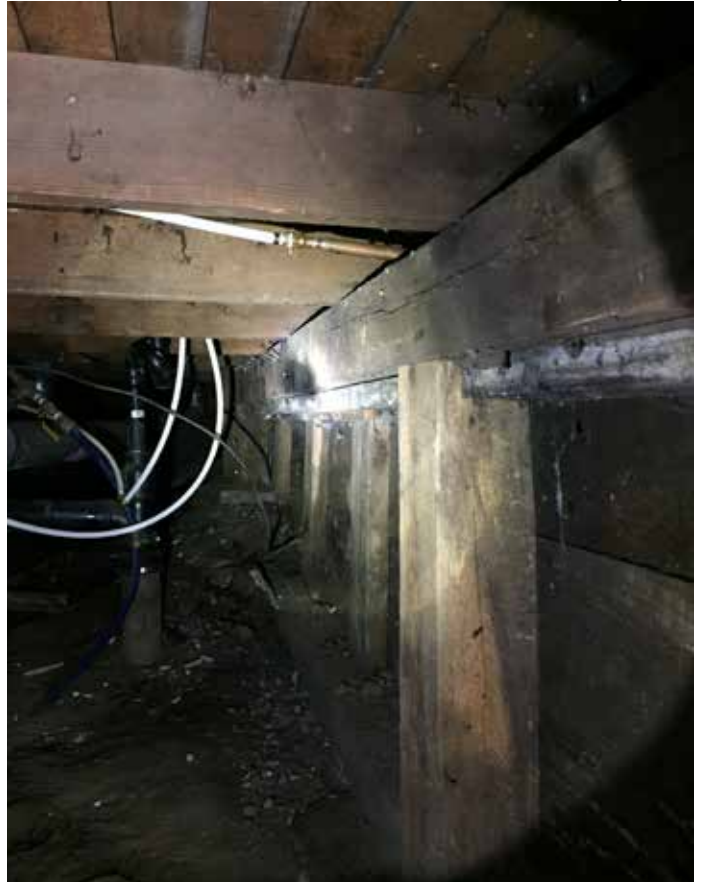
Photo #38: T.O. Foundation Within Crawl Space

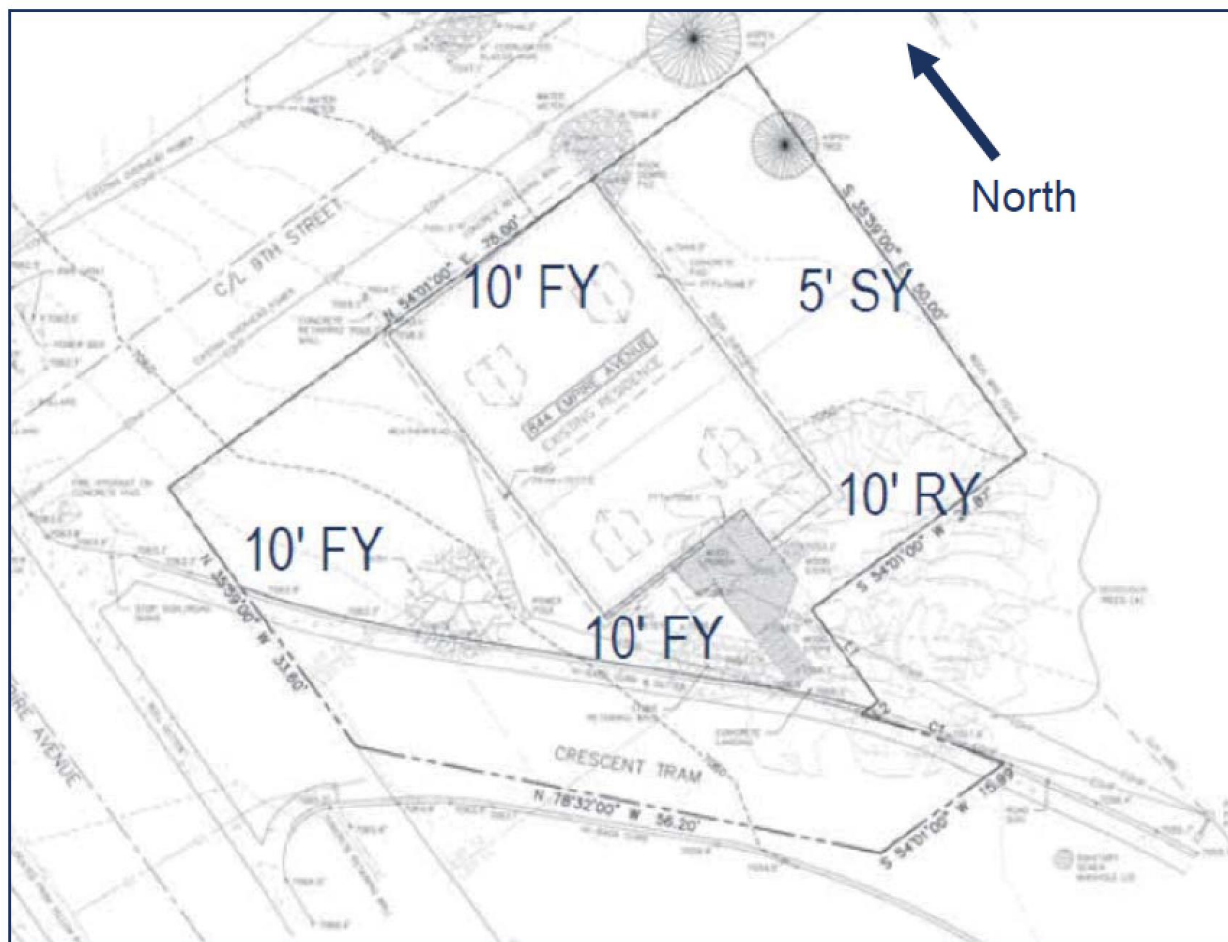
844 Empire Avenue is a uniquely-shaped Lot with frontage along Crescent Tram Road, Empire Avenue, and the 9<sup>th</sup> Street public right-of-way. Historically, the front of the house faced the 9<sup>th</sup> Street right-of-way but presently the front door faces Crescent Tram Road. The home is addressed off Empire Avenue, which is the street the Site has the least amount of frontage on. In 2015 the property owners amended the plat for 844 Empire Avenue; as part of this review process the Planning Director provided a determination of the locations of the front, side, and rear Lot lines as well as the required setbacks:

The 2015 Planning Director Determination acknowledges three front yards; one each along Crescent Tram Road, Empire Avenue, and the 9<sup>th</sup> Street public right-of-way. The eastern side of the Lot is noted as the only side yard area and the remaining portion of the southern portion of the Lot (not along Crescent Tram Road) is noted as the rear yard area.

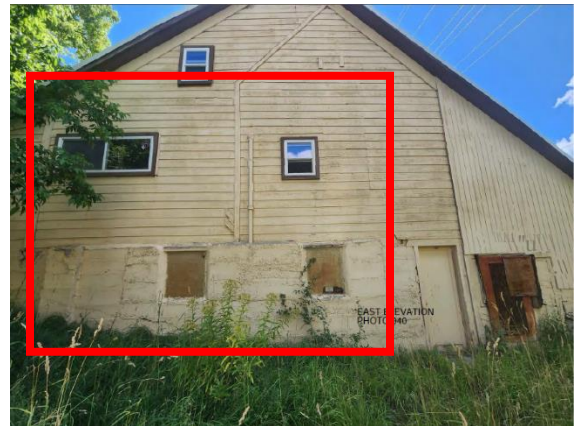
*Figure 5: Photograph of eastern facade of home showing area of siding proposed to be removed.*

The Applicant has proposed to lift the Significant Historic Structure and construct a new basement and foundation. Once completed, the Applicant will set the Significant Historic Structure on the new foundation at a height no more than two feet (2') above its current elevation. Additionally, the Applicant has proposed the removal of the non-compatible addition to the historic front of the Structure and to restore the historic front porch as viewed in the 1940s tax photograph (see Figure 1). The Applicant proposes to remove approximately 308 square feet of siding material from the eastern façade. The affected siding material is generally in good condition and is not visible from the public right-of-way. If the Historic Preservation Board approves Material Deconstruction of this siding, planning staff recommends a Condition of Approval that siding material removed from this section that is in good condition be used to patch or repair other sections of siding on the Historic Structure that may be damaged or missing.

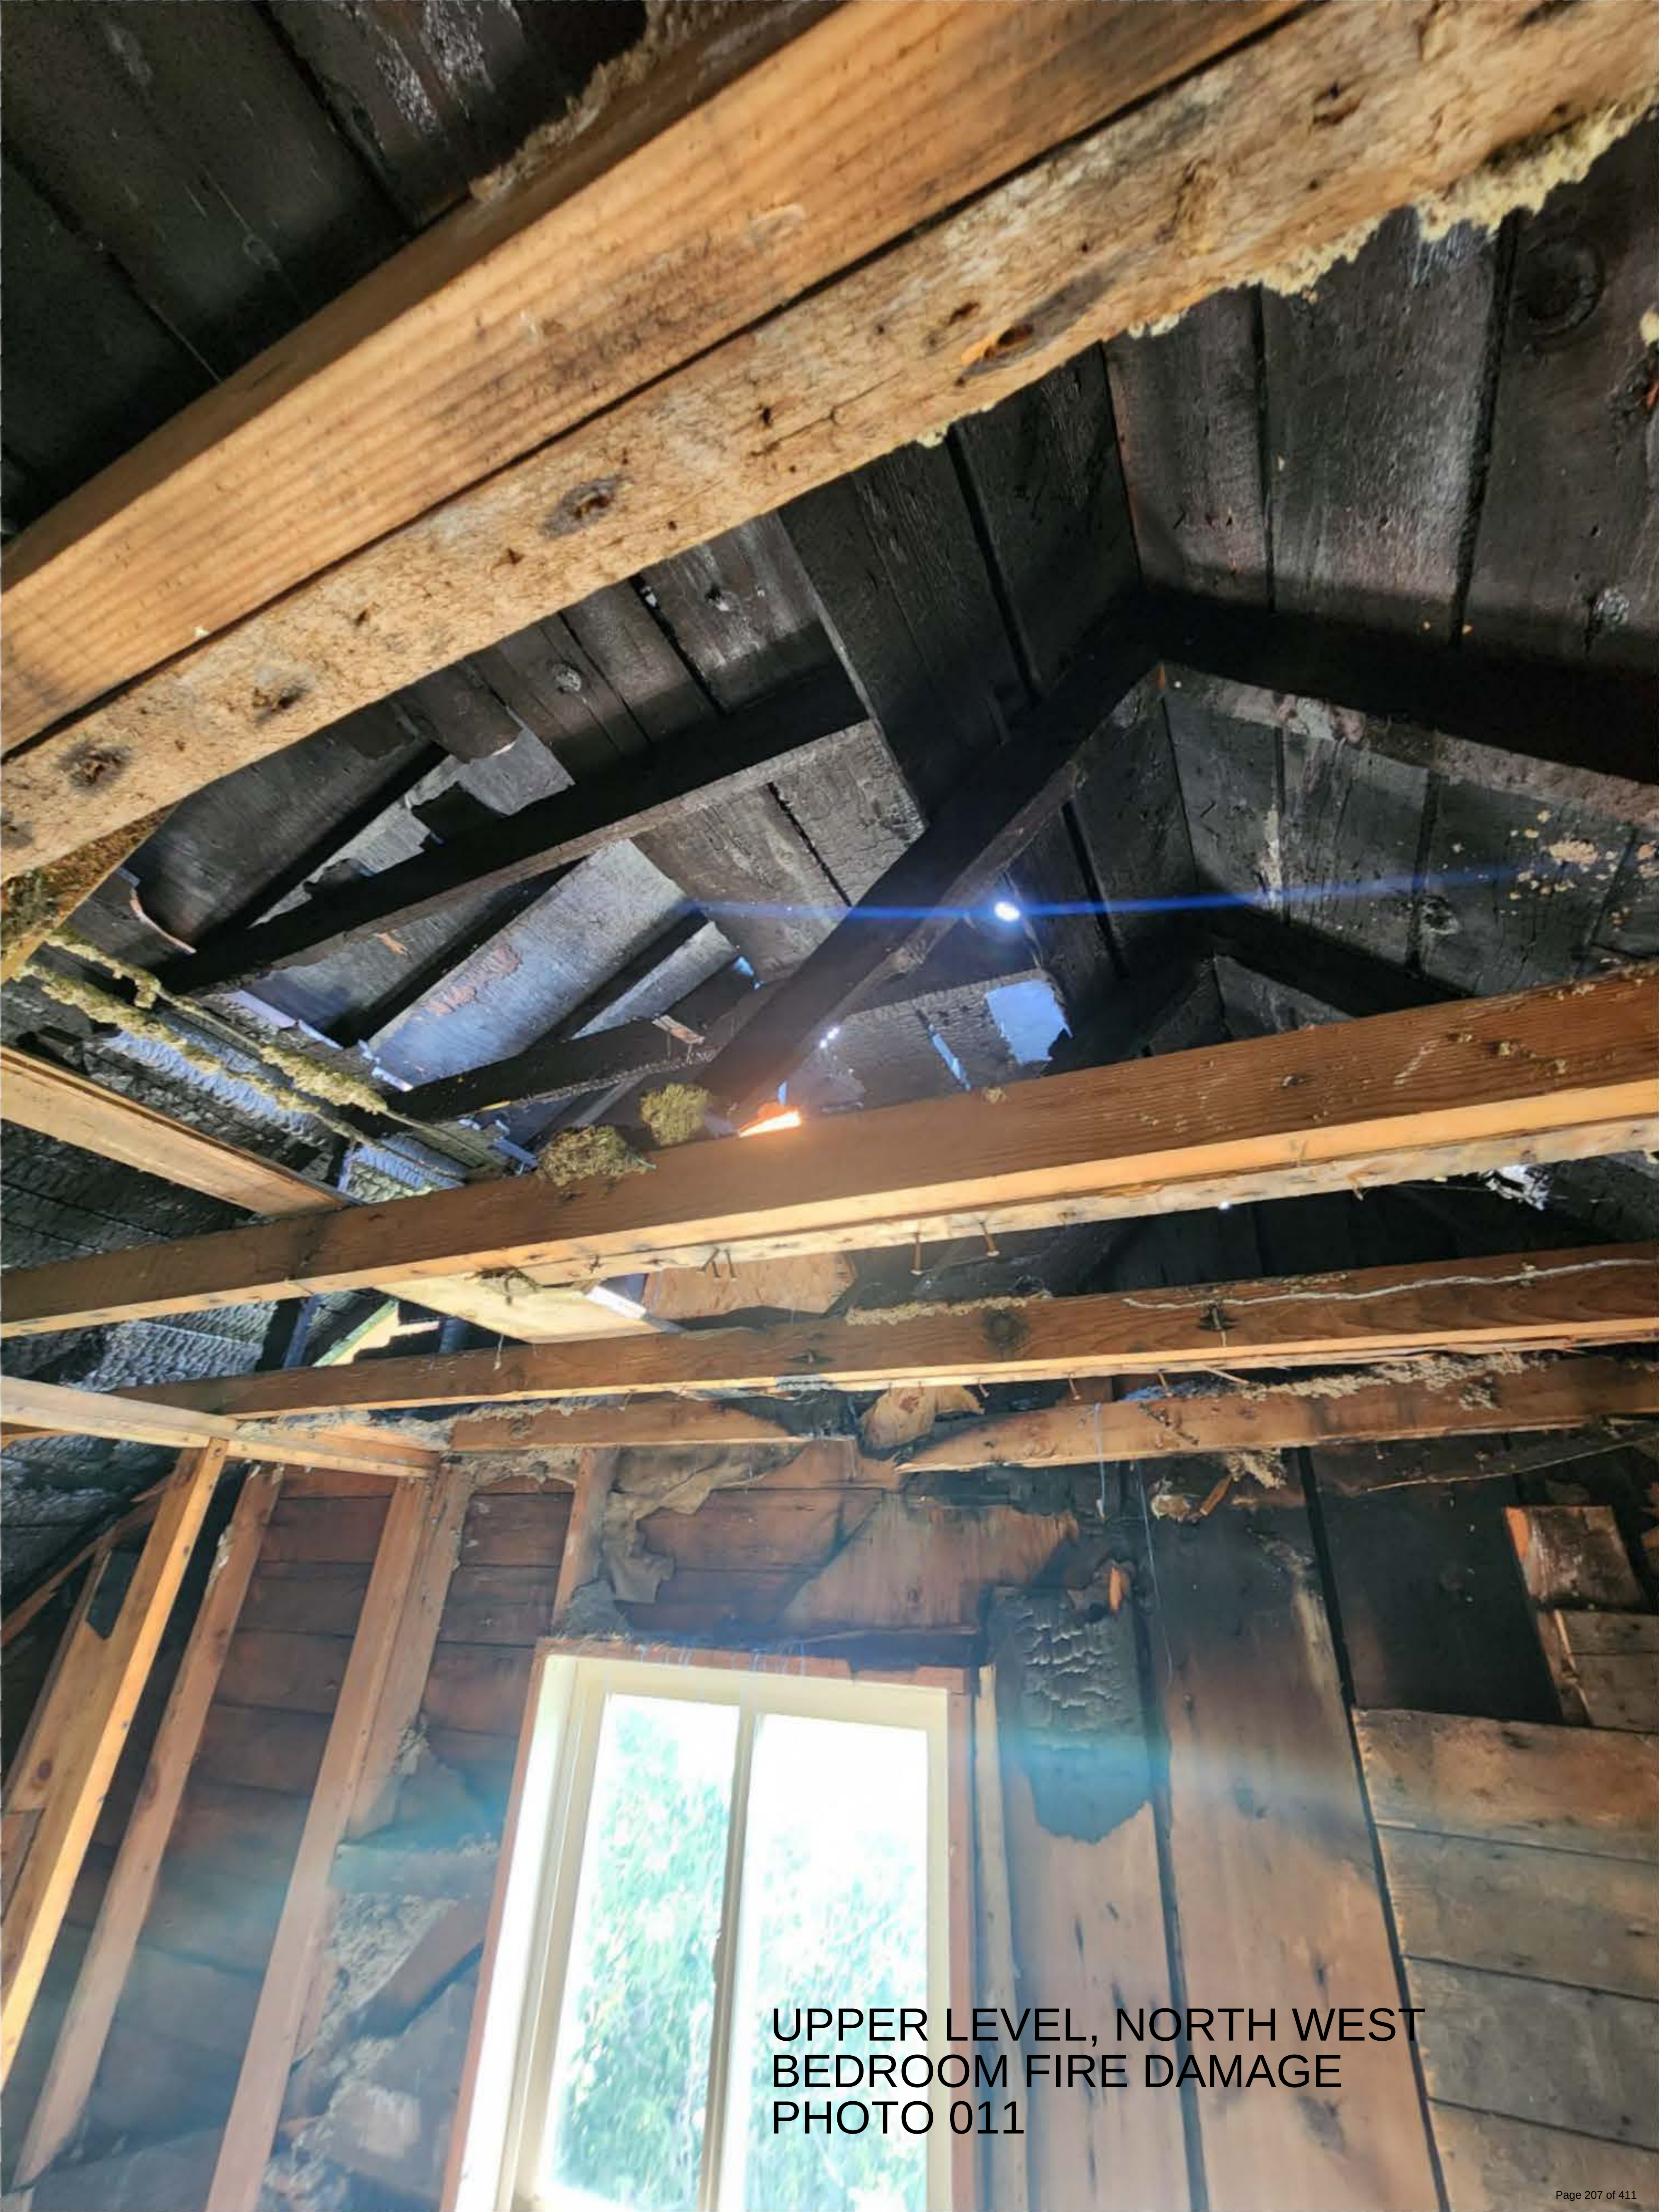
UPPER LEVEL, NORTH WEST  
BEDROOM FIRE DAMAGE  
PHOTO 011

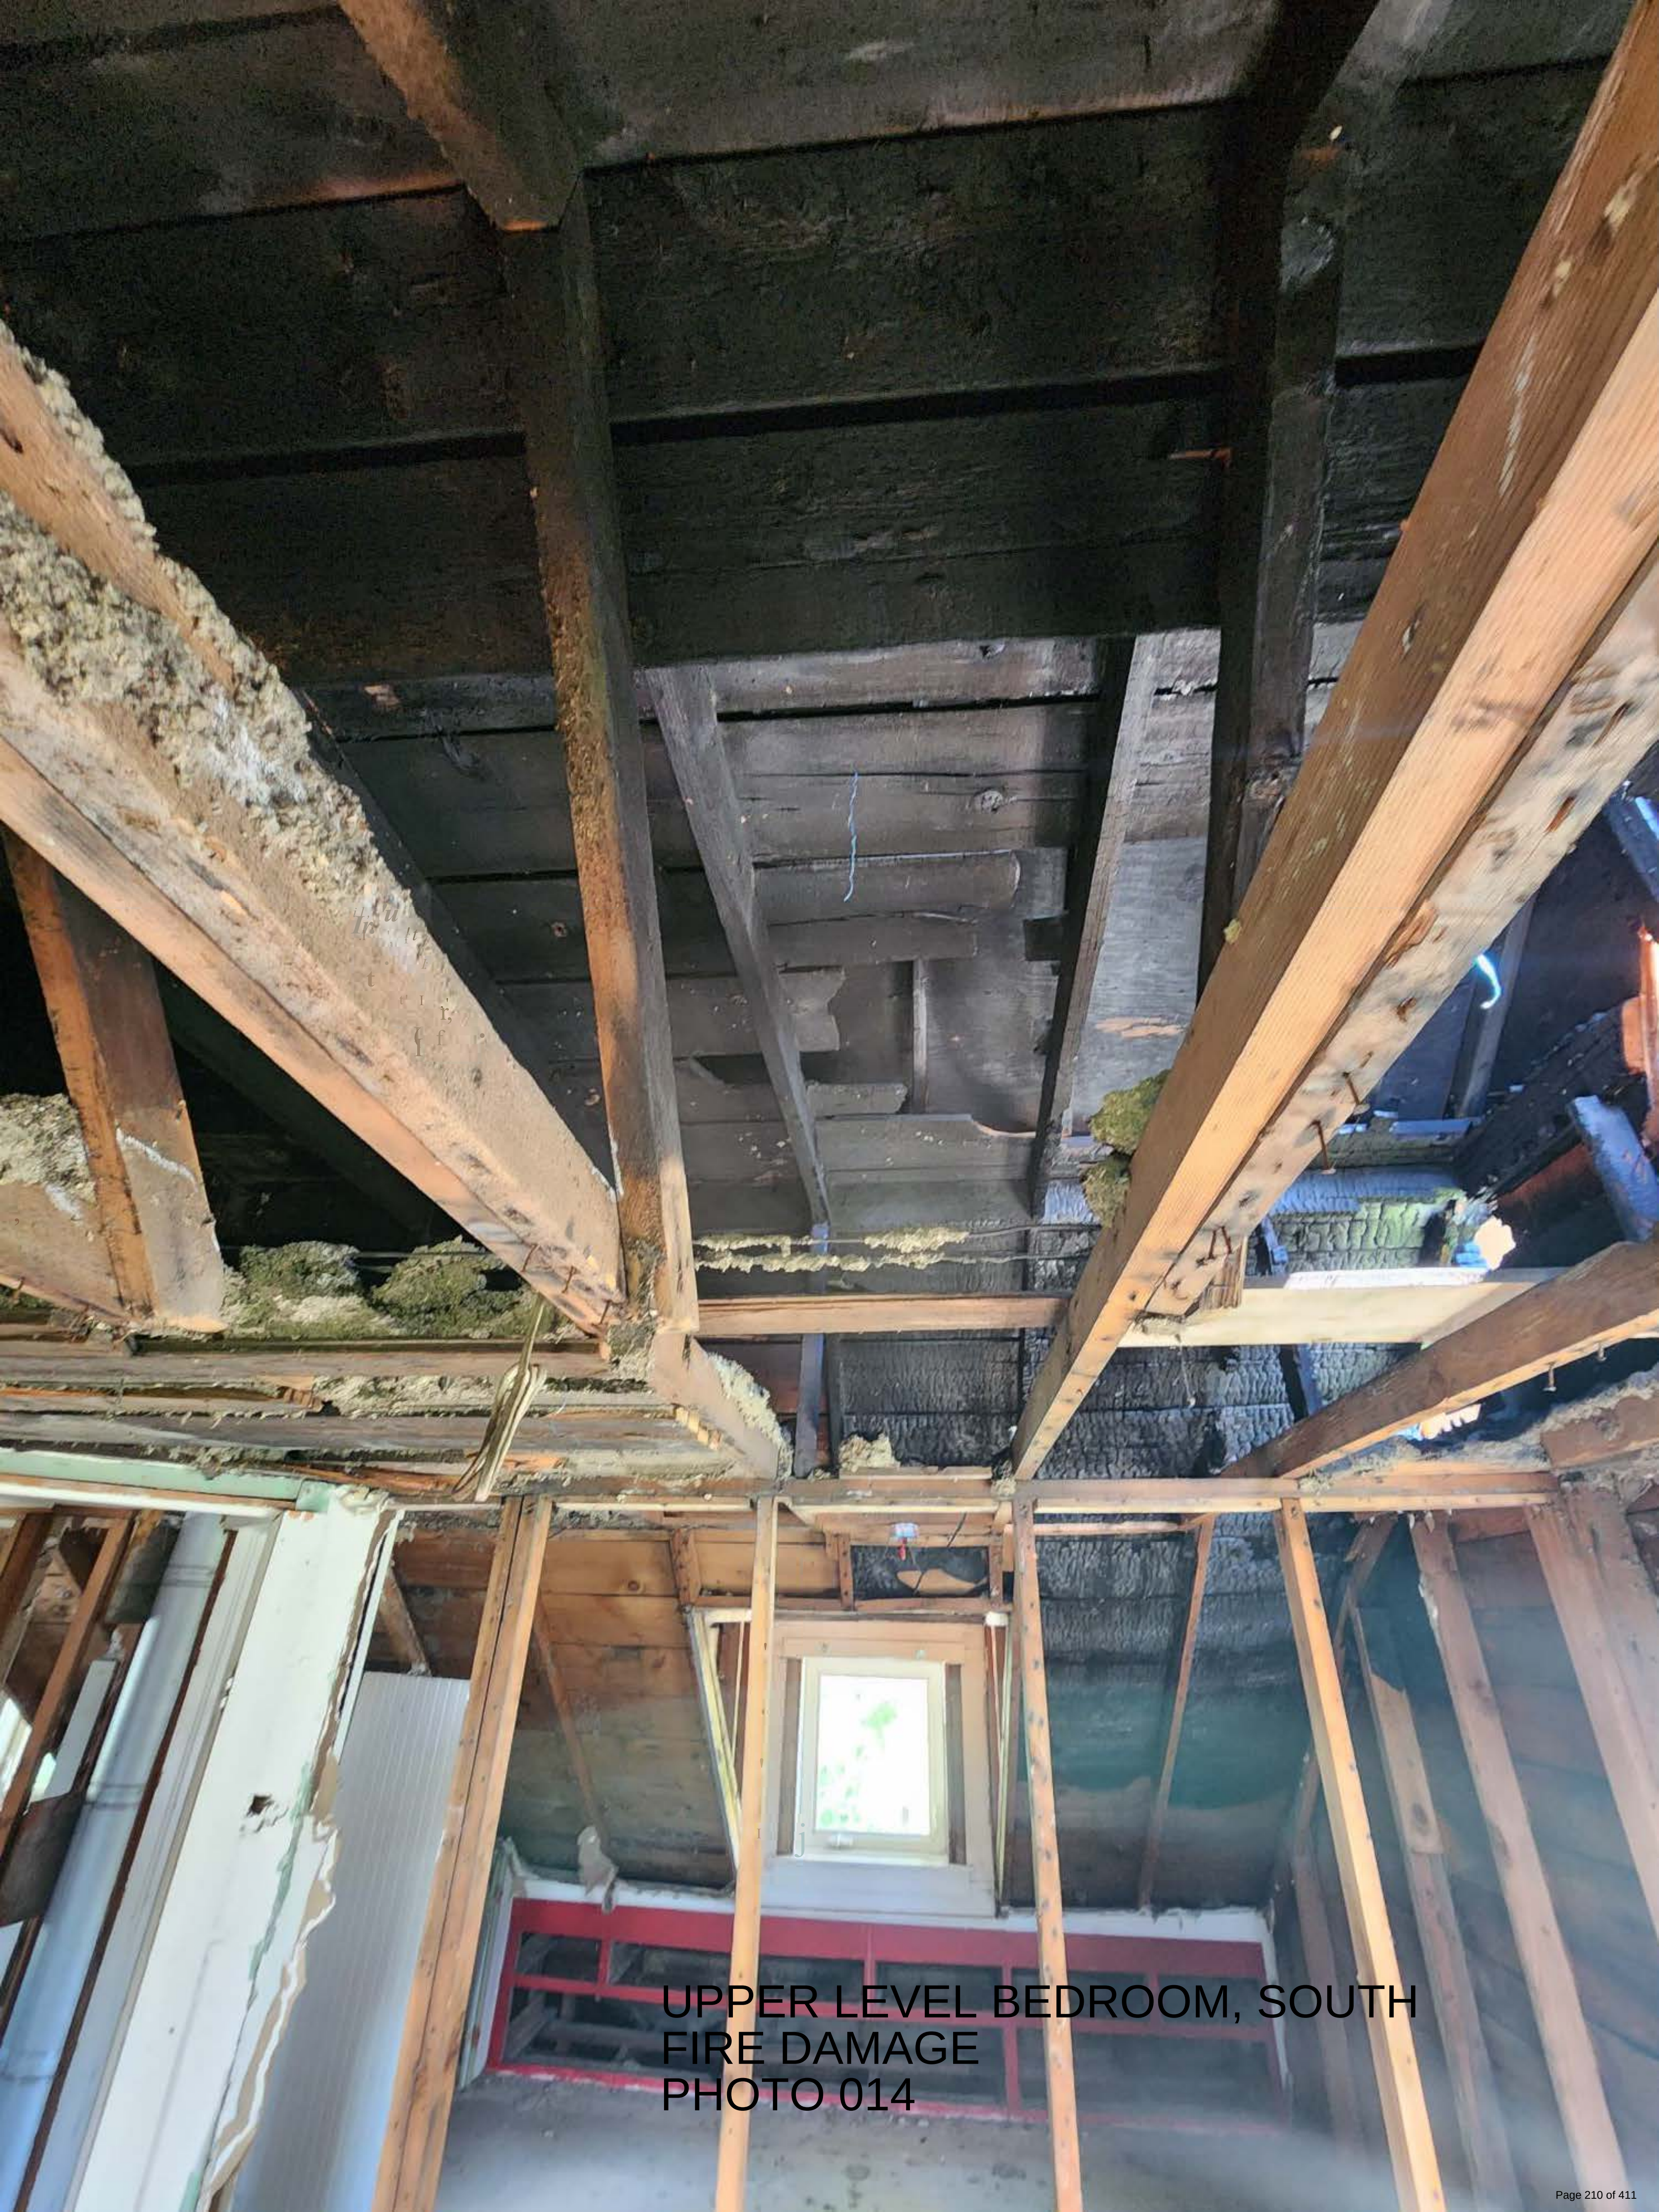
UPPER LEVEL BEDROOM, SOUTH  
FIRE DAMAGE  
PHOTO 014

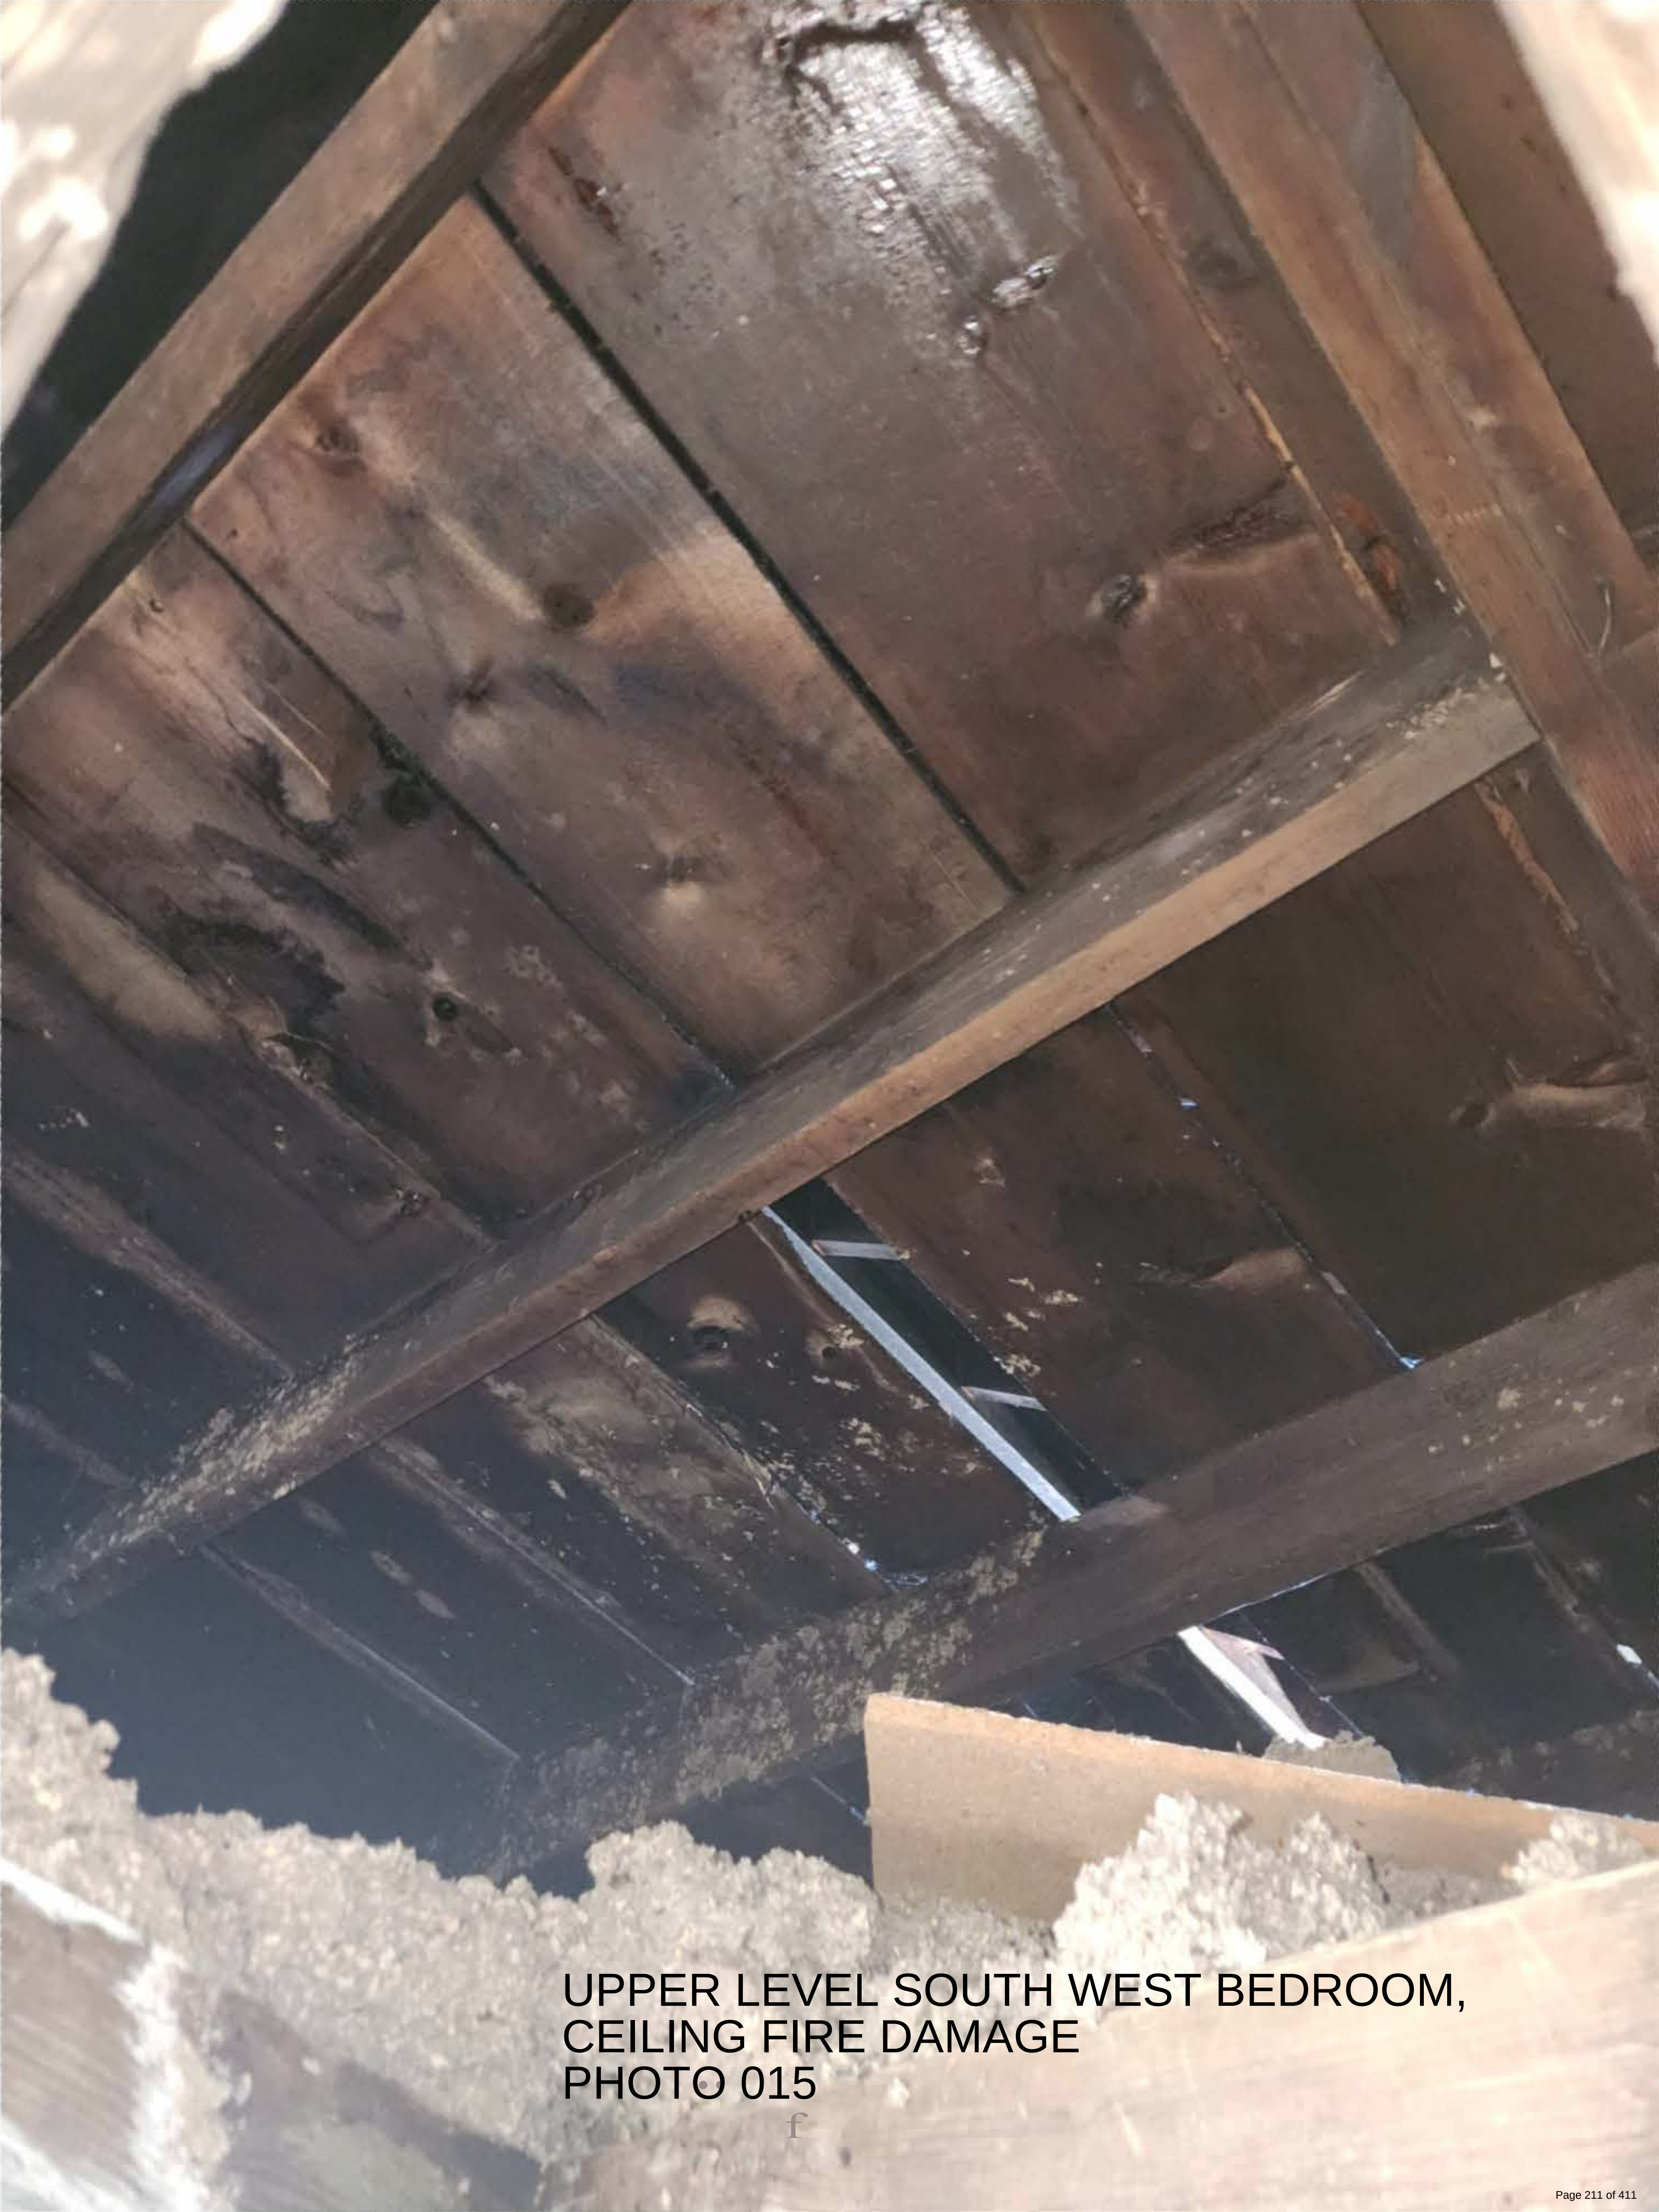
UPPER LEVEL SOUTH WEST BEDROOM,  
CEILING FIRE DAMAGE  
PHOTO 015
