**PARK CITY HISTORIC PRESERVATION BOARD MEETING  
SUMMIT COUNTY, UTAH  
November 1, 2023**

- 6.A. **Historic District Design Guideline Illustrations** - The Historic Preservation Board will Review Draft Amendments to the Standards Adopted in Chapter 15-13: Design Guidelines for Historic Districts and Historic Sites of the Land Management Code.

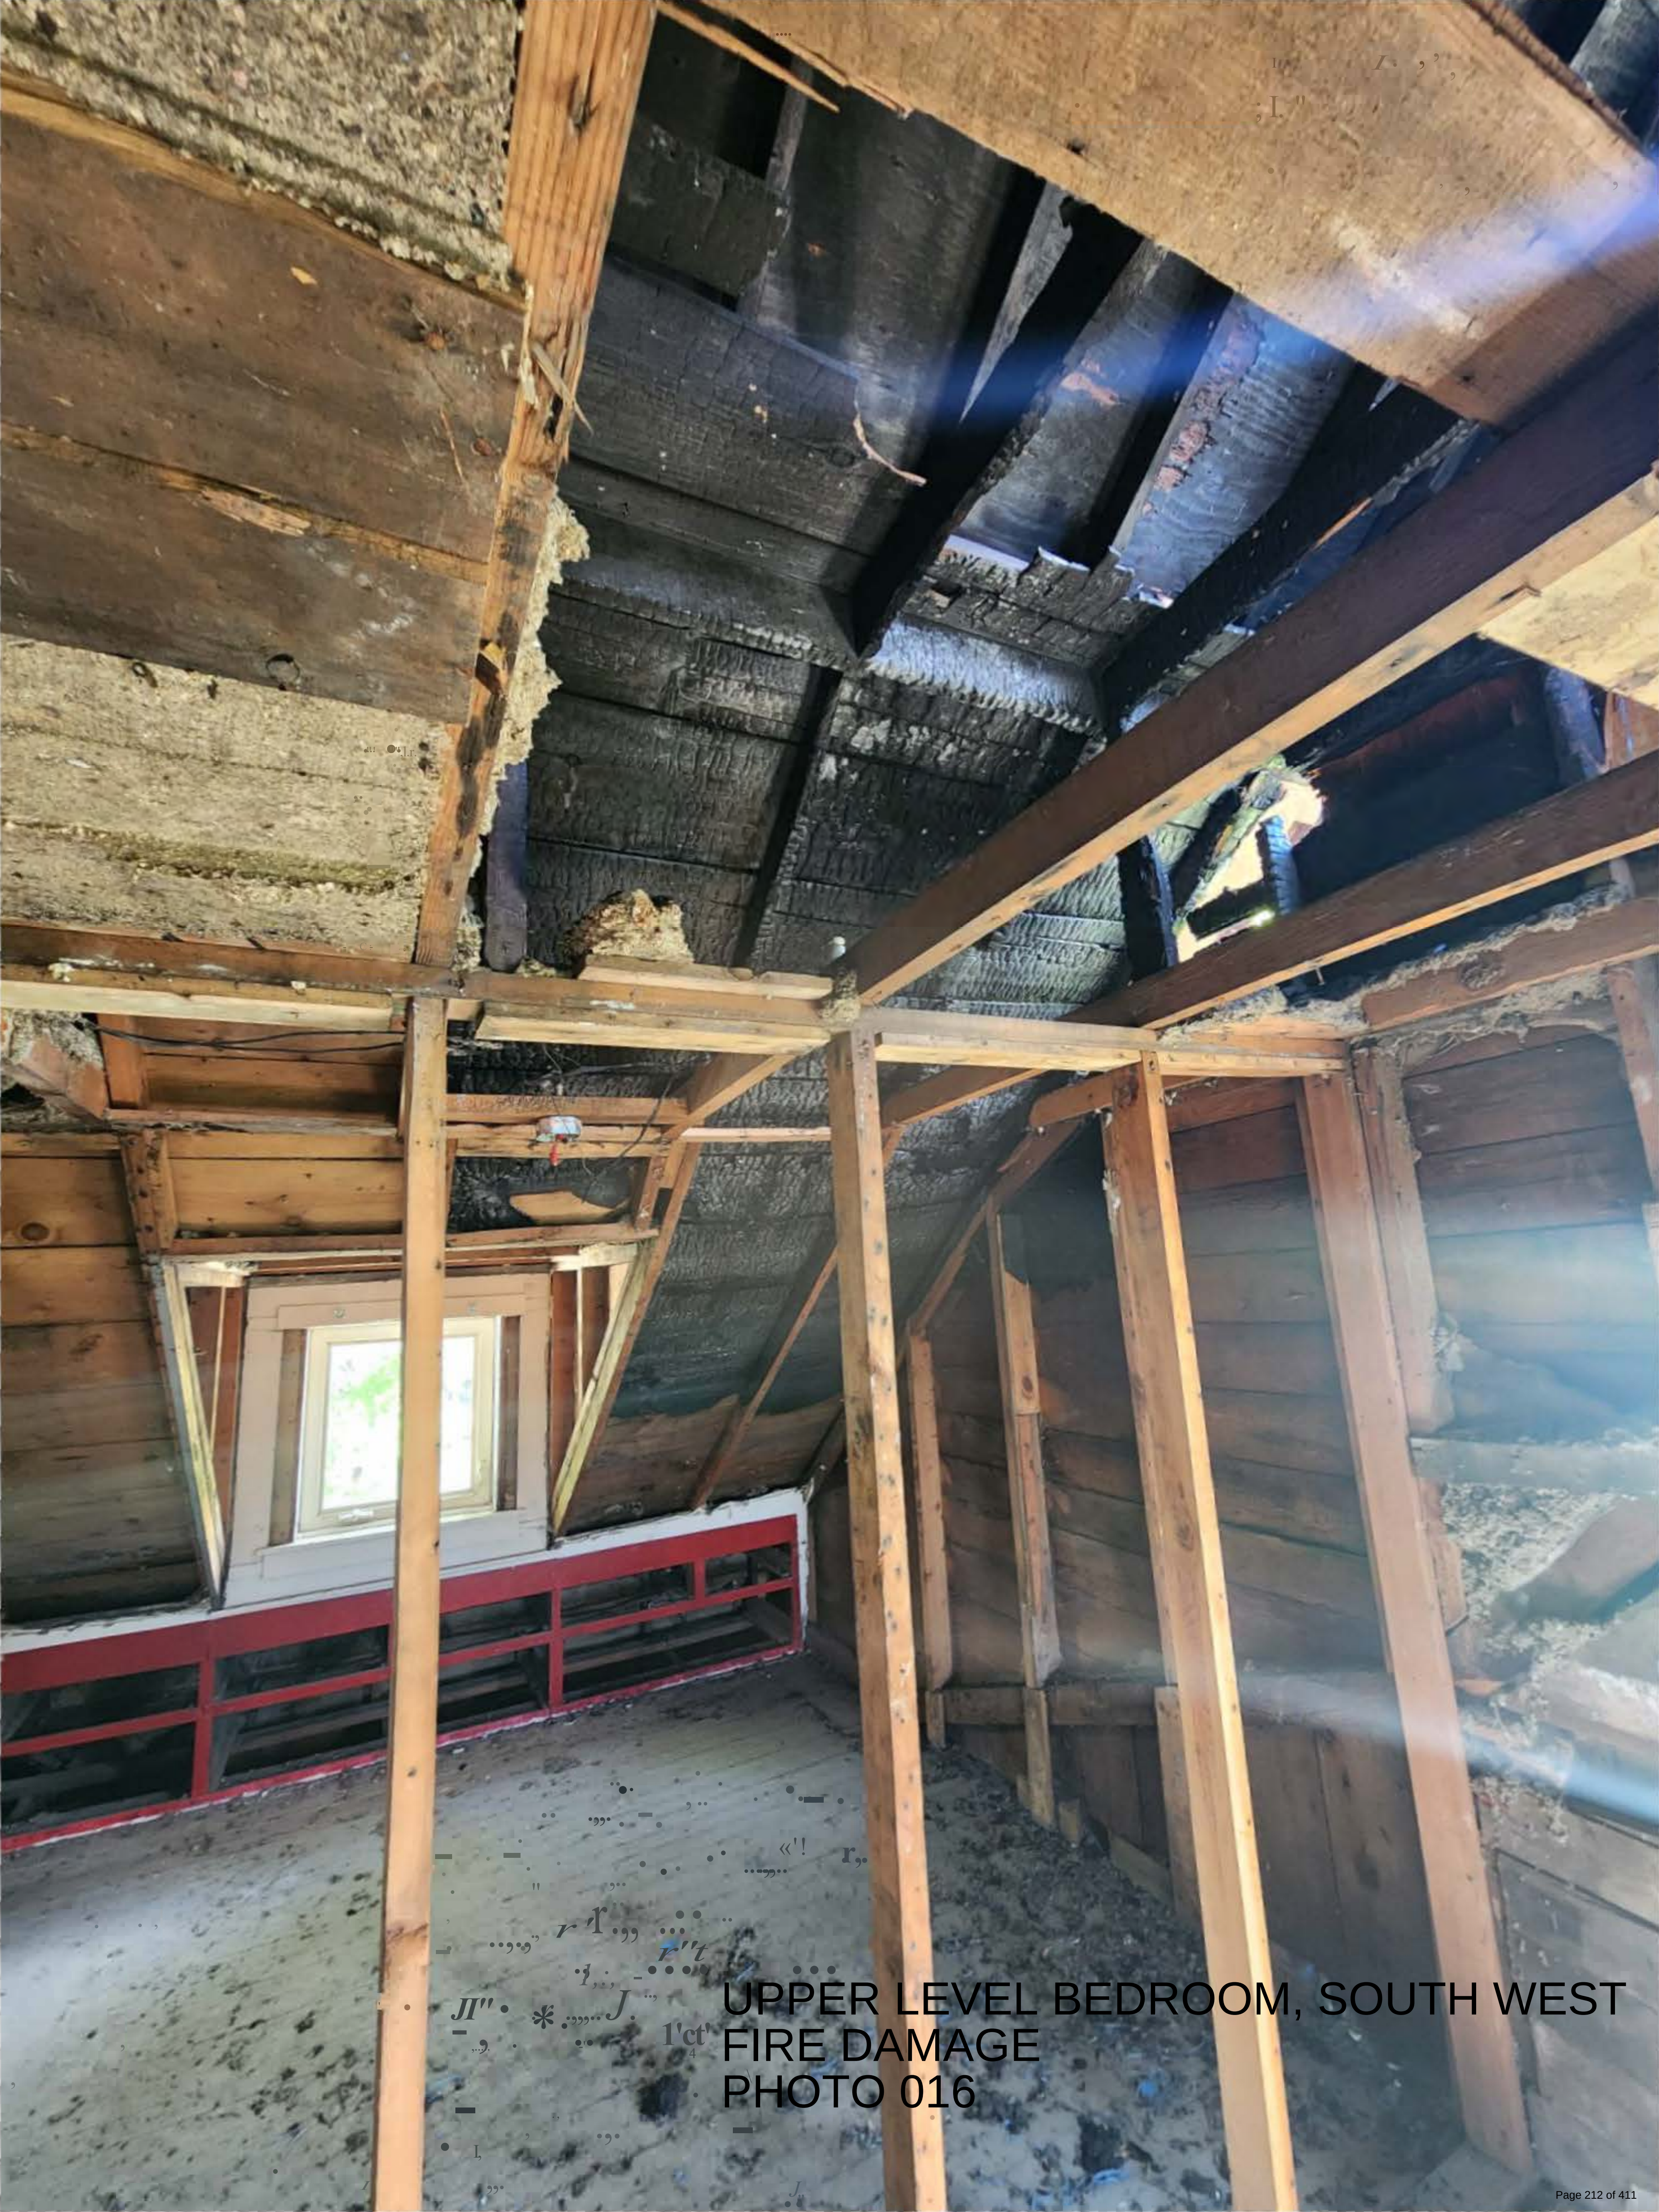
UPPER LEVEL BEDROOM, SOUTH WEST  
FIRE DAMAGE  
PHOTO 016

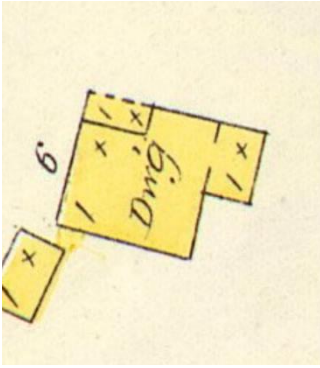
Figure 3: 1889 Sanborn Fire Insurance Map excerpt

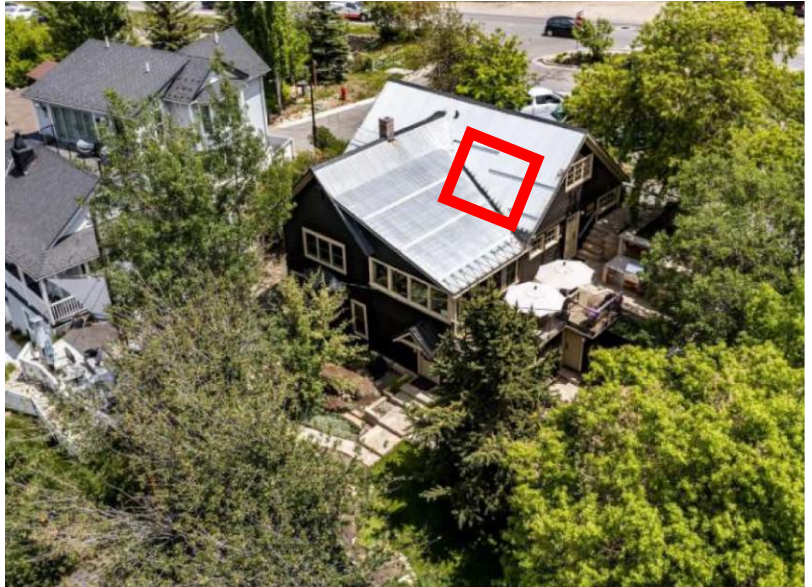
*Figure 11: Aerial view showing proposed location of 1889 roof modification*

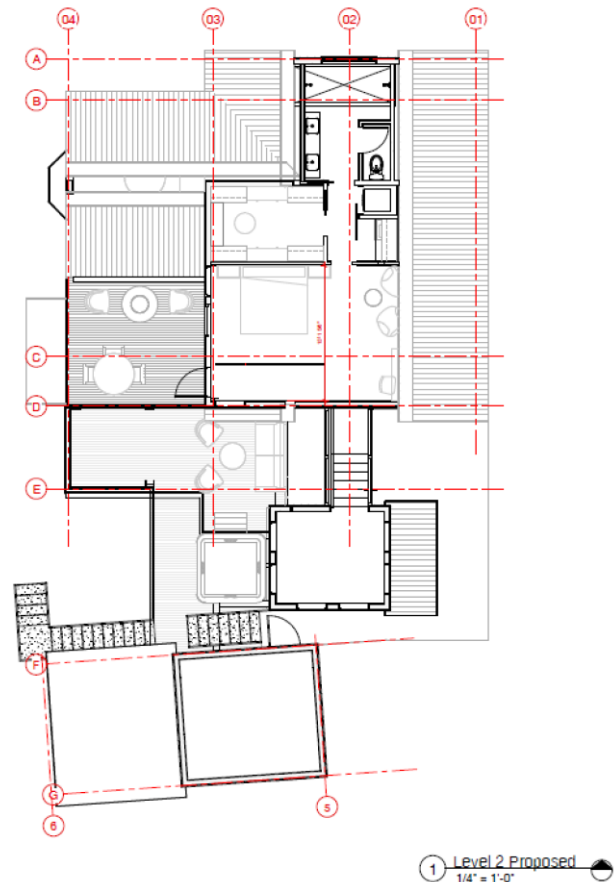
Figure 12: Proposed second level showing primary suite access to proposed roof deck.

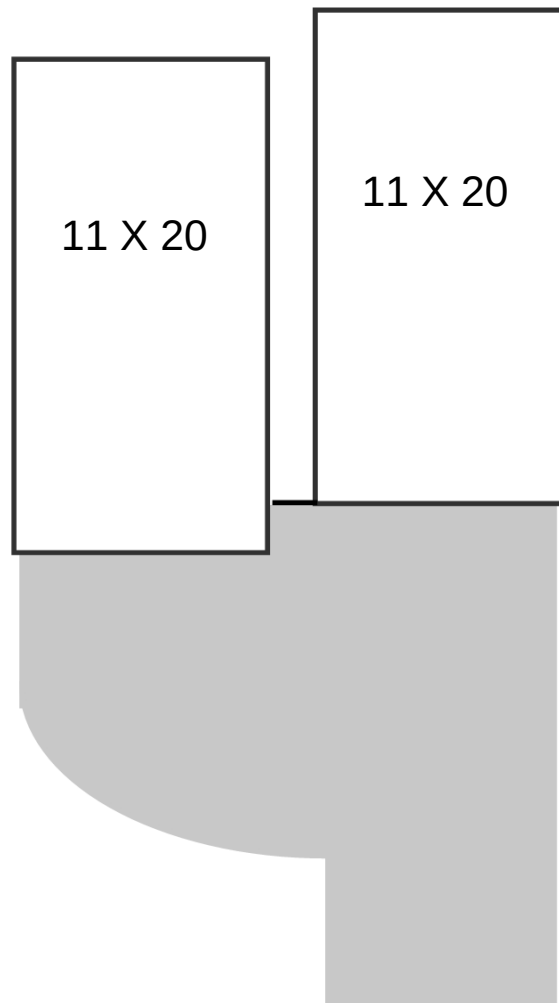
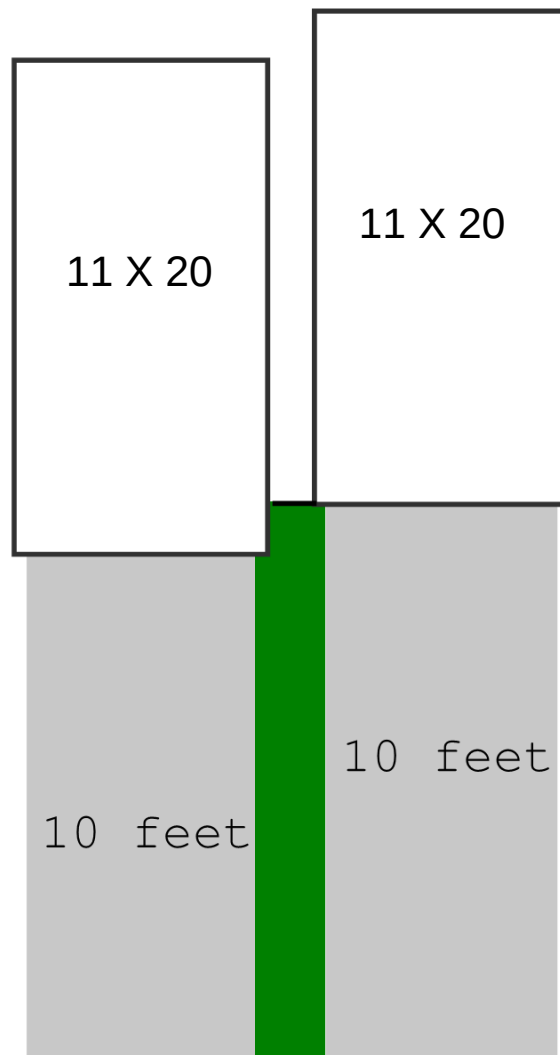
Staff recommends clarifying the driveway width regulations to establish consistent criteria, to address the realities of access to garages and winter conditions in a resort town, and to mitigate impervious surfaces. To comply with the two-foot offset in the wall plane, the driveway width maximum, and the interior garage dimensions, staff recommends the following for a two-car garage:

The minimum 18-inch buffer could include:
