**PARK CITY HISTORIC PRESERVATION BOARD MEETING  
SUMMIT COUNTY, UTAH  
September 6, 2023**

- 5.A **161 Park Avenue - Material Deconstruction** - The Applicant Seeks Material Deconstruction Approval to Lift a Landmark Historic Structure, Construct a Basement and New Foundation, Construct a Rear Addition, and Construct a Detached Accessory Building in the Rear Yard. PL-22-05333  
(A) Public Hearing; (B) Action  
[161 Park Avenue Material Deconstruction Staff Report](#)  
[Exhibit A: 161 Park Avenue Material Deconstruction Draft Final Action Letter](#)  
[Exhibit B: Proposed Plans](#)  
[Exhibit C: Existing Conditions Report](#)  
[Exhibit D: Historic Preservation Plan](#)  
[Exhibit E: 161 Park Avenue Plat](#)  
[Exhibit F: Intensive Level Survey](#)

- 5.B **Mining Resources of Park City Multiple Property Submission Nomination**

**Little Bell Mine Nomination to National Register of Historic Places** – The Historic Preservation Board will review the draft National Register of Historic Places nomination for the Little Bell Mine Site and forward a recommendation to the Utah State Historic Preservation Office for consideration on September 21, 2023. GI-23-00500

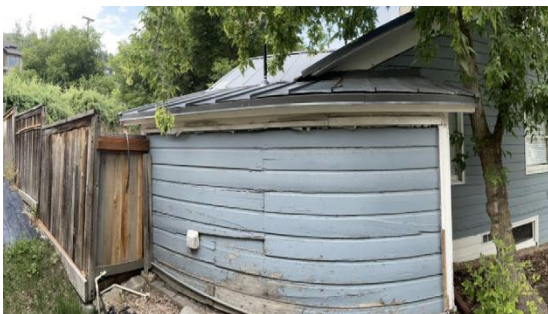
Figure 5: View of southern facade, showing water damaged siding

Presently, the Single-Family Dwelling is in fair condition and the homeowners state no updates have been made in the past 15 years. The bottom few strings of wooden lap siding on the southern shed projection have suffered some water damage and have peeling paint. The white trim also shows some minor water damage. This water damage continues along the rear (western) façade along the lowest strings of wooden lap siding and is particularly visible at the northmost section of the western façade. The middle and southern end of the western façade is made up of a non-historic modification which includes a newer piece of lumber. The siding along the modified façade has not sustained the same level of water damage as the other sections of the Structure.

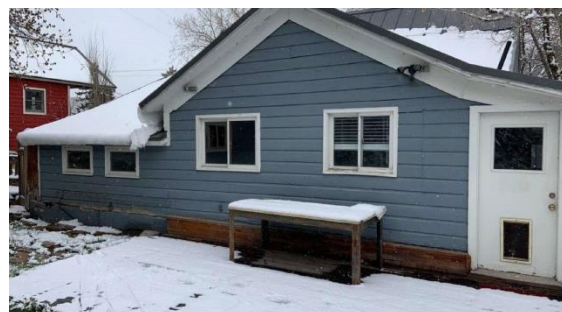
Figure 6: View of western (rear) facade, showing water damaged siding at northern end

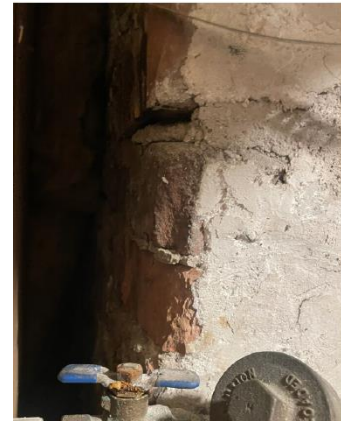
Figure 7: Damaged chimney mortar

The roof of the Structure is generally in fair condition. It is clad in a standing seam metal roofing material that was added after the 1980s. The roofing does not leak; however, several components have been bent or dented and the finish has faded. A major alteration to the historic roof form has already taken place in the form of the gable on the rear of the Structure, which is estimated to have been built in the late 1990s – early 2000s. A non-original, non-functional chimney is also located behind the ridgeline of the Structure and has been relocated at least two times (see 1889, 1900, and 1907 Sanborn maps below, S.P. label for “stovepipe”); this chimney has deteriorated and the mortar is crumbling inside the home. The Applicant has proposed the removal of the chimney.

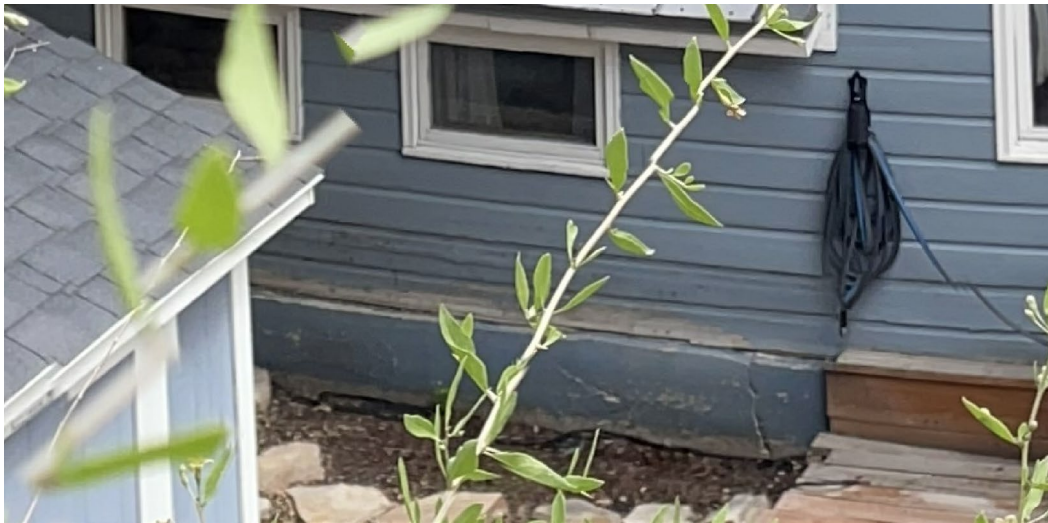
**Photo 18.1 - Foundation**

**Photo #18: West Elevation – Foundation**

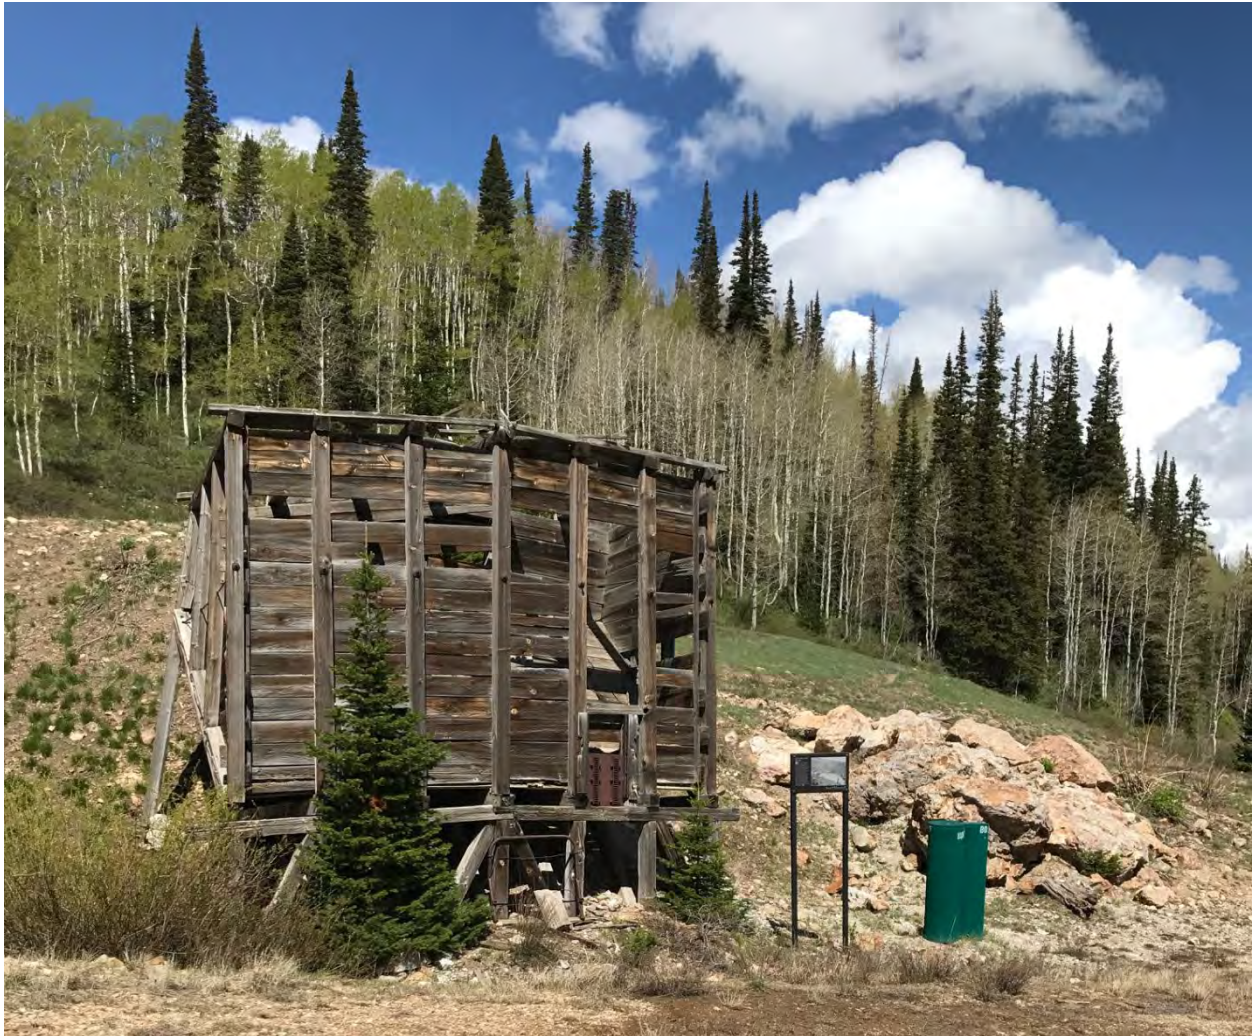
Figure 3. Little Bell ore bin prior to 2017 preservation work. Image courtesy Sandra Morrison.

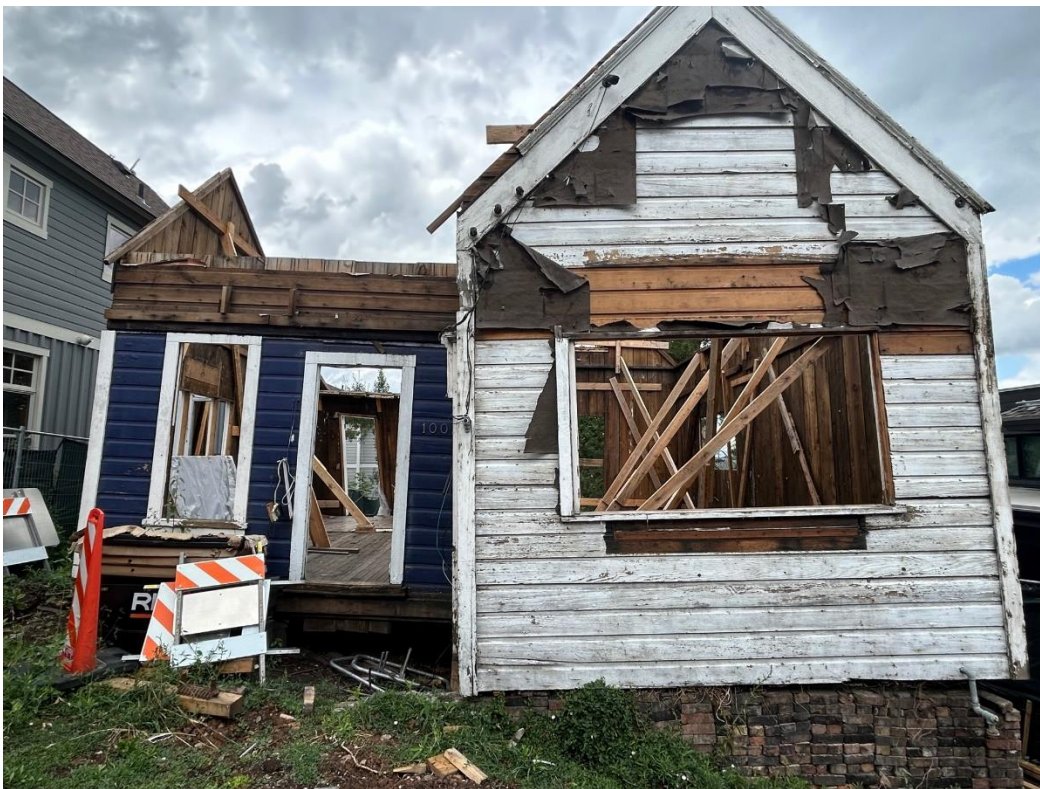
Removal of the roof was contrary to the HPB’s approval. The image below shows the removal of the roof and the current Landmark Historic Structure:

On July 2, 2023, Shen Engineers, Inc. completed an updated report finding “[t]he integrity of the house is totally lost” (Exhibit D). This report notes “the existing roof was totally removed.”

Landmark Historic Structure, staff recommends Condition of Approval 19: *The Applicant removed the roof from the Landmark Historic Structure without appropriate HPB review or approval. The loss of the historic materials and the damage to the Historic Structure shall be compensated for at the time of financial guarantee release in an amount to be determined and approved by the Chief Building Official and City Attorney's Office.*
