**PARK CITY HISTORIC PRESERVATION BOARD MEETING  
SUMMIT COUNTY, UTAH  
August 4, 2021**

- 7.A. 1060 Park Avenue - Historic District Design Review - The Applicant Proposes Removal of Historic Material to Accommodate a New Addition to the Rear of a Significant Historic Structure in the Historic Residential Medium (HRM) Zoning District. PL-21-04866  
(A) Public Hearing; (B) Action  
[Staff Report](#)  
[Exhibit A: Draft Final Action Letter](#)  
[Exhibit B: 1060 Park Avenue Historic Site Form](#)  
[Exhibit C: Existing and Proposed Views](#)  
[Exhibit D: Historic Preservation Plan](#)  
[Exhibit E: Material Deconstruction of Rear Facade](#)  
[Exhibit F: Engineer's Report](#)  
[Exhibit G: Existing Conditions](#)

- 7.B. 909 Woodside Avenue – Disassembly and Reassembly – The Applicant Proposes Disassembly and Reassembly to Accommodate New Additions and Structural Upgrades to a Significant Historic Structure. PL-21-04753  
(A) Public Hearing; (B) Action

- 7.C. 1002.5 Norfolk Avenue – Disassembly and Reassembly – The Applicant Proposes Disassembly and Reassembly and Material Deconstruction to Accommodate New Additions to a Landmark Historic Structure. PL-21-04761  
(A) Public Hearin

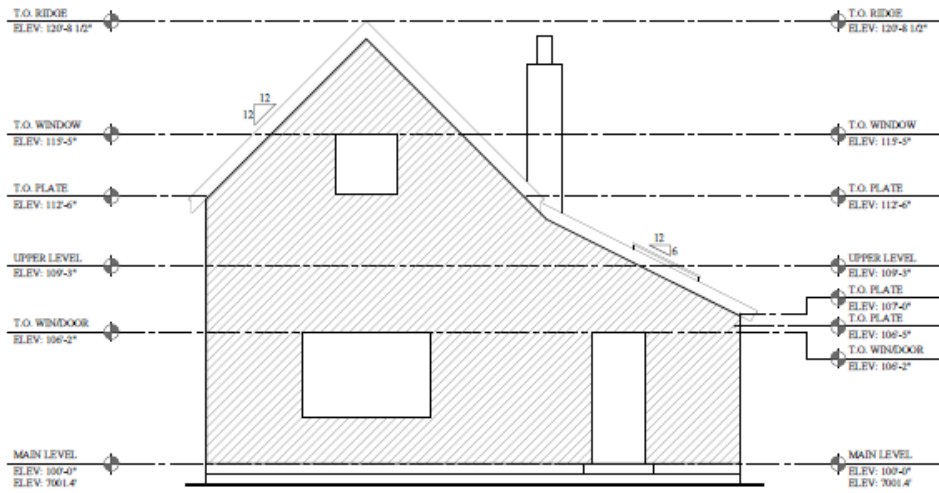
4 EAST ELEVATION - PANEL A  
AB2 SCALE 1/4" = 1'-0"

The images below show the proposed sections to be panelized (Exhibit H):

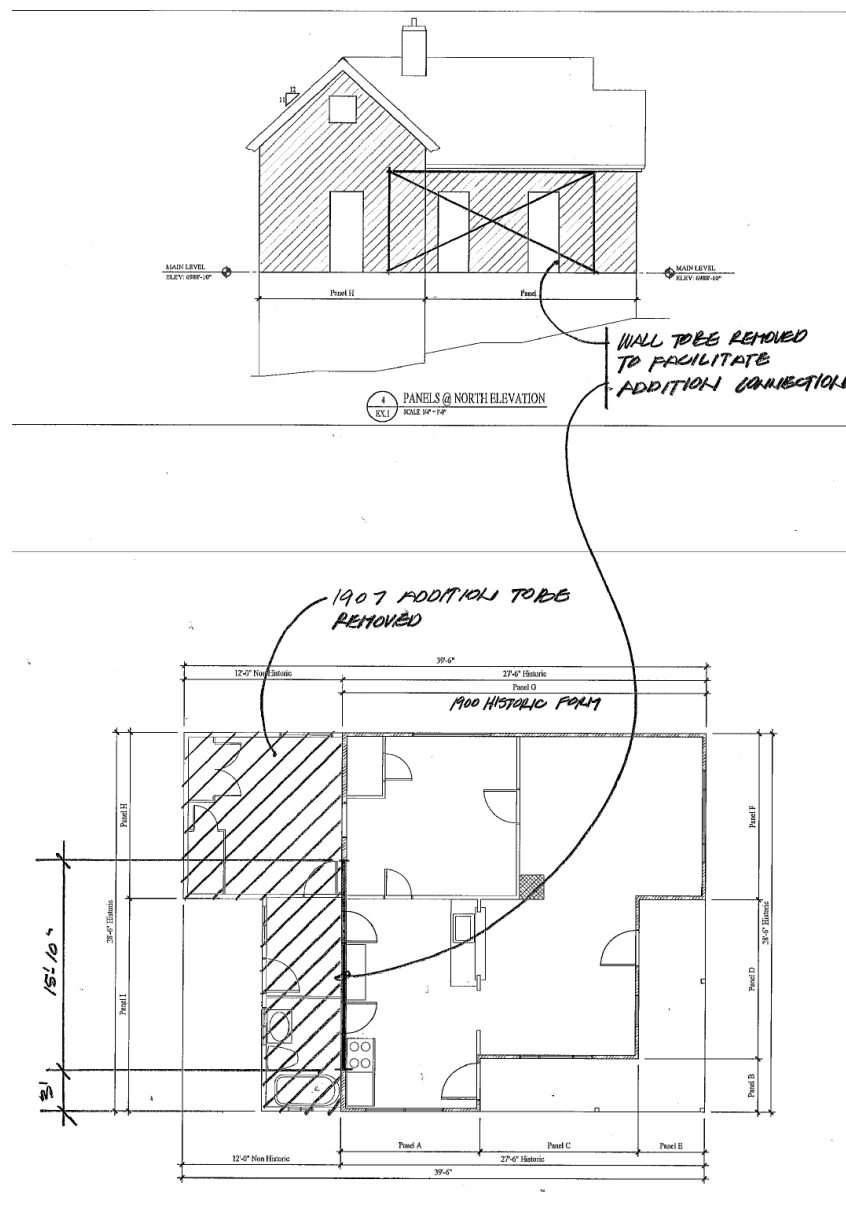
The image below shows the proposed sections and materials to be removed to accommodate the addition (Exhibit G):

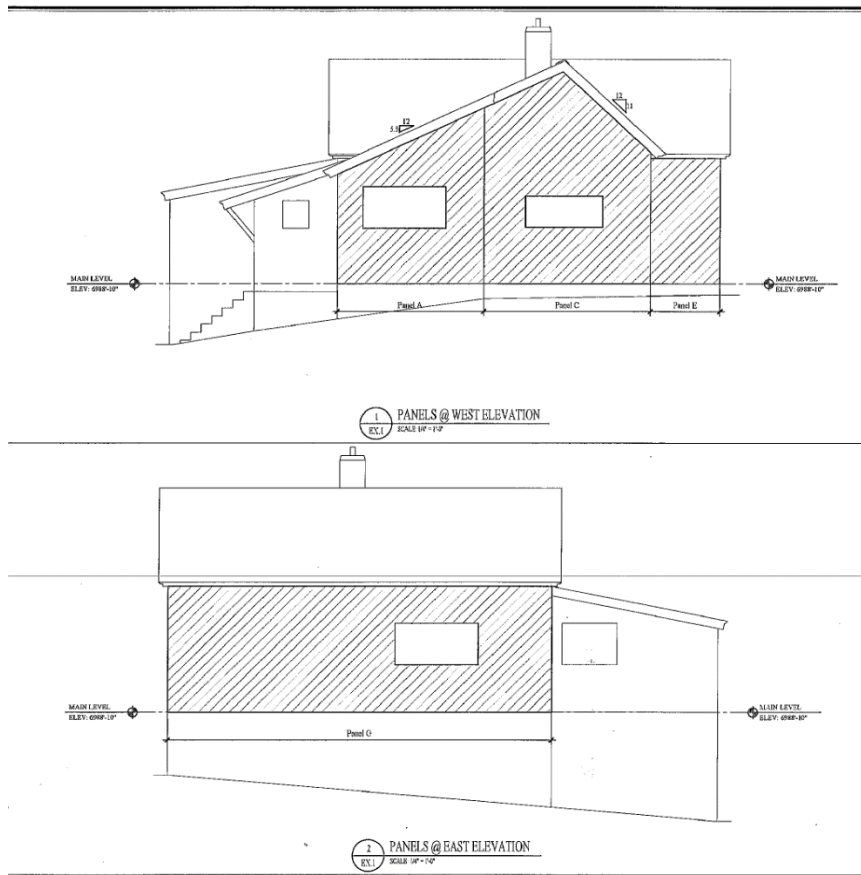
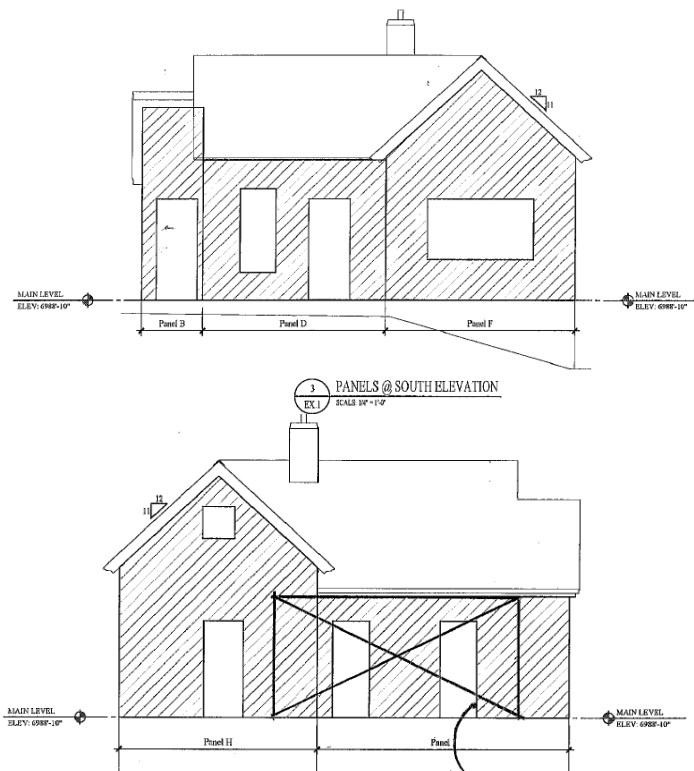
The images below show the proposed sections to be panelized (Exhibit G):

Due to the constraints of the Site, the Applicant proposes panelization in order to allow construction equipment to reach the rear of the narrow Lot to build the addition.
