**PARK CITY MUNICIPAL CORPORATION  
HISTORIC PRESERVATION BOARD  
CITY COUNCIL CHAMBERS  
May 3, 2017**

336 (360) Daly Avenue – Relocation – Significant Garage and Chicken Coop.  
The applicant is proposing to relocate the existing historic garage and chicken coop to the south side of the property.  
*Public Hearing and Possible Action*

243 Daly Avenue – Historic District Design Review – Material Deconstruction on Landmark Site. The applicant is proposing to impact the following: c.1998 front yard landscaping consisting of gathered rocks and backyard retaining walls; shed-roof addition across the east (rear) elevation of the historic hall-parlor form and a poured concrete root cellar/mechanical room; post-1941 shed roof structure constructed on top of the original gable roof; original soffit and fascia; c.1996 porch railings, posts, and roofs; historic door opening on the west façade; historic and non-historic windows.  
*Public Hearing & Possible Action*

911 Empire Avenue – Historic District Design Review – Material Deconstruction on Landmark Site. The applicant is proposing to impact the following: post-1983 railroad tie retaining wall, contemporary concrete block retaining wa

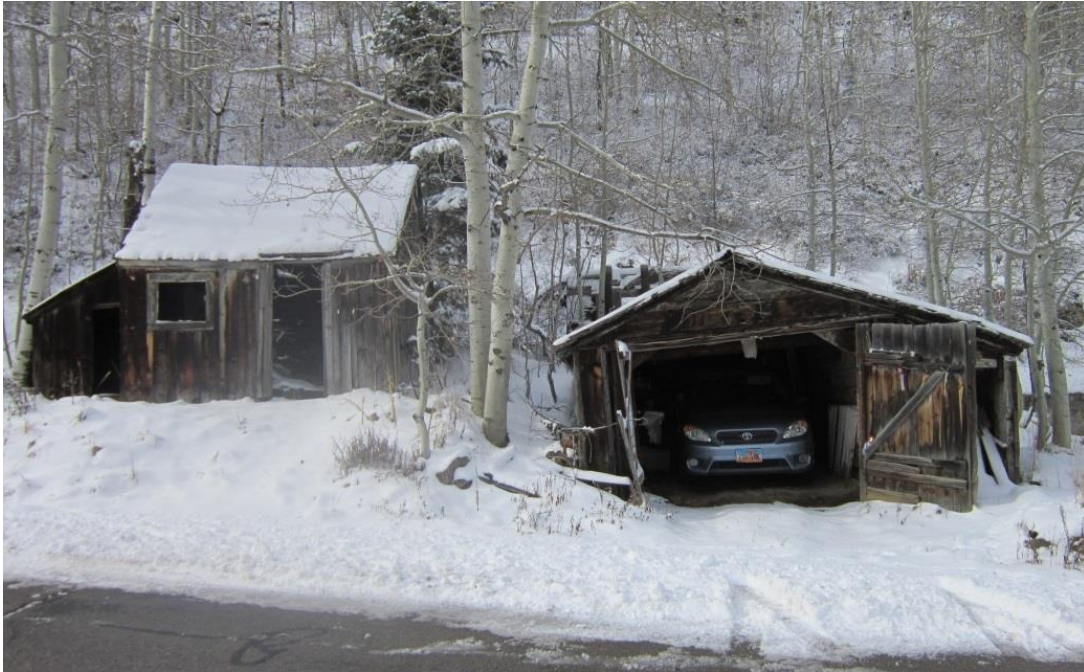
**Single-Cell Cabin (left) and Single-Car Garage (right)**

conditions of the three (3) structures and foundation ruins of the demolished ca. 1896 cross-wing cottage.

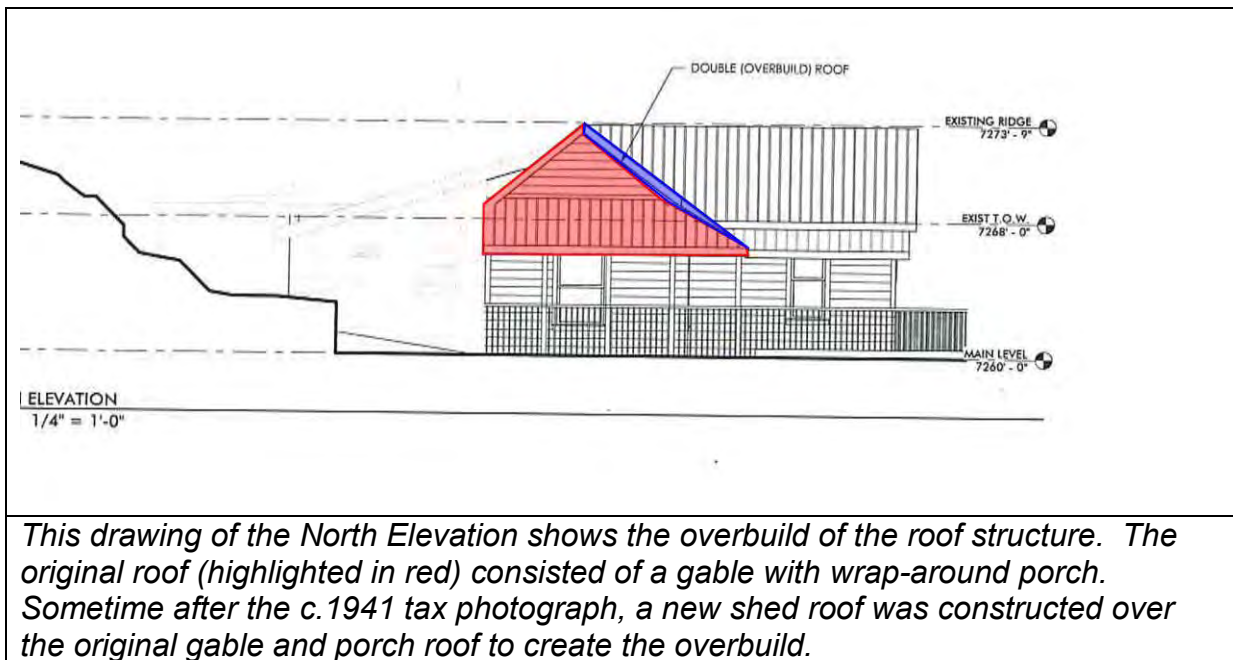
The applicant believes that the original roof structure is in place beneath the overbuild and is in good condition. The applicant finds that the original roof structure is structurally undersized and the main gables of the roof will require further structural upgrades. This has been confirmed by the structural engineer's report as well (Exhibit E).

Staff finds that the roof may be able to be reinforced from the interior once the additional strain of the overbuilds have been removed. This would preserve the original materials and prevent the entire roof form from having to be reconstructed; however, staff also recognizes that additional work may be required due to the poor condition of the original roof form. For that reason, staff has added the following Conditions of Approval:

*#2. The applicant shall maintain the original gabled roof form including its original dimension, pitch, and height. Structural stabilization shall occur by adding new structural members to the interior of the roof.*

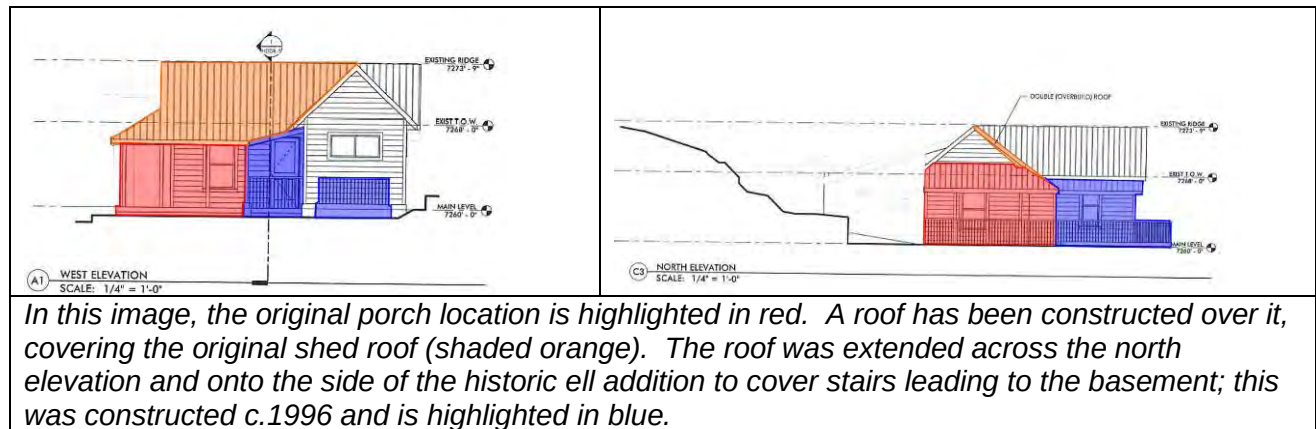
Existing porch floor is the new c.1996 concrete floor over the basement; it likely replaced an original wood deck. The porch posts are consistent in their location to those seen historically, however, overloading on the roof has caused them to be structurally unsound and require replacement. The porch railing consists of vertical 2x2 picket railing, but only around the non-historic c.1996 exterior basement stairs and north elevation of the wrap-around porch. The original porch roof has been modified; the original slope of the roof was built over with a new roof that extends from the top of the original ridgeline to the outside of the porch. The ceiling of the porch has been modified and covers the original open ceiling of the porch; these later additions have settled and are at varying slopes.

The roof structure will be reinforced and returned to its original form by removing overbuilt which exists over the original slope. The applicant proposes to remove structure added beneath the porch ceiling. The non-historic roof over the existing stairs will also be rebuilt to correctly tie into the reconstructed historic roof and correct drainage at the intersection with the historic porch. New railings will wrap the basement stairs. The historic porch will be reconstructed with new posts.

Staff finds that the proposed material deconstruction is required for the restoration of the original porch. Years of alterations have caused the materials to be replaced over time and settle at different rates. The introduction of an exterior basement stair in 1996 required an extension of the porch to protect the stairs from the elements. As the current owner is not proposing to modify the foundation, staff finds that reconstructing the porch roofs in a shed configuration is appropriate to maintaining the look and feel of the original porch structure.

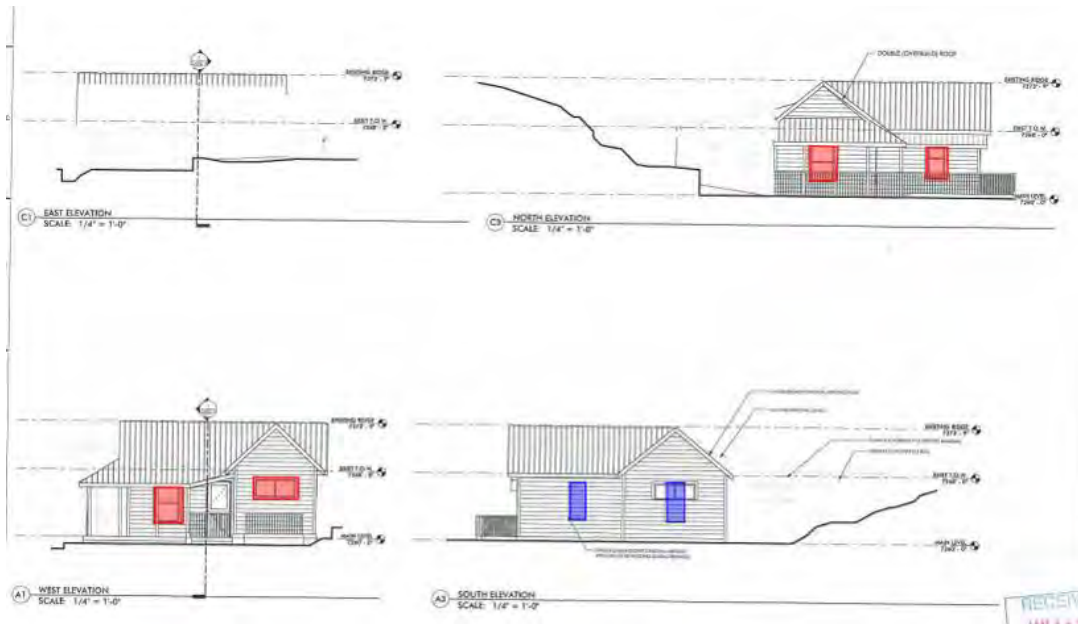
The existing windows are in poor condition and were added at multiple times. The frames are warped, the tracks don't allow for operation, the hardware is failing, and many were installed poorly to begin with. The applicant is proposing to replace the existing windows with new windows that match the historic window opening sizes. American Heritage Window Rebuilders has assessed the windows and found they are beyond repair (see Exhibit F). On the south elevation, windows have been covered and replaced with new sliding windows; the applicant is proposing to restore these original window openings. Staff has highlighted the original windows to be replaced in red and the original window openings to be restored in blue:

Staff finds that the proposed material deconstruction is necessary in order to restore and rehabilitate the house. Staff has added the following Conditions of Approval to ensure that the replacement windows will not detract from the architectural integrity of this structure:

*#6. Historic window openings shall be maintained where existing and restored where they have been lost. The applicant shall replace the historic windows with new wood windows that match originals in all respects: size, dimensions, glazing pattern, depth, profile, and wood material. Special consideration shall be taken to ensure historic trim that has deteriorated beyond repair is accurately reconstructed around the new window units.*

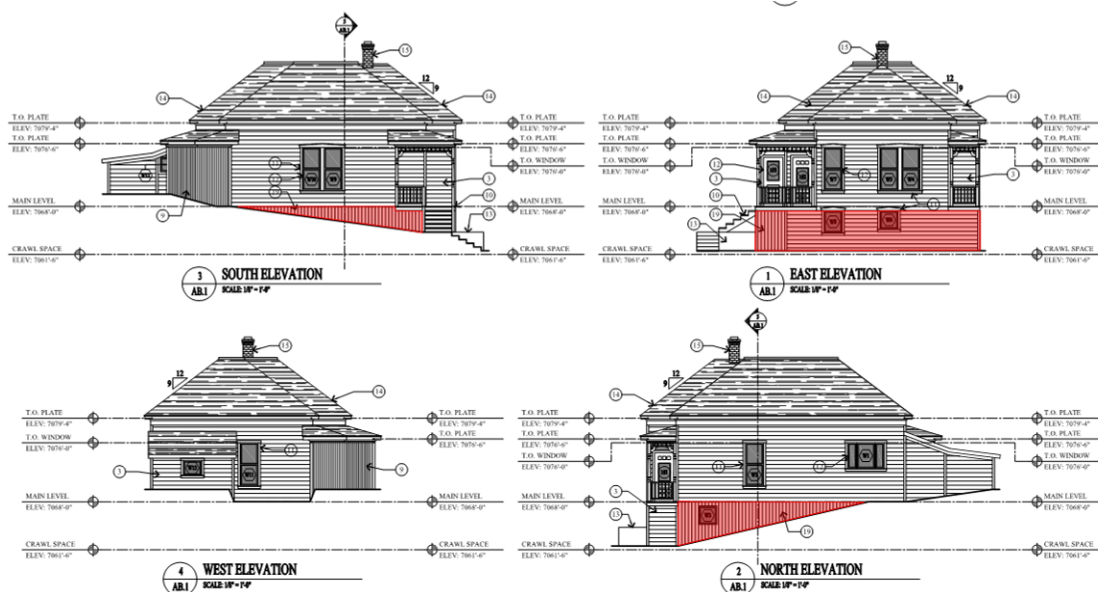
Staff has shaded the areas to be (potentially) impacted by the construction of the foundation in red:

The applicant has not yet completed exploratory demolition. At this time, they are not proposing to remove the walls of the basement in order to temporarily lift the house and pour a new foundation; however, they anticipate that this may need to occur if the walls are in poor condition.

Staff finds that the proposed work to construct a new foundation is necessary in order to rehabilitate the historic house; however, staff finds that the extant historic walls of the foundation should be minimally impacted by this scope of work. Staff has added the following Condition of Approval to ensure the preservation of these walls:

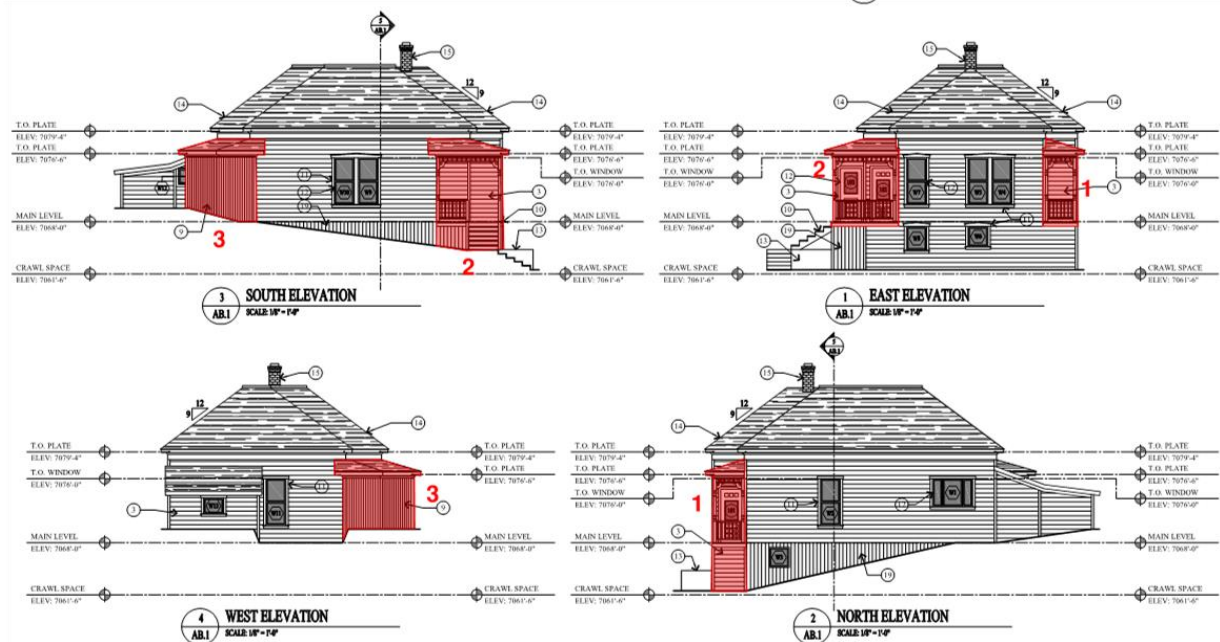
Staff has shaded these three porches in red below:

The applicant believes that Porches 1 and 2 can be lifted with the house to pour the foundation. The applicant believes the historic materials will be able to be preserved. Contemporary additions to the porches, such as the wood railing, will be replaced with new materials. Staff finds that the material deconstruction is required for the restoration of the building.

The applicant believes that Porch 3 on the southwest corner of the house will need to be demolished and reconstructed to facilitate the lift. They anticipate trying to salvage any historic materials they find on this porch to reuse in the reconstruction following construction of the foundation. Staff finds that the material deconstruction is required for the reconstruction of Porch 3 as an open porch.

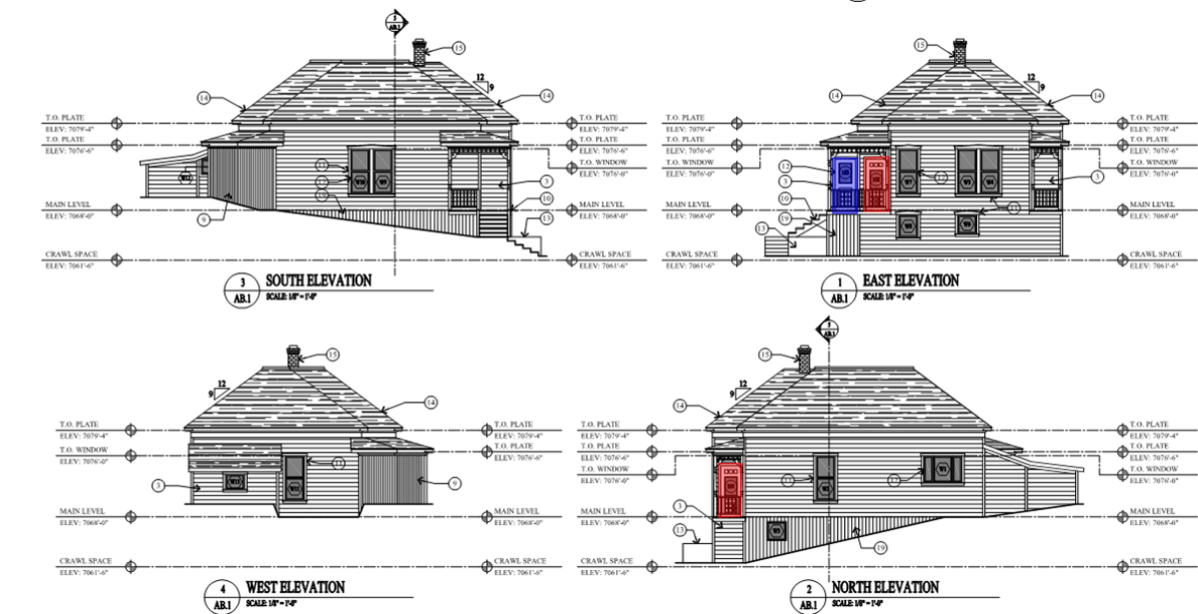
The two doors to be restored are shaded in red and the third door to be removed is shaded in blue below:

Staff finds that the material deconstruction on the two (2) historic front doors is required for the restoration of the house.

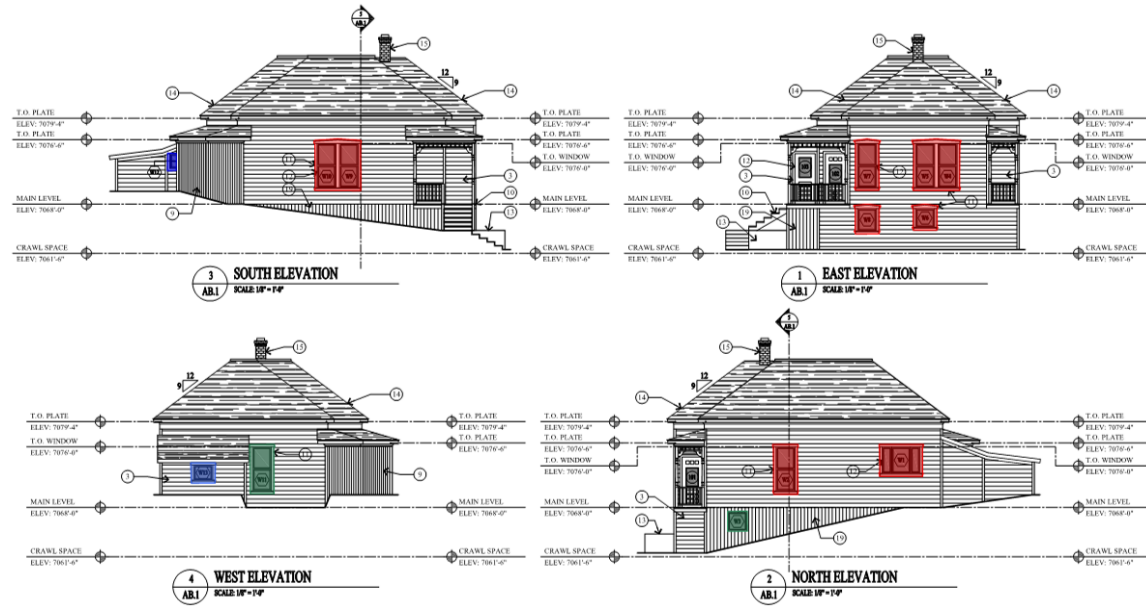
Staff has shaded the historic window openings in red, non-historic openings in blue, and openings to be altered in green:

The applicant is proposing to remove the historic windows (shaded red) and replace them with new wood windows. The applicant has had a window assessment completed by American Heritage Window Rebuilders (Exhibit E), and they found that the windows were beyond restoration. They need to be replaced in-kind.

The non-historic windows (shaded blue) are on the rear addition and are proposed to be removed along with the addition.
