**PARK CITY COUNCIL MEETING  
SUMMIT COUNTY, UTAH,  
January 29, 2015**

| 3:40pm McPolin Barn Preservation and Structural Plan discussion | PG 5 |

## MCPOLIN BARN – STRUCTURAL STUDY

PROJECT #14359

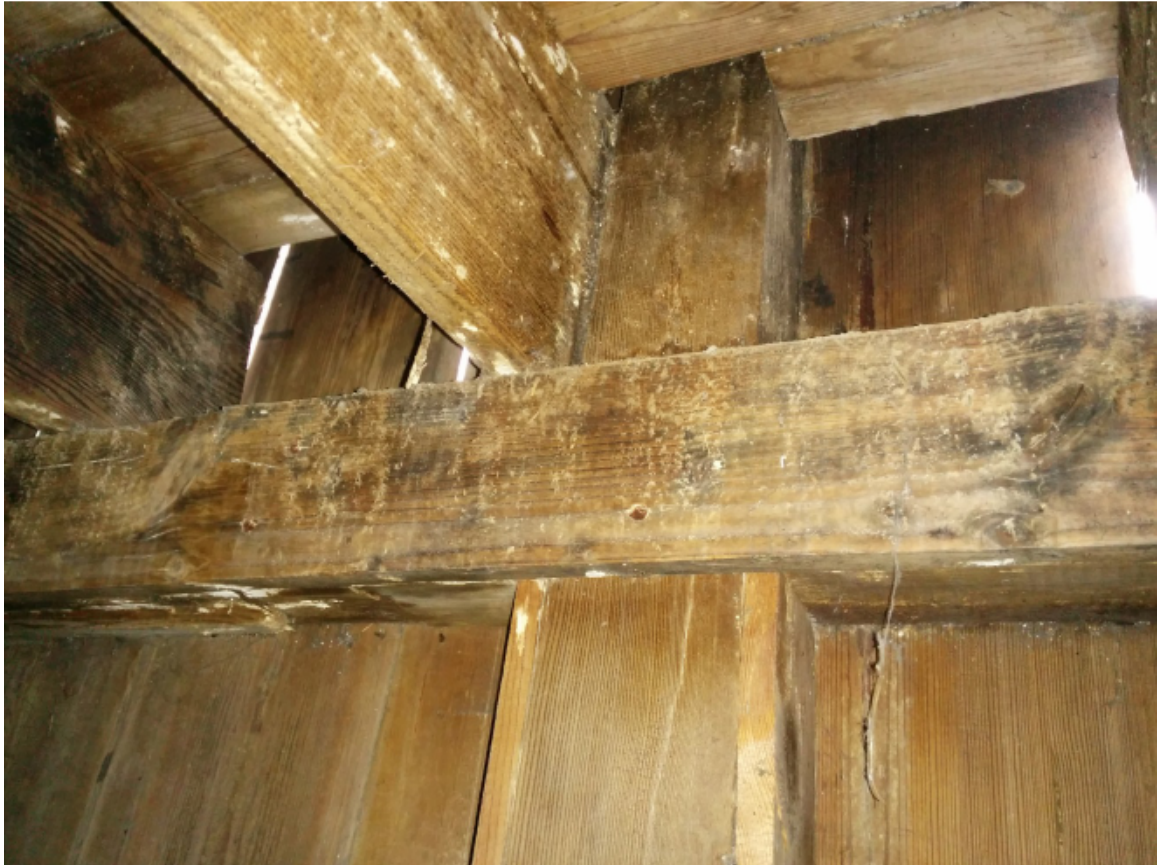
Figure 4. Column to beam connection

1. Gravity Loads
  - a. The beam to column connections at the exterior wall does not have adequate transfer of load from beam to column.

- o To address gravity load deficiencies, a) reinforce beam-to-column connections at the exterior walls by flanking timber columns with 2 x 6 studs and attaching correctly; b) replace modified column on the southwest side of the building and improve beam-to-column connection; c) add additional framing at the stair opening to reinforce the joists; and d) repair deteriorated masonry and wood elements.

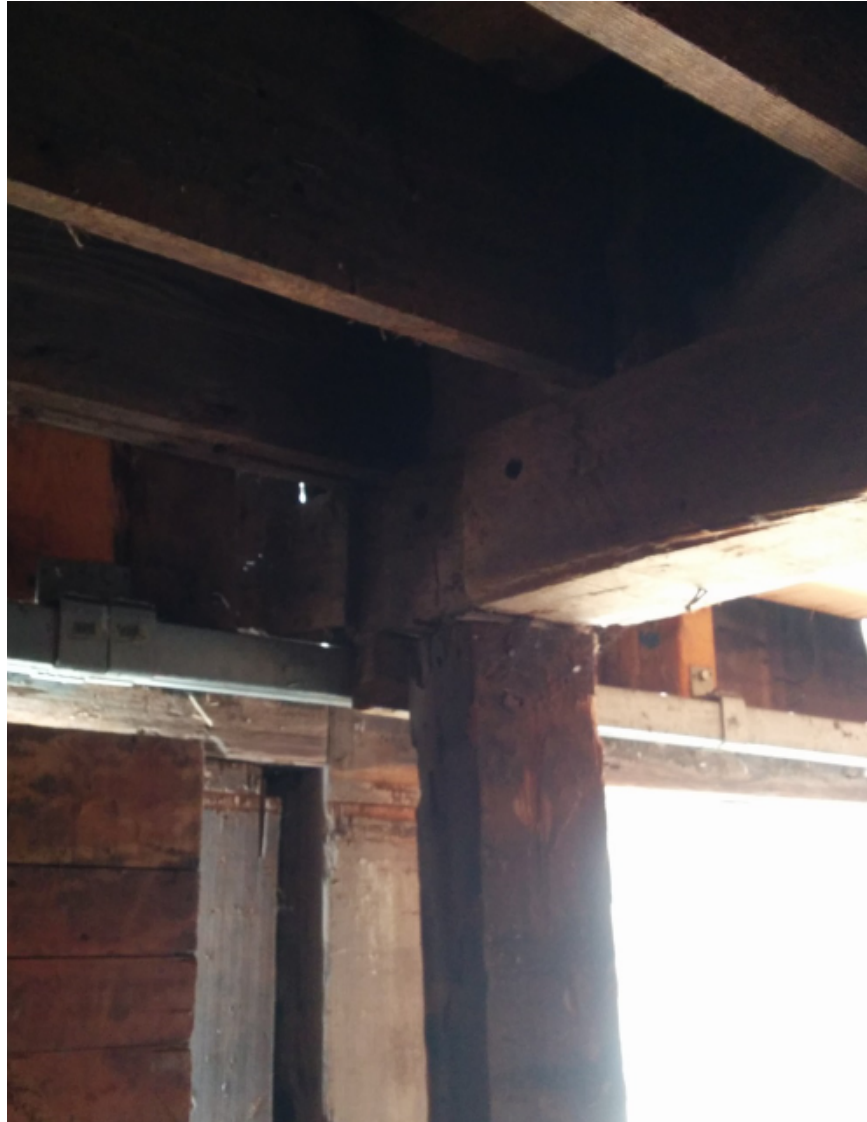
Figure 5. Modified Column

- b. There is a column in the south west of the building that has been modified and does not appear to be installed properly.

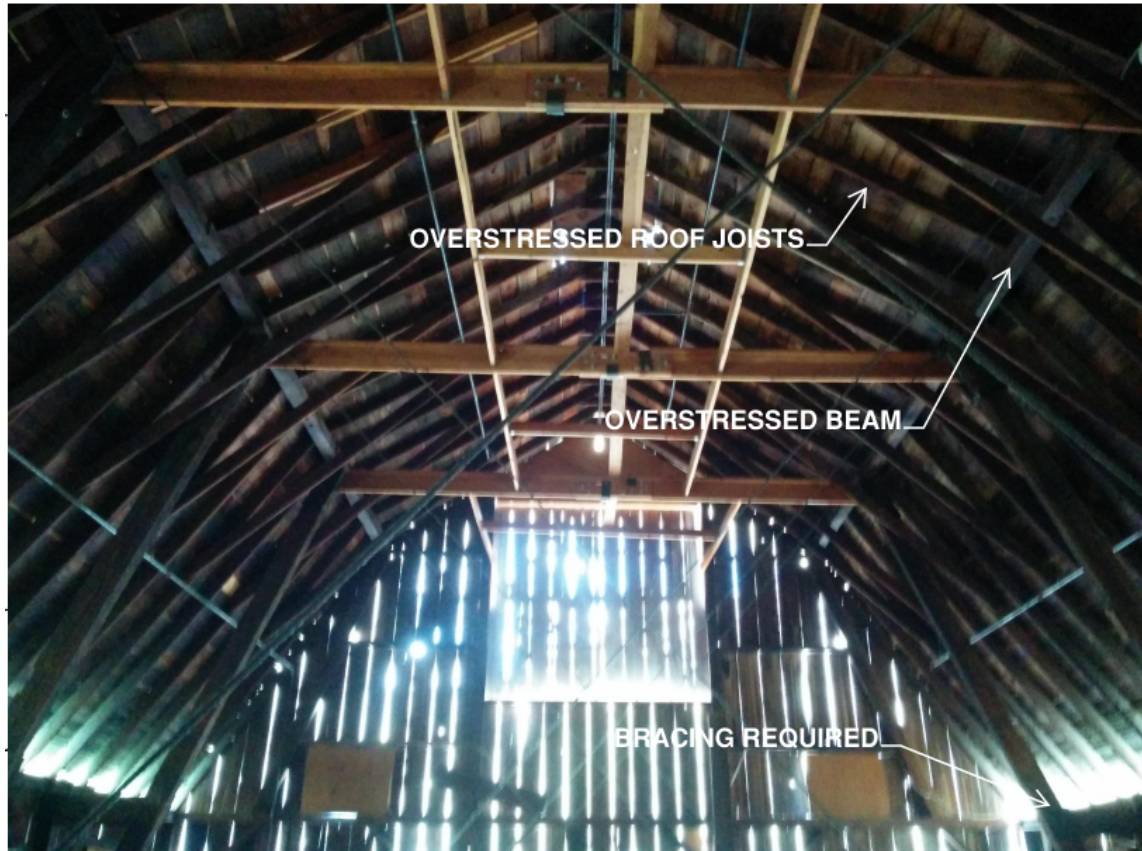
Figure 6. Roof Framing

- a. Roof joists are over stressed between 120% and 500% under design snow loads.
- b. The 6 X 6 roof beam is stressed at 300% under design snow loads.
- c. The diagonal 6 x 10 timber is not braced adequately to withstand design snow loads.
