**PARK CITY PLANNING, ADMINISTRATIVE PUBLIC HEARING  
SUMMIT COUNTY, UTAH  
January 13, 2022**

**Subject:** 1063 Empire Avenue  
**Application:** PL-21-04989  
**Author:** Makena Hawley, Planner II  
**Date:** January 13, 2022  
**Type of Item:** Administrative – Historic District Design Review

Joe Paunovich  
Remodel  
1063 Empire Ave, Park City, Ut  
84060

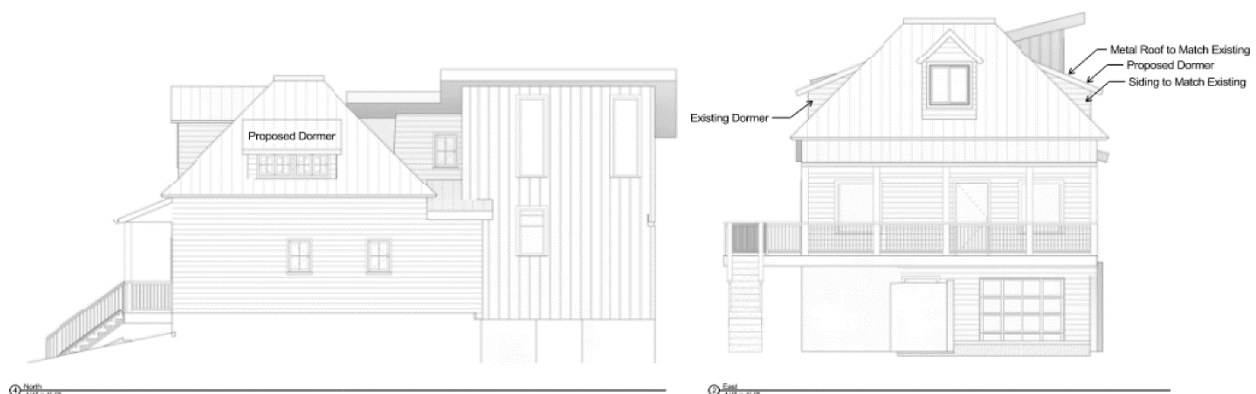
*Proposed dormer addition to match existing southern dormer.*

The Applicant proposes to add a dormer to the north side of the Significant structure, matching the existing historic dormer on the south side. The proposal complies with HR-1 Zoning District requirements found in LMC chapter [15-2.2](#). The proposal does change the existing Setbacks, Lot Size, Building Footprint, Building Height, Final Grade, interior height, or contributing Roof Pitch.

According to the HSI, the roofing material has had significant changes. Through the Physical Conditions Report the Applicant noted the roof framing is new engineering lumber completed between 2016 and 2020 as set forth in the plans completed by the prior builder, using photos as evidence of the new materials utilized for the roof structure (Exhibit F & G).
