**PARK CITY MUNICIPAL CORPORATION  
HISTORIC PRESERVATION BOARD  
CITY COUNCIL CHAMBERS  
December 5, 2017**

424 Woodside Avenue – HDDR Review for Reorientation - Reorientation (rotation) of a “Significant” Structure towards Woodside Avenue and lifting of the Historic Structure 7 feet 7 ¾ inches. The primary façade of the Significant Structure is currently oriented towards Main Street and the applicant is proposing to rotate the structure 180 degrees so that the primary façade is oriented towards Woodside Avenue. Upon reorientation, the Historic Structure would be lifted 7 feet 7 ¾ inches.

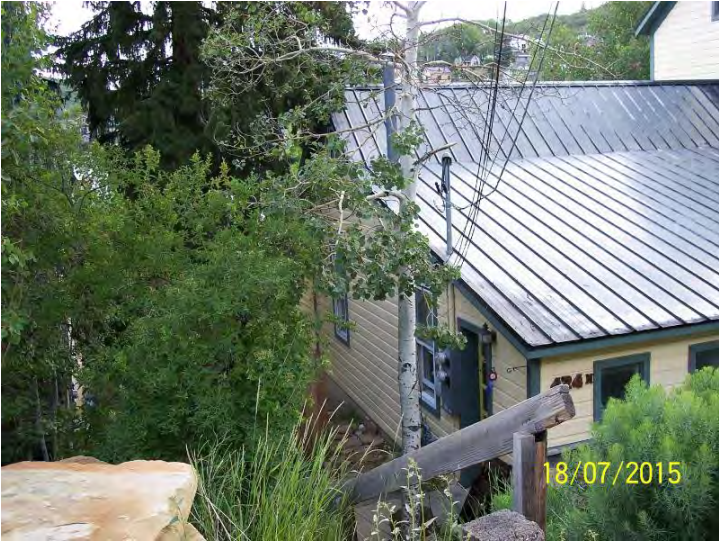
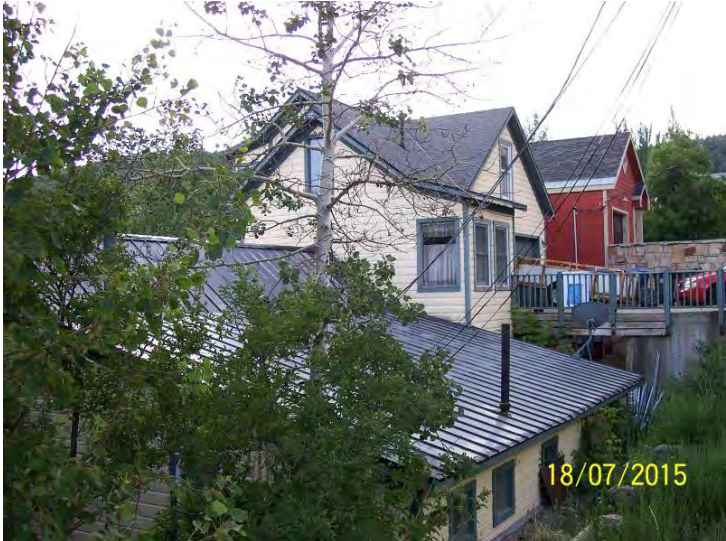
**Figure 1c:** Current Site Orientation – Photographs North Façade

Figures 1a through 1f identify the current conditions and existing orientation of the Historic Structure towards Main Street (east). Renderings provided by Jonathan DeGray. Photographs provided by Jonathan DeGray and CRSA.

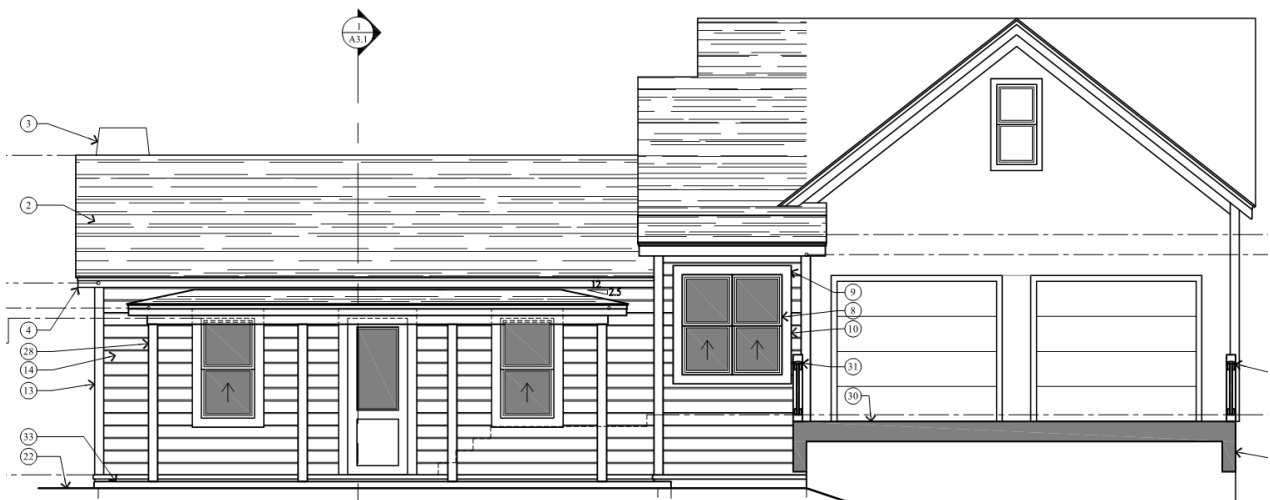
**Figure 2a: Proposed Reorientation – West Façade**

Figures 2a-2d identify the proposed reorientation of the Historic Structures towards Woodside Avenue (west). Renderings provided by Jonathan DeGray.

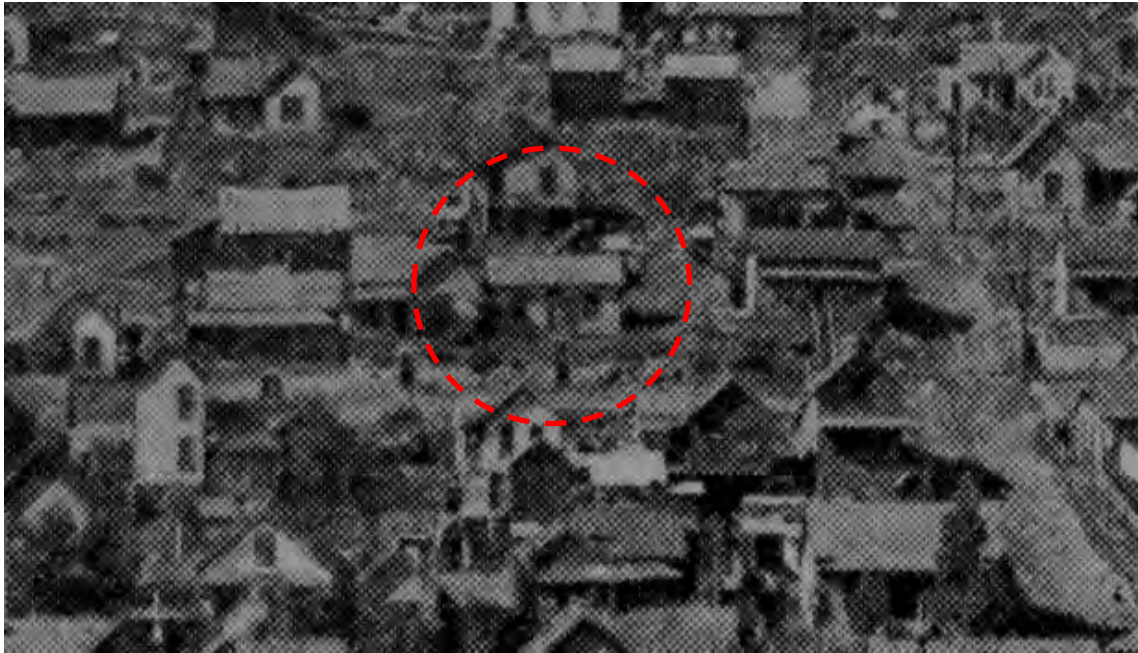
**Figure 5:** View of property ca. 1905-1907, facing west-northwest (circled in red). Note retention of simple hall-parlor form and continued absence of front porch on east side. Photograph provided by Jonathan DeGray courtesy of Park City Historical Society and Museum

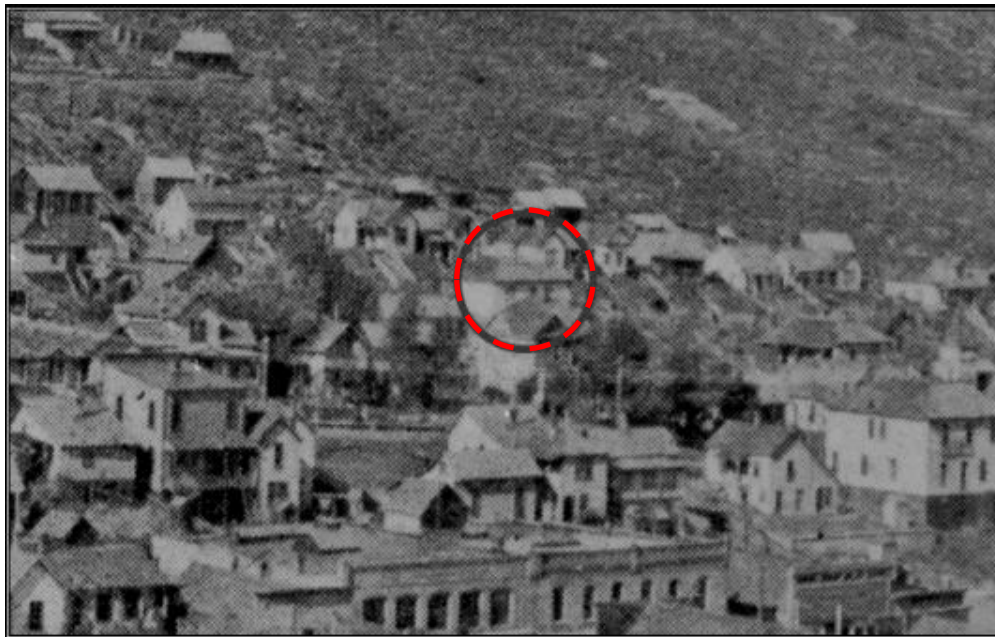
**Figure 6:** View of property ca. 1905-1907 facing north-west (circled in red). Note retention of simple hall-parlor form and continued absence of front porch on east side. Photograph provided by Jonathan DeGray courtesy of Park City Historical Society and Museum

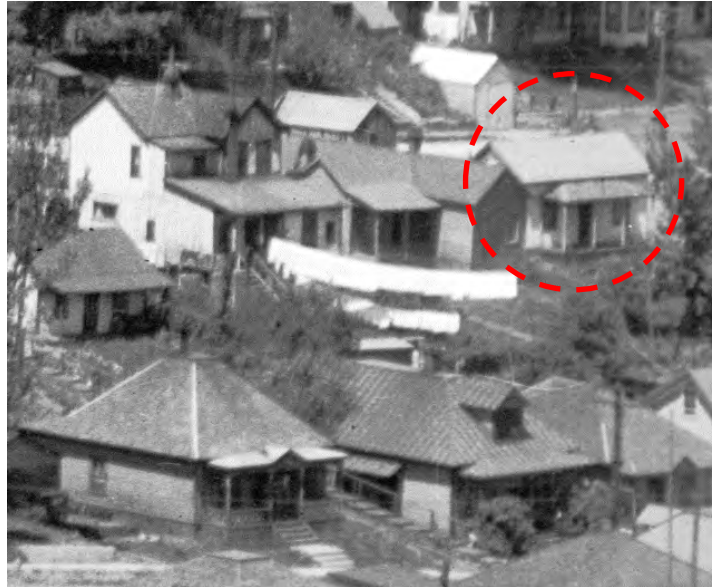
**Figure 9:** View of property at 424 Woodside in 1930, facing northwest. Note the retention of the simple hall-parlor form and addition of hip-roofed front porch, which was removed by 1941 according to the Sanborn Map. Photograph provided by Jonathan DeGray courtesy of Park City Historical Society and Museum.

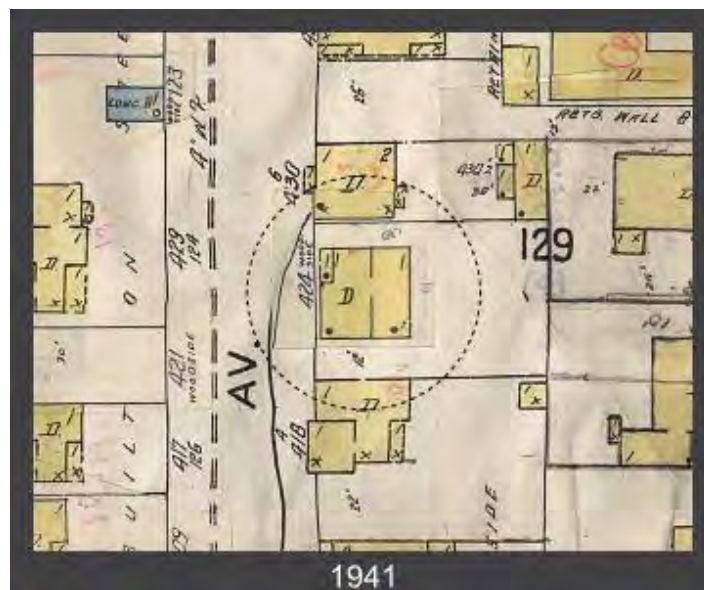
**Figure 10:** 1941 Sanborn Fire Insurance Map

- By 1941, a second shed-roofed addition had been built across the west side, incorporating the 1907 rear screened porch and essentially filling the terrace between the rear wall of the house and the retaining wall so that the eave was nearly at grade. The front porch had been removed and asbestos shingles had been applied over the original wood siding by this time.

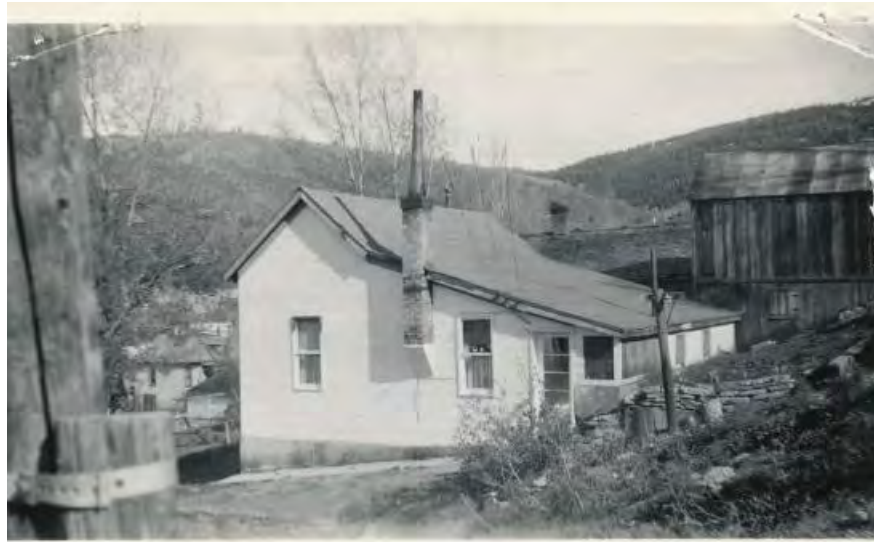
**Figure 11:** Tax appraisal photograph of property at 424 Woodside dating to ca. 1941, facing southeast.

- Asbestos shingle siding was also noted on the 1957 tax appraisal card, which also documents the absence of an east porch.
- The 1968 tax appraisal card indicates that a porch had been rebuilt across the east façade.

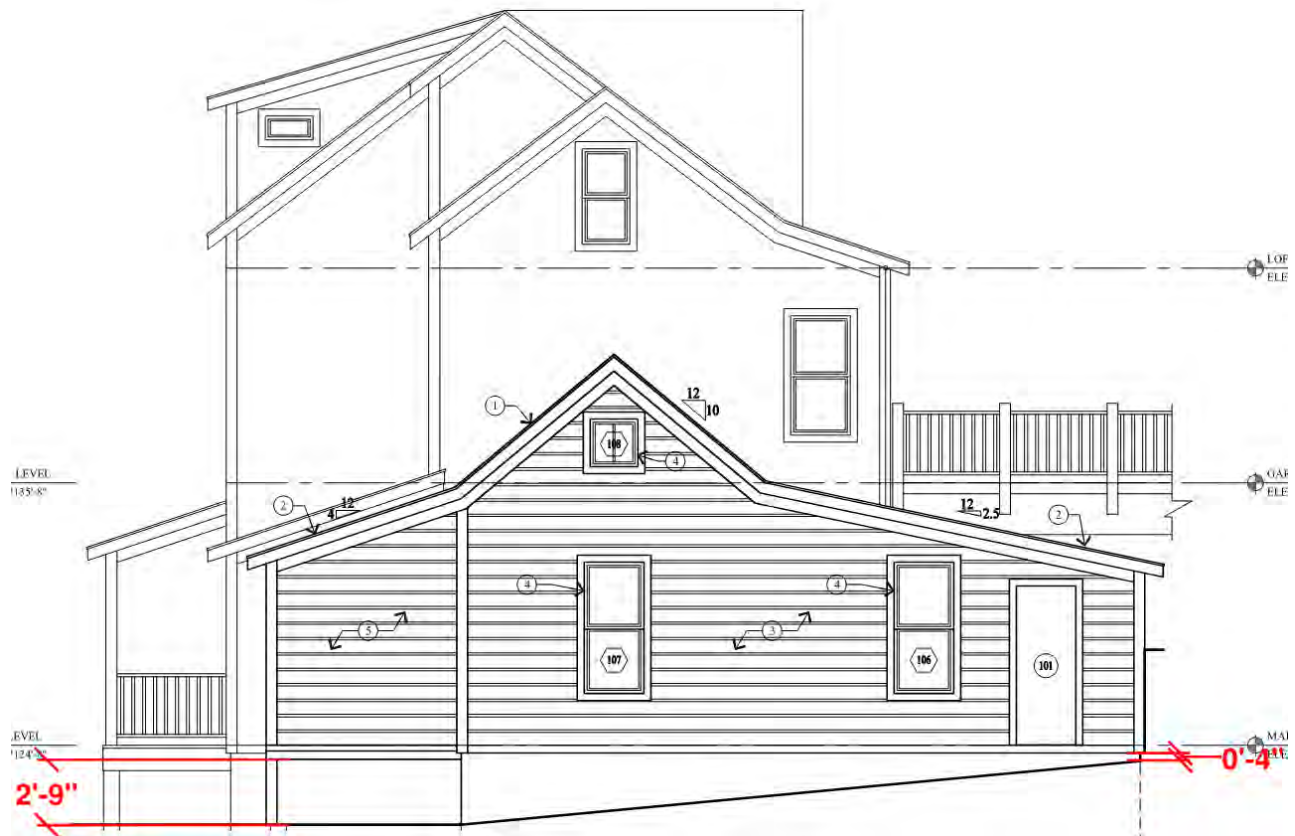
**Figure 12:** Existing Conditions of the North Elevation – Approximate Measurement Of Main Floor Level Above Existing Grade.

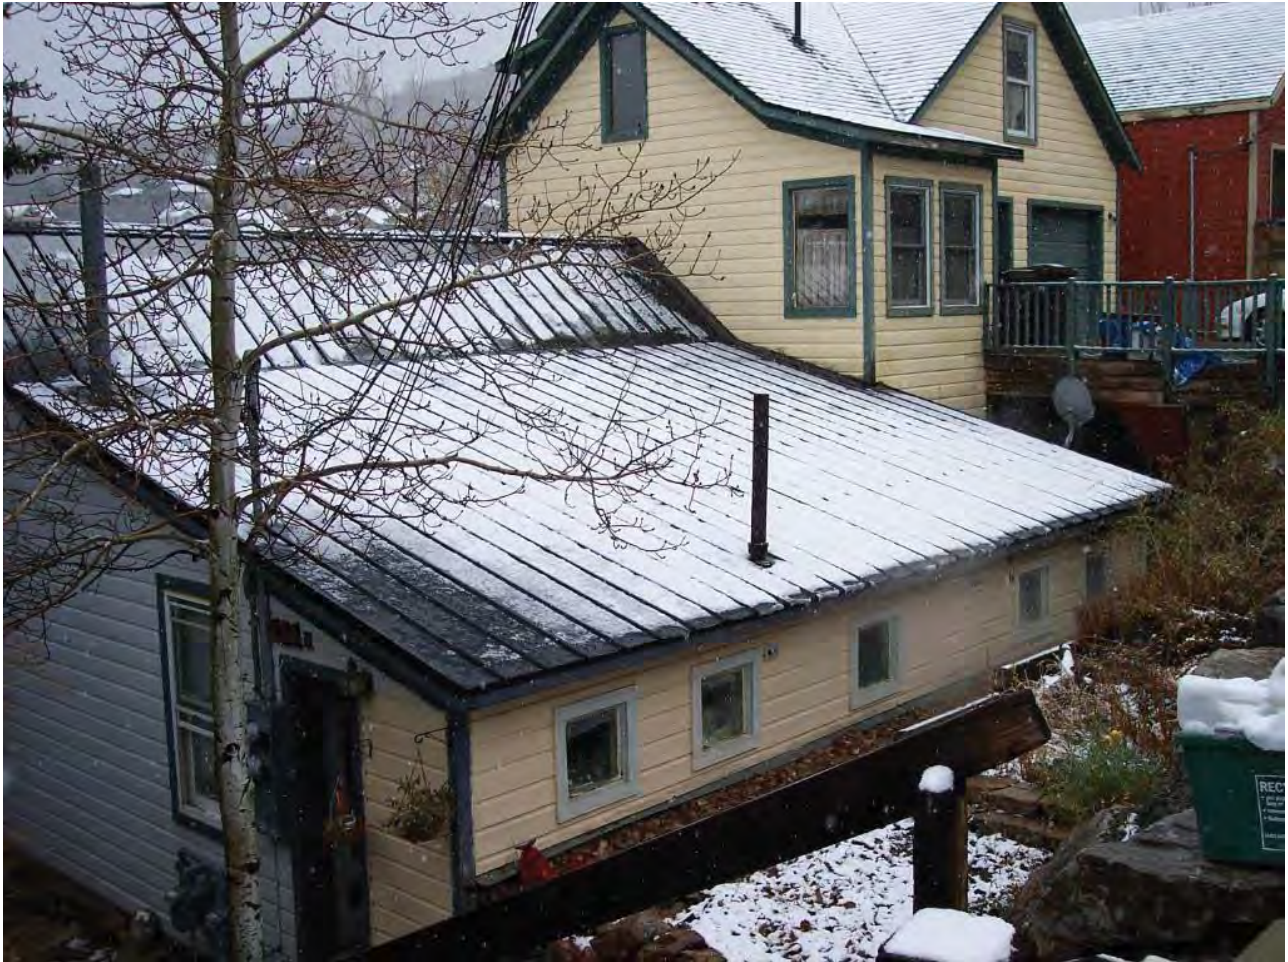
***The west elevation is 1x8 horizontal lap siding applied after 1978, over historic 1x12 vertical plank on 2x4 studs at 24" o.c***

***West elevation***

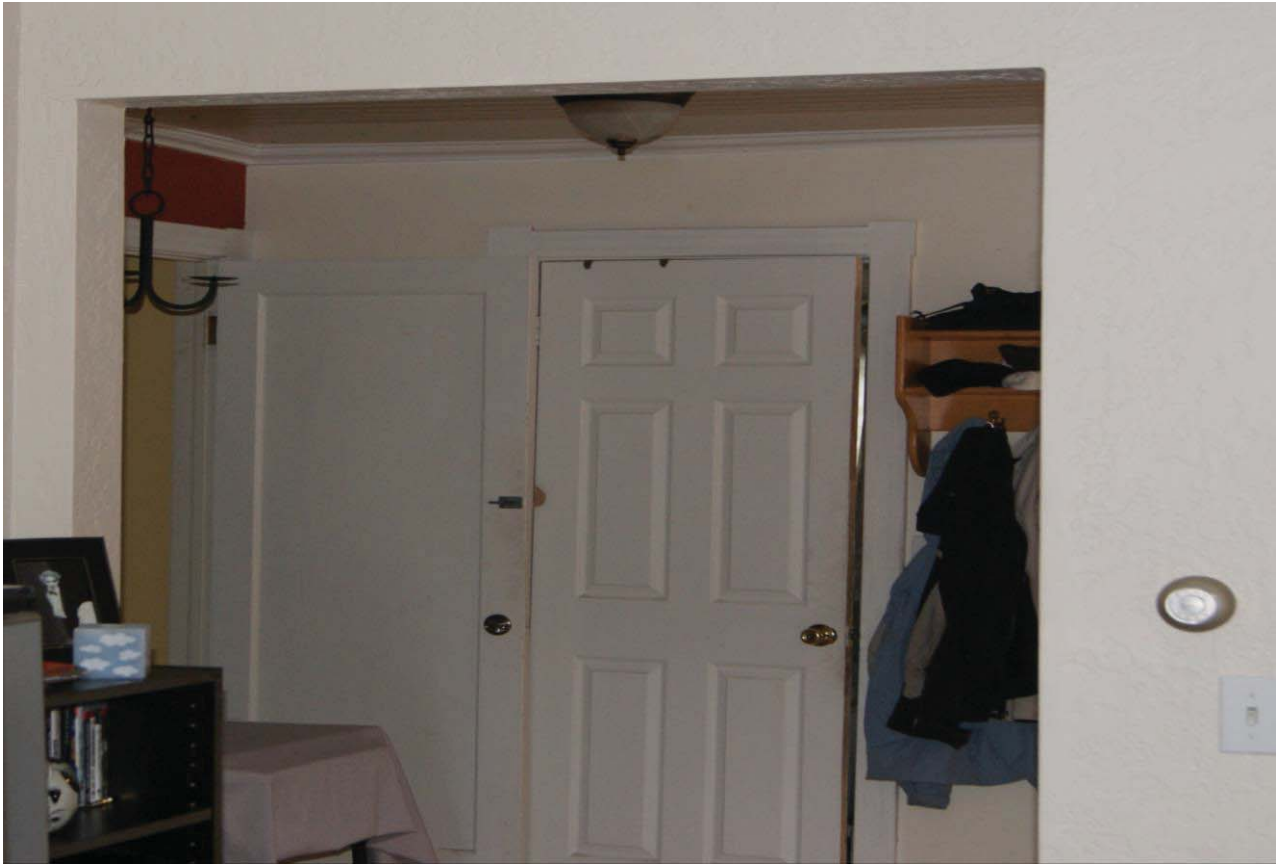
***The doors were updated after 1978 with solid core interior doors and the exterior patio door is insulated wood clad aluminum. No historic doors remain.***

***Interior doors***

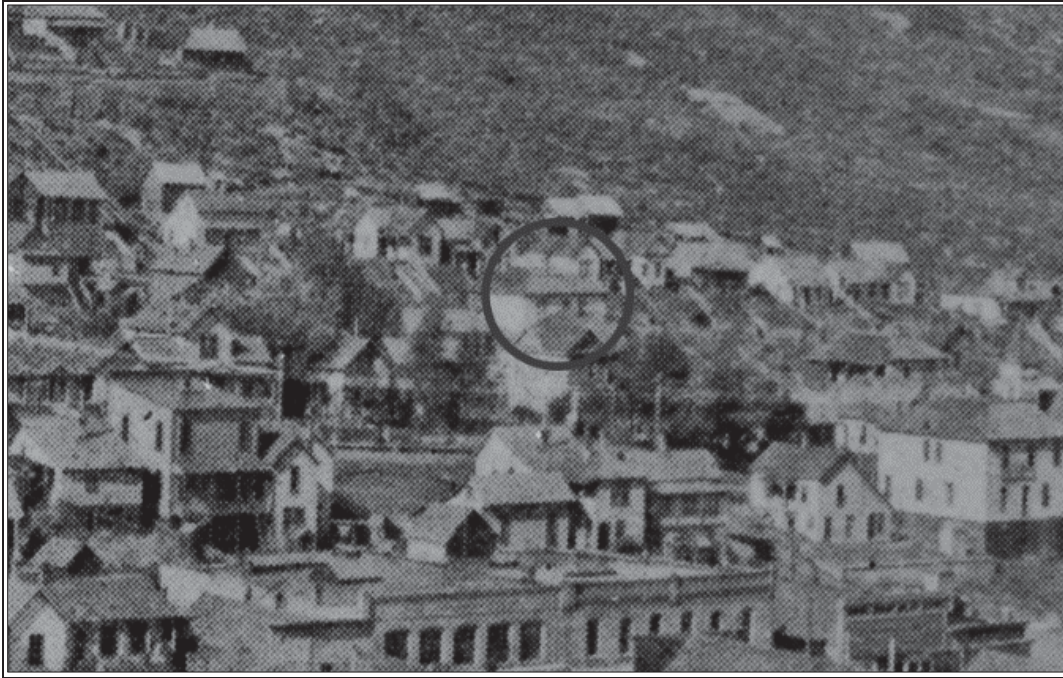
**Figure 2.** View of property at 424 Woodside ca. 1905-1907, facing west-northwest. Note retention of simple hall-parlor form and continued absence of front porch on east side. Photograph no. 1985-6-001.

- As visible in historic photographs, the principal façade was composed of a central doorway flanked by a window on each side (Figures 2 and 3). Woodside Avenue was present to the west but, in the pedestrian-oriented city of the time, access to the house was also via a footpath leading north from Fourth Street behind the Park Avenue houses, and then a short staircase leading up to the east façade (obscured by houses in the foreground). The orientation of houses along the uphill (west) side of Woodside was uniformly east-facing, while orientations along the downhill (east) side was mixed, with some facing the street and others the canyon.

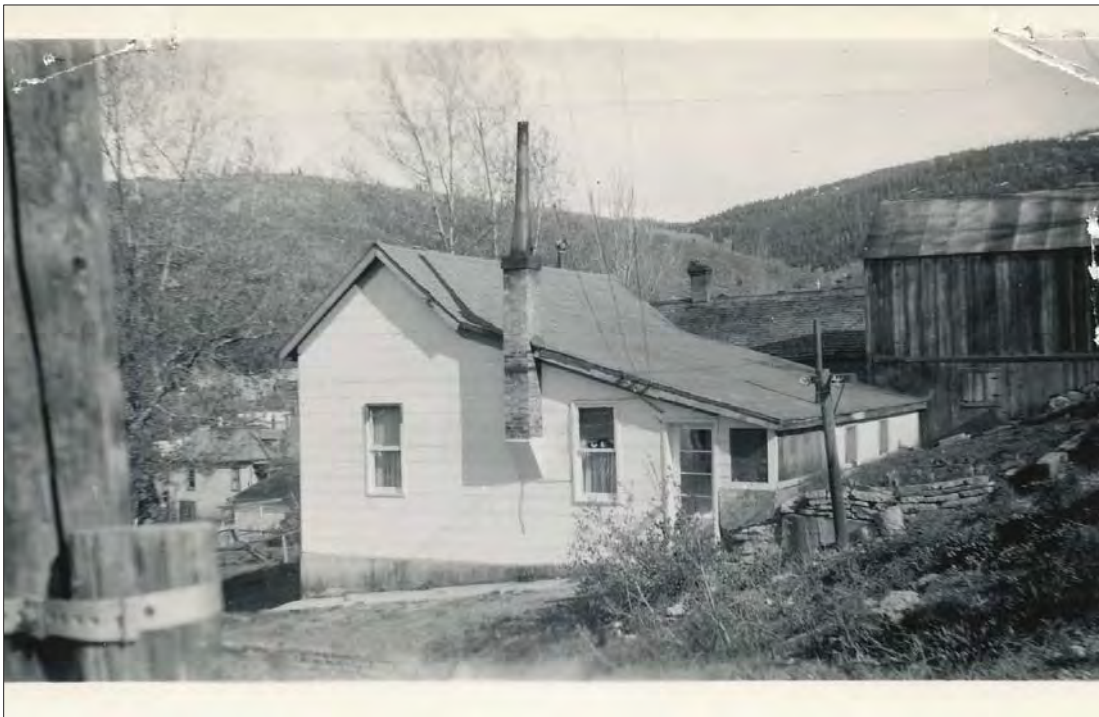
**Figure 5.** Tax appraisal photograph of property at 424 Woodside dating to ca. 1941, facing southeast.

- By 1941, a second shed-roofed addition had been built across the west side, incorporating the 1907 rear screened porch and essentially filling the terrace between the rear wall of the house and the retaining wall so that the eave was nearly at grade (Figure 5; see also Figure 1). The front porch had been removed and asbestos shingles had been applied over the original wood siding by this time (see Figures 1 and 5).

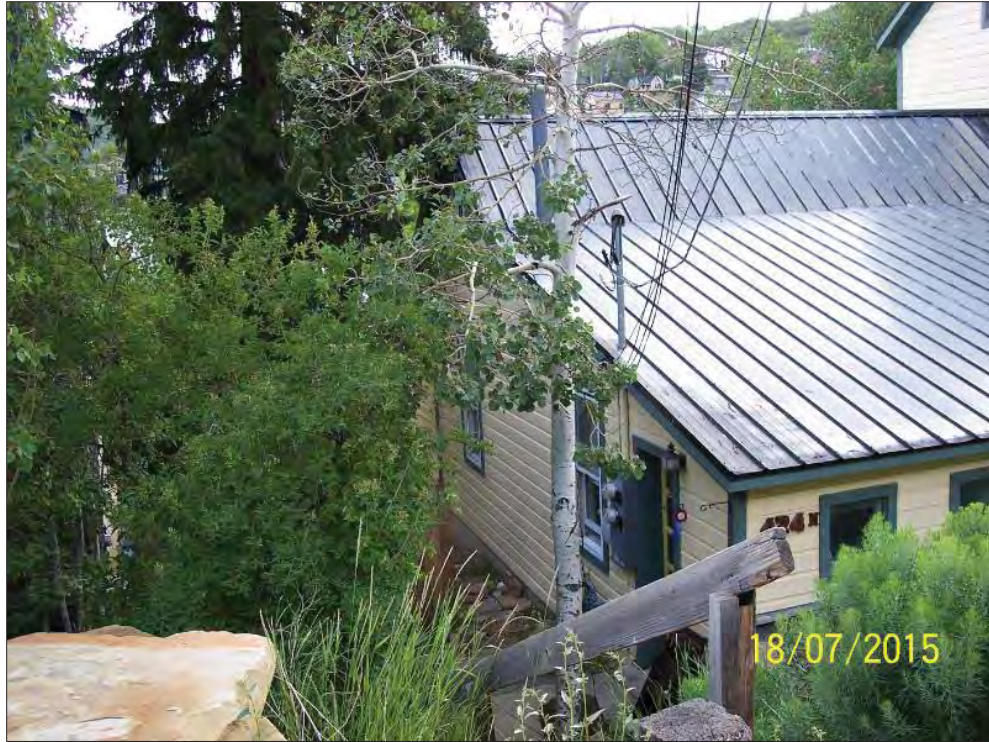
**Figure 6.** North and west sides of historic house at 424 Woodside, facing east-southeast, 2015.

- Between 1978 and 1993, the east façade was modified by the addition of a sunroom across the north two-thirds (which likely was created by enclosing the ca. 1968 front porch), covering the original doorway and north window. The interior floor plan indicates that these historic openings were completely removed or covered at the time. As well, the south window on the east façade was enlarged to accommodate two one-over-one windows (see as-built drawings in DeGray 2016). The asbestos shingles were also removed during this period and replaced with new drop siding; on the west and north elevations this was applied over the original 1 x 12 vertical plank sheathing (Figure 6). It appears that all original windows and doors were replaced as well (DeGray 2016).
