**PARK CITY HISTORIC PRESERVATION BOARD MEETING  
SUMMIT COUNTY, UTAH  
November 6, 2024**

- 6.A. **2025 Regular Meetings** – Consideration to Adopt the Historic Preservation Board Regular Meeting Dates for 2025  
(A) Action
- 6.B. **615 Woodside Avenue – Material Deconstruction** – The Applicant Proposes to Lift a Significant Historic Structure to Construct a Basement Addition and Structural Upgrades. PL-23-05838  
(A) Public Hearing; (B) Action

(I) Review the proposed Material Deconstruction to lift 615 Woodside Avenue, a Significant Historic Site, to construct a basement and garage addition and to restore the sun room windows, (II) conduct a public hearing, and (III) consider approving the Material Deconstruction based on the Findings of Fact, Conclusions of Law, and Conditions of Approval outlined in the draft Final Action Letter (Exhibit A).

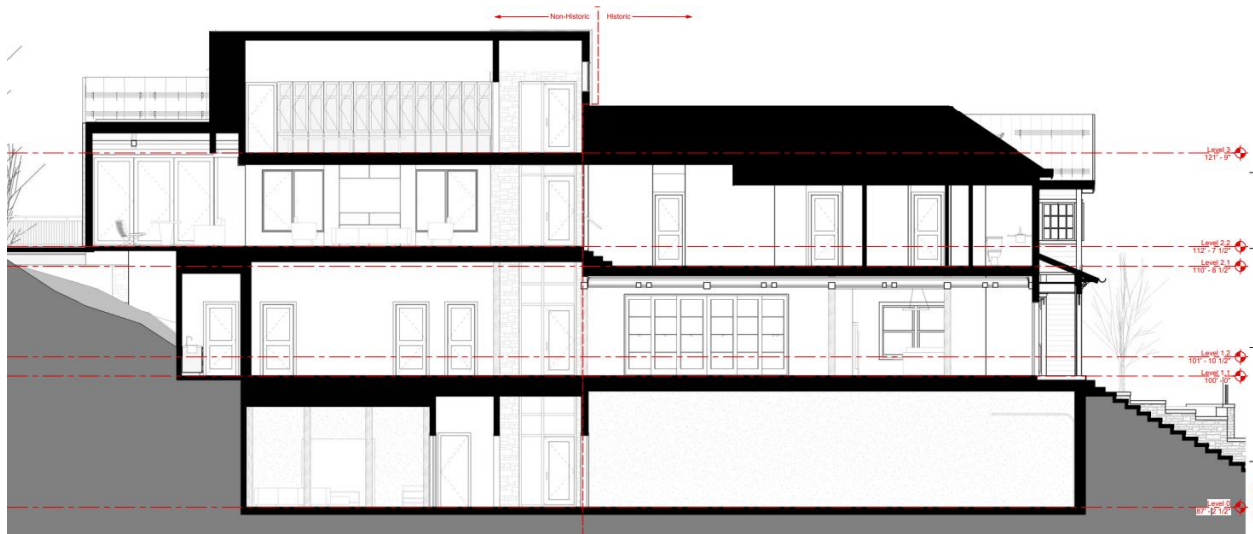
LMC [§ 15-13-2\(B\)\(5\)](#) prohibits the basement garage addition from extending beyond the exterior wall plane of the Significant Historic Structure's primary or secondary facades. The Applicant proposes the garage basement extend out to the furthest exterior wall plane of the Historic Structure.

*Elevation showing the basement garage addition extending to the end of the historic façade.*

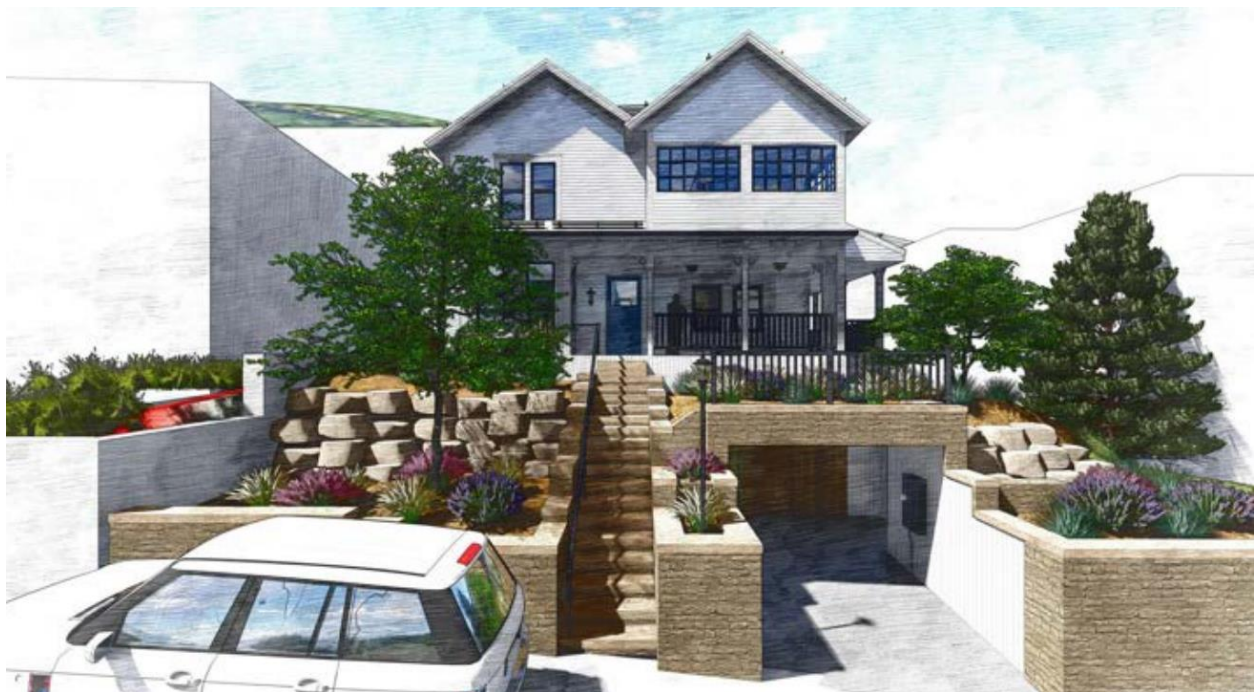
LMC [§ 15-13-2\(B\)\(5\)](#) requires the vertical wall area of a basement garage addition visible from the primary public right-of-way to be visually minimized. It is preferential for the garage opening to be set back from the wall plane of the Significant Historic Structure to diminish the presence of the garage. The garage is visually minimized as the entrance remains setback from the street and is covered by plantings on the top and retaining walls on the side and the Applicant proposes the garage basement extend out to the furthest exterior wall plane. Staff recommends Condition of Approval 18, which requires the Applicant to move the basement addition back six inches to off-set the addition from the same wall plane as the Historic structure.

*615 Woodside Avenue viewed from Woodside Avenue, provided by the Applicant.*

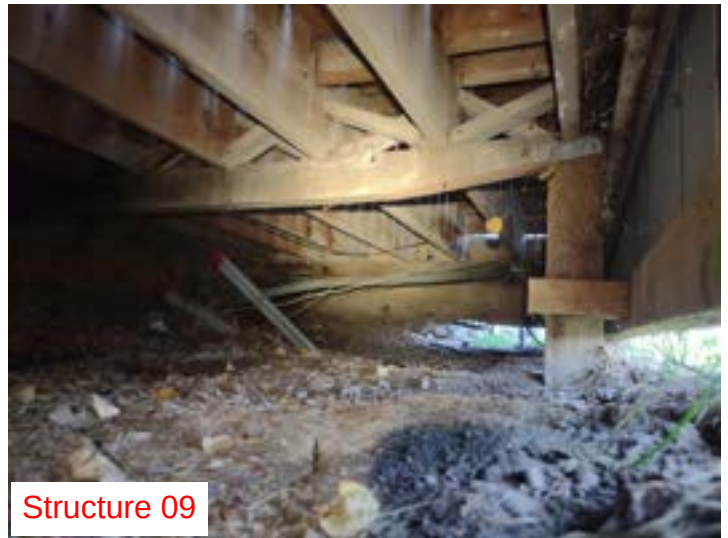
Structure 09

Wood joist structure of front porch.

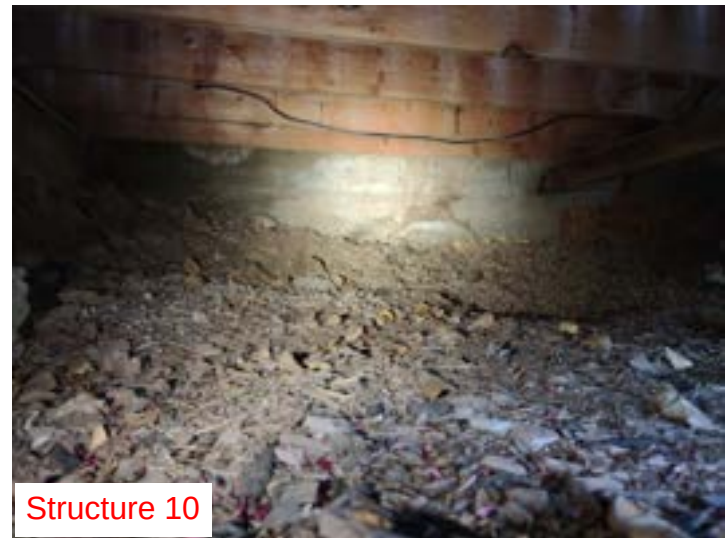
Structure 10

Wood joist structure of front porch, and area of concrete foundation at Northwest corner of house.

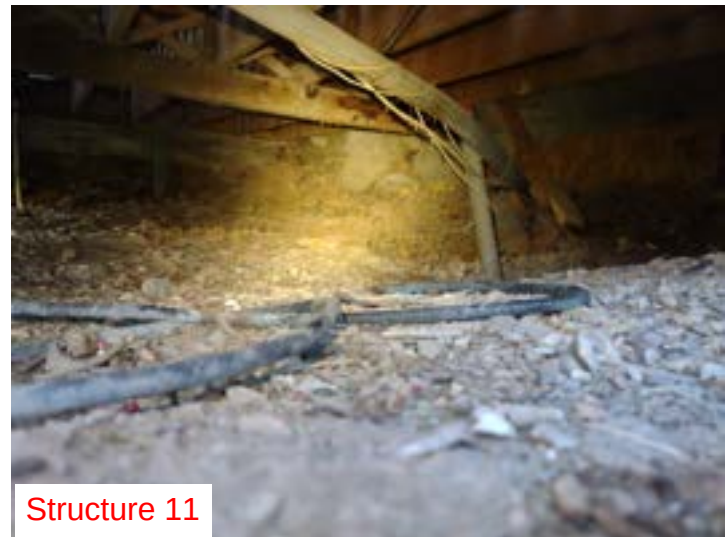
Structure 11

Wood joist structure of front porch, and area of concrete foundation at Northwest corner of house.

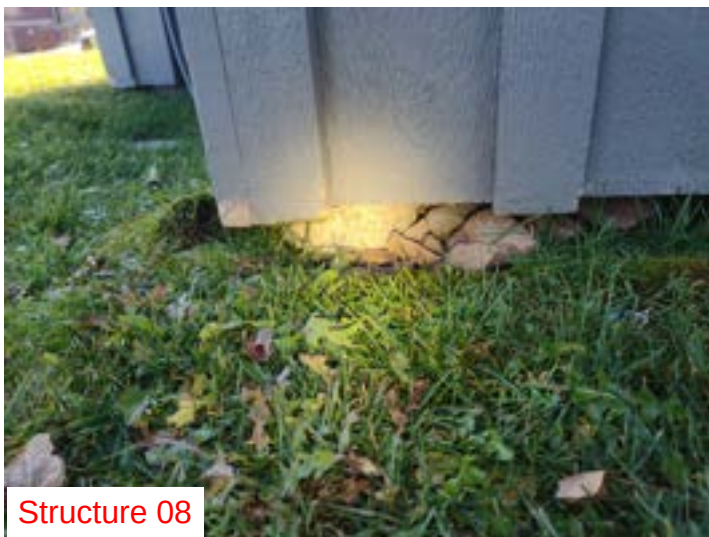
Structure 08

Concrete pier foundation on Northwest corner of front porch.

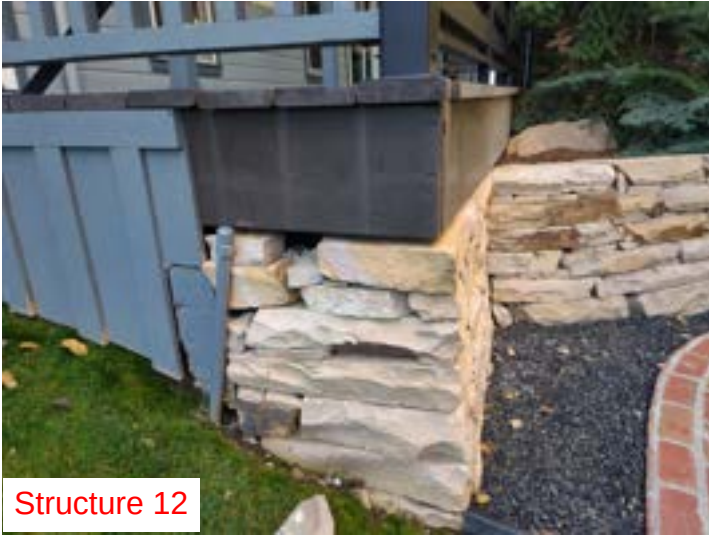
Structure 12

Deck on North side of 1988 addition.

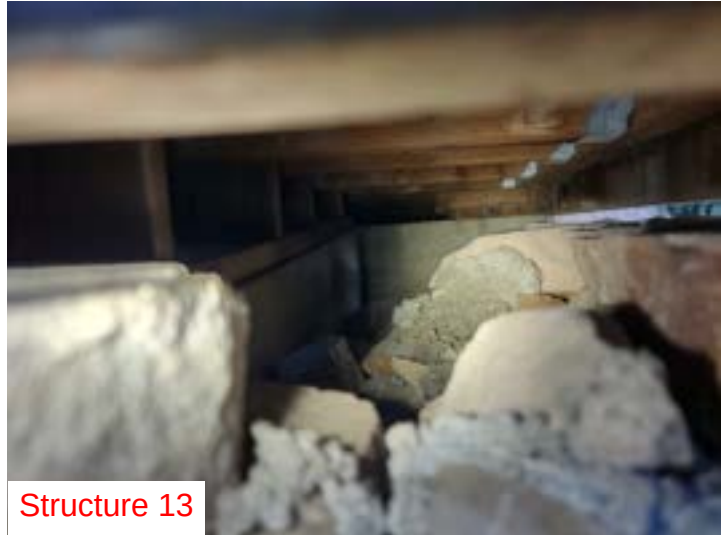
Structure 13

Structure of deck on North side of 1988 addition (wood joists and concrete foundations).

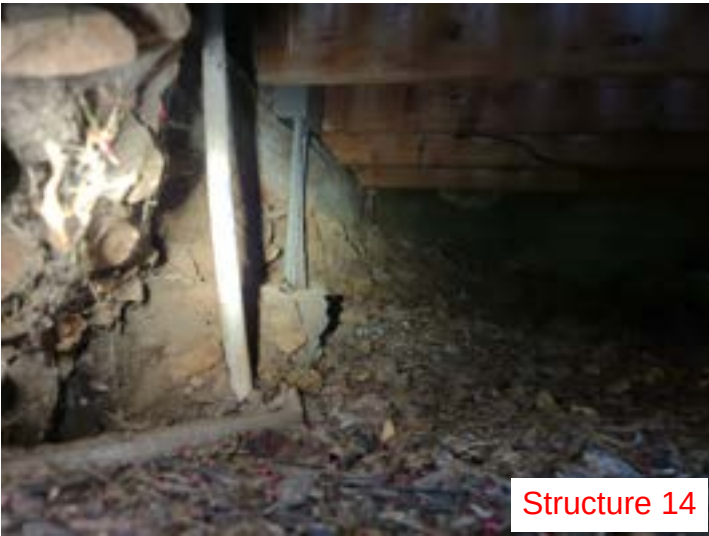
Structure 14

Structure of deck on North side of 1988 addition (wood joists and concrete foundations).

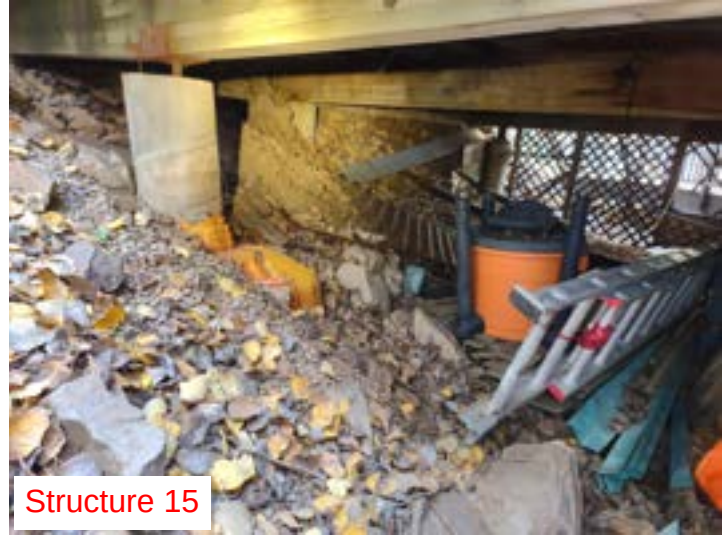
Structure 15

Structure of deck on West side of 1988 addition (concrete piers and wood joists).

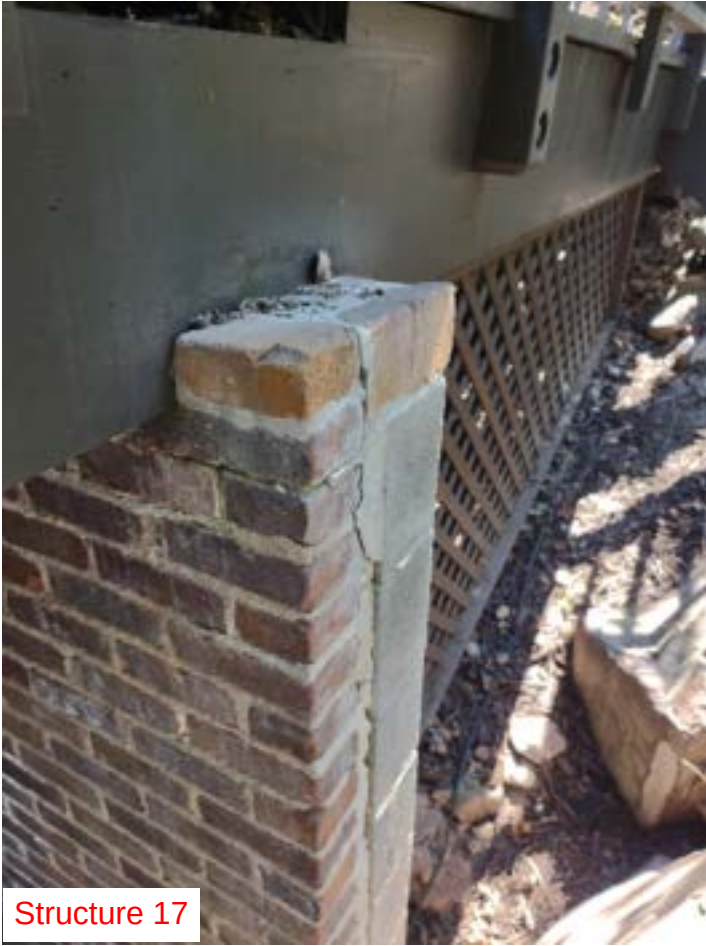
Structure 17

Structure of deck on West side of 1988 addition (wood joists and concrete foundations)

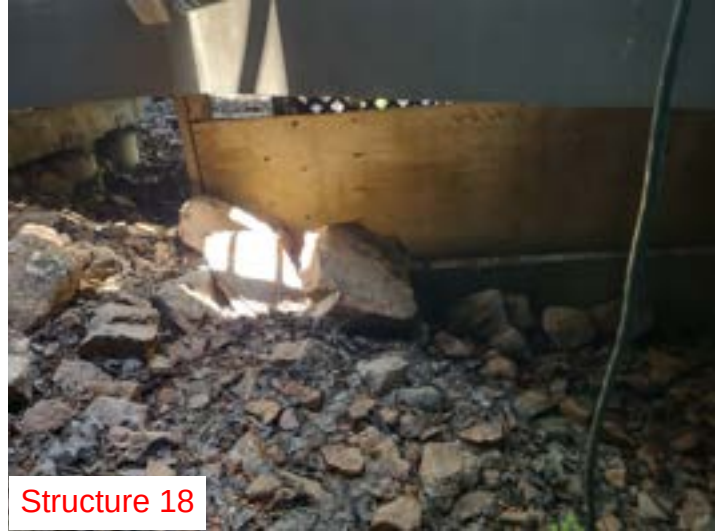
Structure 18

Structure of deck on West side of 1988 addition (wood joists and concrete foundations)

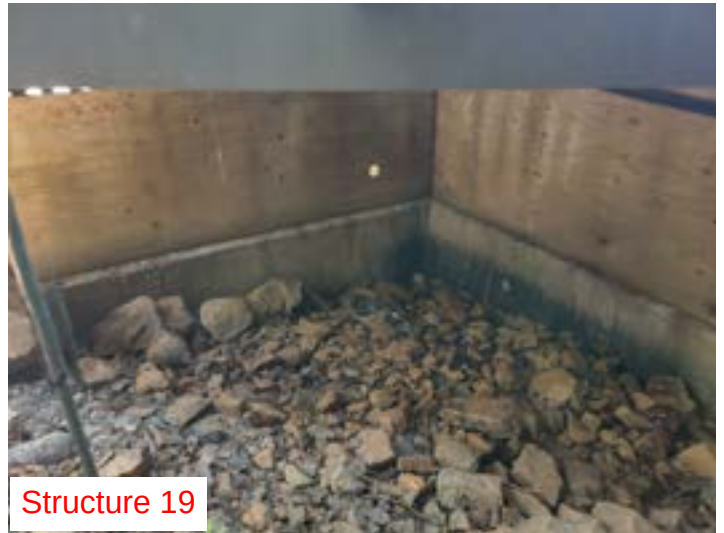
Structure 19

Structure of deck on West side of 1988 addition (wood joists and concrete foundations)

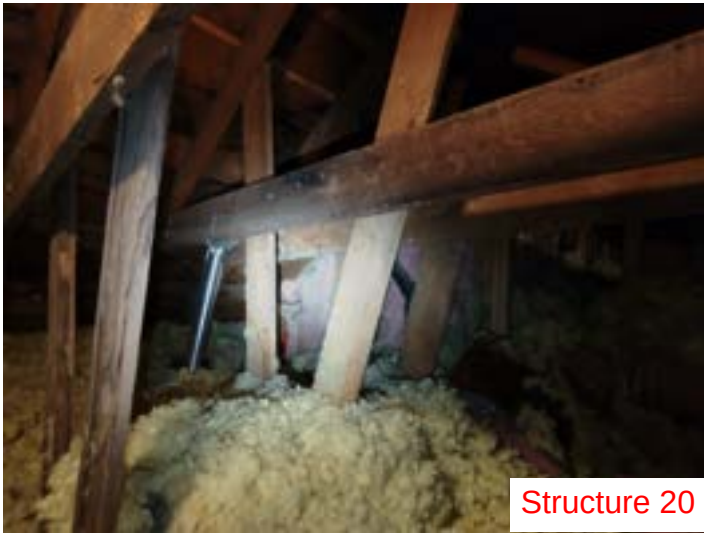
Structure 20

Roof structure of historic portion of house (Southeast area).
