**PARK CITY HISTORIC PRESERVATION BOARD MEETING
SUMMIT COUNTY, UTAH
March 4, 2026**

- 6.C. **1060 Woodside Avenue – Relocation of a Landmark Historic Structure** – The Historic Preservation Board Will Conduct a Work Session to Review the Applicant's Request to Relocate a Landmark Historic Structure. PL-25-06673 (30 mins.)

(A) Public Hearing; (B) Possible Recommendation for City Council Consideration
 - 7.B. **322 Main Street – Material Deconstruction** – The Applicant Proposes a Rooftop and Rear Addition and Changes to the Front Facade of the Landmark Historic Structure in the Historic Commercial Business District. PL-24-06265 (30 mins.)

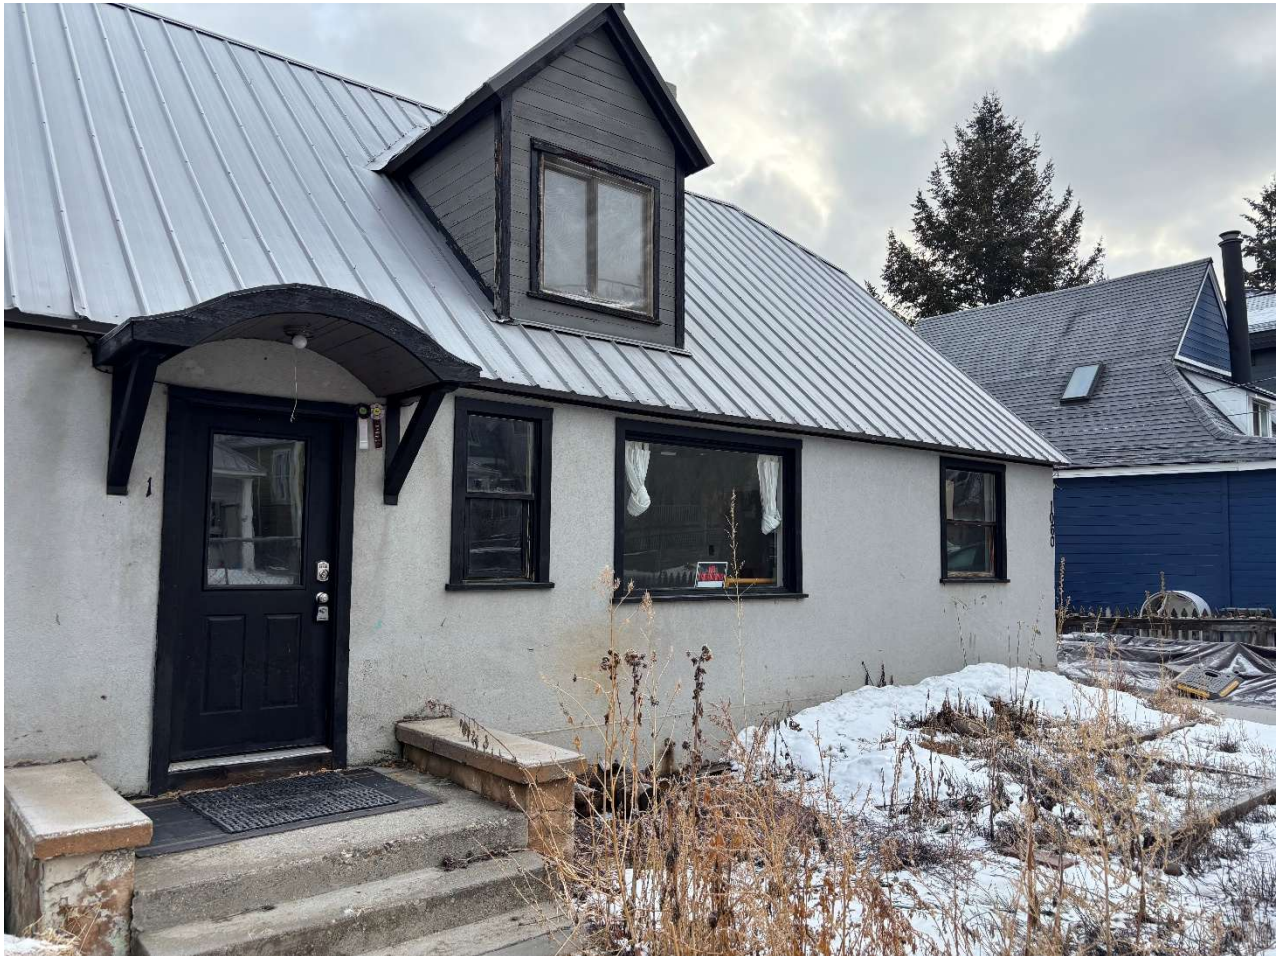
Figure 2. Modifications to the primary (west) façade include removal of the hipped roof at the entry, addition of a window opening south of the primary entrance, addition of a roof dormer, and roof cladding replacement.

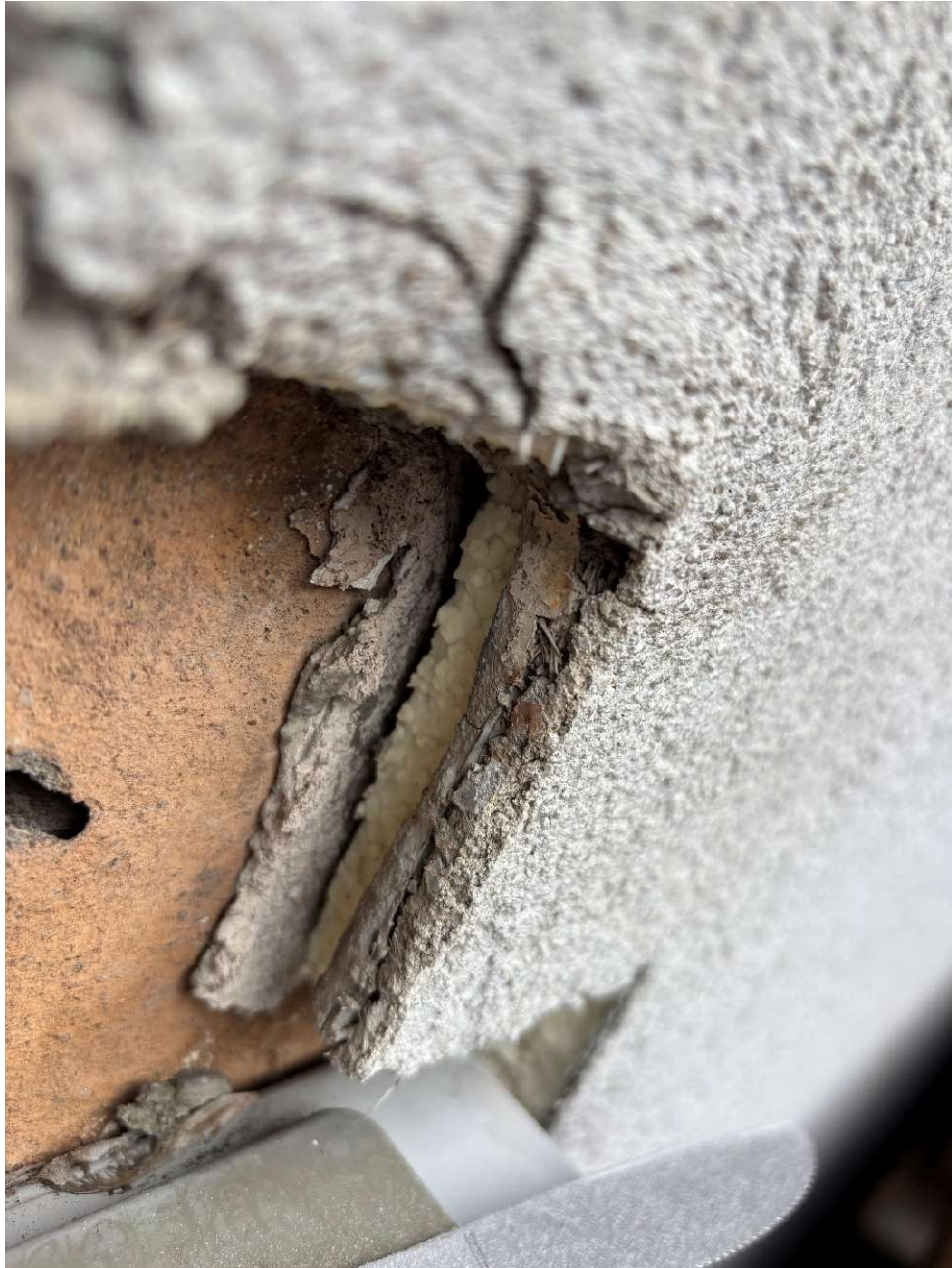
Figure 3. The exterior of the original building has been re-clad in EIFS. The addition is clad in EIFS.

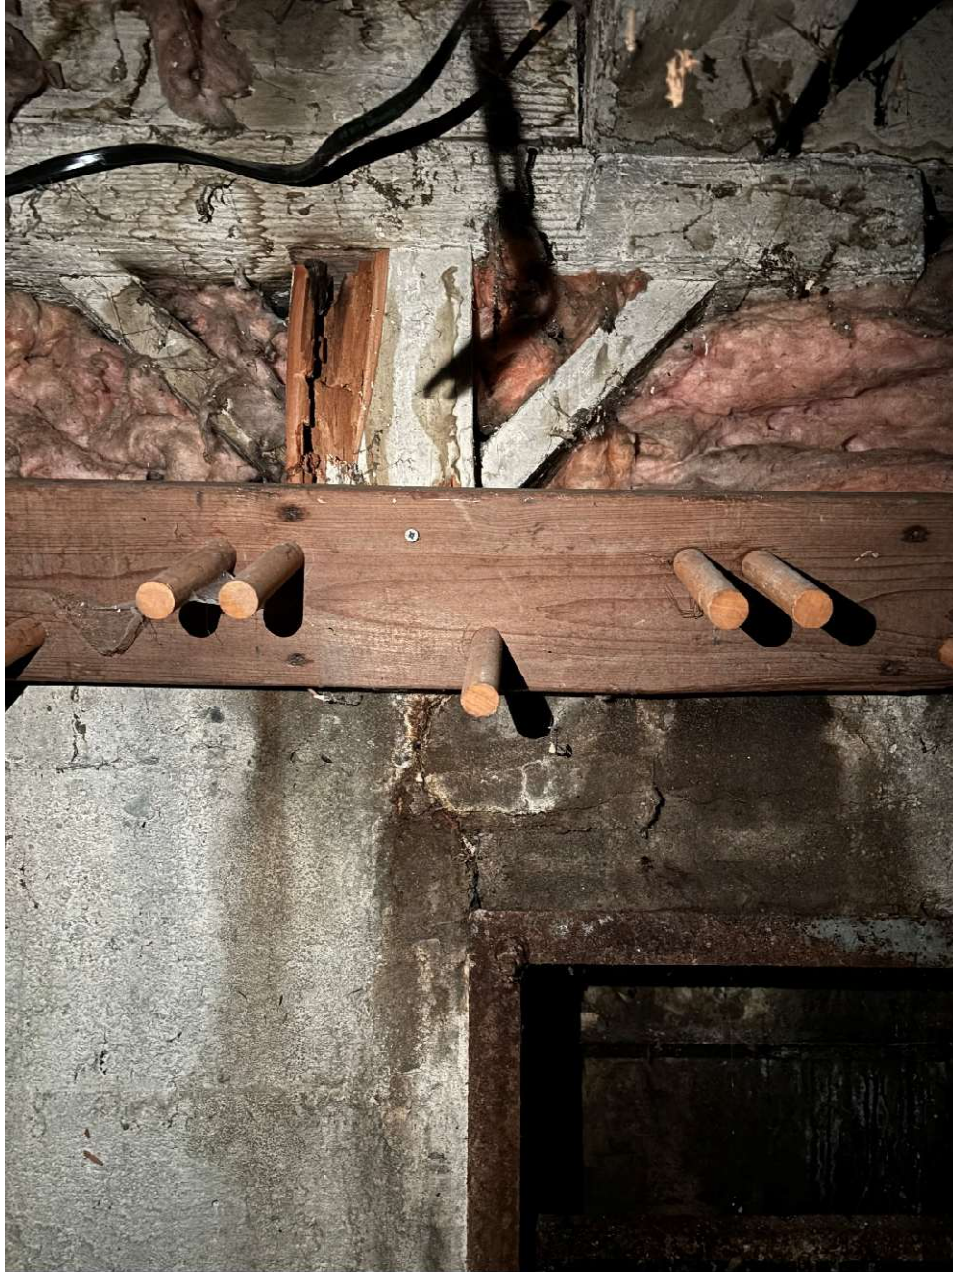
Figure 7. The floor and foundation structure is visible in the basement.

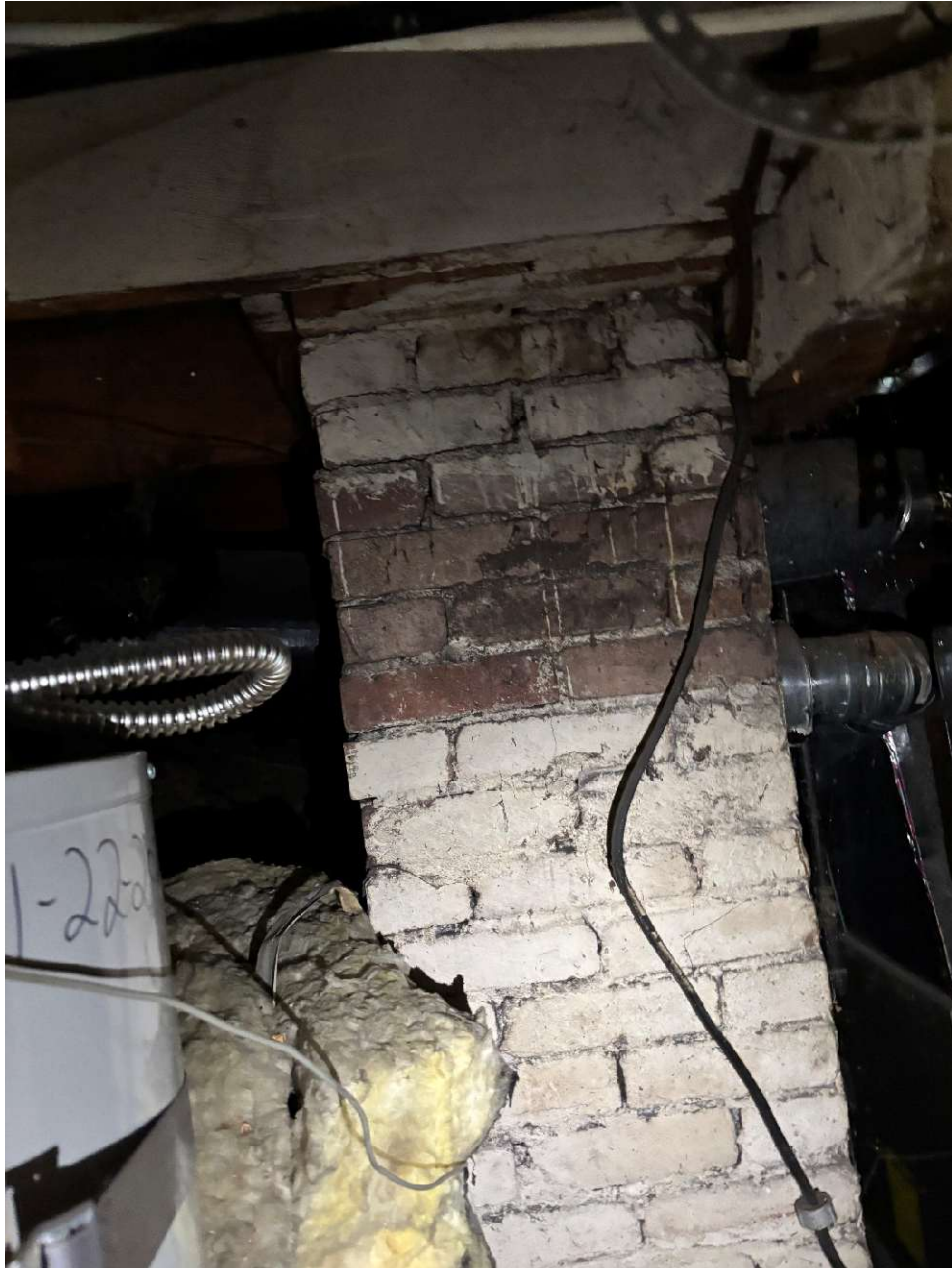
Figure 8. The southernmost, interior chimney extends through the basement and may have originally connected to a stove in the kitchen. It is no longer apparent in the kitchen.

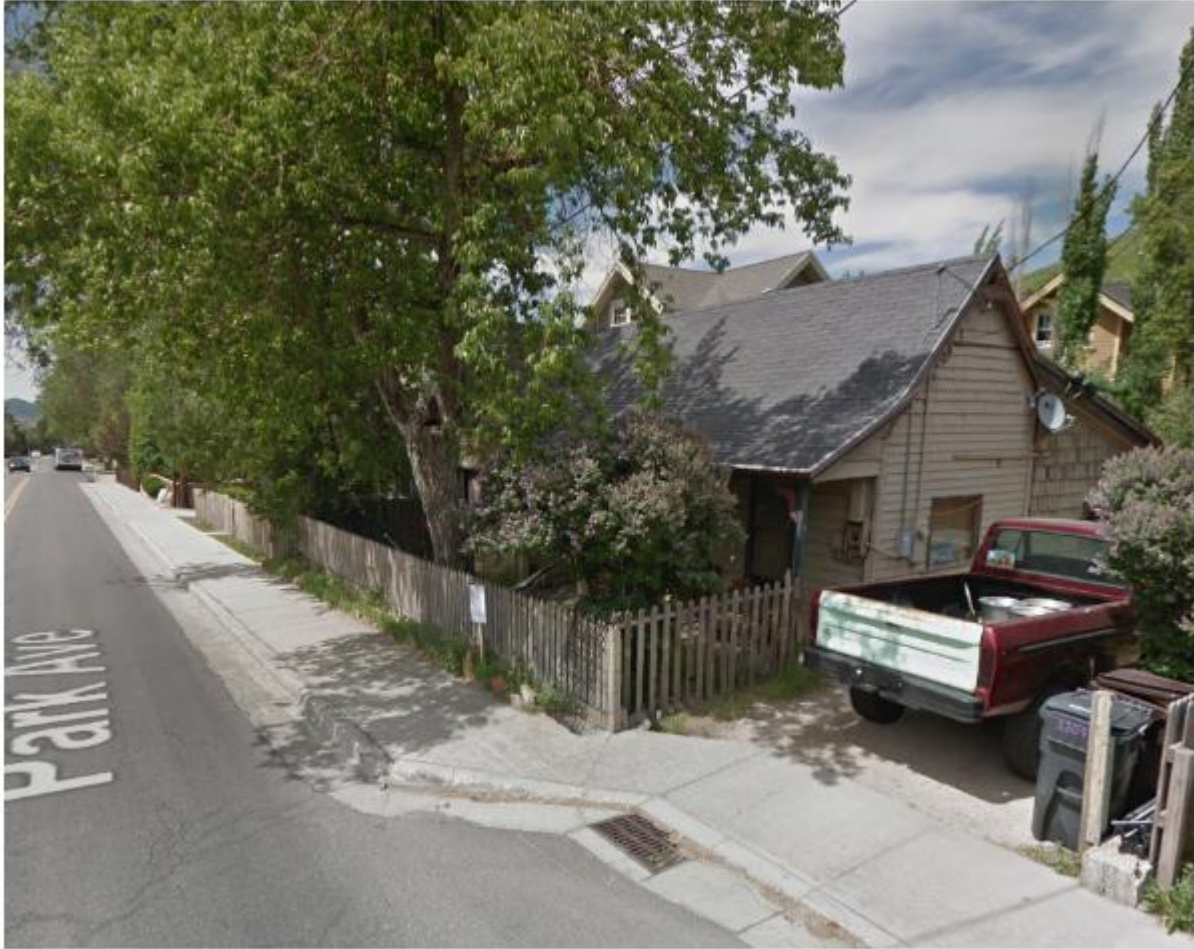
Figure 1: 1304 Park Ave wood picket fence, Google Maps

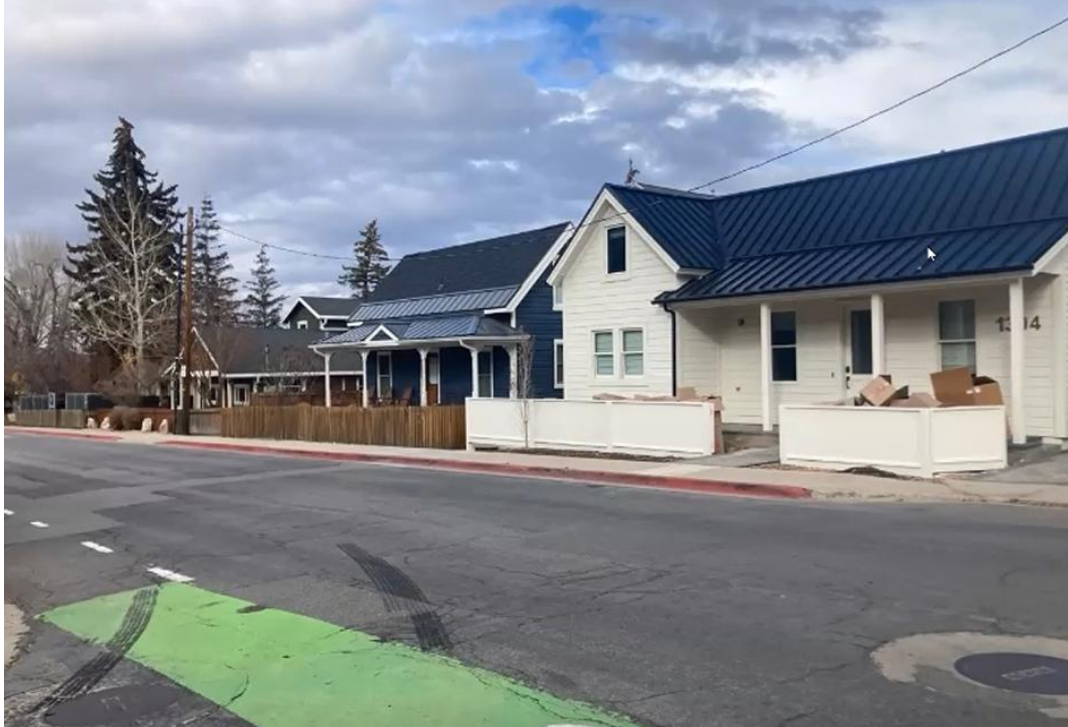
The Fence proposed to replace the wood picket Fence is a four-foot-tall painted solid cedar Fence. The solid wood impedes visibility of the front yard and Historic Site. Additionally, because of a need to provide for snow storage and that the previous and proposed fence are within the City's right-of-way, Engineering requested the Fence be installed 4-feet from the sidewalk and closer to the Historic Structure than the previous fence. This location does not currently align with other adjacent Fences in the Right-of-Way. The installed fence is shown below.

Figure 3: 1304 Park Ave, painted cedar fence

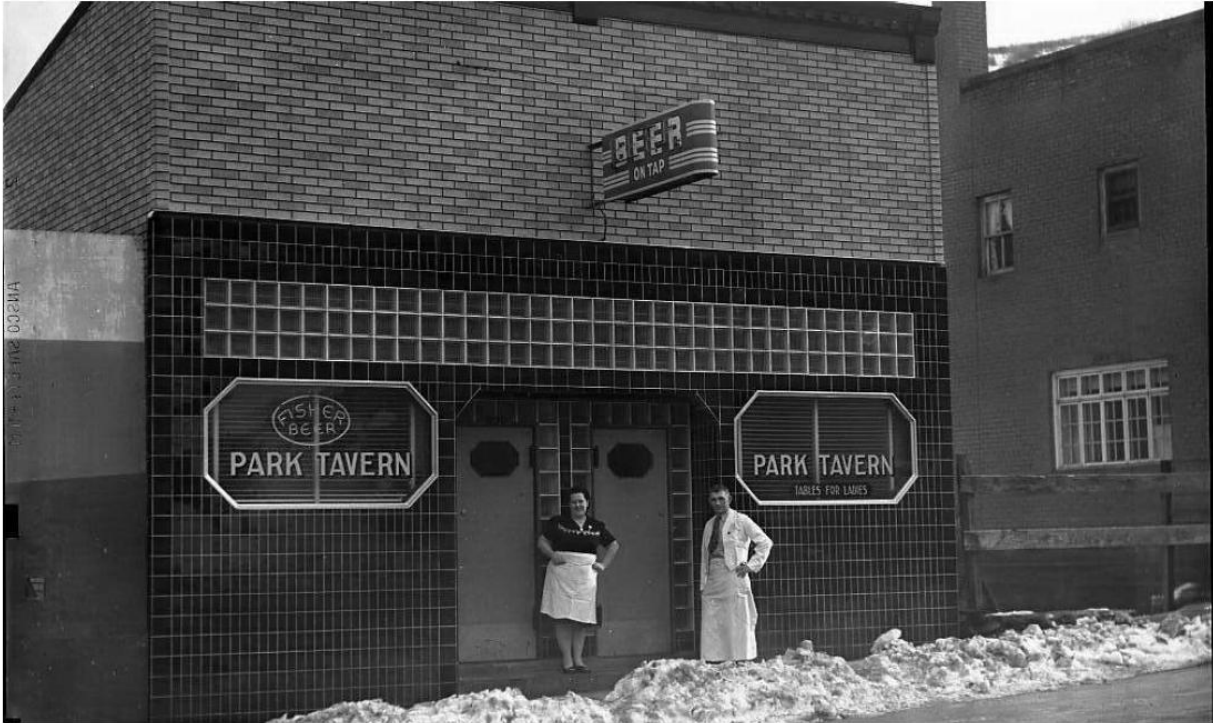
Figure 4: Structure in the 1940s and 1950s showing modifications to the entryways, reduction of the storefront windows, and replacement of the transom windows with a horizontal span of grid glazing

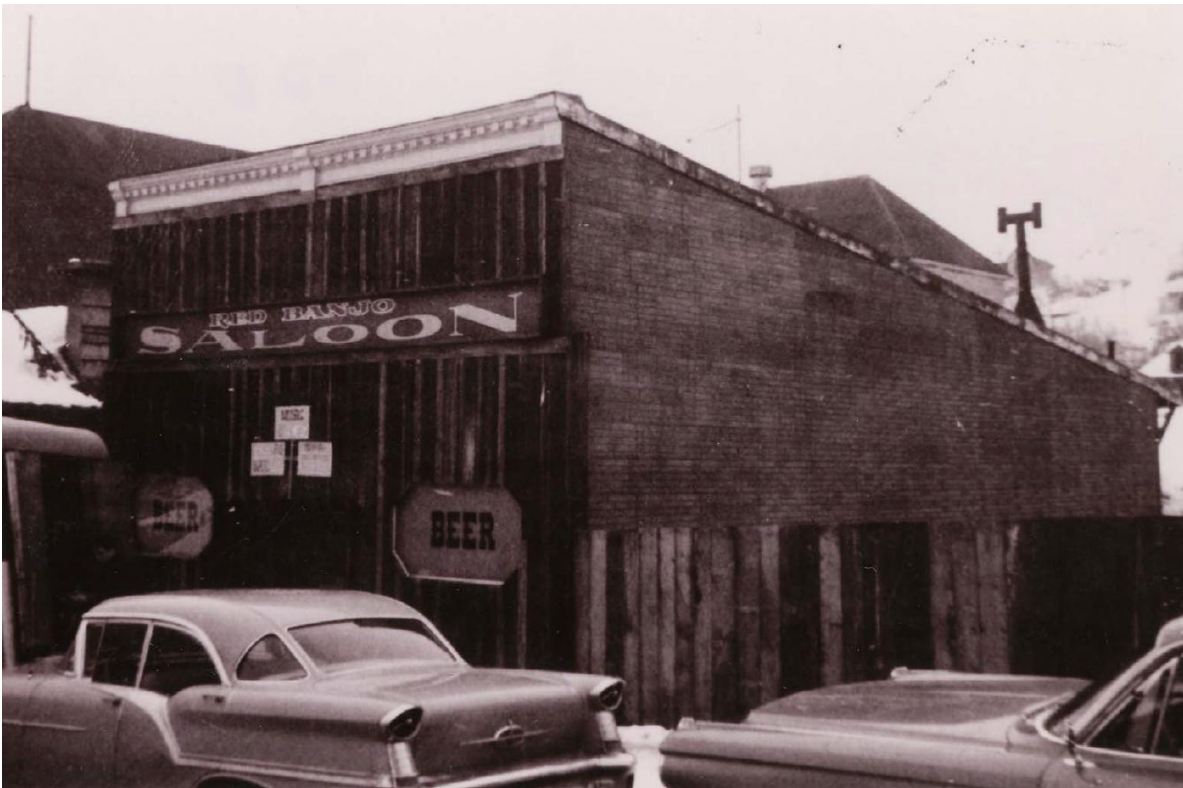
Figure 5: Photo of 322 Main Street likely from the 1960s showing a transition from brick and tile to a vertical wood facade

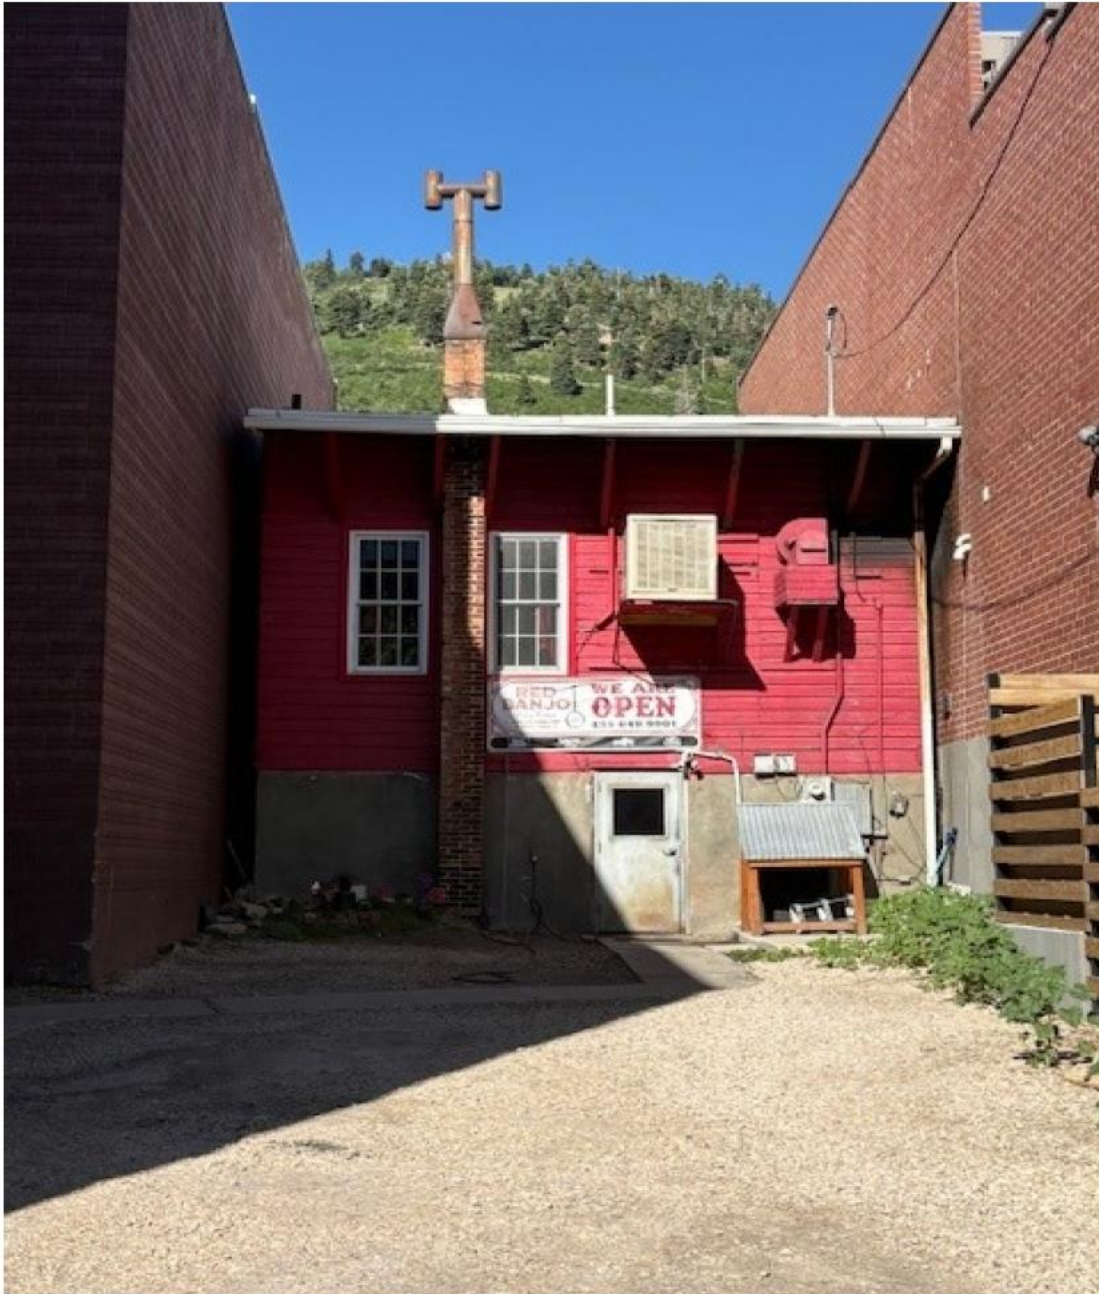
the building and de-constructed. Rather, they propose retaining the bricks to be used decoratively in the building. The metal component on top of the existing roof will be removed. Staff finds that because this proposal meets the requirements of rear additions along Swede Alley, the Material Deconstruction of the chimney be approved.

Figure 9: Applicant's photo submittal showing the rear façade, with most materials replaced in 1976. The Applicant's Historic Preservation Plan indicates the brick of the chimney is historic but is proposed to be removed.

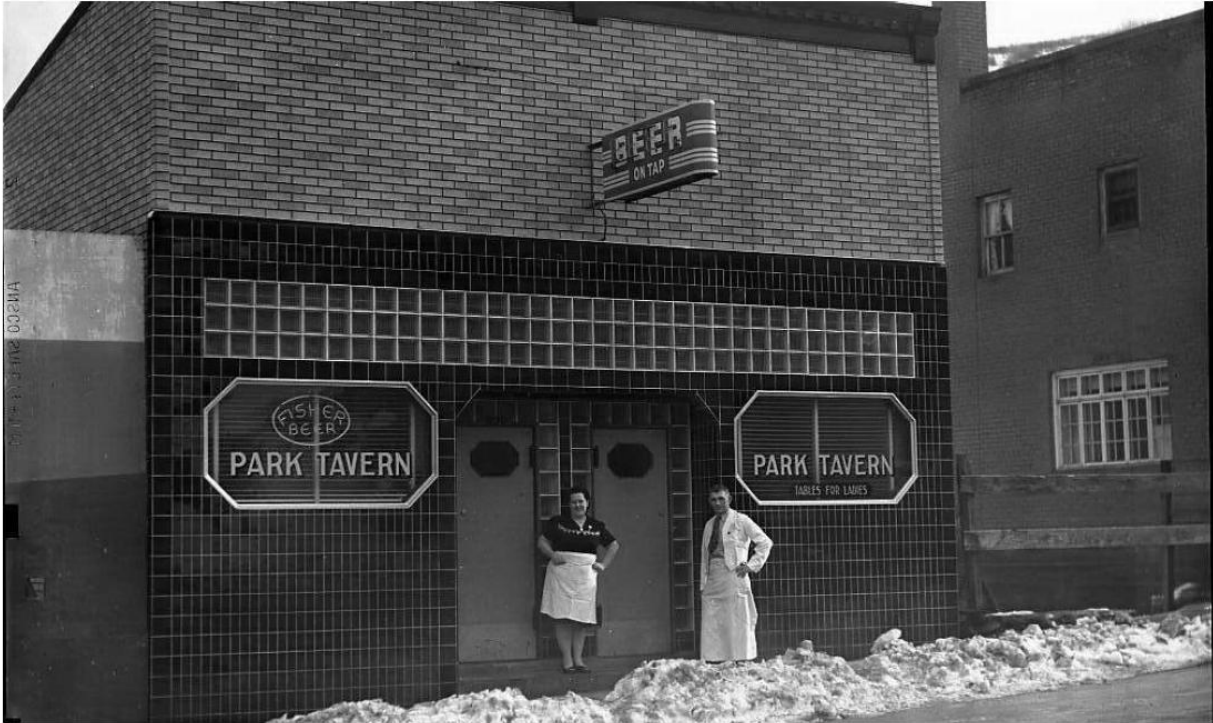
Figure 12: Structure in the 1940s and 1950s showing the storefront windows were reduced in size and the transom windows were replaced with a horizontal span of extensive glazing

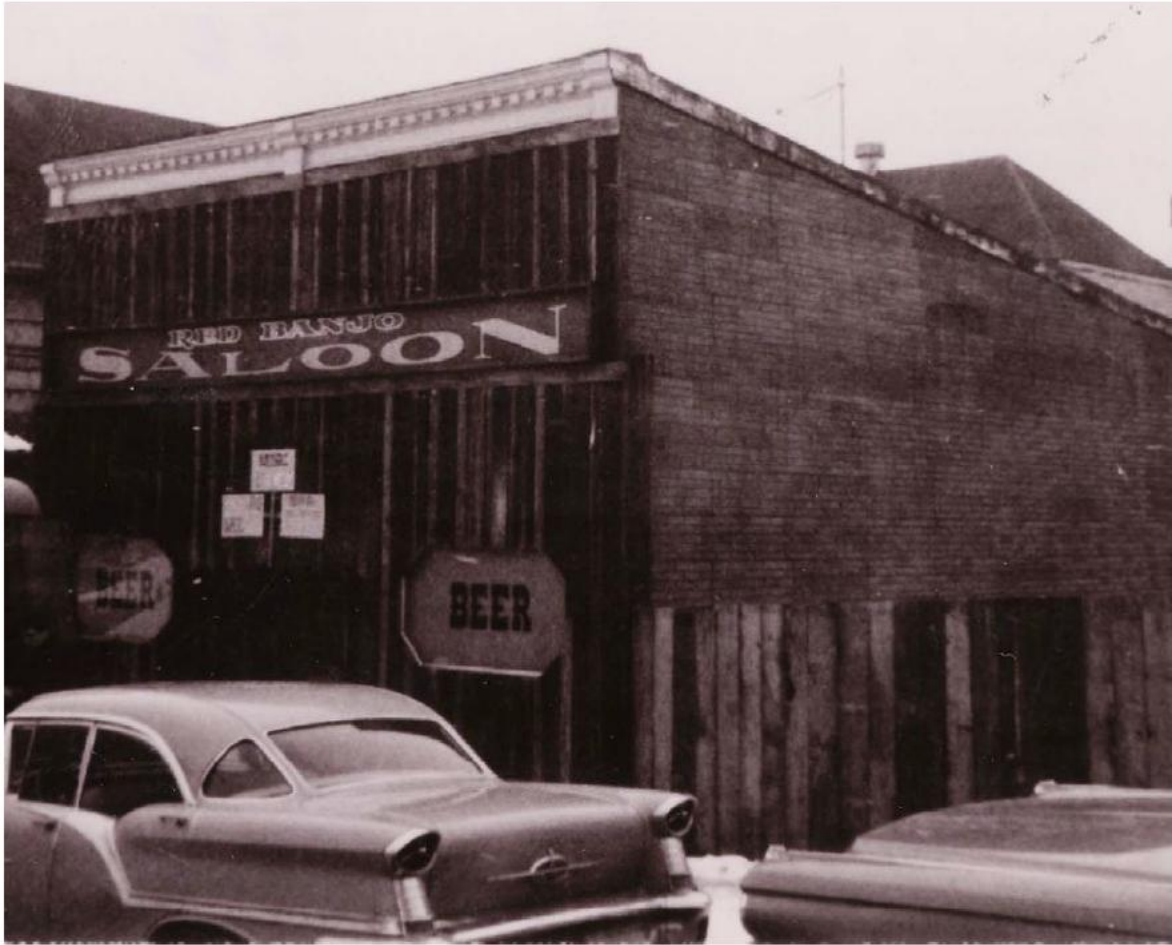
Figure 13: 1960s photo with horizontal expanse of glazing removed

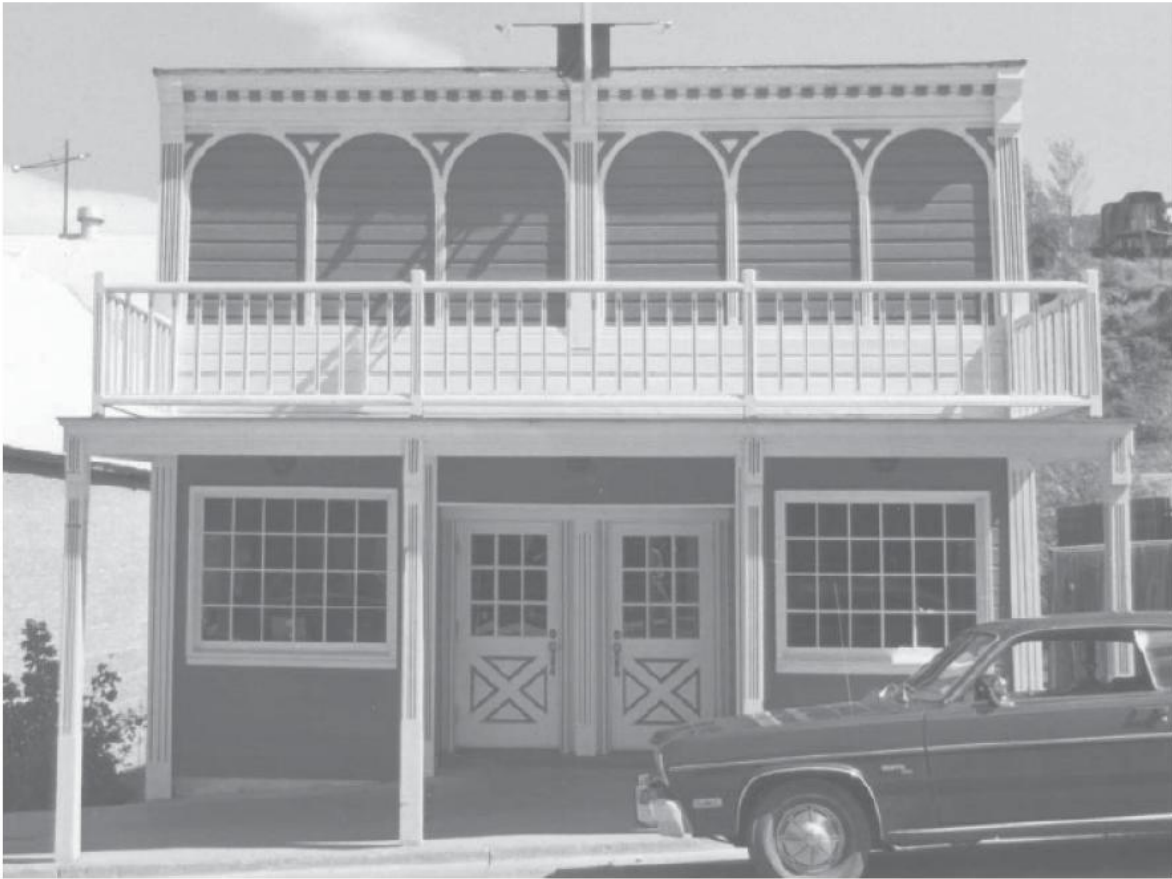
Figure 14: 1970s façade modifications with the 1899 arches on the second story and reduced storefront glazing. The transom windows are not replaced but a deck/balcony is added.

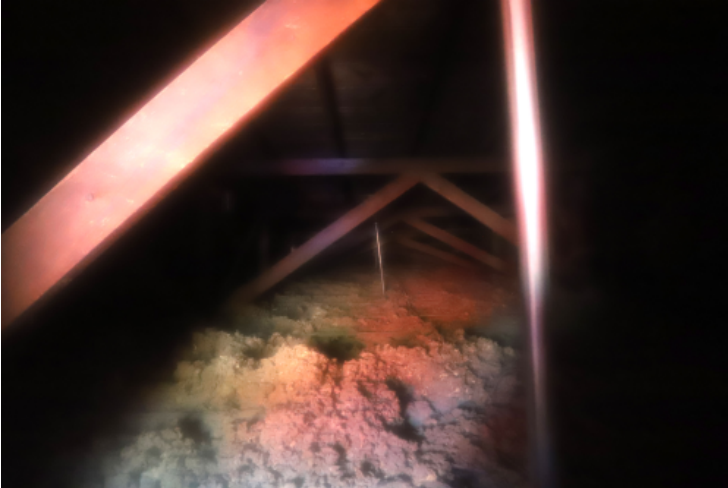
INSULATED ROOF / TRUSSES

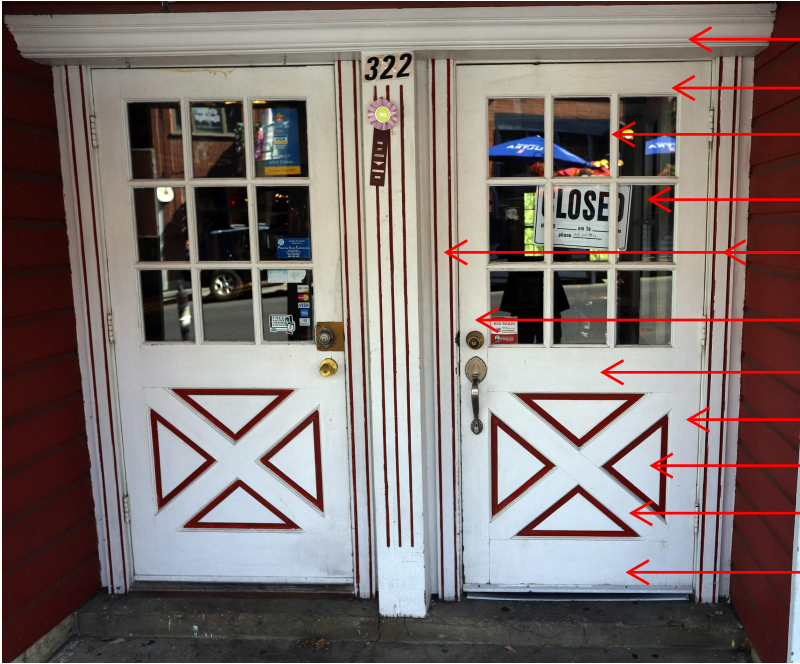
DOOR E1 & E2

- Top Jamb/Head
- Top Rail
- Muntins
- Panes
- Jamb
- Lock Rail
- Lock Style
- Hinge Rail
- Cross Panel
- Cross Rail
- Bottom Rail

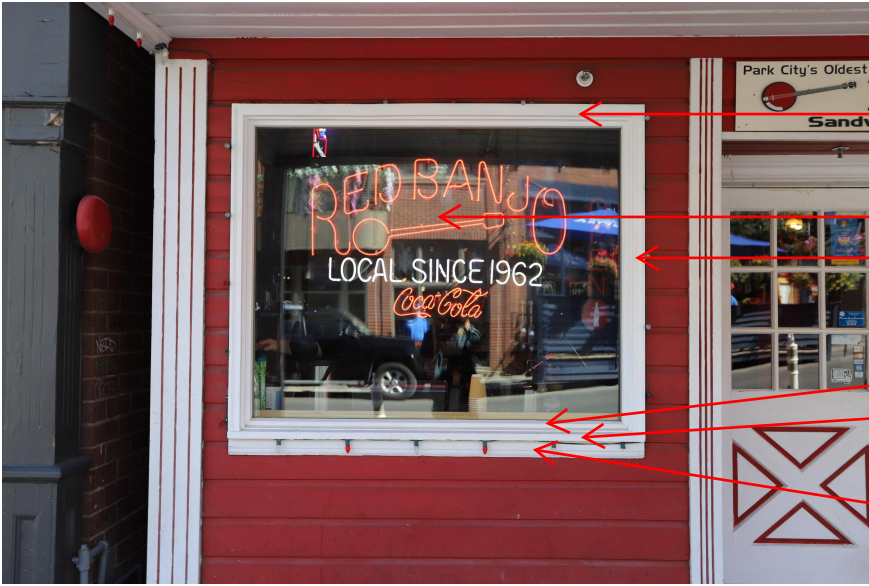
WINDOW 01

Upper Rail
