**PARK CITY COUNCIL MEETING  
SUMMIT COUNTY, UTAH  
November 7, 2019**

4:15 p.m. - Flagstaff Historic Preservation Plan Update  
[Flagstaff Mountain Resort HPP Update Staff Report](#)  
[Exhibit A: SWCA 2019 Historic Preservation Plan Update](#)  
[Exhibit B: Memorandum of Agreement \(2019 between EPMOA and PCMC\)](#)  
[Exhibit C: Public Comment](#)

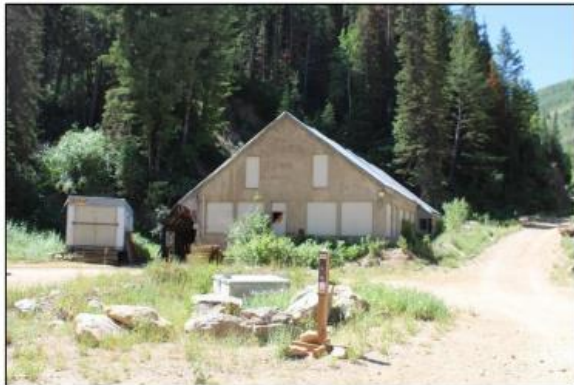
**Figure 3. Overview of Judge Mining and Smelting Company Office, facing southwest.**

Staff's greatest concern is the condition of the roof structure of the Judge Mining and Smelting Company Office. This is echoed by public comment included as Exhibit C. Staff finds that it is critical that roof stabilization and repair occur as soon as possible. The Memorandum of Agreement (MOA) between the EPMOA and PCMC establishes the Judge Mining and Smelting Company Office as a work priority (see Exhibit B). Staff has included photographs excerpted from the 2019 HPP Update to provide greater detail of the roof issues.

The 2001 recommendation was for this structure to serve as an office or recreation building. Staff's recommended priority is to work with the EPMOA to take necessary steps with the owner to stabilize the structure and roof, providing seasonal protection from the elements as soon as possible. After protecting the site, staff will confirm future use and next steps. While the public comment questions whether it makes sense to expend limited funds available for a temporary fix, staff recommends proceeding as soon as possible to prevent further structural compromise.

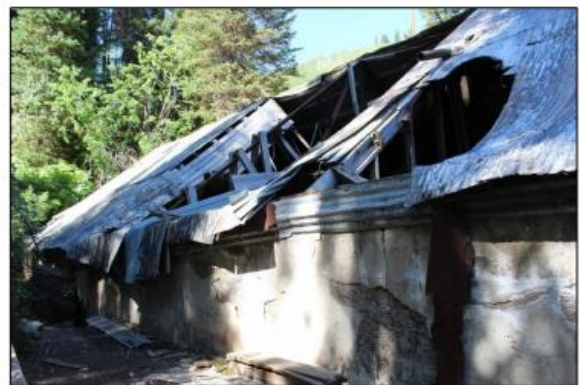
**Figure 9. Southeast side of Judge Mining and Smelting Company Office, facing west. Note collapsed roof and spalling concrete of wall.**

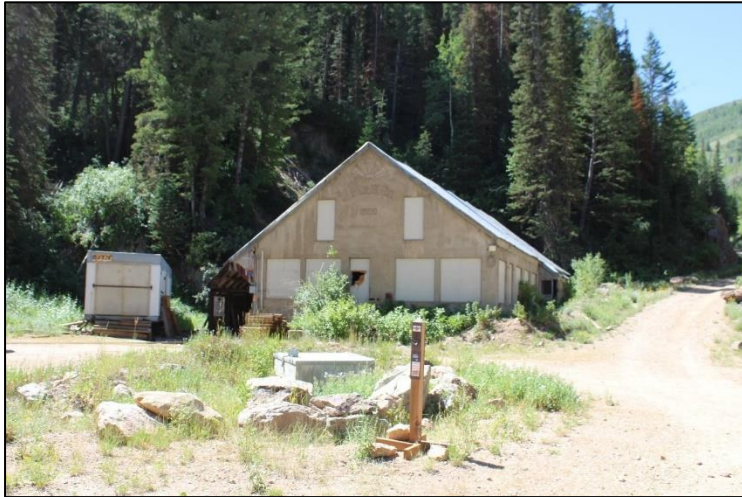
**Figure 3. Overview of Judge Mining and Smelting Company Office, facing southwest.**

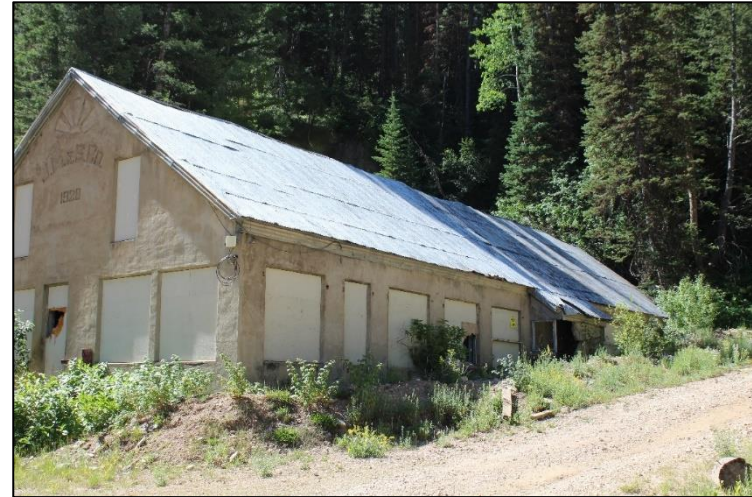
**Figure 4. Northeast and northwest sides of Judge Mining and Smelting Company Office, facing south.**

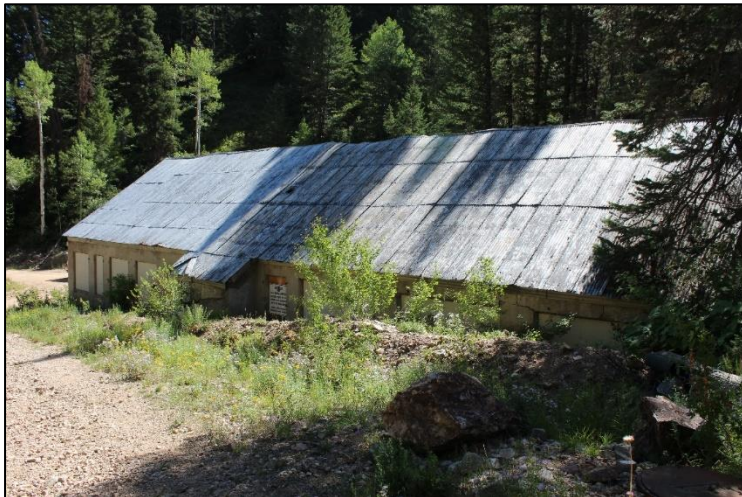
**Figure 5. Northwest side of Judge Mining and Smelting Company Office, facing east.**

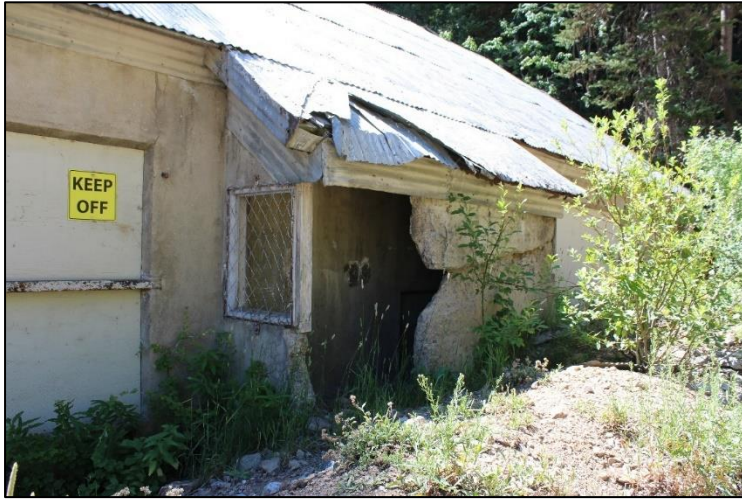
**Figure 7. Entrance on northwest side of building, facing south. Note damaged roofing and deteriorated concrete, as well as earth piled against the building.**

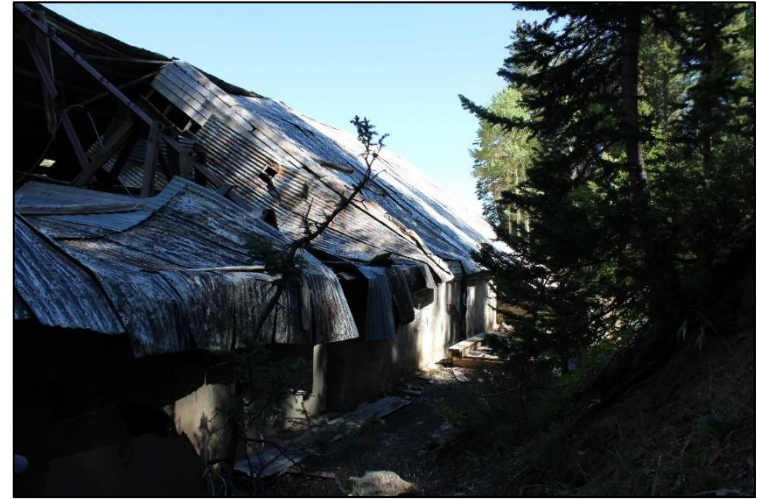
**Figure 8. Southeast side of Judge Mining and Smelting Company Office, facing north. Note collapsed roof.**

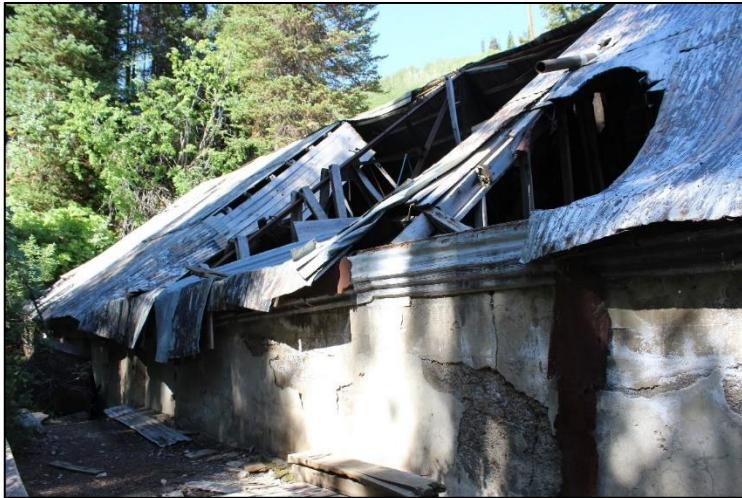
**Figure 9. Southeast side of Judge Mining and Smelting Company Office, facing west. Note collapsed roof and spalling concrete of wall.**

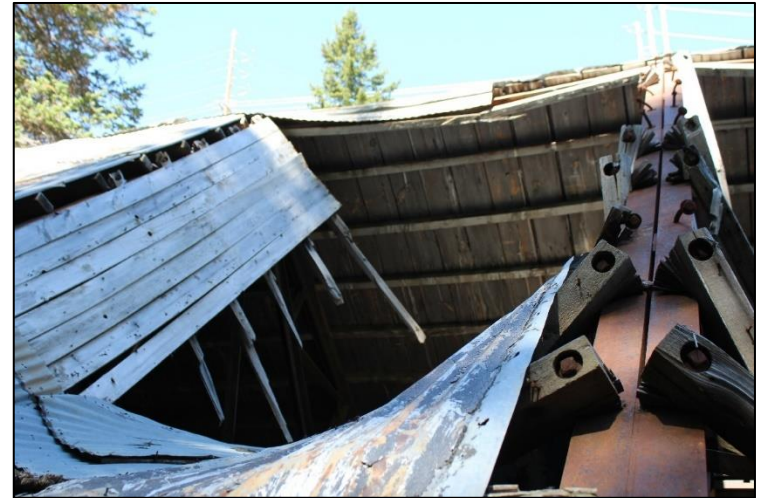
**Figure 10. Detail of collapsed roof with twisted wood purlins visible in foreground at right, facing west-northwest.**

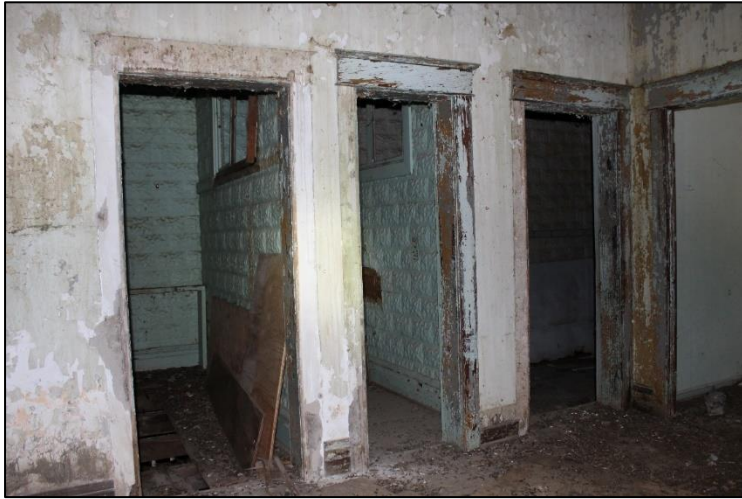
**Figure 11. Interior of Judge Mining and Smelting Company Office, first floor, facing south-southwest. Note the use of pressed tin for wall finishes.**

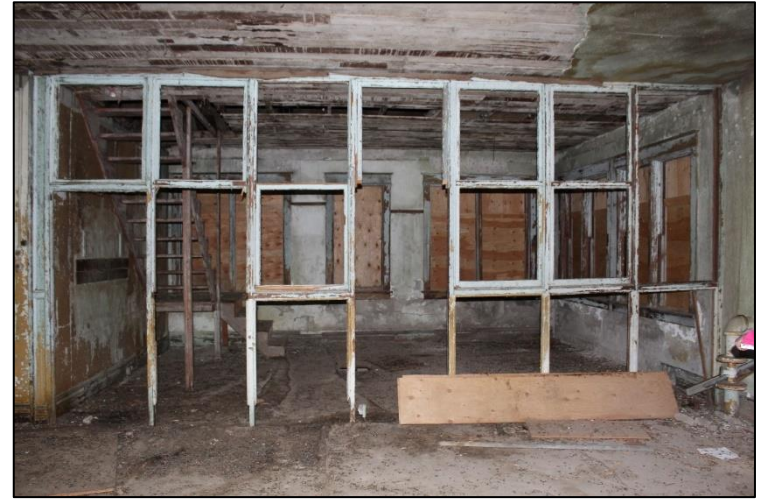
**Figure 12. Interior of Judge Mining and Smelting Company Office, first floor, facing northwest. Note the wood partition wall, which may have originally contained windows.**

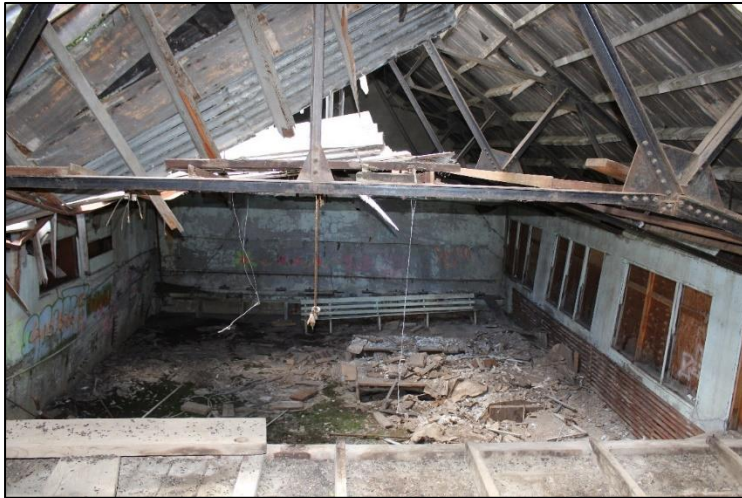
**Figure 13. Interior of Judge Mining and Smelting Company Office changing room, facing southwest. Note accumulation of debris on floor and collapsed roof, but with intact metal truss system.**

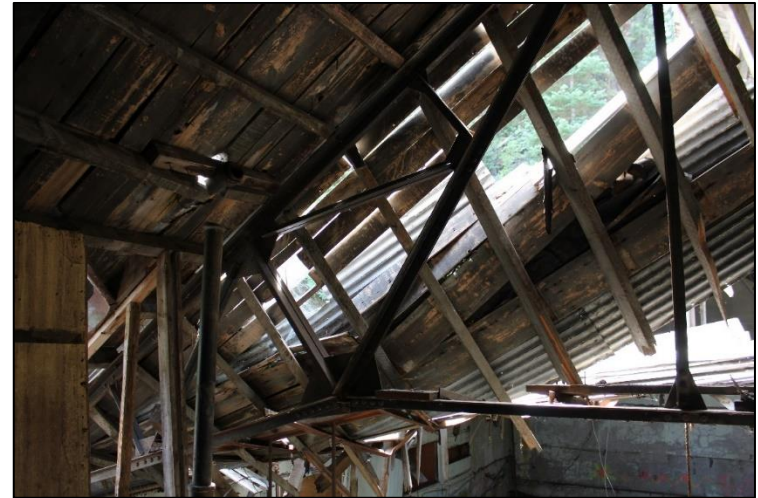
**Figure 14. Interior of Judge Mining and Smelting Company Office changing room. Detail of collapsed roof with intact metal truss system, facing south.**

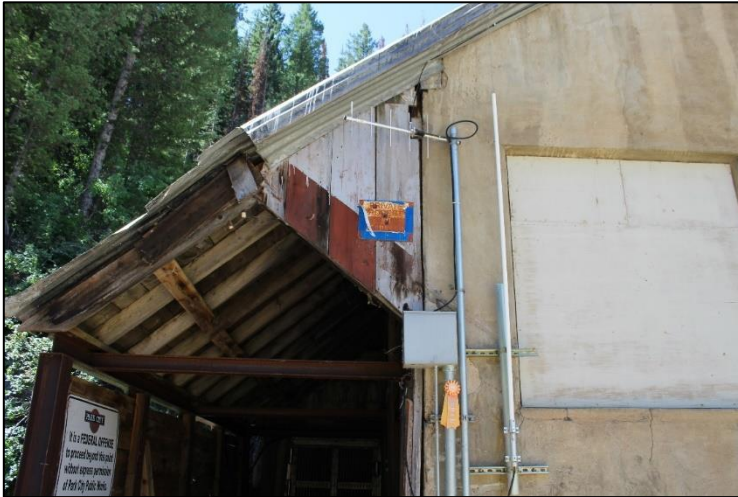
**Figure 15. Covered entrance to Anchor (Daly-Judge) Drain Tunnel, facing southwest.**

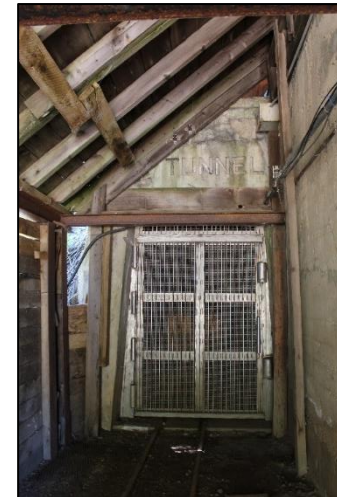
**Figure 16. Entrance to Anchor (Daly-Judge) Drain Tunnel, facing southwest. Note modern metal posts supporting roof and modern gate over entrance.**

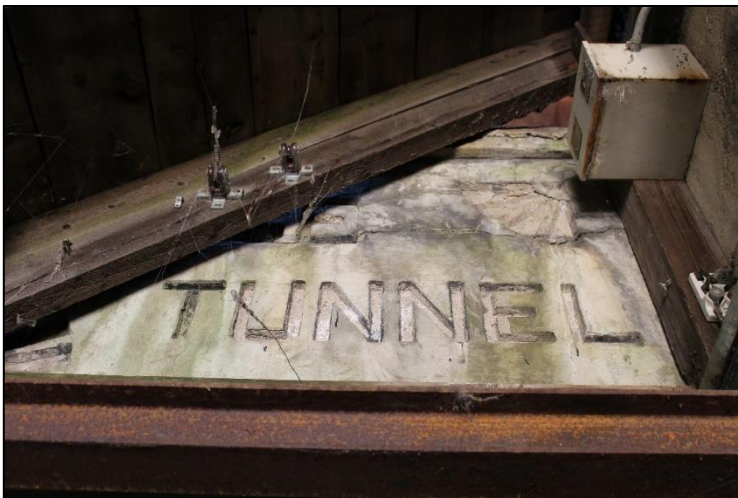
**Figure 17. Embossed concrete panel over Anchor (Daly-Judge) Drain Tunnel, facing southwest. Note roof framing partially covering embossed panel, as well as minor cracks and evidence of water infiltration.**

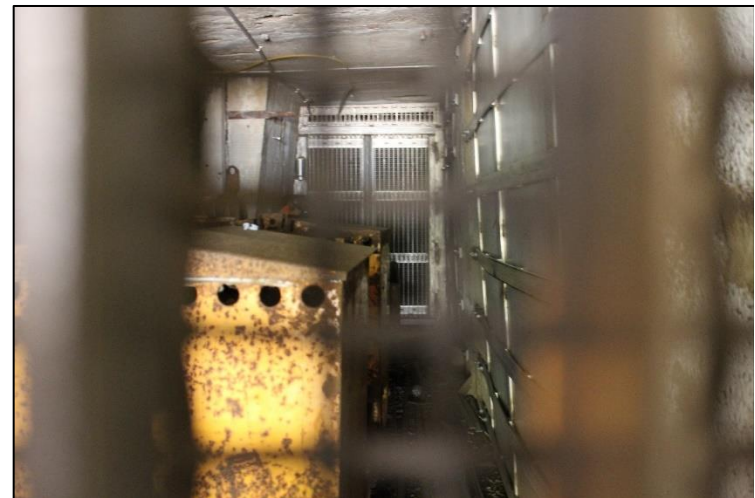
**Figure 18. View of Anchor (Daly-Judge) Drain Tunnel entrance, through gate. Note additional modern gate and spalling concrete on ceiling.**

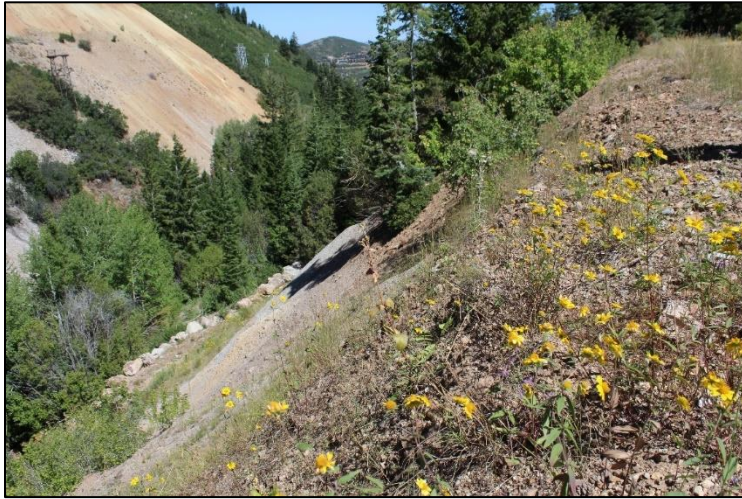
**Figure 19. Overview of American Flag Mine Waste Dump, facing northeast.**

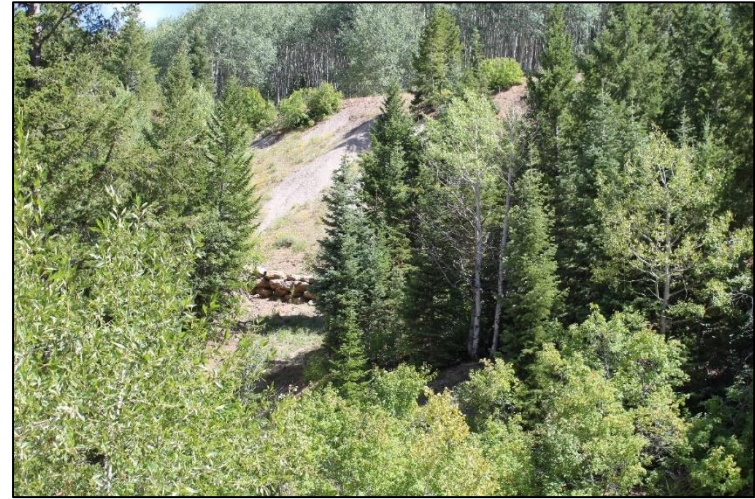
**Figure 20. Overview of American Flag Mine Waste Dump, facing east.**

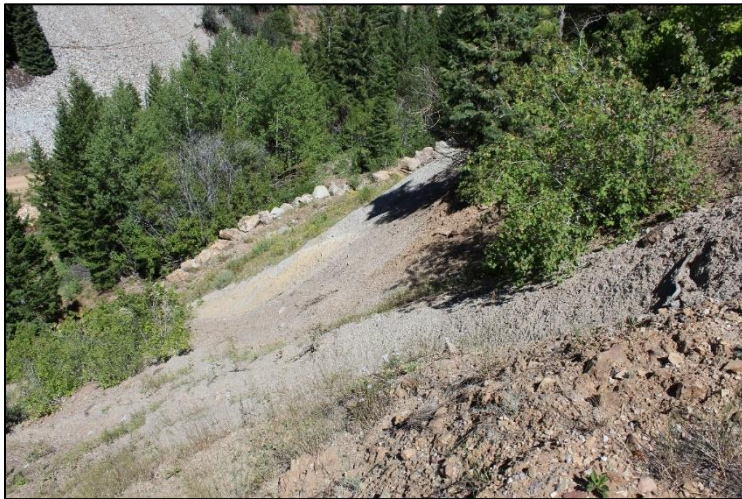
**Figure 21. Overview of American Flag Mine Waste Dump slope, facing north. Note areas of vegetation cover mixed with areas of unvegetated tailings.**

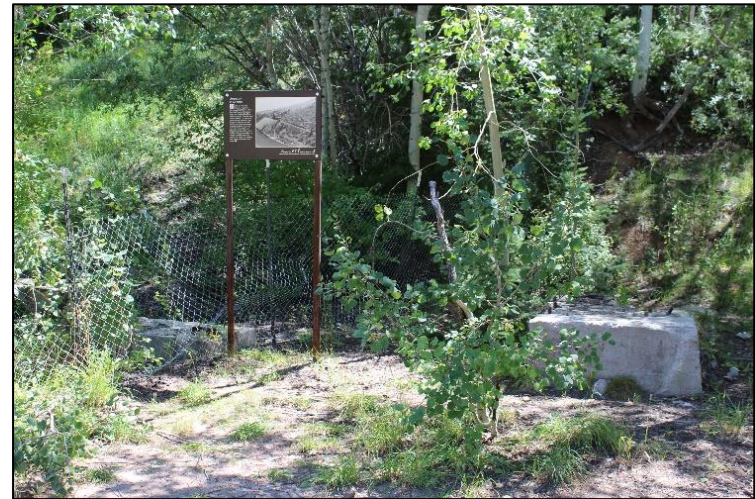
**Figure 22. Overview of nearby American Flag Mine site, with interpretive sign, facing east.**

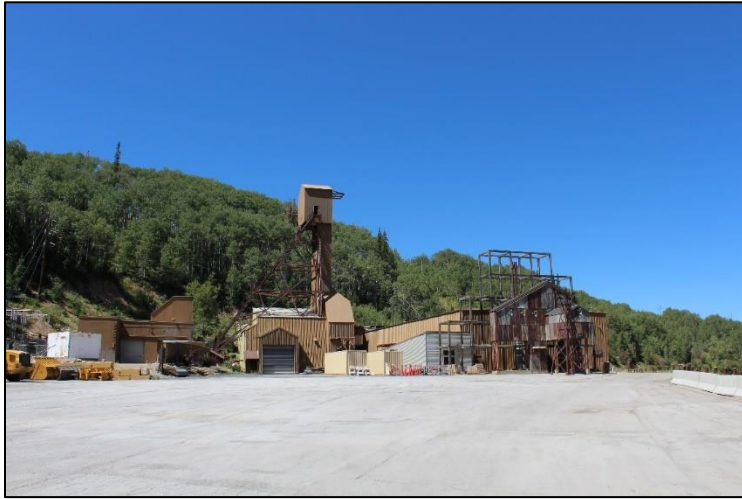
**Figure 23. Overview of Ontario Mine Shaft No. 3, facing northwest.**

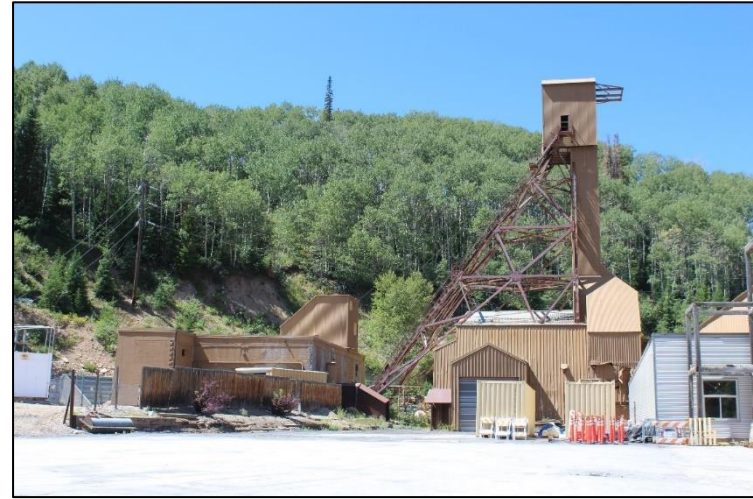
**Figure 24. Overview of Ontario Mine Shaft No. 3 hoist and associated buildings, facing west-northwest.**

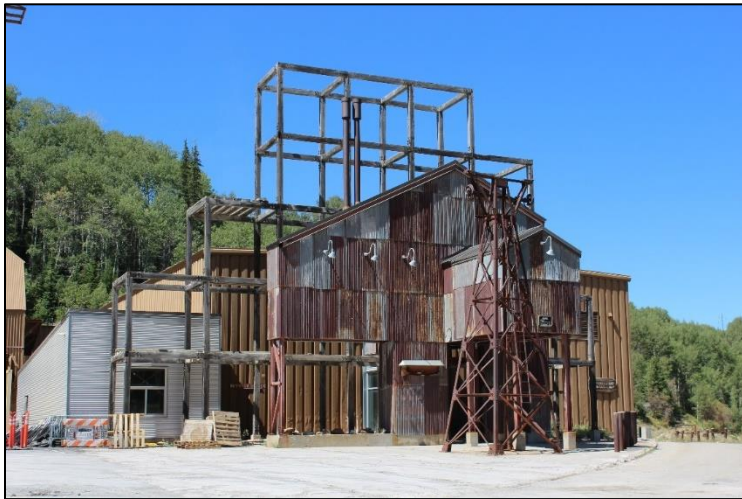
**Figure 25. Overview of Ontario Mine Shaft No. 3 building north of hoist, facing north. Note square-set timbering and tram tower, later additions to building.**

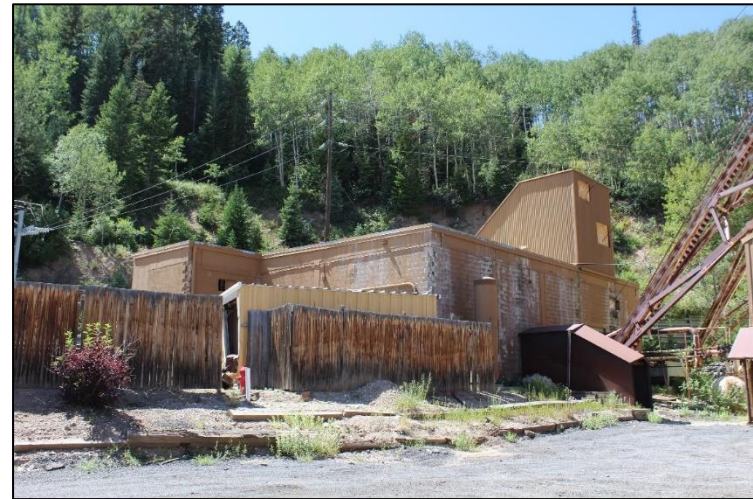
**Figure 26. Overview of Ontario Mine Shaft No. 3 buildings south of hoist, facing west.**

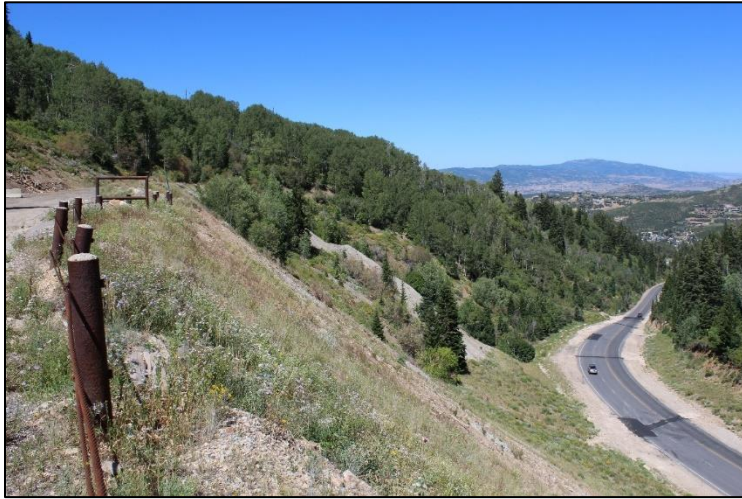
**Figure 27. Overview of Ontario Mine Shaft No. 3 Waste Dump, from top, facing northwest.**

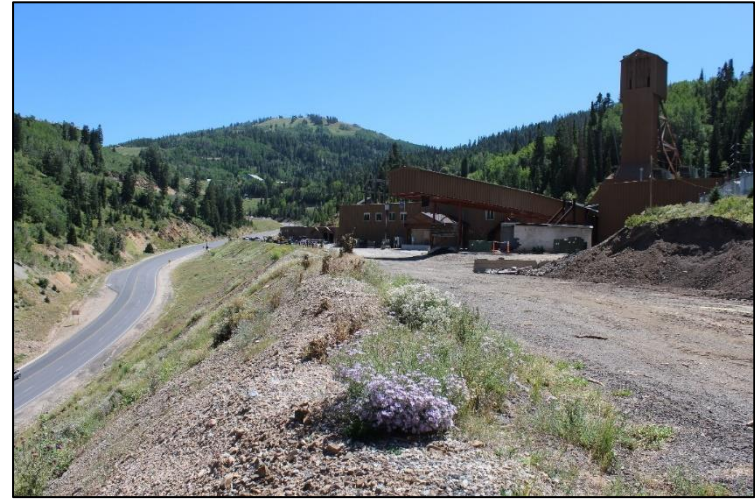
**Figure 28. Overview of Ontario Mine Shaft No. 3 Waste Dump, from top, facing southeast.**

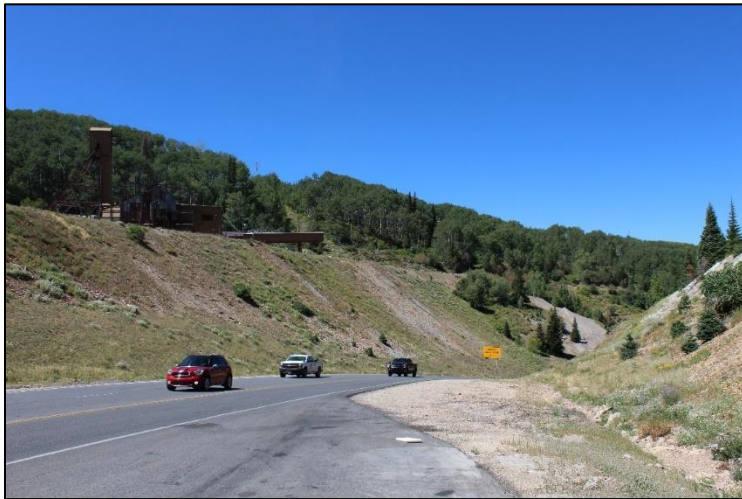
**Figure 29. Overview of Ontario Mine Shaft No. 3 Waste Dump, from base, facing northwest.**

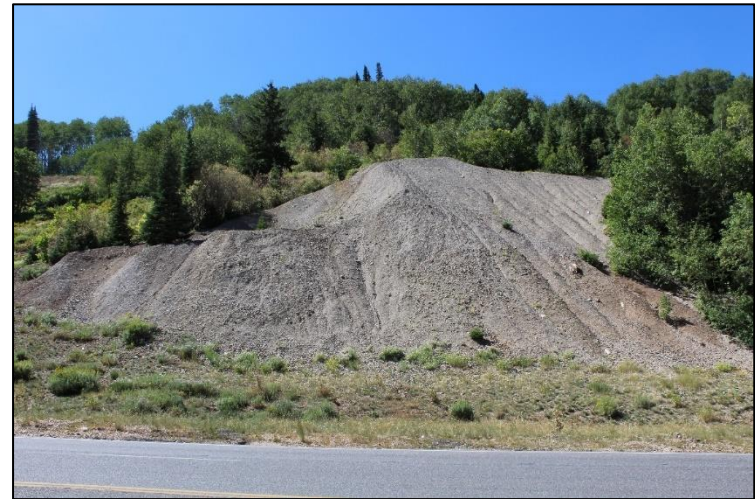
**Figure 30. Overview of Ontario Mine Shaft No. 3 Waste Dump, from bottom, facing northwest.**

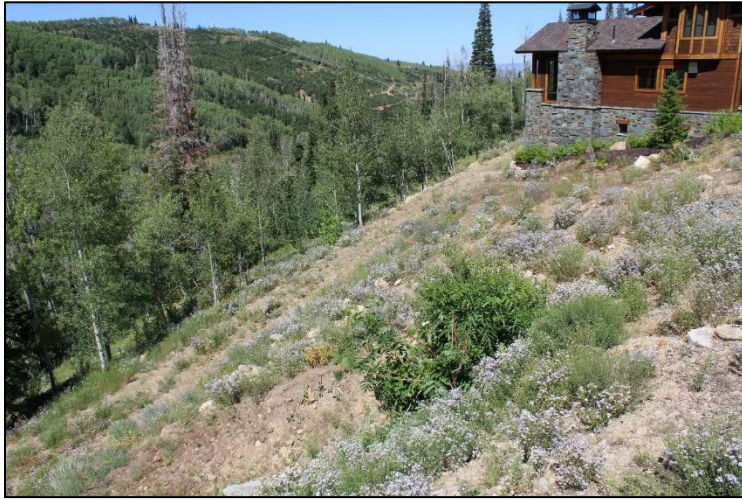
**Figure 31. Overview of Daly Mine No. 1 Waste Dump, facing north.**

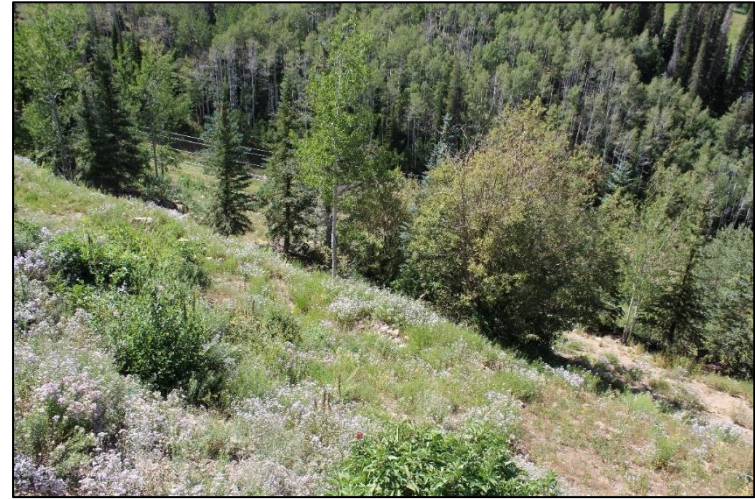
**Figure 32. Overview of Daly Mine No. 1 Waste Dump, facing southwest. Note extensive revegetation.**

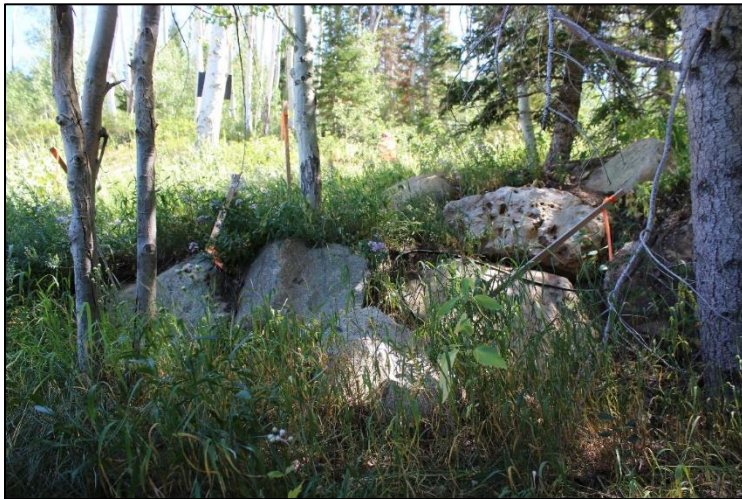
**Figure 33. Overview of Daly Mine No. 1 Waste Dump and possible stone wall, facing southeast.**

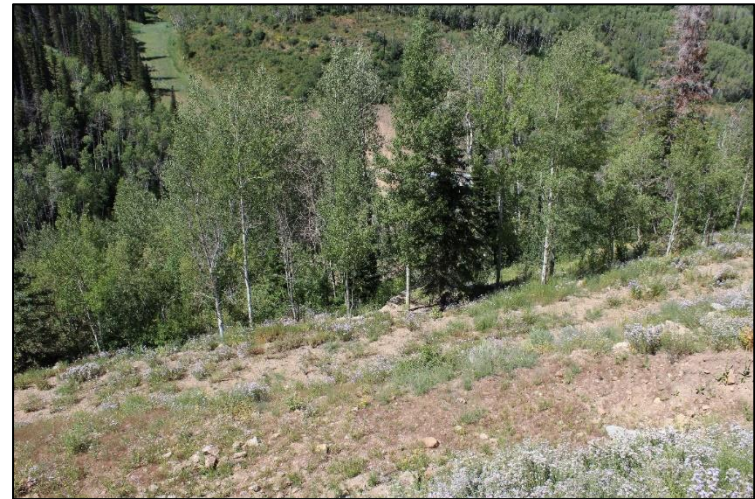
**Figure 34. Overview of Daly Mine No. 1 Waste Dump showing revegetation, including tree growth, facing north-northwest.**

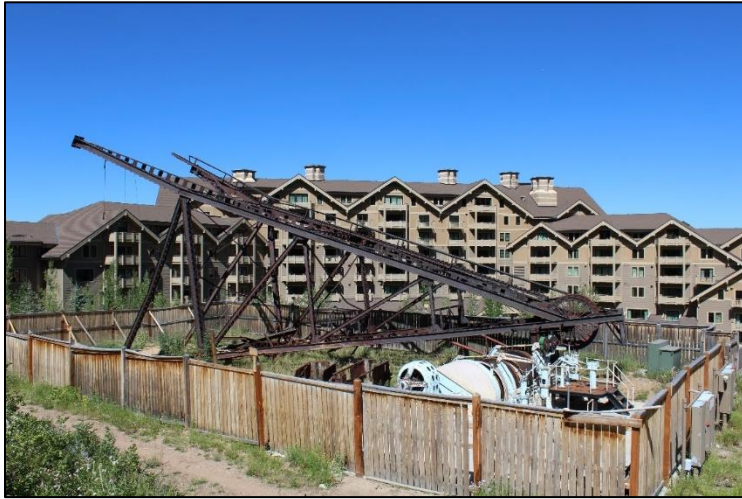
**Figure 35. Overview of Daly-West Mine Headframe, Shaft, and Hoist, facing north. Note collapsed headframe.**

- Areas of corrosion on the hoist mechanism should be scraped to a sound surface, and previously painted areas should be repainted to match the current color.
- Plant growth should periodically be removed from around the shaft opening.
- Concrete should be monitored for further deterioration; if deterioration becomes severe or pervasive, it should be repaired using National Park Service (NPS 2007) preservation standards.

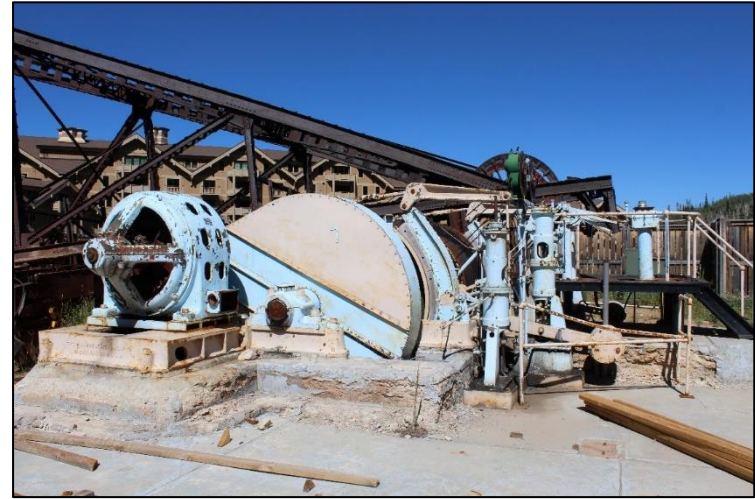
**Figure 36. Overview of Daly-West Mine Hoist, facing northeast, with collapsed headframe in background.**

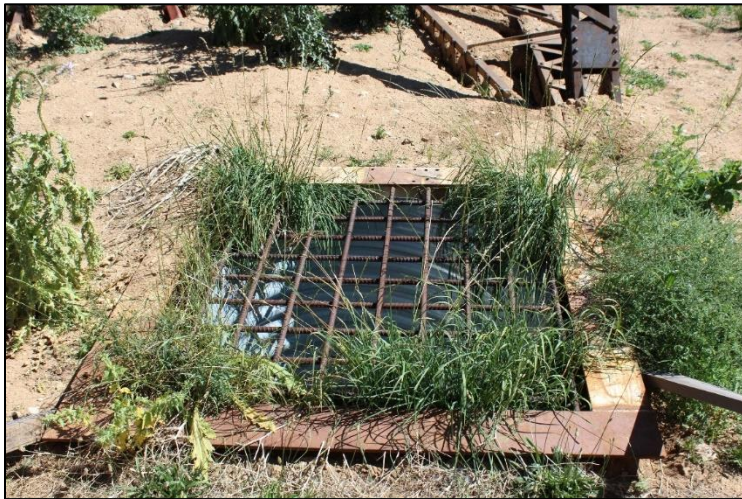
**Figure 37. Detail of Daly-West Mine Shaft, facing southeast.**

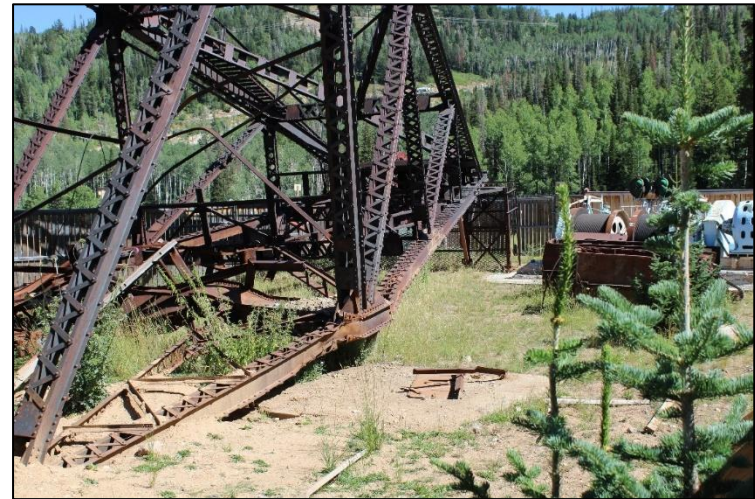
**Figure 38. Overview of collapsed Daly-West Mine Headframe, facing southeast.**

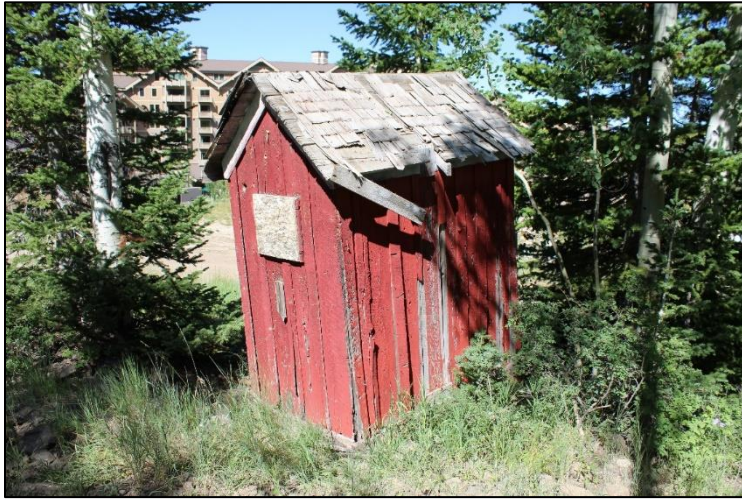
**Figure 39. Overview of Daly-West Mine Fire Hydrant Shack No. 1, facing north.**

- Foundations should be stabilized for Shacks No. 1 and No. 3 by replacing wood sills in kind as needed.
- For all buildings, detached, missing, or deteriorated building elements, such as wood wall boards or roofing materials, should be reattached or replaced in kind.
- Vegetation growing around and inside Shacks No. 2 and No. 3 has the potential to increase moisture in foundation and walls. Vegetation should be cleared from around buildings.
- Doors similar in design and materials to that of Shack No. 1 should be installed on Shacks No. 2 and No. 3 to reduce animal activity and the amount of moisture entering the buildings.

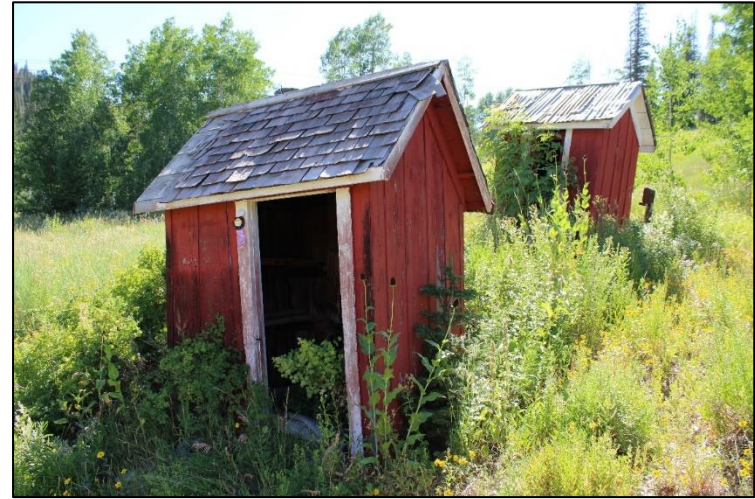
**Figure 40. Overview of Daly-West Mine Fire Hydrant Shacks No. 2 (foreground) and No. 3 (background), facing west.**

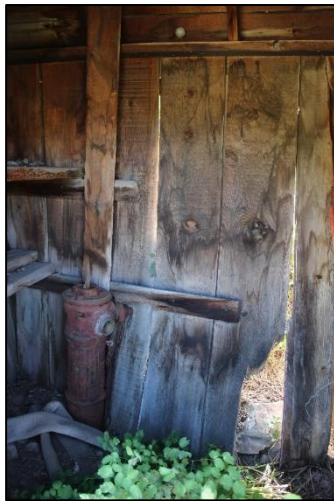
**Figure 41. Interior of Daly-West Mine Fire Hydrant Shack No. 2, facing west. Note damaged wood on wall.**

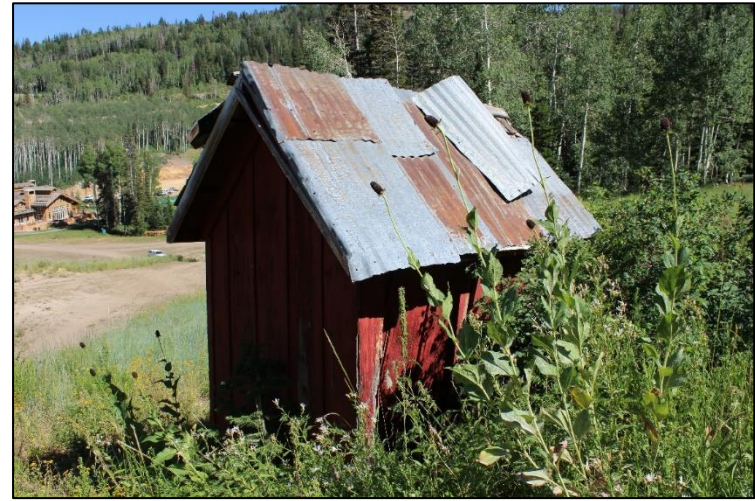
**Figure 42. Detached roofing on Daly-West Mine Fire Hydrant Shack No. 2, facing east.**

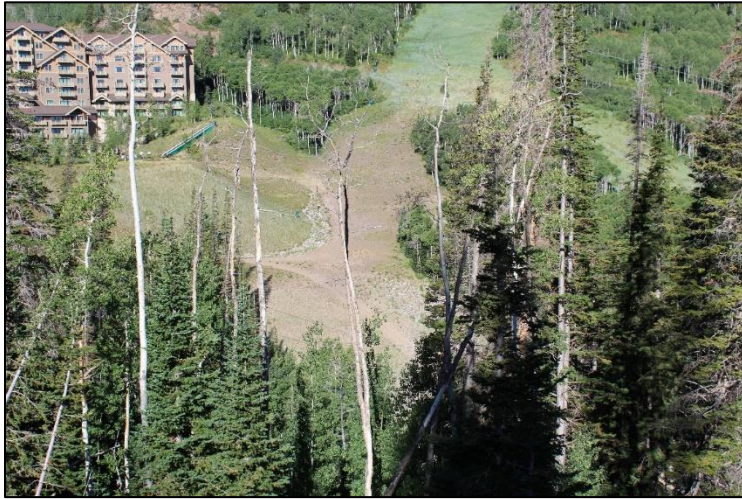
**Figure 43. Overview of Daly-West Mine Waste Dump, facing west, from Highway 224.**

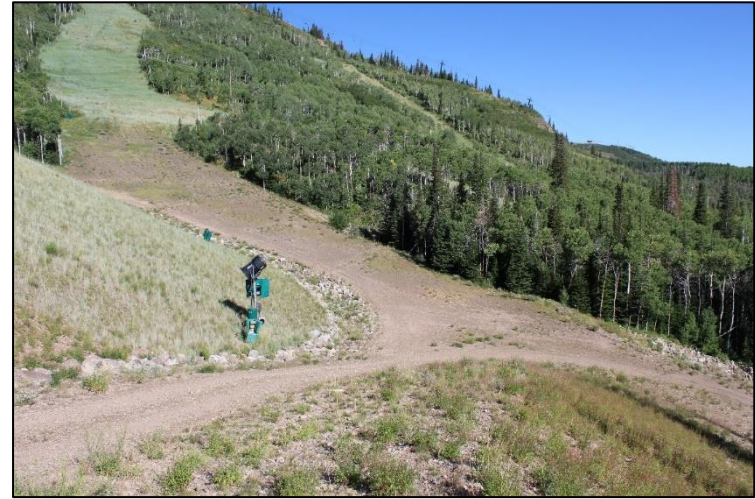
Conditions and changes observed during the 2019 condition assessment are as follows (Figures 43–46):

**Figure 44. Overview of top of Daly-West Mine Waste Dump, facing northwest.**

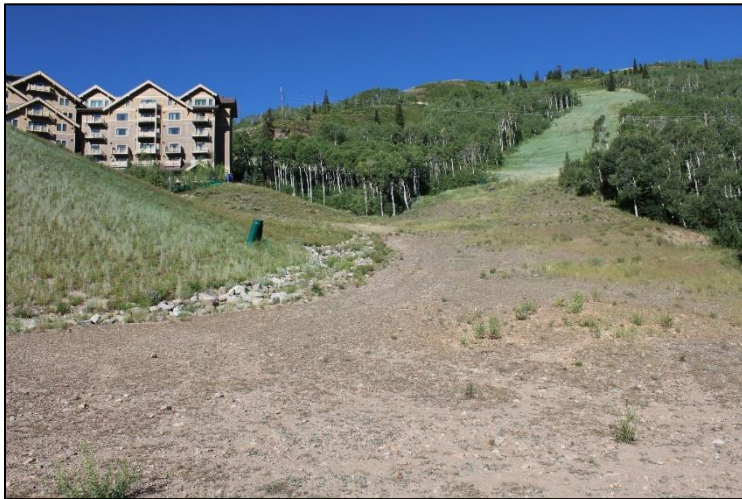
**Figure 45. Overview of Daly-West Mine Waste Dump, facing southwest.**

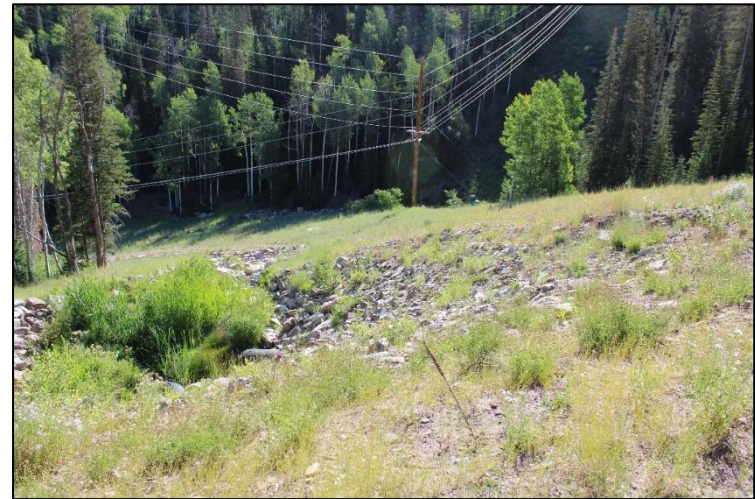
**Figure 46. Overview of Daly-West Mine Waste Dump, facing northeast.**

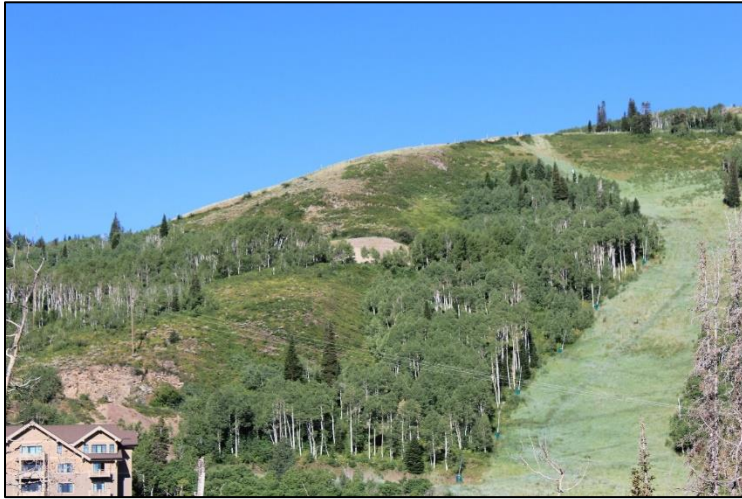
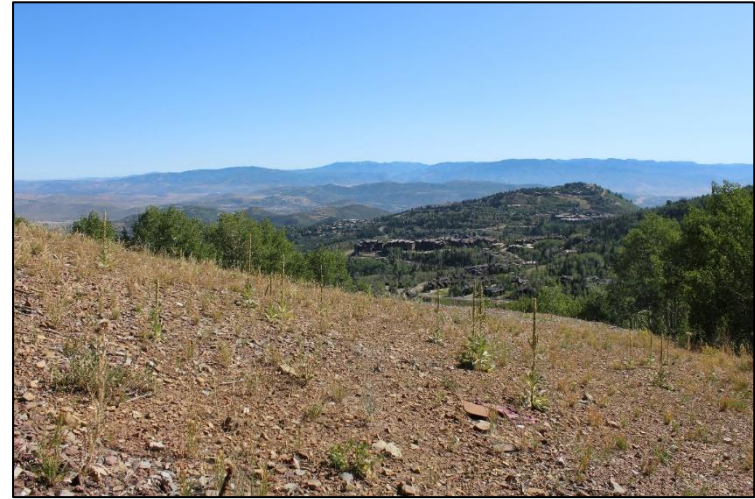
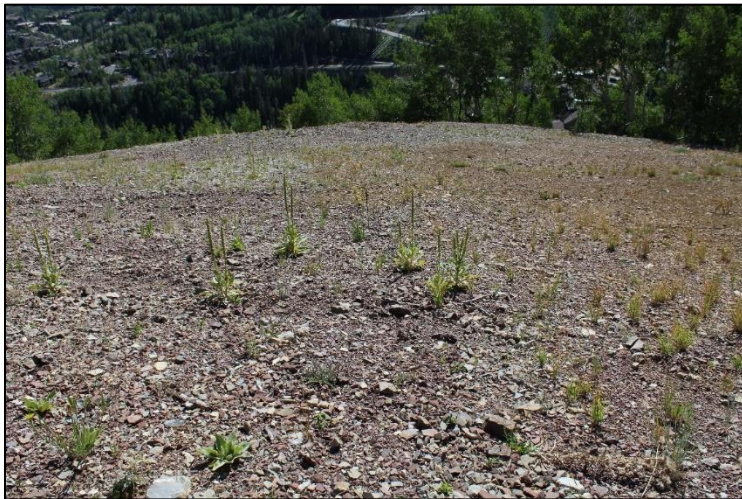
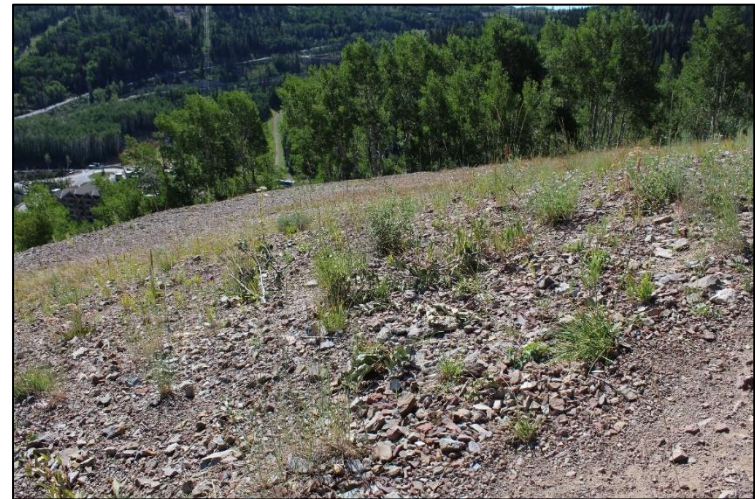
- The 2001 recommendation relating to the installation of an interpretive sign has not been addressed for either waste dump.
- The slope of the Diamond Waste Dump is partially revegetated (approximately 30 percent); large portions of the slope remain bare, likely due to the steepness of the slope and soil composition.
- The slope of the Nemrod Waste Dump is partially revegetated (approximately 50 percent); large portions of the slope remain bare, likely due to the steepness of the slope and soil composition.

**Figure 47. Overview of Diamond Waste Dump, facing west.**

**Figure 48. Overview of Diamond Waste Dump, facing northeast.**

**Figure 49. Overview of Diamond Waste Dump, facing south.**

**Figure 50. Overview of Diamond Waste Dump, facing southeast.**

- An interpretive sign specifically for the Diamond Mine Waste Dump and for the Nemrod Mine Waste Dump should be created and installed to meet recommendations in the 2001 HPP Summary.
- Revegetation efforts, including the broadcasting of mulch, should continue in order to support ongoing revegetation.

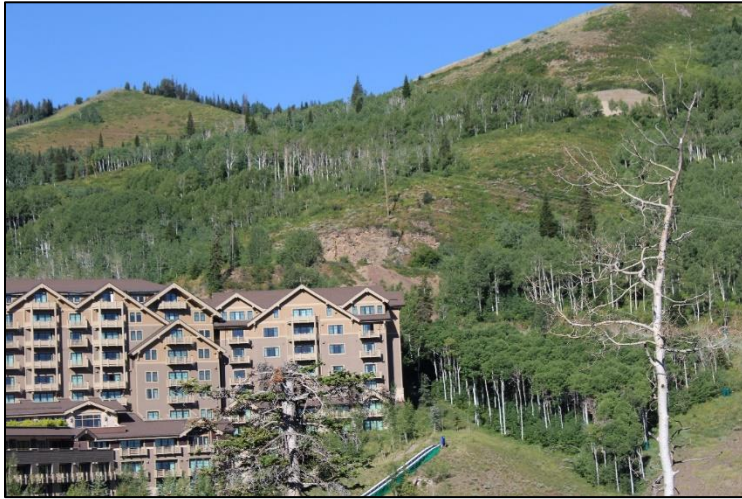
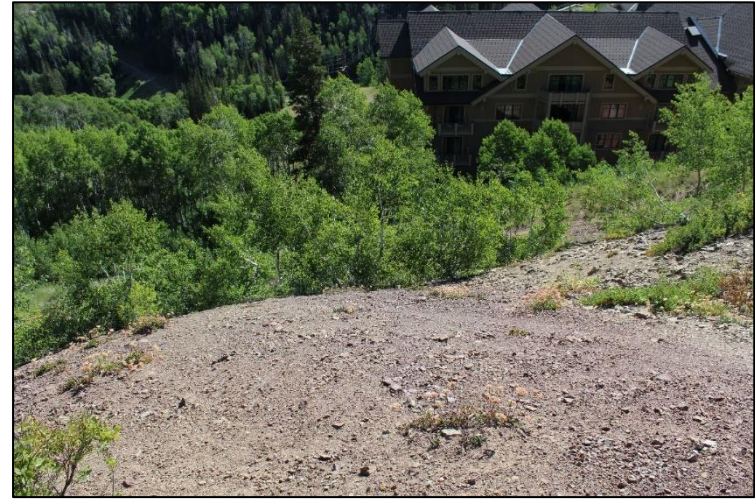
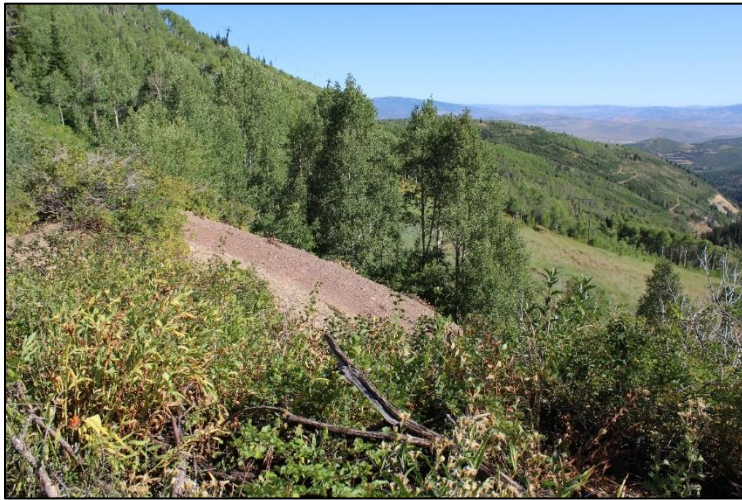
- A mountain bike trail parallels the northwest side of the slope of the Diamond Waste Dump.
- A large hole (approximately 12 feet in diameter) is present in the ground at the northwest corner of the Nemrod Waste Dump; the cause of the hole is unclear but may be mining related.
- No serious condition issues (such as erosion) were noted.

**Figure 51. Overview of Nemrod Waste Dump, facing west.**

**Figure 52. Overview of Nemrod Waste Dump, facing east.**

**Figure 53. Overview of Nemrod Waste Dump, facing north.**

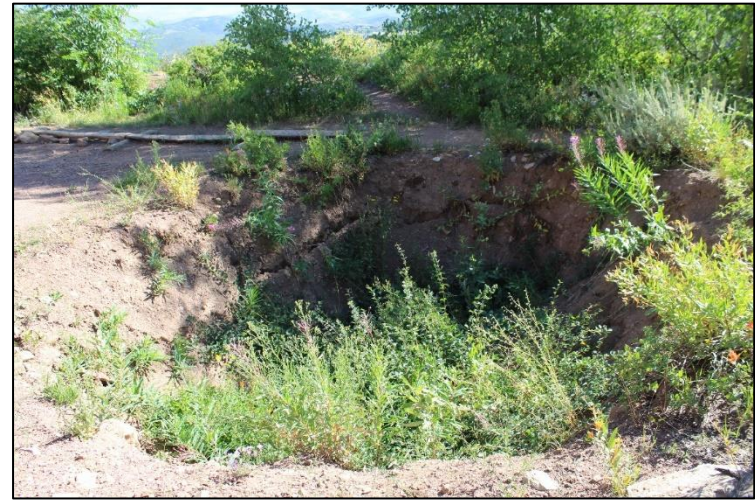
**Figure 54. Hole in ground northwest of Nemrod Waste Dump, facing northeast.**

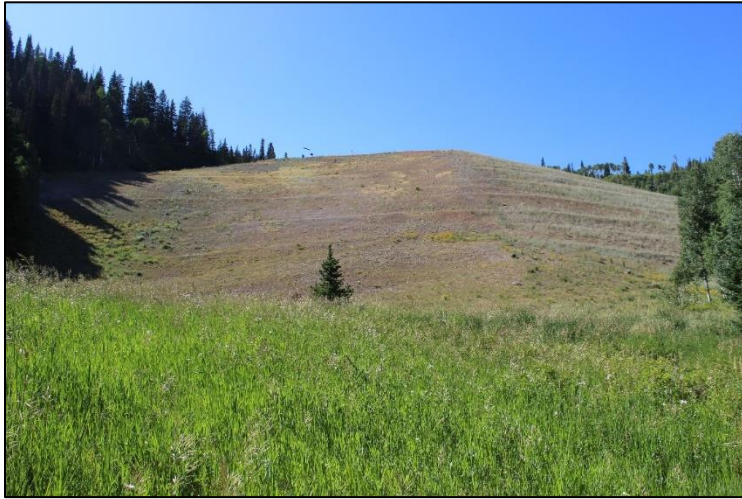
**Figure 55. Overview of Anchor Mine Waste Dump, facing north.**

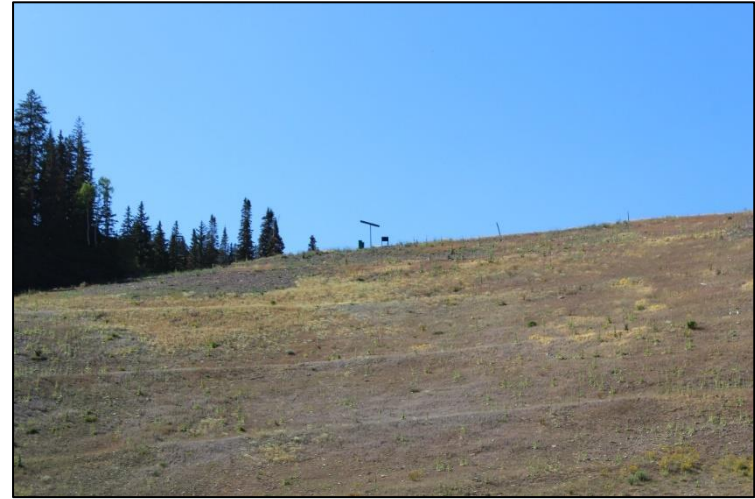
**Figure 56. Overview of Anchor Mine Waste Dump, facing northwest. Note terracing of slope.**
