**PARK CITY COUNCIL MEETING  
SUMMIT COUNTY, UTAH  
November 7, 2019**

4:15 p.m. - Flagstaff Historic Preservation Plan Update  
[Flagstaff Mountain Resort HPP Update Staff Report](#)  
[Exhibit A: SWCA 2019 Historic Preservation Plan Update](#)  
[Exhibit B: Memorandum of Agreement \(2019 between EPMOA and PCMC\)](#)  
[Exhibit C: Public Comment](#)

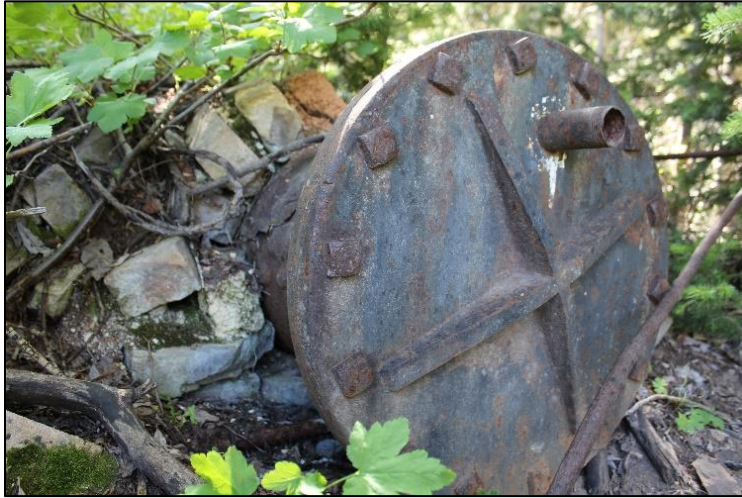
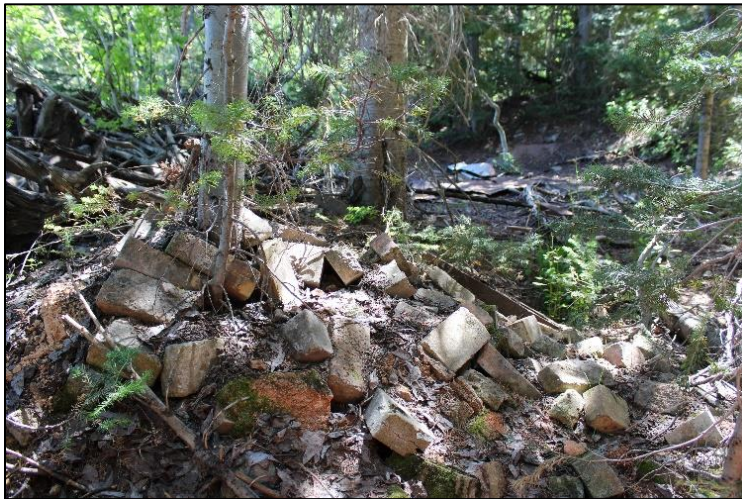
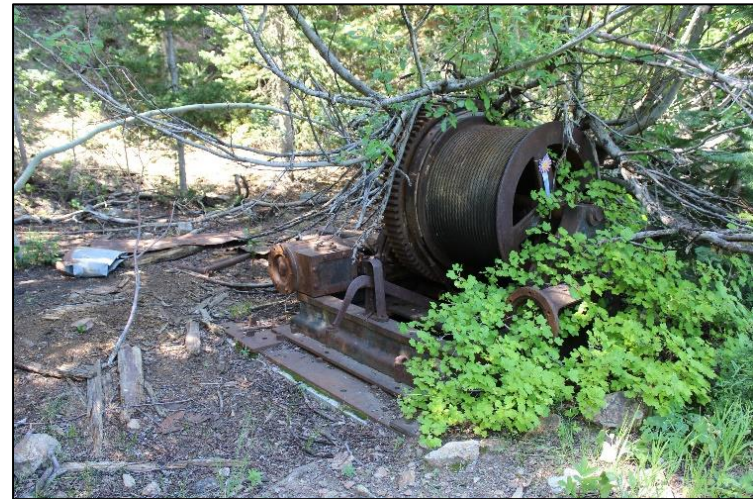
**Figure 57. Overview of Quincy Mine Hoist Plant, facing west.**

**Figure 59. Overview of Quincy Mine Hoist Plant, facing south.**

**Figure 60. Overview of Quincy Mine Hoist Plant, facing northwest.**

- Although the condition of the hoist plant is poor, the level of difficulty in stabilizing an already extremely decayed resource likely makes most treatment options unfeasible. Possible treatment options to assist in the long-term preservation of resources include the following:
  - Pruning plants to prevent additional damage to building elements and to make existing resources more visible to visitors. However, this option may result in theft or vandalism of the remaining materials.
  - Conducting additional archaeological survey to fully record the site. This option would be time- and cost-intensive and was not required by the 2001 HPP Summary.
  - Implementing treatments to stabilize extant resources, such as repairing concrete or replacing and repointing brick. This option would be time- and cost-intensive and was not required by the 2001 HPP Summary.

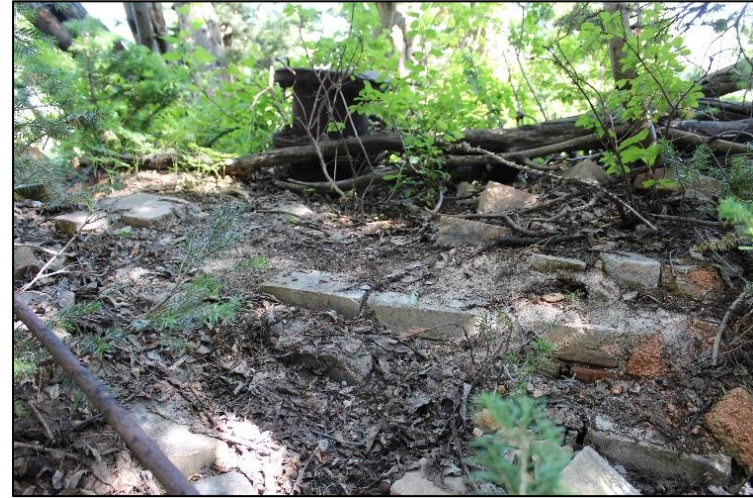
**Figure 58. Overview of Quincy Mine Hoist Plant brick foundations, facing west.**

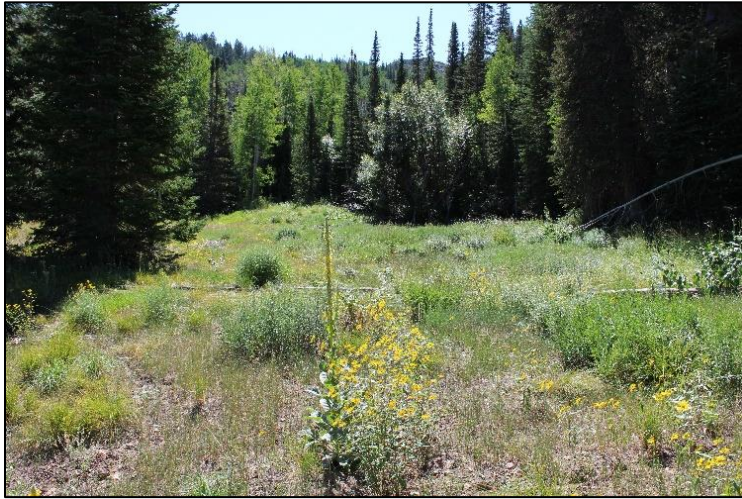
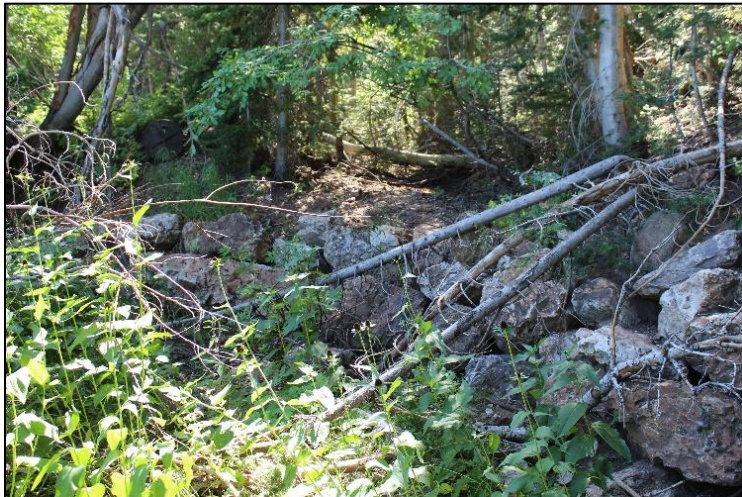
**Figure 61. Overview of Quincy Mine Shaft site, facing south.**

**Figure 63. Overview of Quincy Mine Shaft, facing south.**

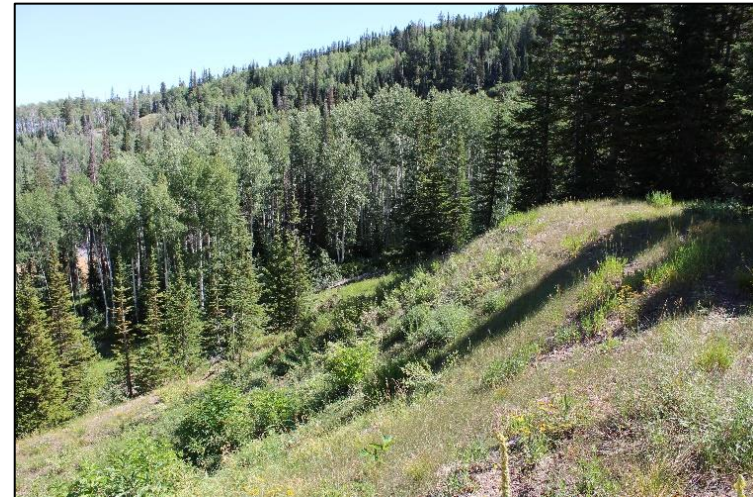
**Figure 64. Overview of Quincy Mine Waste Dump, facing southeast.**

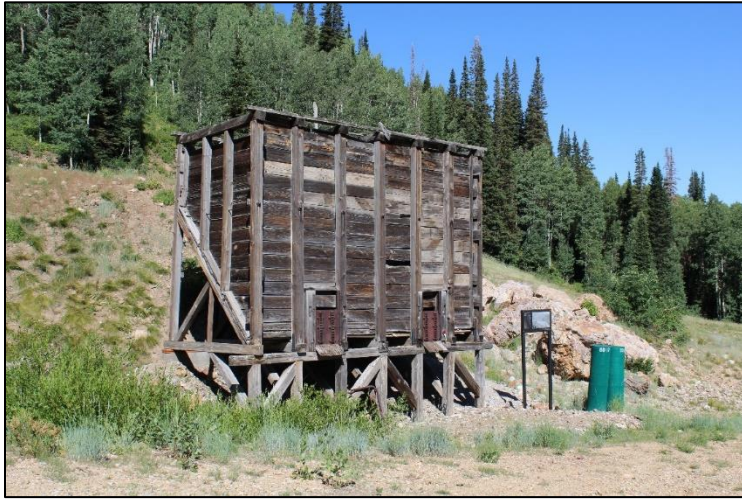
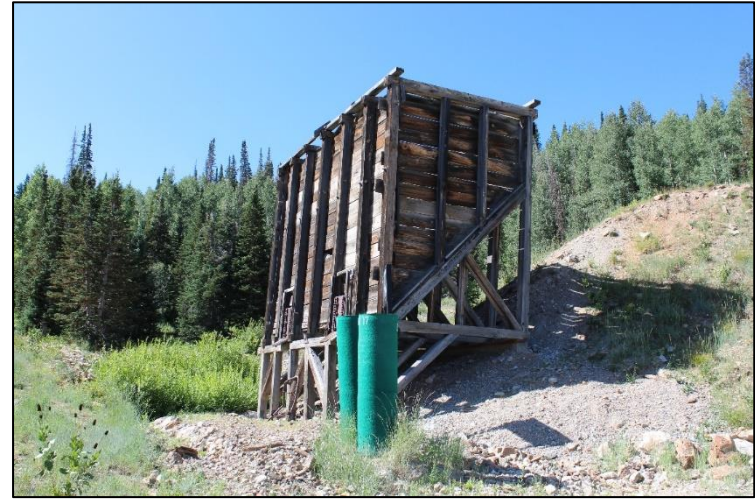
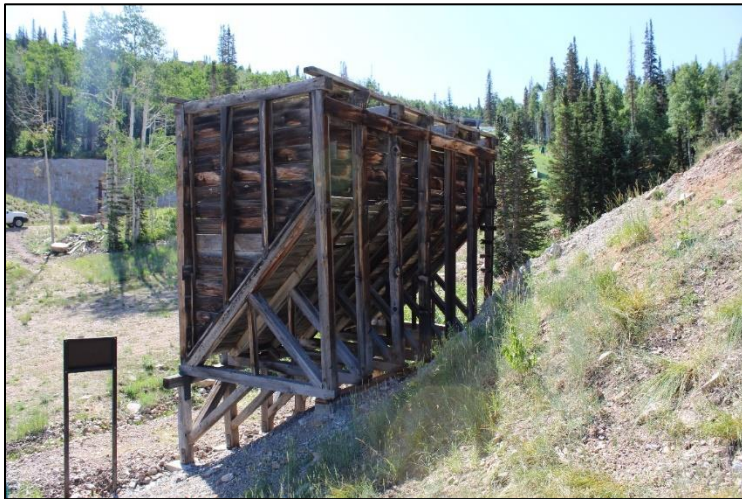
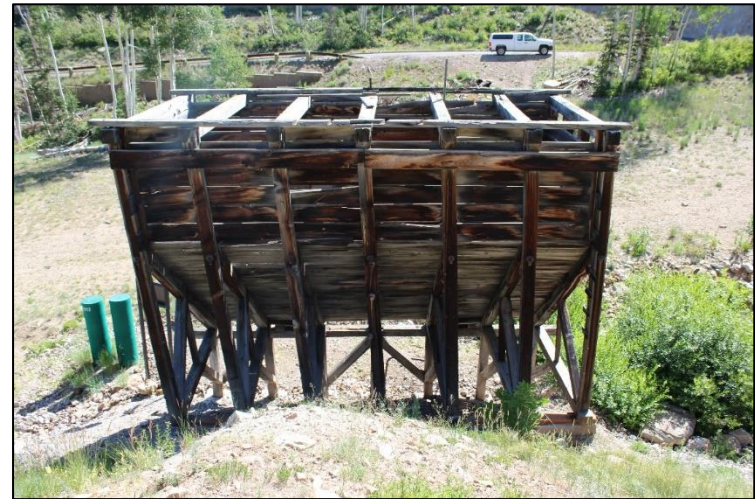
**Figure 65. Overview of Little Bell Mine Ore Bin, facing northwest.**

**Figure 66. Overview of Little Bell Mine Ore Bin, facing southwest.**

**Figure 67. Overview of Little Bell Mine Ore Bin, facing southeast.**

**Figure 68. Overview of Little Bell Mine Ore Bin, facing east.**

- Rotted joists or other structural members should be monitored and replaced in kind when their condition threatens the structural stability of the ore bin.
  - Rotted or damaged wood members should be consolidated and retained to the greatest extent possible, using epoxy or another appropriate compound. If retention of the original materials does not prove feasible, rotten sections of wood should be replaced in kind with treated lumber, whereas sound sections should be retained to the maximum extent possible.
- Missing boards or wall elements should be replaced in kind when required to preserve the physical or structural integrity of the ore bin.

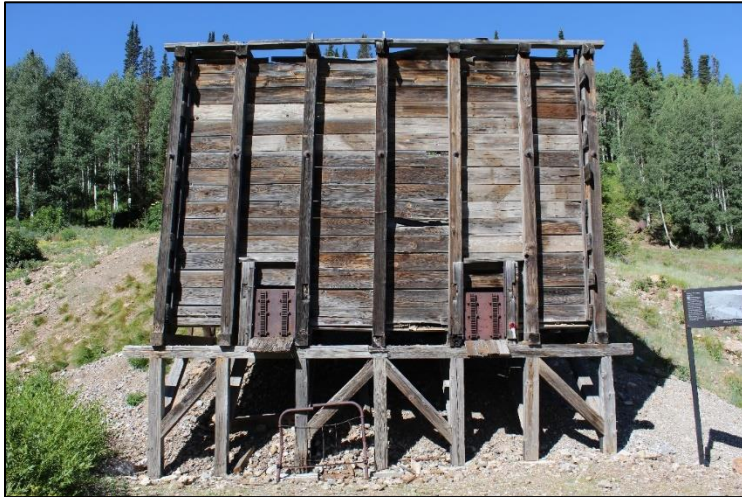
**Figure 69. Overview of Little Bell Mine Ore Bin, facing west. Note deteriorated boards at top of walls.**

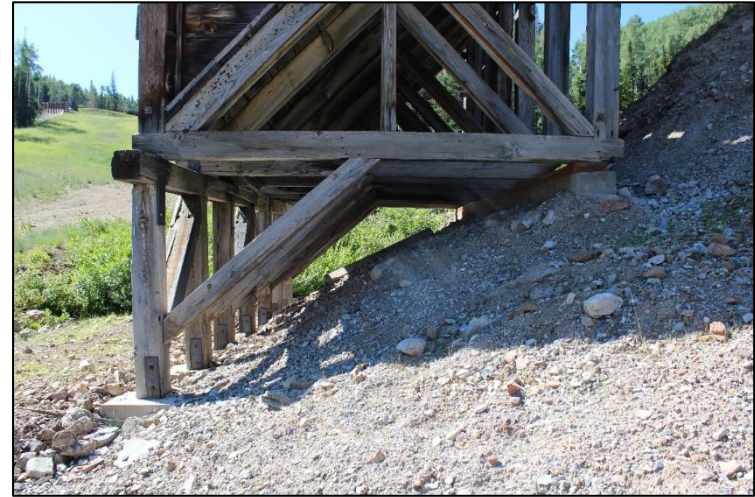
**Figure 70. Concrete footings and repaired wood posts supporting Little Bell Mine Ore Bin, facing south.**

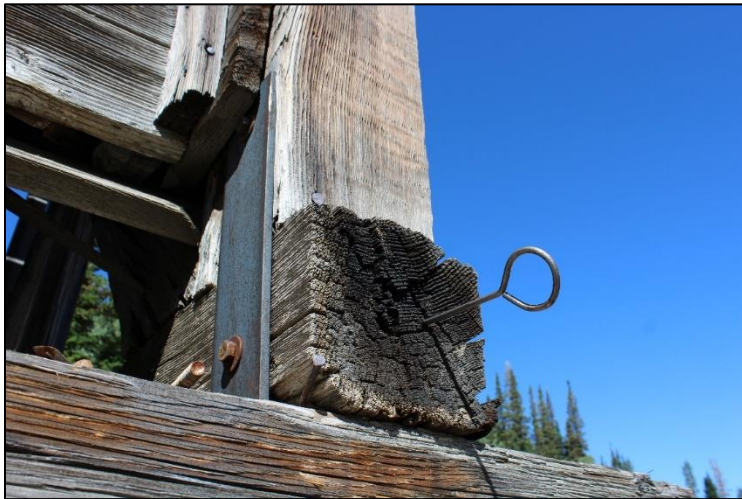
**Figure 71. Deteriorated structural member, north end of Little Bell Mine Ore Bin, facing northwest. Note the 1-foot-long probe illustrating depth of rot.**

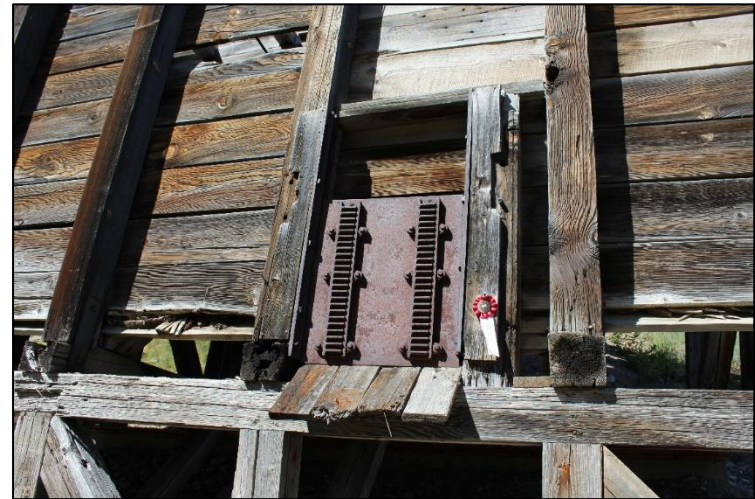
**Figure 72. Close up of north gate for Little Bell Mine Ore Bin, with damaged and missing boards visible, facing west.**

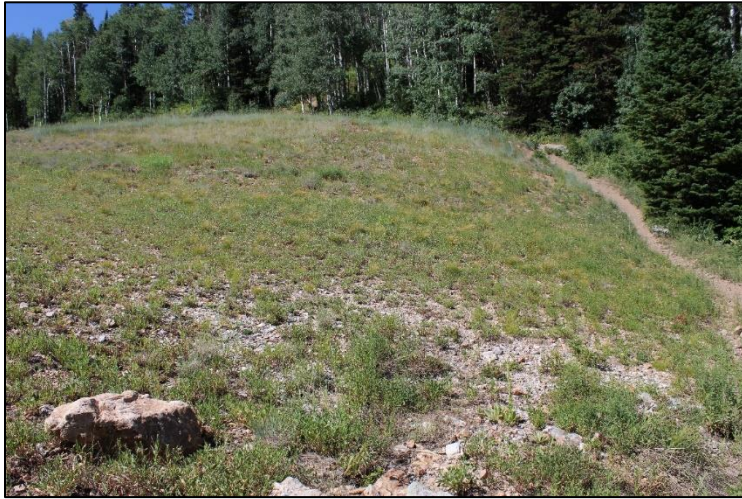
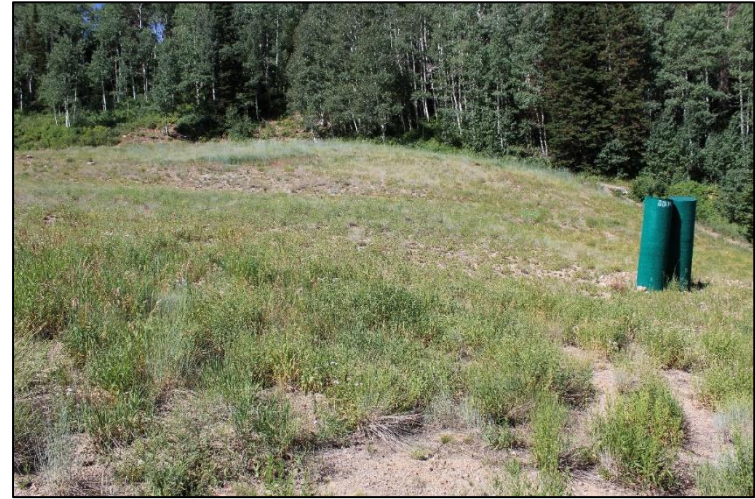
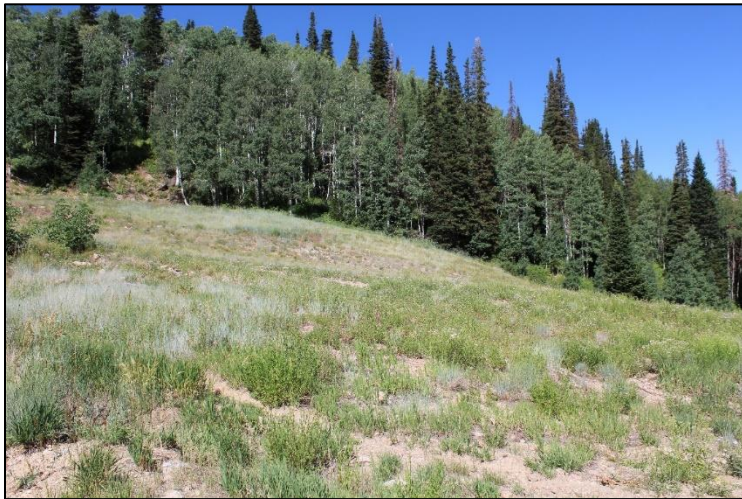
**Figure 73. Overview of Little Bell Mine Waste Dump, facing southwest.**

**Figure 74. Overview of Little Bell Mine Waste Dump, facing west.**

**Figure 75. Overview of Little Bell Mine Waste Dump, facing northwest.**

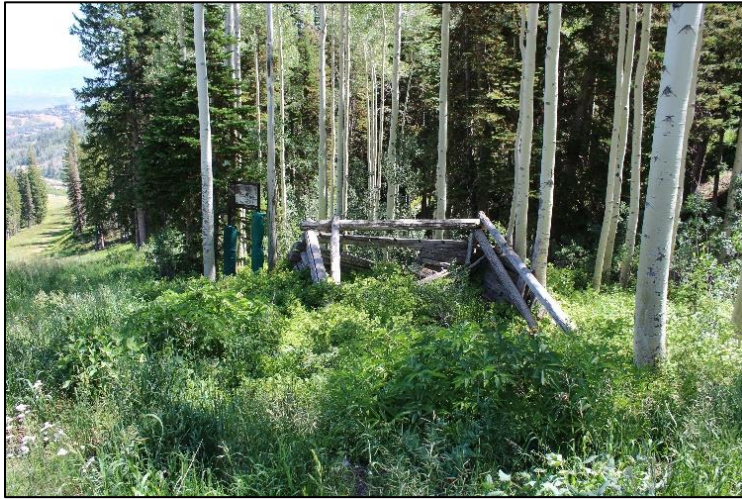
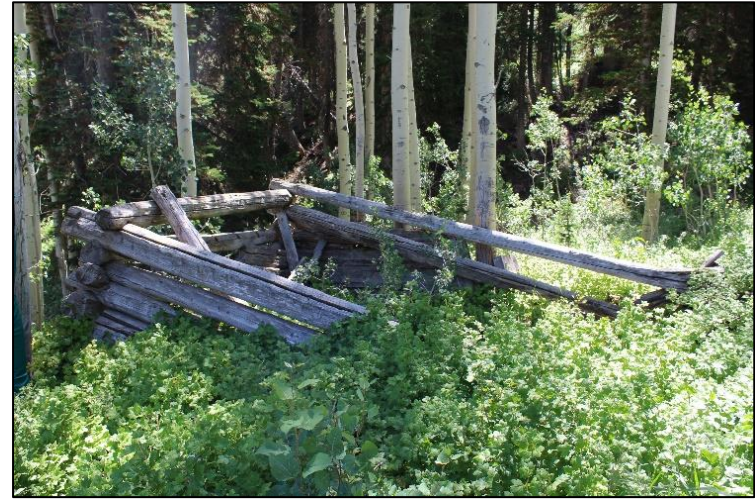
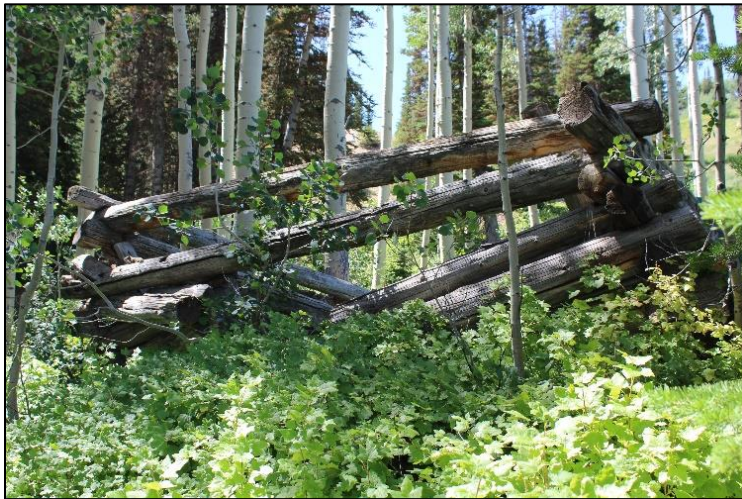
**Figure 76. Overview of White Pine Mine Log Structure, facing northeast.**

**Figure 77. Overview of White Pine Mine Log Structure, facing east.**

**Figure 78. Overview of White Pine Mine Log Structure, facing southwest.**

- Methods to divert moisture and runoff from the structure, to dry soil, and to prevent further deterioration of log sills should be considered. Possible methods for doing so include the following:
  - Regrading the hill around the cabin to direct waterflow away from the structure
  - Removing low vegetation (such as bushes) surrounding the structure

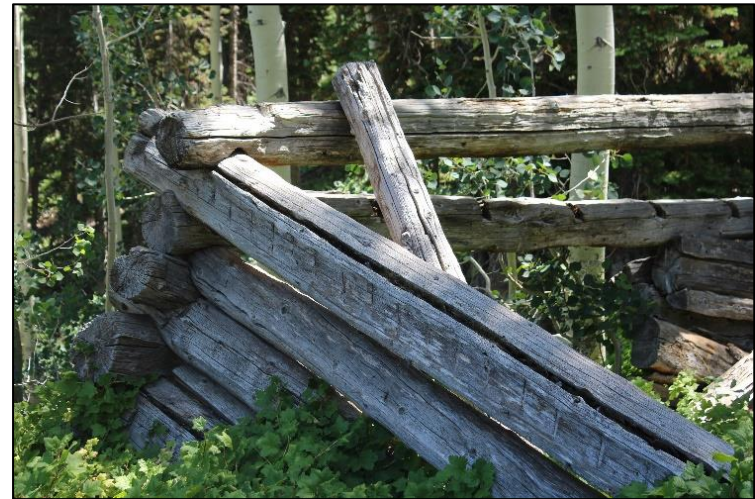
**Figure 79. Detail of logs and notching, White Pine Mine Log Structure, facing east.**

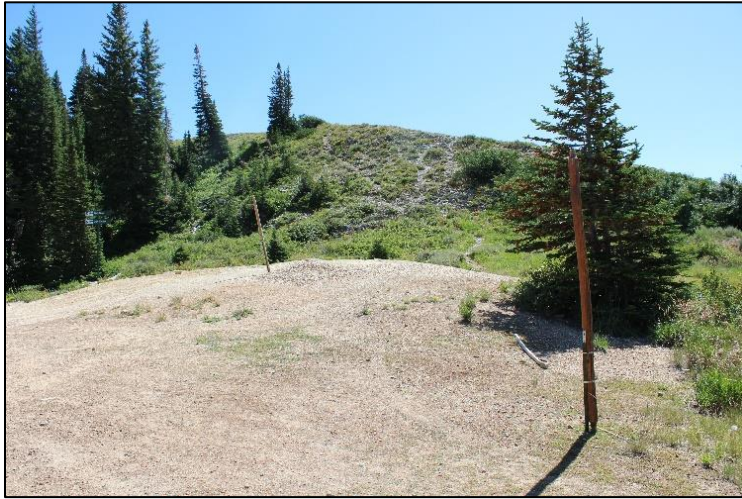
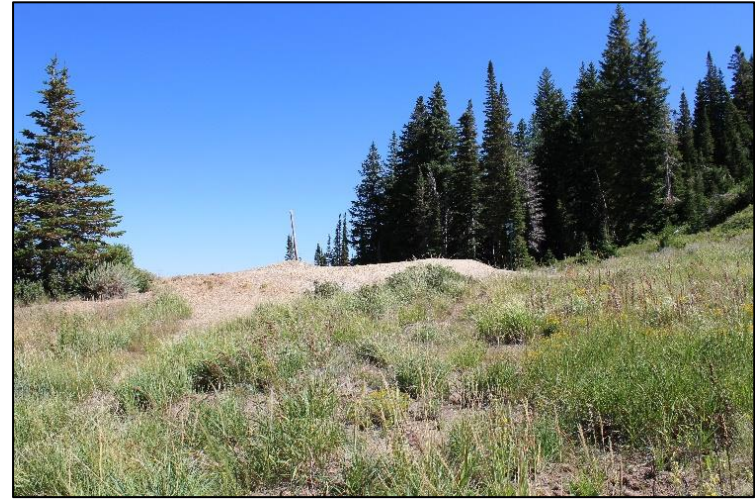
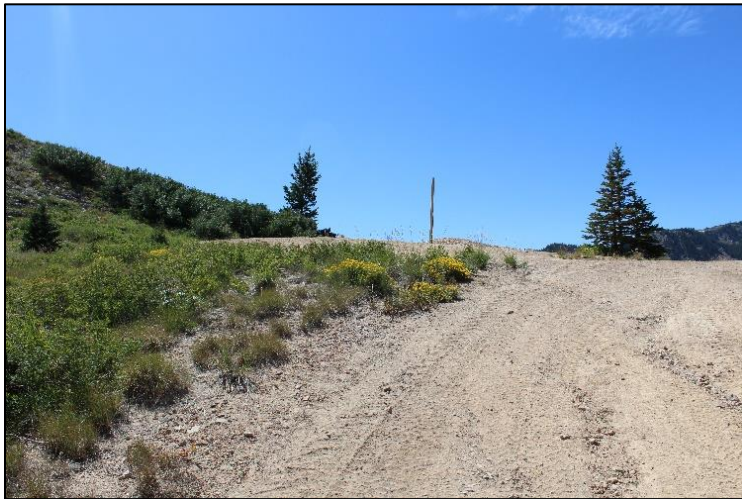
**Figure 80. Overview of White Pine Mine Ridgeline Waste Dump, facing southeast.**

**Figure 81. Overview of White Pine Mine Ridgeline Waste Dump, facing north.**

**Figure 82. Overview of White Pine Mine Ridgeline Waste Dump, facing south.**

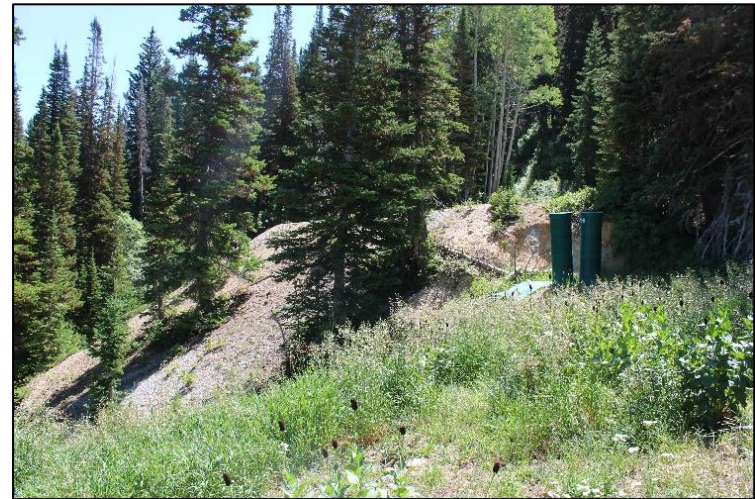
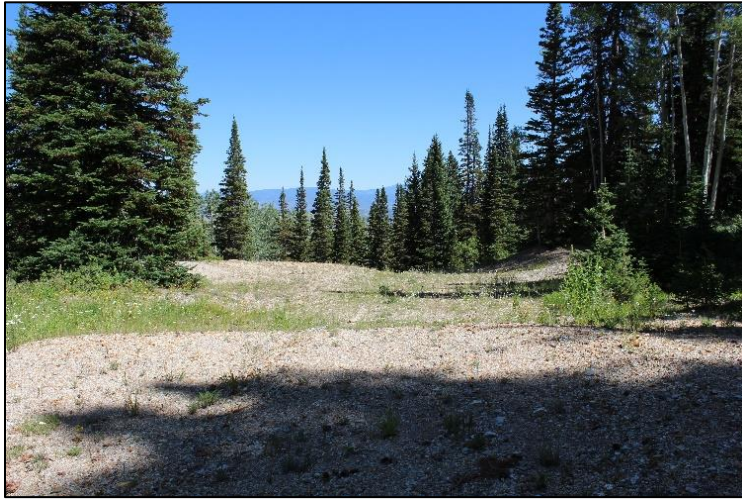
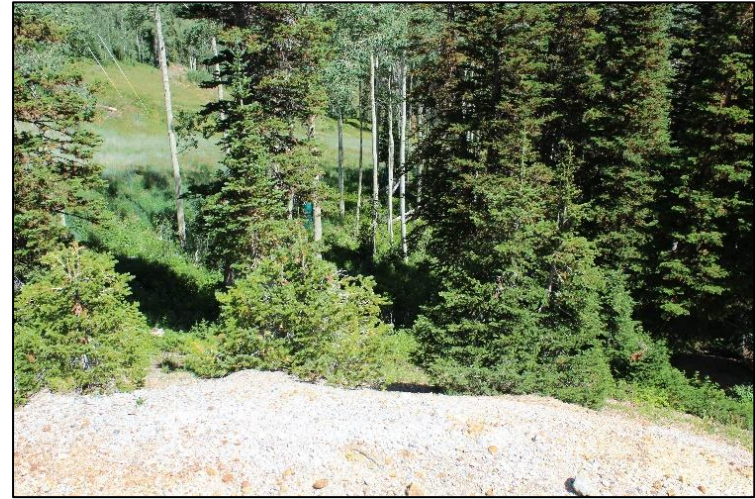
**Figure 83. Overview of White Pine Mine Downslope Waste Dump, facing east.**

**Figure 84. Overview of White Pine Mine Downslope Waste Dump, facing northeast.**

**Figure 85. Overview of White Pine Mine Downslope Waste Dump, facing northwest.**

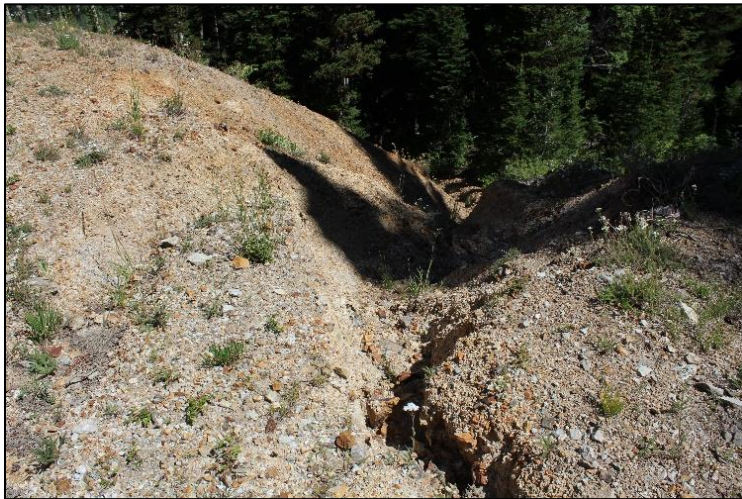
**Figure 86. Erosion on east side of White Pine Mine Downslope Waste Dump, facing northeast.**

- Regrade the east side of the Downslope Waste Dump to prevent additional or ongoing erosion.

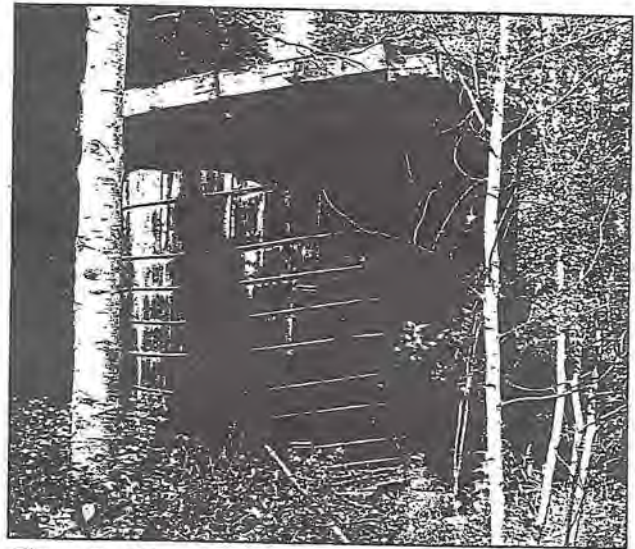
Figure 8 – Water Tank E.

West of this group of three tanks, at the end of a short dirt road, is a fifth tank (Tank E, Figure 8) that is surrounded by trees and cannot be seen from State Road 224 when the trees are in foliage. This tank has not been used in recent times and is listing to one side. It appears to be the oldest of the five tanks and can be considered historic. This tank, like the others, is circular, but it rests upon timbers that in turn rest upon a set of four historic-period mortared stone footings. The layout of the footings does not correspond to the form of the wooden tank, which raises the possibility that the current wooden tank is a historic-period replacement for an earlier tank. A water pipe with an outside diameter of approximately 4-1/2 inches and a valve with a hand-wheel are still connected to the tank. The tank is approximately 10 feet in height and 38

Only two of the tanks appear to be historic. These include Tank D (Figure 7), the smallest tank in the group of three tanks, and Tank E (Figure 7), the larger tank located in the trees to the west of the group of three tanks. However, there is a possibility that the other tanks (A, B, and C) may have been built to replace earlier tanks and that there could be some historic implications if they were removed. If historical associations can be established for tanks A, B, and C, then they may also warrant stabilization treatment.

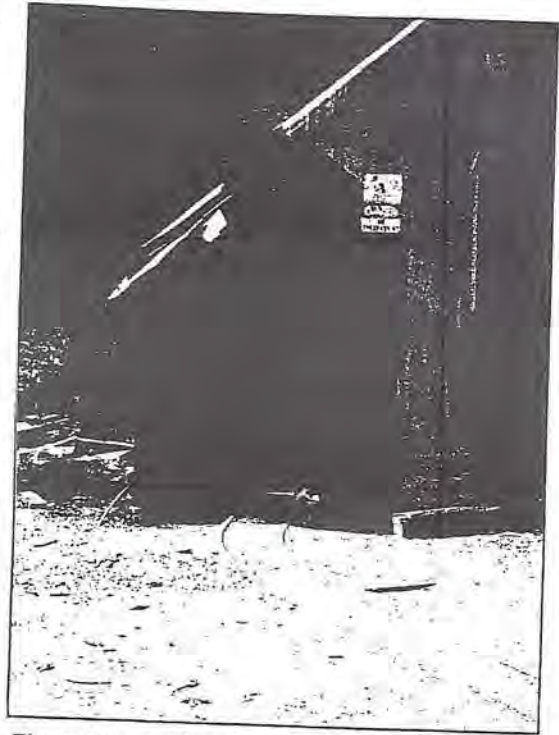
Figure 10 – Anchor Drain Tunnel portal.

The portal of the Anchor Drain Tunnel (known later as the Daly-Judge Drain Tunnel) is located approximately one mile up Empire Canyon. The portal's covered extension (Figure 10) is directly adjacent to the east wall of the Judge Mining & Smelting Company office building. Access to the tunnel is secured with a hinged steel grating that allows ventilation. A doorway in the changing room in the rear section of the office building connects directly to the tunnel. This doorway allowed miners to conveniently enter the tunnel from the changing room. This opening is covered with a steel grating. The portal itself is of concrete construction, and its covered extension is a wood-frame structure with galvanized corrugated steel panels.

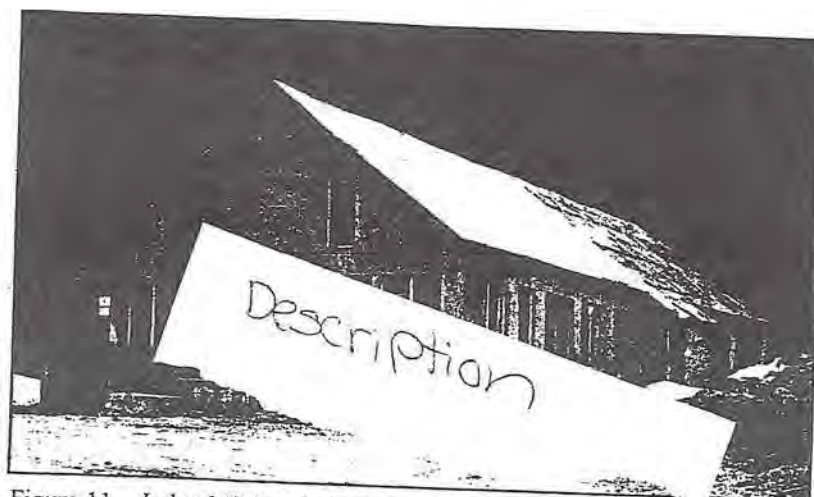
Figure 11 – Judge Mining & Smelting Company office building.

The Judge Mining & Smelting Company office building is located adjacent to the extension of the Anchor (Daly-Judge) Drain Tunnel portal. It is a simple, front-gabled, one-story, concrete-walled structure (Figure 11) that is divided into two functional areas.

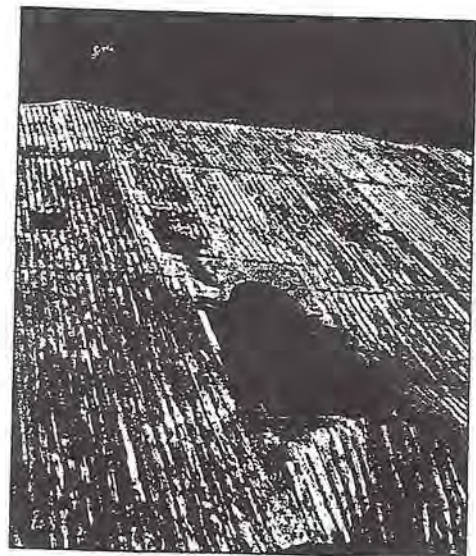
**Deficiency Description** – The corrugated galvanized roofing panels are in fair condition on the west side of the building, with only some minor rusting, but on the east side of the building, a number of panels are badly damaged. It appears that one of the chimneys and a sewer vent pipe have been pushed down, probably by a heavy snow load sliding off the roof, and have torn large openings in the roofing material (Figure 17). Water entering through these holes is damaging the adjacent wooden structural elements of the roof. The other chimney is missing, although it did not tear a large hole in the roof. A secondary problem is that the roofing nails have crept out about half an inch.

Figure 17 – Damaged roofing panels.

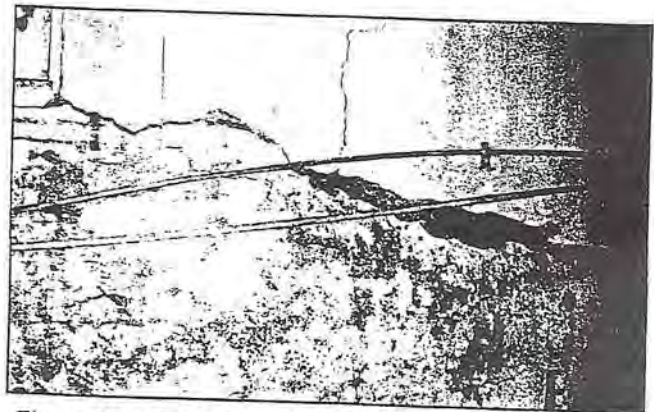
Figure 19 – Cracks in concrete wall.

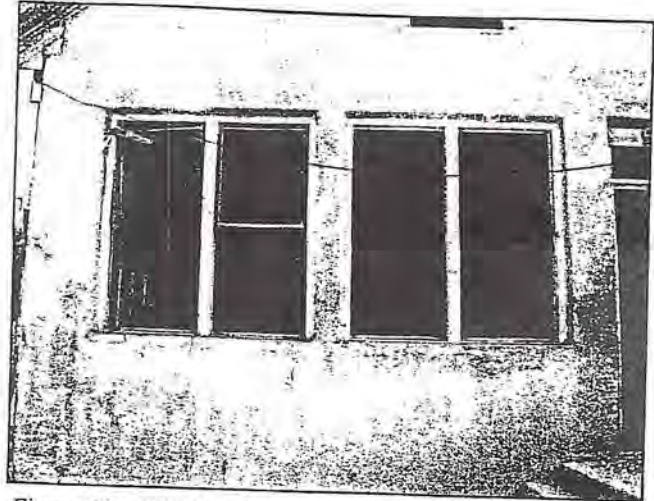
Figure 20 – Window frames in front wall.

**Suggested Mitigation Work** – Plywood or Lexan fillers could be installed in the window openings. Lexan (or a similar polycarbonate material) is break resistant and allows light to penetrate into the structure, which may be an advantage under certain circumstances. Heavy-duty, lockable doors should be installed. These doors could be constructed of thick plywood sheets. Optionally, if a historic photo or building plan could be located, doors that are stylistically appropriate could be installed.

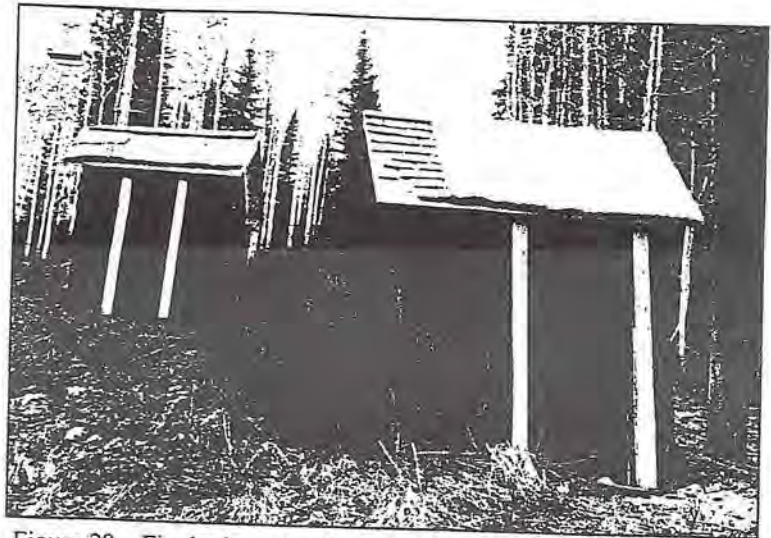
Figure 29 – Fire hydrant shacks at the Daly-West Mine site.

**Deficiency Description** – Other than some missing galvanized roofing panels and typical weathering, these sheds are in reasonably good condition and do not appear to have been significantly altered over time. It is possible that the wooden sills may have some deterioration below ground level, but this could not be ascertained without invasive testing. Some of the paint appears quite old, and demonstrates considerable weathering, especially on the south-facing sides.

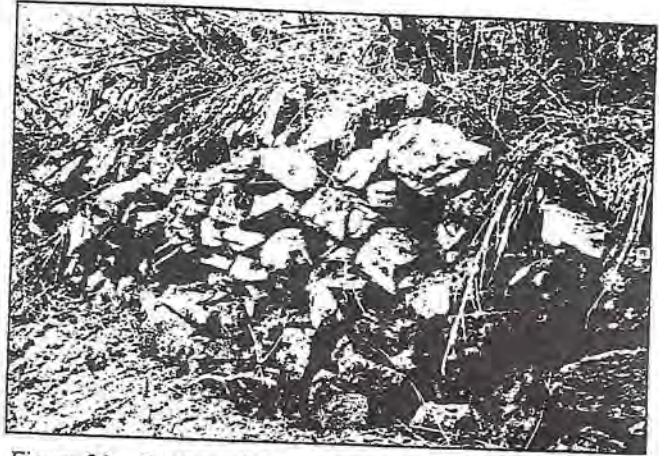
This feature is a rock wall (Figure 31) located directly upslope from the Daly-West shaft and adjacent to a fenced-in transformer area. This wall is approximately 30 feet in length and averages about three feet in height. It is constructed of uncoursed and unmortared irregular rocks of varying sizes, and it is in reasonably good condition.

Figure 31 – Rock retaining wall by transformer platform.

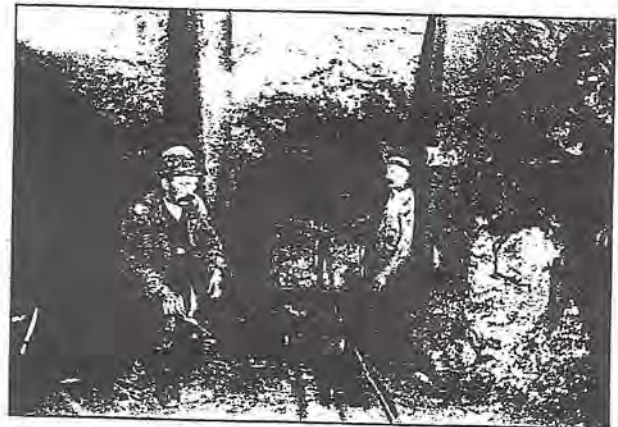
Figure 34 – An incline at the Anchor Mine.  
Photo courtesy of the Utah State Historical Society.

A two-cylinder steam-driven hoist is still mounted on its concrete pad. The hoist is powered by a double-acting, crosshead-type engine, which, like many hoist engines and marine windlasses, is integrated into the same iron frame as the hoist. Historic photos (Figure 33 and Figure 34) depict what appears to be the same kind of hoist being used as a winch at the Anchor Mine for raising ore cars in an incline. This hoist could even be the same hoist as the one at the Quincy, since it was common to buy, sell, trade, and move equipment from one mine to another.

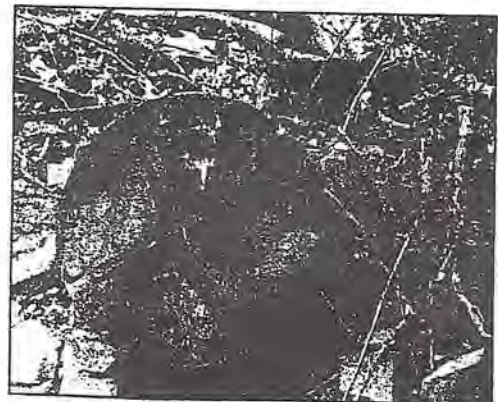
Figure 35 – Lower drum of boiler.

Located between the hoist engine and the mine shaft, and apparently within the area once covered by the hoist building, are the remains of a boiler, consisting of the lower portion of its brick enclosure and the boiler's lower water drum (Figure 35).

The larger, upper drum has been removed, and the bricks from the upper part of the brick enclosure are scattered around the base of the boiler. There are also some remaining vertical iron or steel straps that may have acted as supports or anchors for the brick boiler enclosure. It is difficult to make a determination of the boiler type without removing the debris that covers the remains of the boiler and firebox.

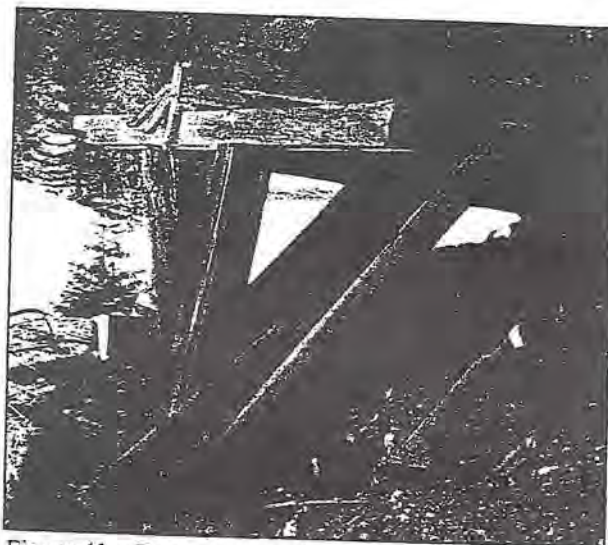
Figure 41 – Damage at northeast corner of ore bin.

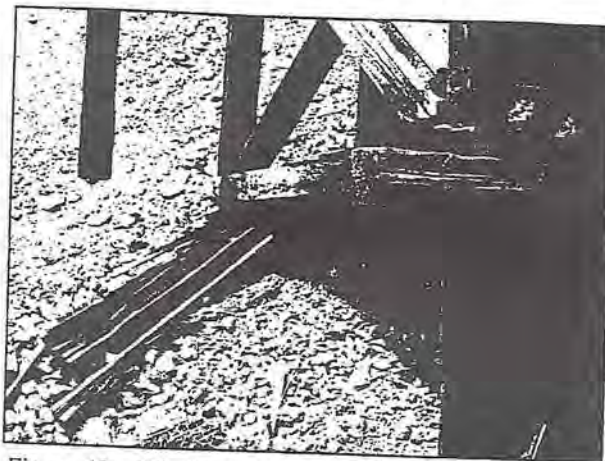
Figure 42 – Missing beam and post, rotted footing.

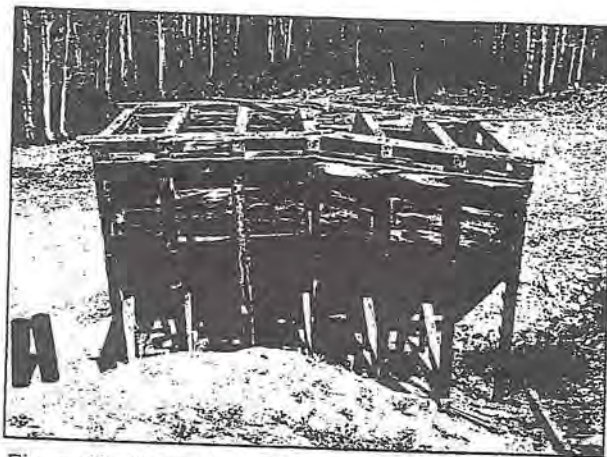
Figure 43 – Rear view, showing sagging corner.

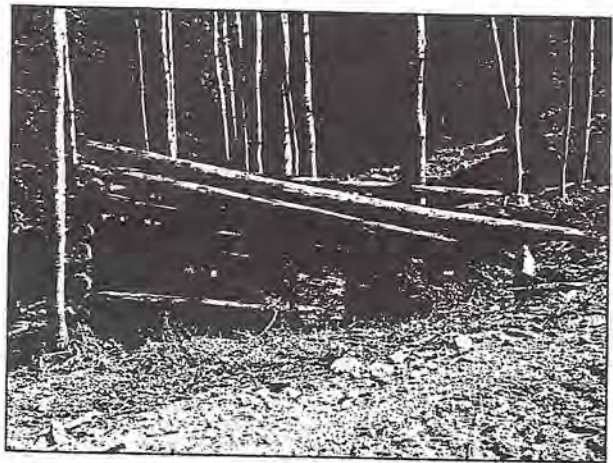
Figure 47 – West side of log structure.

**Deficiency Description** – Most of the logs that are above ground level (Figure 47) have weathered considerably, but appear to be quite solid and free of significant rot, with the exception of about ten percent of the logs, which are badly decayed from some combination of moisture, insects, bacteria, fungus, and oxidation. Several aspen trees along the east wall of the structure are in direct contact with the wall, but they appear to be serving a beneficial role in helping to keep the structure upright.

**Deficiency Description** – The south end of the structure has settled noticeably (Figure 47), possibly due to rotting subsurface logs or other support components. An exploratory probe suggested that the logs have rotted very badly below the soil level as the result of long-term contact with soil moisture, bacteria, fungus, insects, etc. A small stream runs down the slope just a few feet from the east wall of the structure, saturating the ground with water, which could be accelerating moisture-related decay. It appears that this stream may have been rerouted by the recontouring of the area immediately west of the structure.

**Suggested Mitigation Work** – A few of the logs that have rotted or shifted off center could be reinforced or replaced and shifted back into position directly over the underlying logs and secured against further movement. This would tend to stabilize the structure to some degree. It may also be advisable to install a few wood braces at key locations where shifting is possible. The logs next to the window and door openings could also be aligned more vertically and unobtrusively secured. Wood consolidants or water repellent solutions could be applied to the remaining logs, as appropriate.

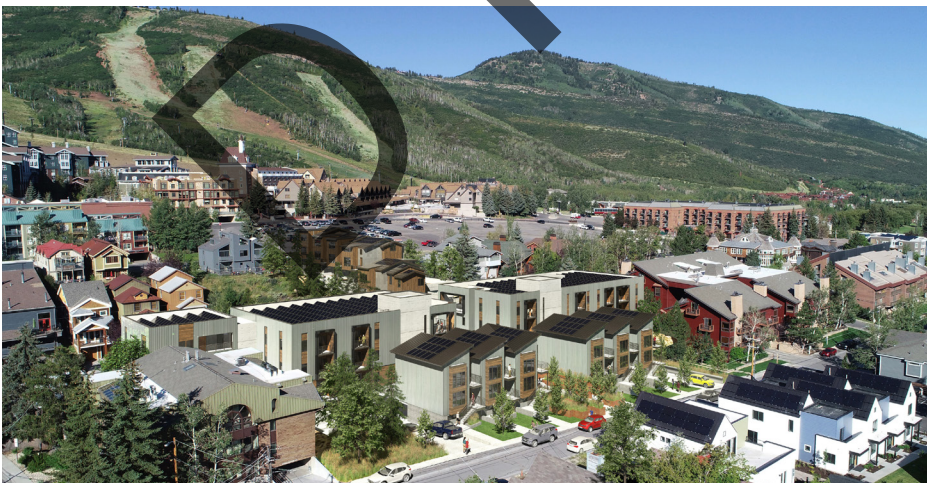
Woodside Park Phase II, shown on the left, is slated for construction in the next few years and will provide 50-60 affordable units. The units are located in Old Town and are within walking distance to the City's free transit.

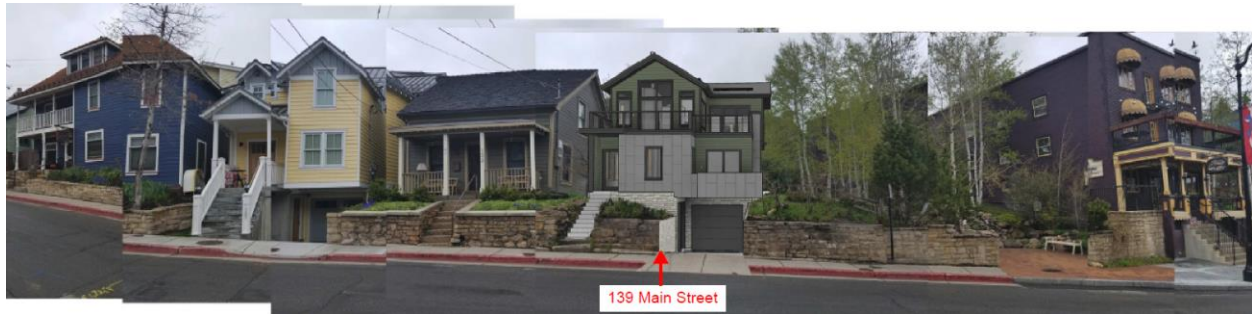
*In Paragraph #9, the Appellant argues that the rhythm along Main Street was not reinforced by the proposed design. Staff has included the proposed Streetscape, which can also be seen in Exhibit G.*

*As shown in the image above, the proposed design is similar to other new residential infill projects along the street. Further, the Appellant claims that the scale and height is not following the predominant pattern of the neighborhood. However, as seen in the image above, the building is consistent in height, scale, and mass with the surrounding buildings, both Historic and non-historic. Staff included the table below identifying approximate heights of the surrounding buildings (from left to right in the photo above) based on the available plans.*
