**PARK CITY MUNICIPAL CORPORATION  
HISTORIC PRESERVATION BOARD  
CITY COUNCIL CHAMBERS**

**August 1, 2018**

227 Main Street – HDDR Material Deconstruction and Reconstruction – The applicant is proposing to reconstruct the historic boarding house designated as “Significant” on the City’s Historic Sites Inventory. In addition the applicant will be removing the existing c.1920 retaining and post-1976 retaining walls; c. 1889, c.1920, and 1976-1977 roof structures, non-historic asphalt and corrugated metal roofing materials; c.1920 brick chimney; c. 1889 wood drop novelty siding and wall structures, c.1920 stucco and wall structures, and 1976-1977 framed walls and wood paneling; c.1920 and 1976 enclosed piazza; c.1920 and contemporary doors units; and c.1889 double-hung wood window, c.1920 wood casement windows, 1976 picture windows, and contemporary aluminum and vinyl window units.

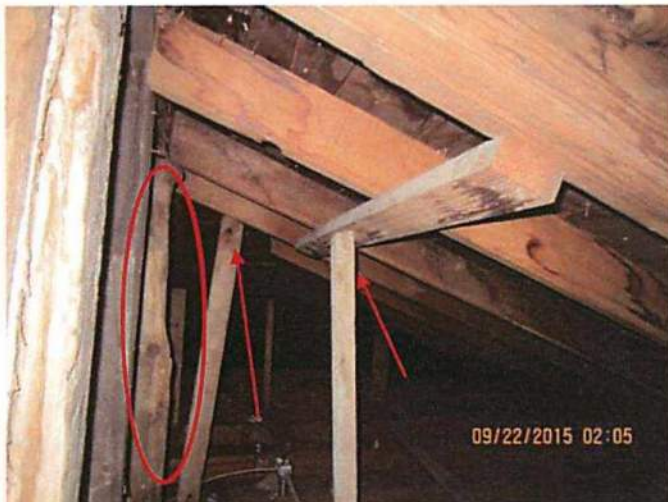
**Photo 2** Support members for roof are not adequate for the purpose being served. Engineer to justify

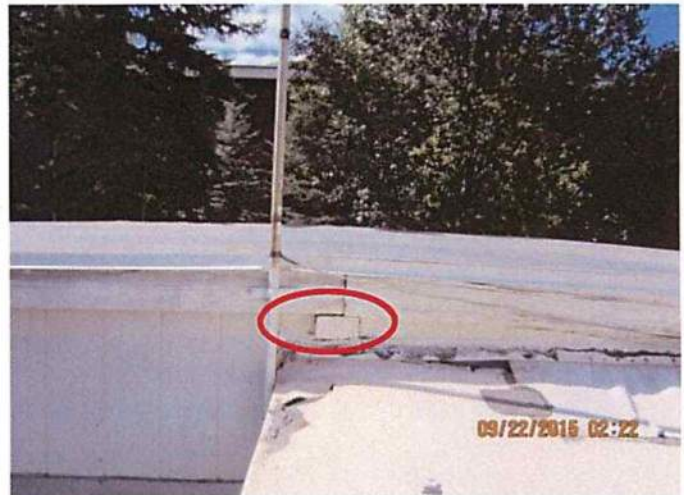
**Photo 7** Roof has been repaired, support members not properly installed. Engineer to evaluate and justify

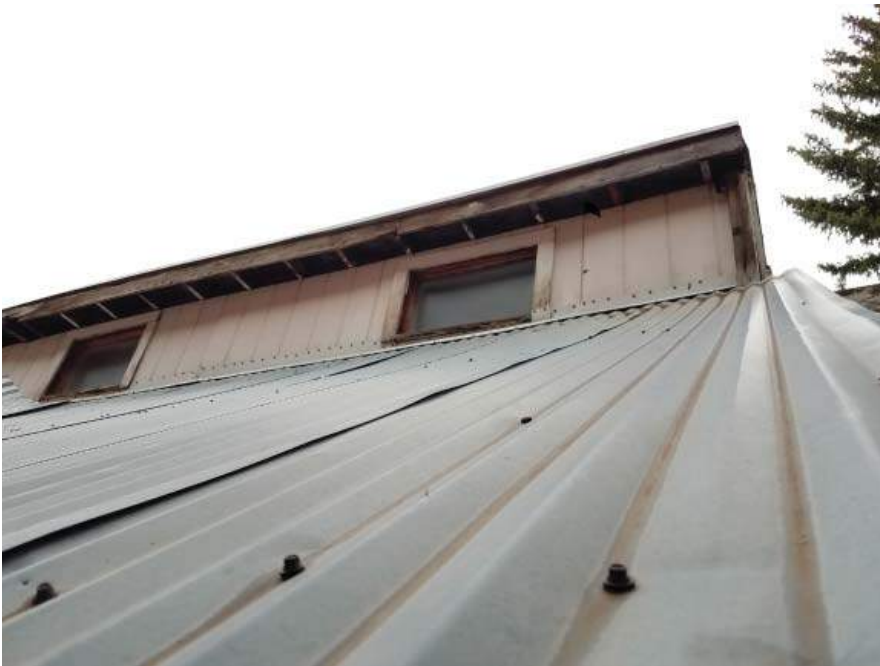
**8 - North Corrugated Roofing**

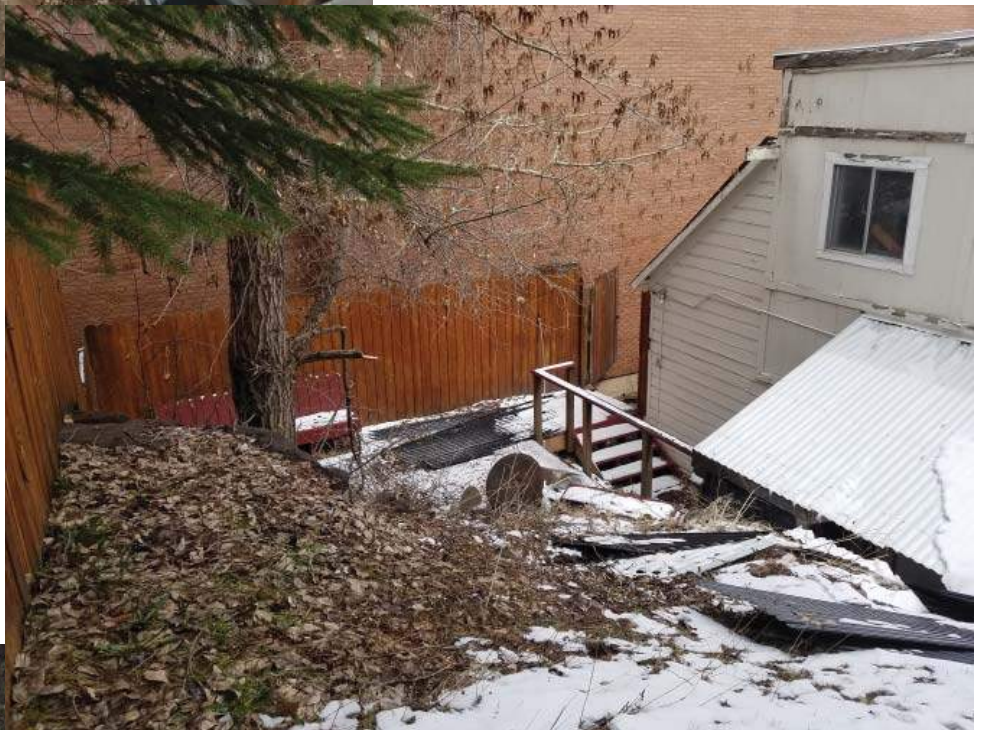
**14 - West Site Conditions**

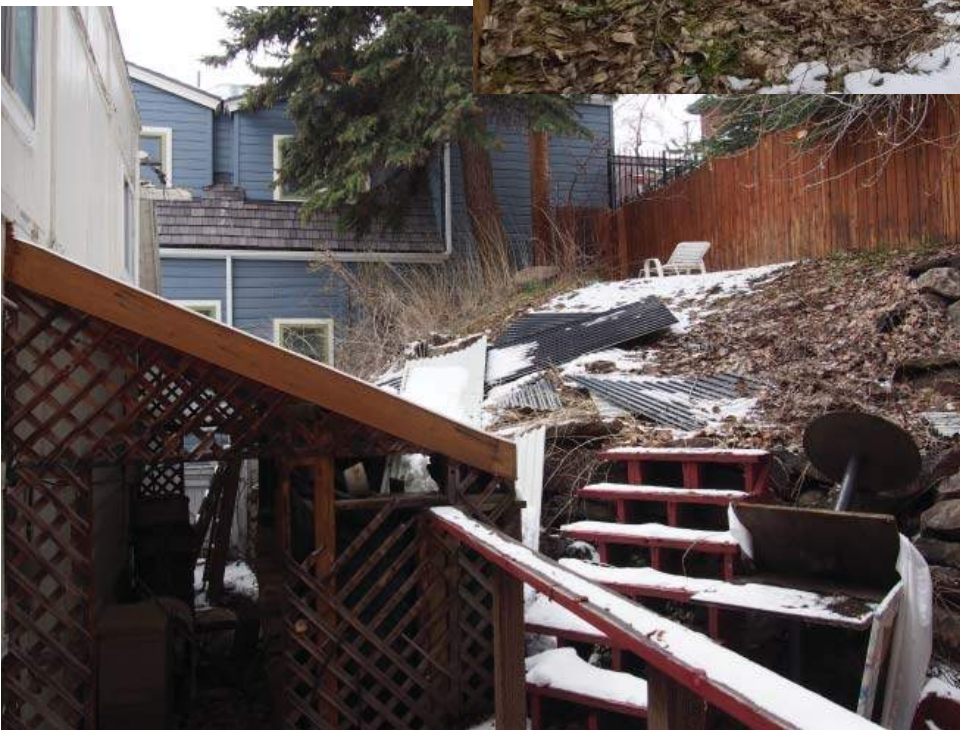
**15 - West Site Conditions**

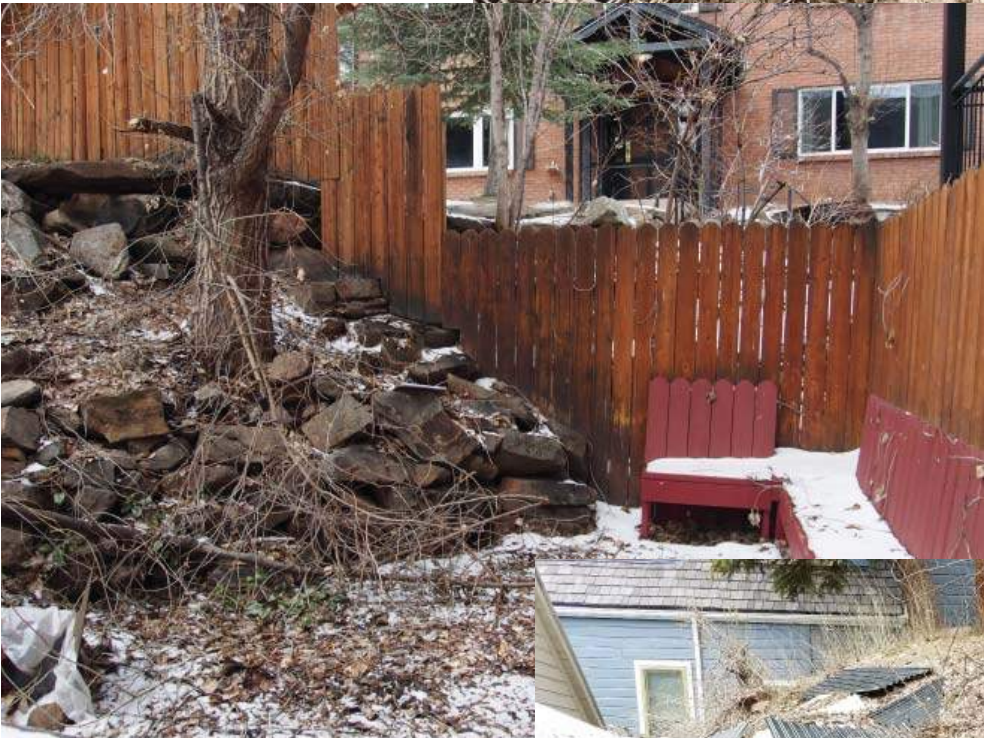
**18 - West Site Conditions**

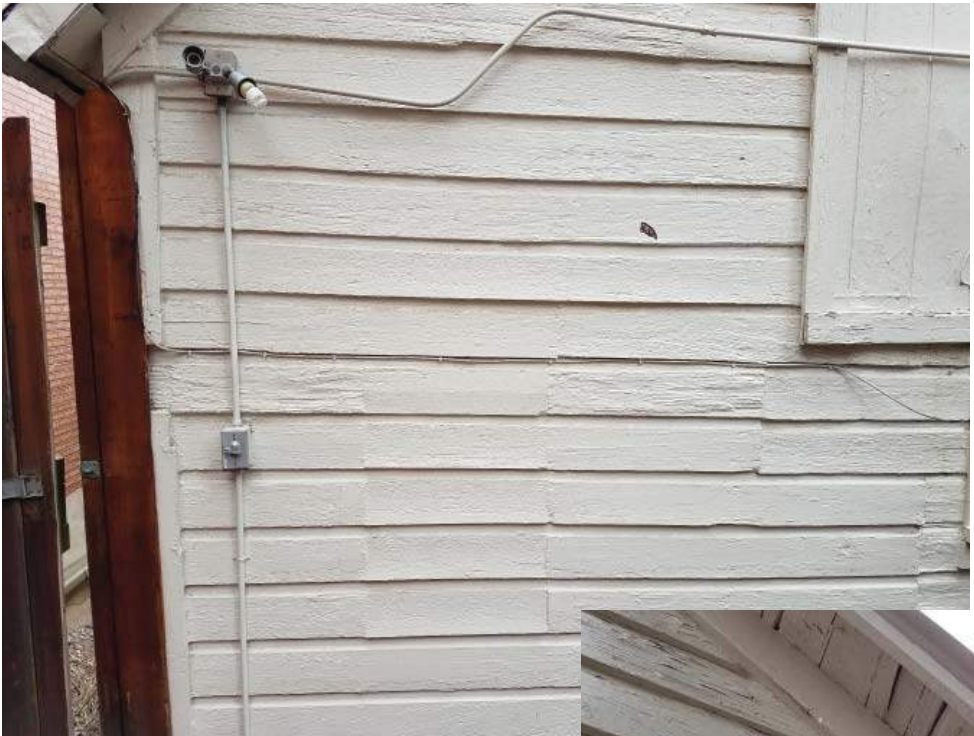
**22 - Patched Siding on Wall**

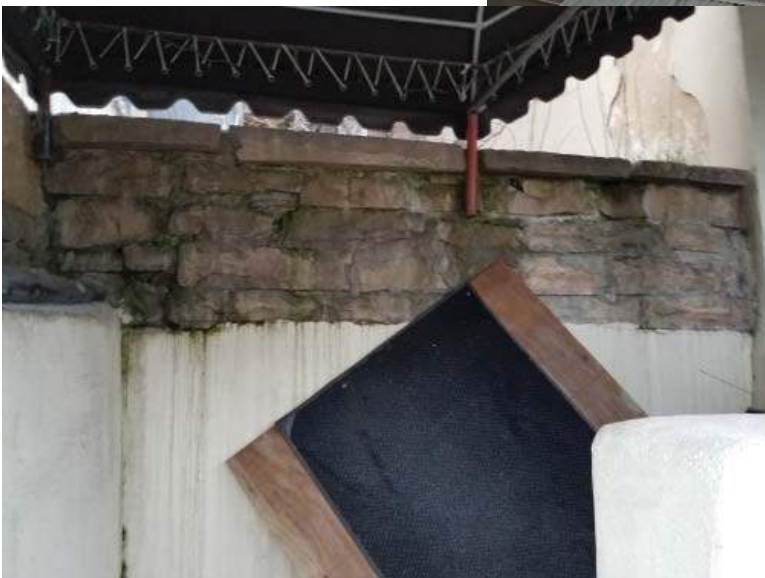
**27 - East Retaining Wall**

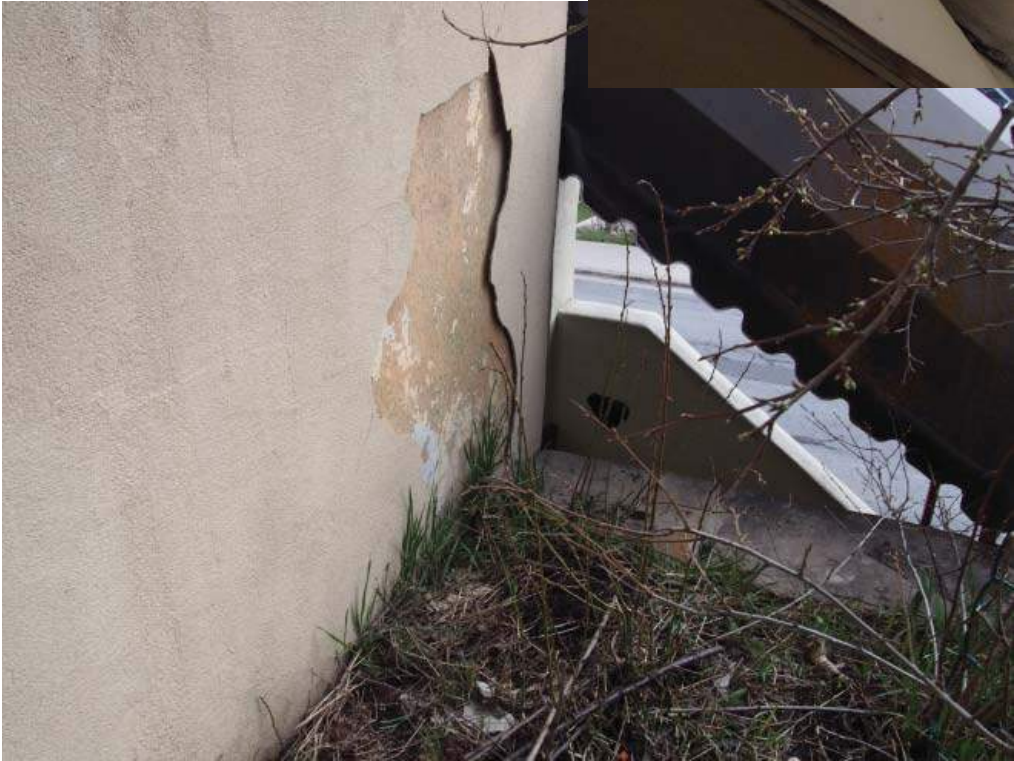
**33 - SE Wall Stucco Peel**

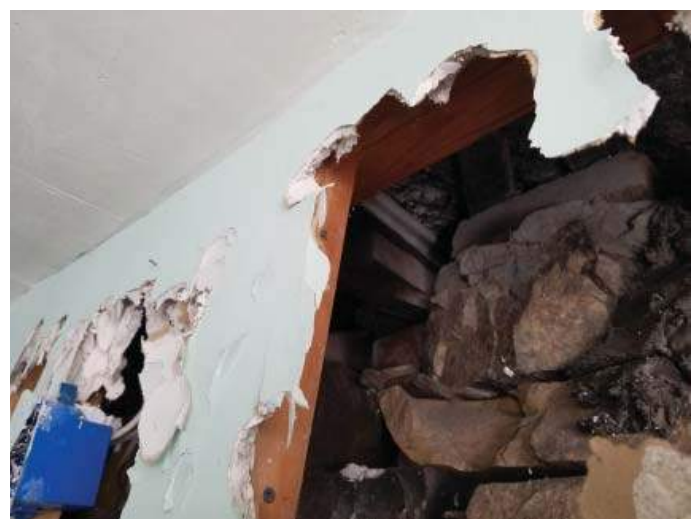
**57 - L0 - S. side of Central Stone Wall**
