**PARK CITY MUNICIPAL CORPORATION  
HISTORIC PRESERVATION BOARD  
CITY COUNCIL CHAMBERS  
May 16, 2018**

1021 Park Avenue –Historic District Design Review – Material Deconstruction on Landmark Site. The applicant is proposing to impact a portion of the rear (west) elevation for a new addition, modifications to historic window and door openings. The house was approved to be reconstructed through the Historic District Design Review (HDDR) process in 2016.

115 Sampson Avenue – HDDR Material Deconstruction and Reconstruction – The applicant is proposing to reconstruct the historic house designated as “Significant” on the City’s Historic Sites Inventory. In addition the applicant will be removing existing non-historic parking pad along with its associated wood staircases and railroad tie retaining wall; non-historic stacked stone retaining walls and 1990s wood slat fences; post-1947 addition on the west elevation and an underground root cellar; rebuilding the historic pyramid roof and dormers; reconstructing the existing masonry chimney; raising the house 2 feet to pour a new foundation; reconstructing the historic ca.1900 wraparound porch on the east and south elevations; replacing t

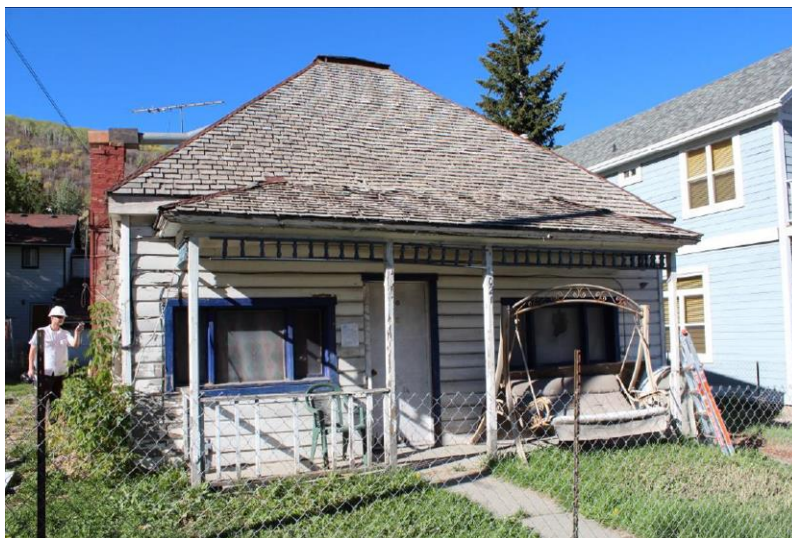
*Porch as it existed in 2014*

It was typical of pyramid-roof cottages in Park City to have a full-width hip roof front porch. According to previous surveys, the porch on this house was added between 1941 and 1949. The 1978 site form discusses how the overall form of the building, with the porch, contributes to the Park City vernacular architectural style.

Staff finds that the porch added between 1941 and 1949 was constructed in the traditional Park City style. While it may not have been original to the historic structure, it does contribute to its overall form and architectural style. The applicant

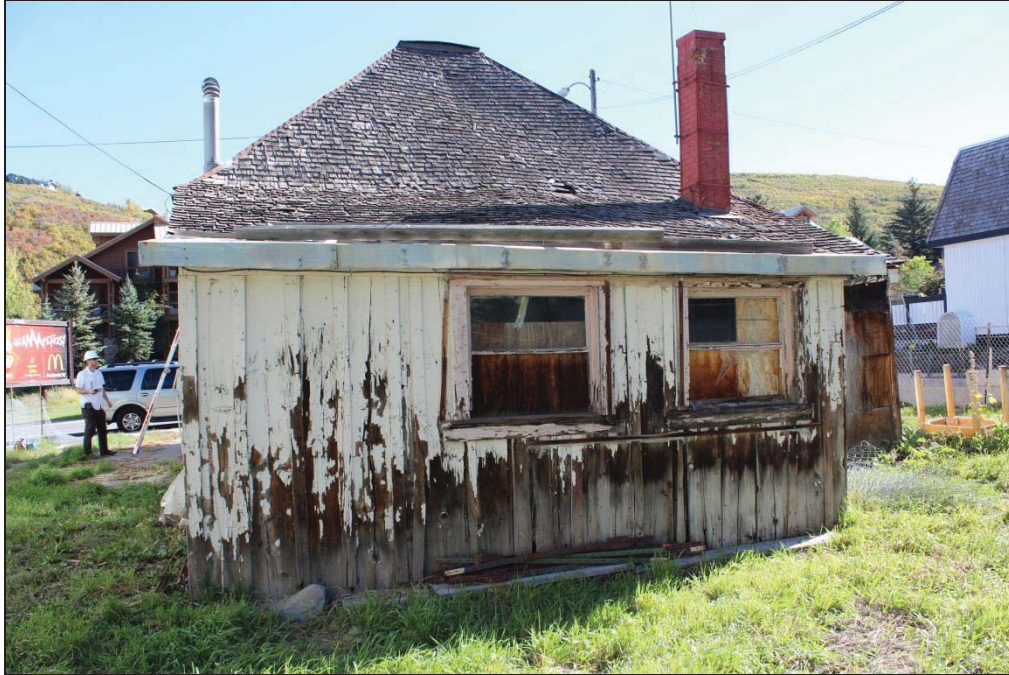
**B.4. EXTERIOR WALL – REAR FAÇADE:** West side, detail of Addition 2, facing east.
