**PARK CITY MUNICIPAL CORPORATION  
HISTORIC PRESERVATION BOARD  
CITY COUNCIL CHAMBERS  
May 2, 2018**

945 Norfolk Avenue – HDDR Material Deconstruction– The applicant is proposing to remove existing improvements in the front yard such as the non-historic stone retaining walls in the front yard, stairs and decks in the south side yard, and a c.1990 rock retaining walls in the backyard; reconstruct the historic c.1896 roof form and c.1990 wood shake roofing materials; reconstruct two c.1896 chimneys; reconstruct c.1997 basement; reconstruct c.1983 reconstructed front porch; replace c.1900 front door and two non-historic doors; replace 12 total historic wood windows.

PL-17-03686 43  
*Planner Grahn*

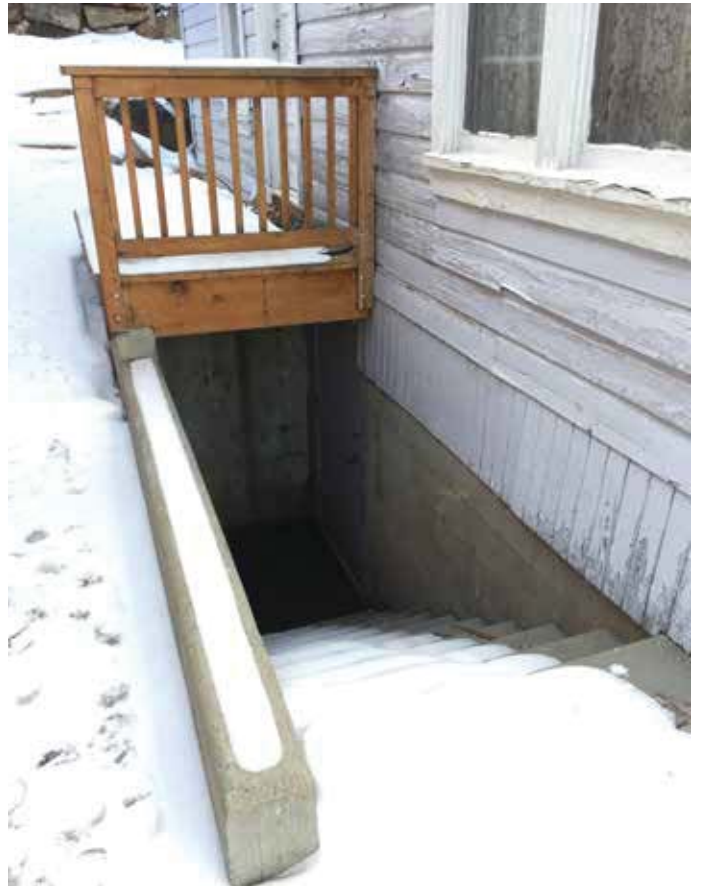
Photo #9: Added Concrete Stair

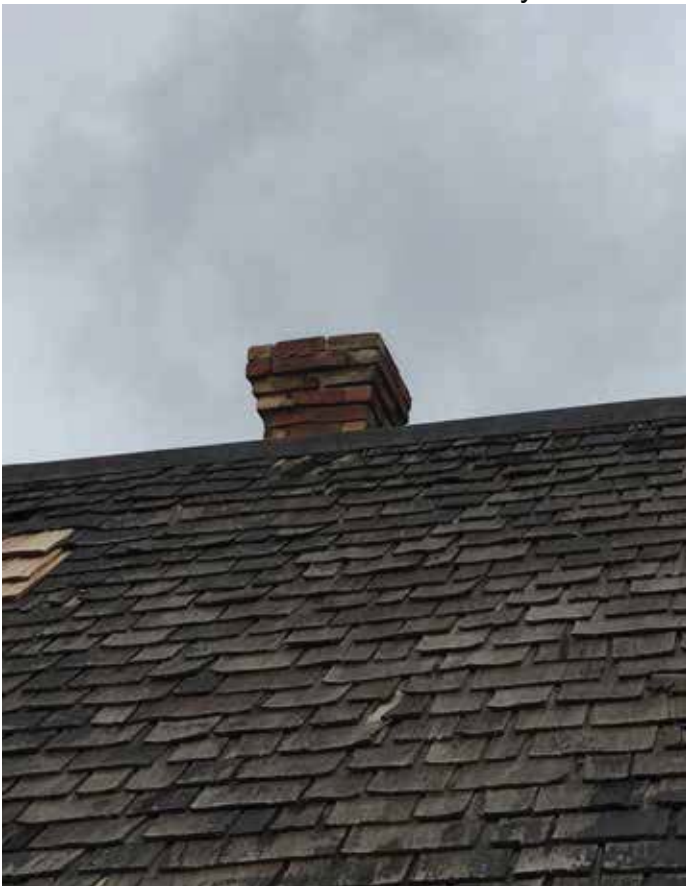
Photo #20: Exterior w/ Front Chimney

The two brick chimneys protruding through the existing roof are in decent condition with little repair required.

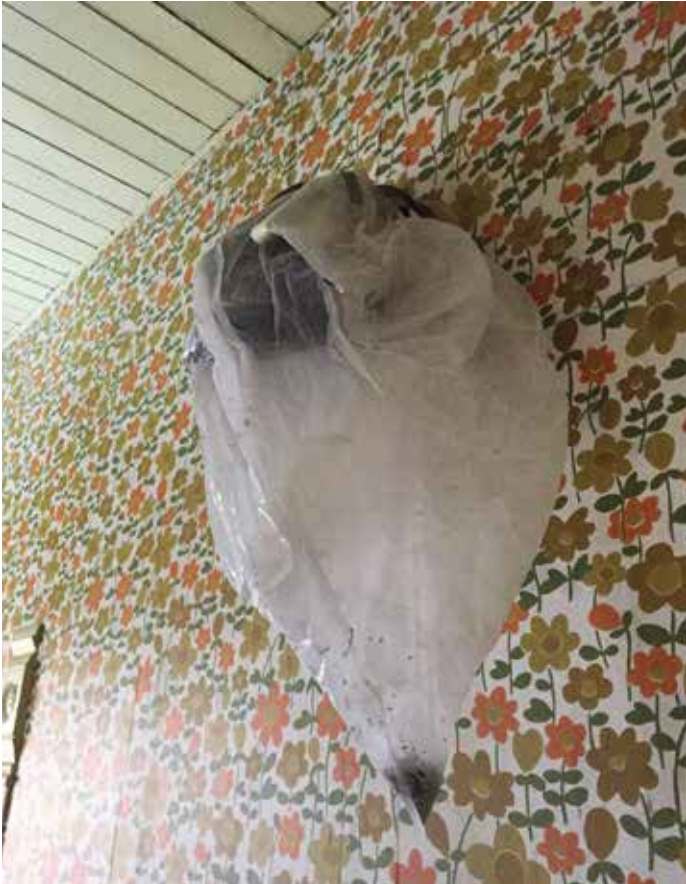
Photo #25: Disconnected Bottom
