**PARK CITY HISTORIC PRESERVATION BOARD MEETING  
SUMMIT COUNTY, UTAH  
June 4, 2025**

**PARK CITY MUNICIPAL CORPORATION  
HISTORIC PRESERVATION BOARD MEETING  
MARSAC MUNICIPAL BUILDING  
COUNCIL CHAMBERS  
445 MARSAC AVENUE  
PARK CITY, SUMMIT COUNTY, UTAH  
MINUTES OF MAY 7, 2025**

# PHYSICAL CONDITIONS REPORT

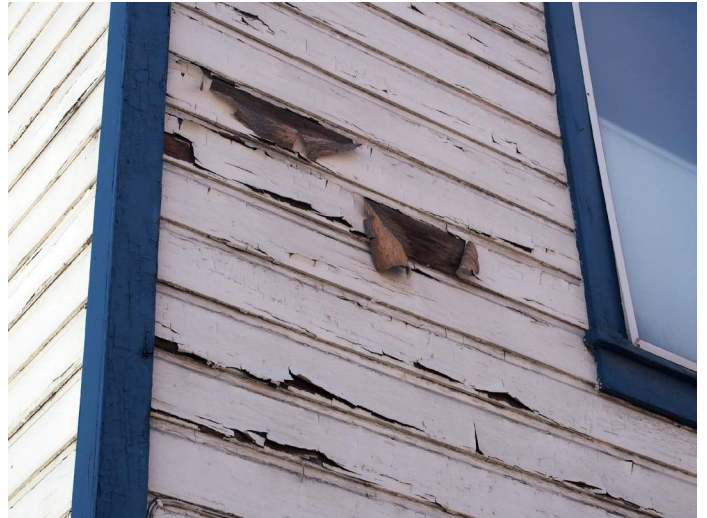
Example of Peeling paint on West Facade

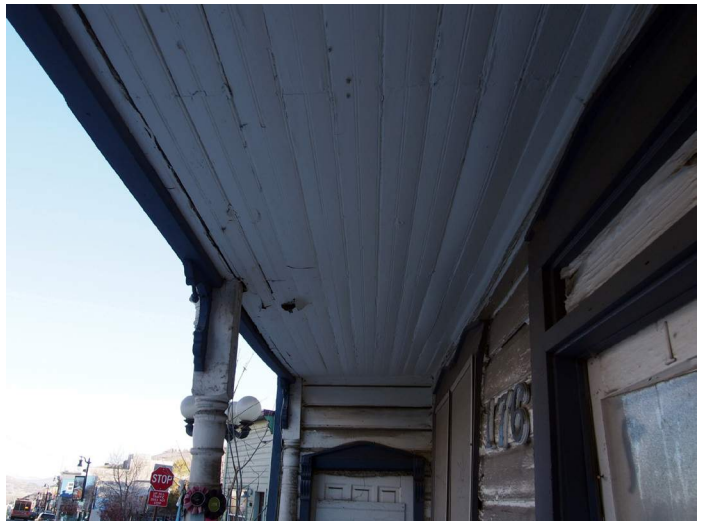
Front Deck soffit bowing

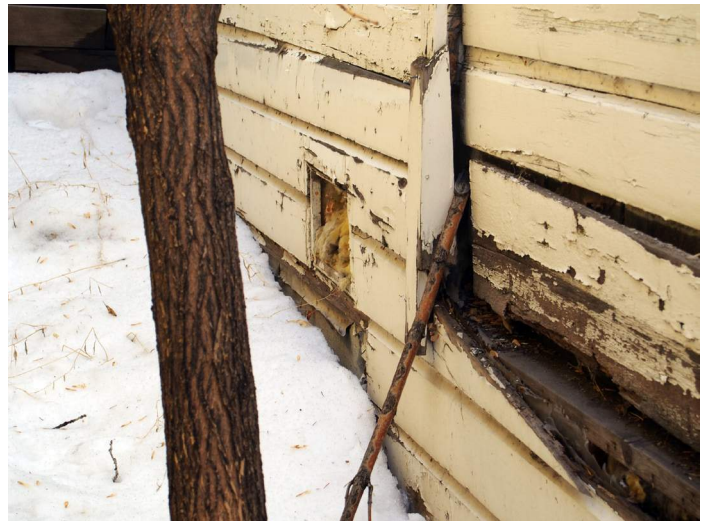
South facade trim issues

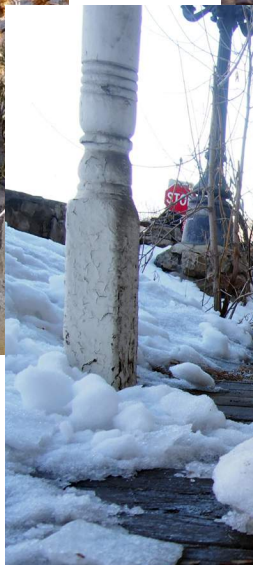
Base of Front Porch Post

There are numerous posts to document but generally they are in poor condition and likely need replacement to perform structural duties. Photographs from historic documentation should be used to augment the remaining decorative elements in a rehabilitation of posts where possible and reconstruction where necessary.
