**PARK CITY MUNICIPAL CORPORATION
HISTORIC PRESERVATION BOARD MEETING
MARSAC MUNICIPAL BUILDING
COUNCIL CHAMBERS
445 MARSAC AVENUE
PARK CITY, SUMMIT COUNTY, UTAH
MINUTES OF JUNE 4, 2025**

**PRE-DEMOLITION/RENOVATION INSPECTION
FOR ASBESTOS, LEAD, UNIVERSAL,
HAZARDOUS AND TOXIC WASTES**

**The Centennial House
176 Main Street
Park City, Utah 84060**

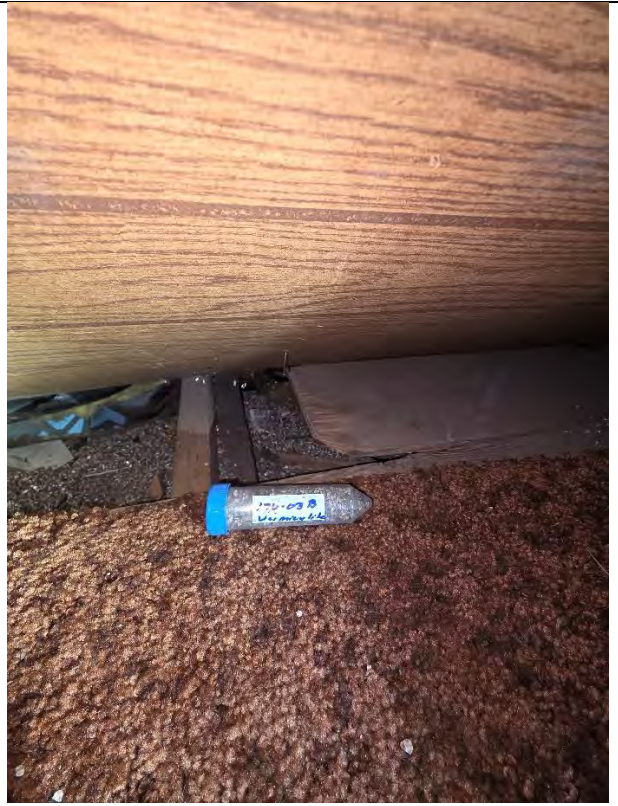
176 – 03B Vermiculite Insulation

176 – 03B	T001	Vermiculite – Third Floor	Third Floor See Figures	<1% Asbestiform amphibole suite mineral by Point Count
176 – 03C	T001	Vermiculite – Third Floor	Third Floor See Figures	2.62% Asbestiform amphibole suite mineral 2% by Point Count
176 – 03D	T001	Vermiculite – Basement	Basement North Apartment	0.73% Asbestiform amphibole suite mineral <1% by Point Count
176 – 03E	T001	Vermiculite – Basement	Basement North Apartment	1.67% Asbestiform amphibole suite mineral <1% by Point Count
176 – 04A	S002	Textured Wall Material	First Floor NE Room	1.5% Chrysotile 1% by Point Count

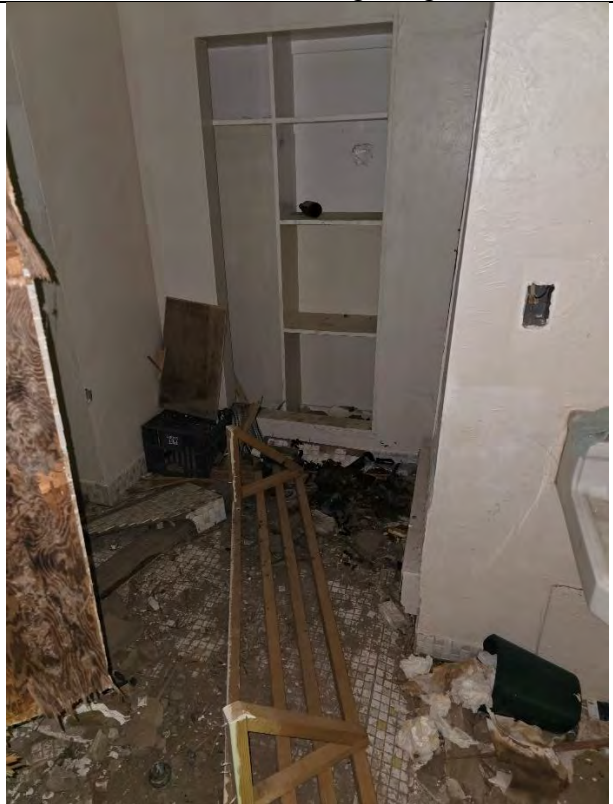
Basement South Apartment bathroom
