**PARK CITY MUNICIPAL CORPORATION  
HISTORIC PRESERVATION BOARD  
CITY COUNCIL CHAMBERS  
November 2, 2016**

## **AGENDA**

227 Main Street (Star Hotel) – Determination of Significance

**Physical Conditions Report  
Internal Demolition Report  
227 Main Street - Star Hotel  
Submitted by Westlake Land, LLC**

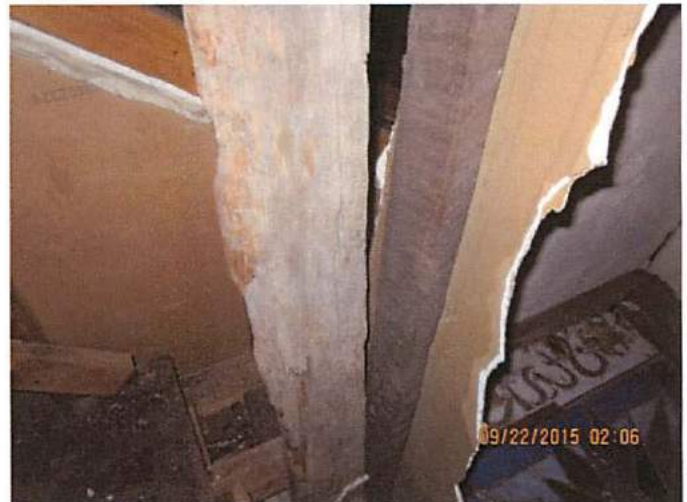
**Photo 4** Structural members not properly supported

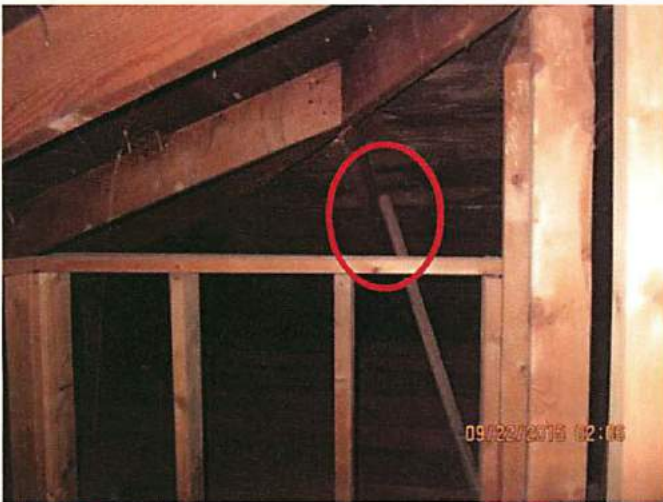
**Photo 5** Support member not properly fastened

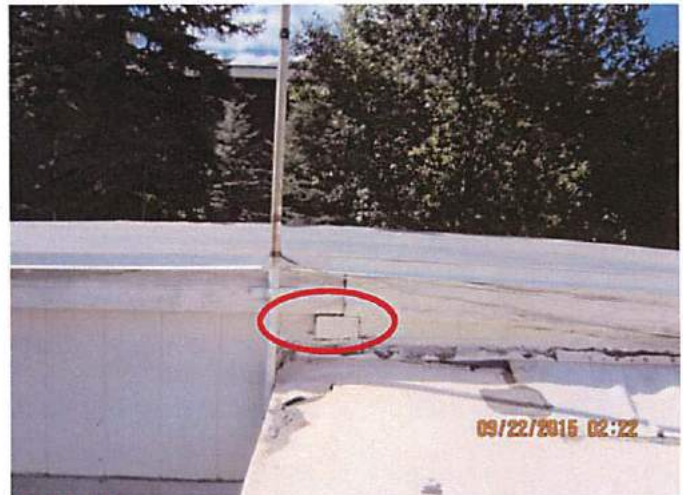
**Photo 8** Note structural beam. Refer to photo 9

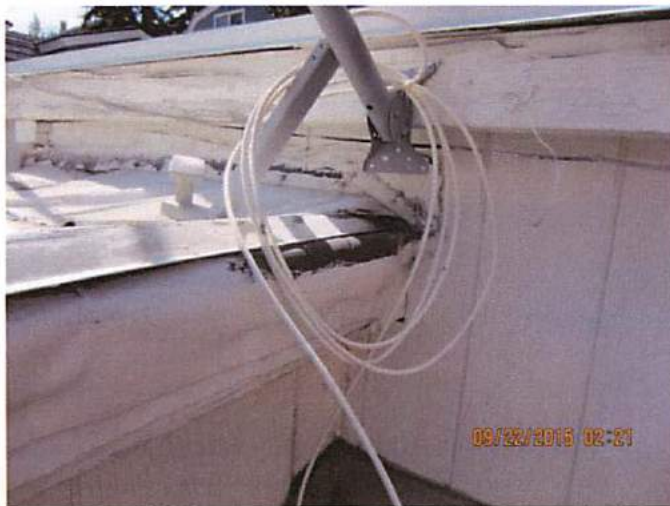
**Photo 30** Possible location of water infiltration
