**PARK CITY MUNICIPAL CORPORATION  
HISTORIC PRESERVATION BOARD  
CITY COUNCIL CHAMBERS  
July 19, 2017**

424 Woodside Avenue – HDDR Review for Reorientation - Reorientation (rotation) of a “Significant” Structure towards Woodside Avenue and lifting of the Historic Structure 7 feet 7 ¾ inches. The primary façade of the Significant Structure is currently oriented towards Main Street and the applicant is proposing to rotate the structure 180 degrees so that the primary façade is oriented towards Woodside Avenue. Upon reorientation, the Historic Structure would be lifted 7 feet 7 ¾ inches.

PARK CITY MUNICIPAL CORPORATION  
HISTORIC PRESERVATION BOARD  
MINUTES OF JUNE 7, 2017

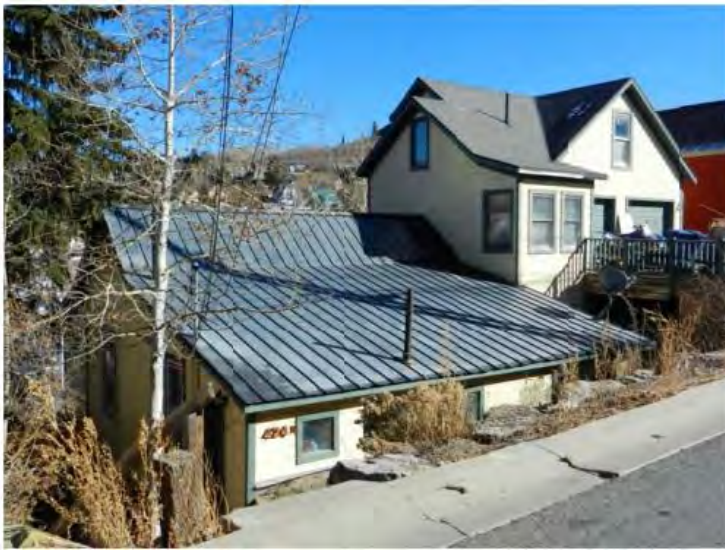
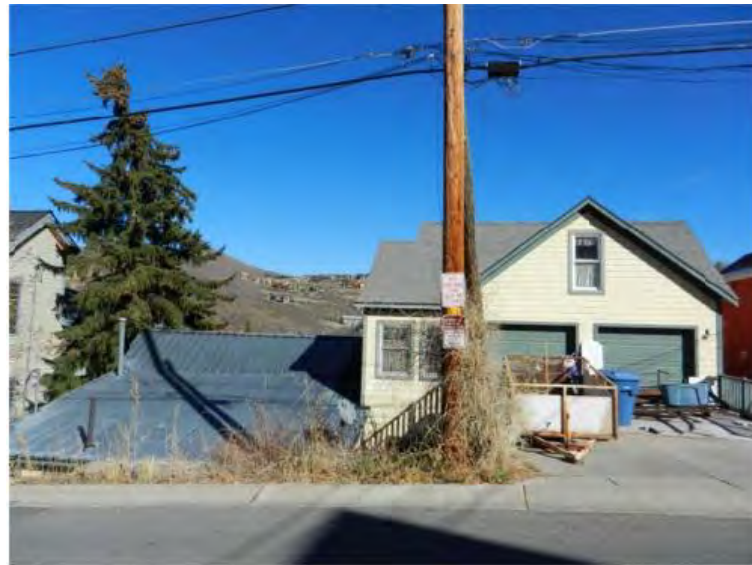
**Figure 1a:** *Current Site Orientation – Photographs West Façade*

Figures 1a through 1f identify the current conditions and existing orientation of the Historic Structure towards Main Street (east). Renderings provided by Jonathan DeGray. Photographs provided by Jonathan DeGray and CRSA.

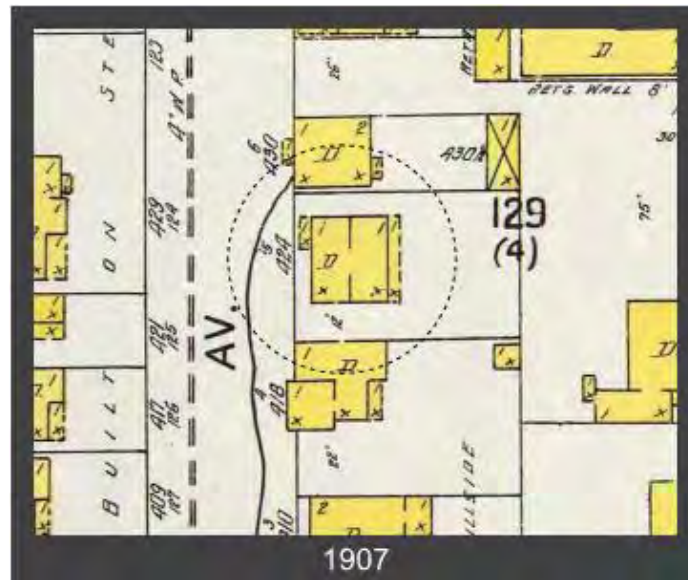
**Figure 4:** 1907 Sanborn Fire Insurance Map

- The 1907 Sanborn Map indicates that a formal front porch was added to the east side, further defining it as the primary façade, at the same time that a secondary entry porch was added to the west side. The house retained this configuration through 1930.

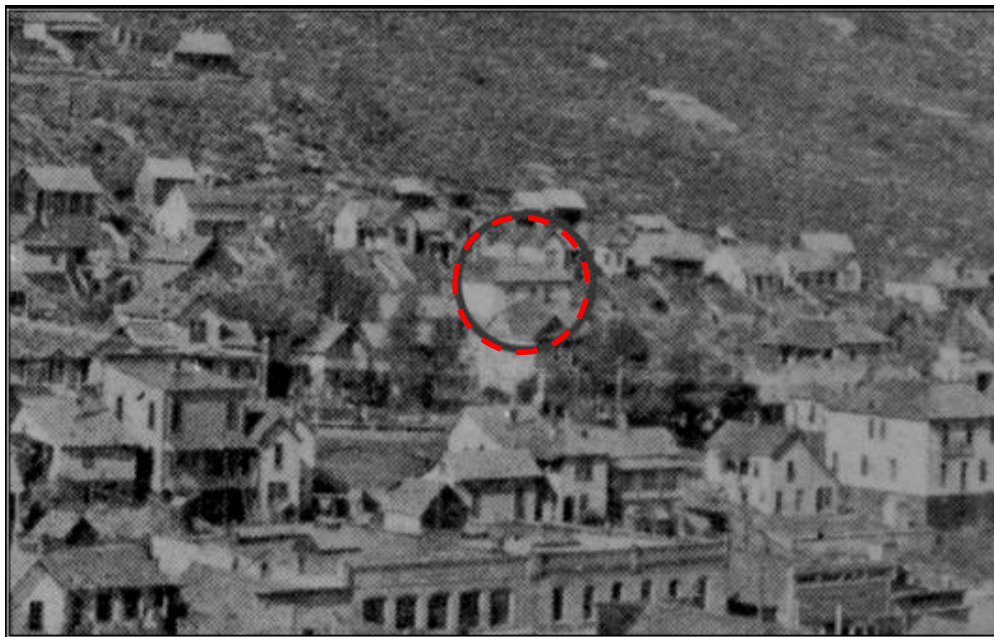
**Figure 6:** View of property ca. 1905-1907 facing north-west (circled in red). Note retention of simple hall-parlor form and continued absence of front porch on east side. Photograph provided by Jonathan DeGray courtesy of Park City Historical Society and Museum

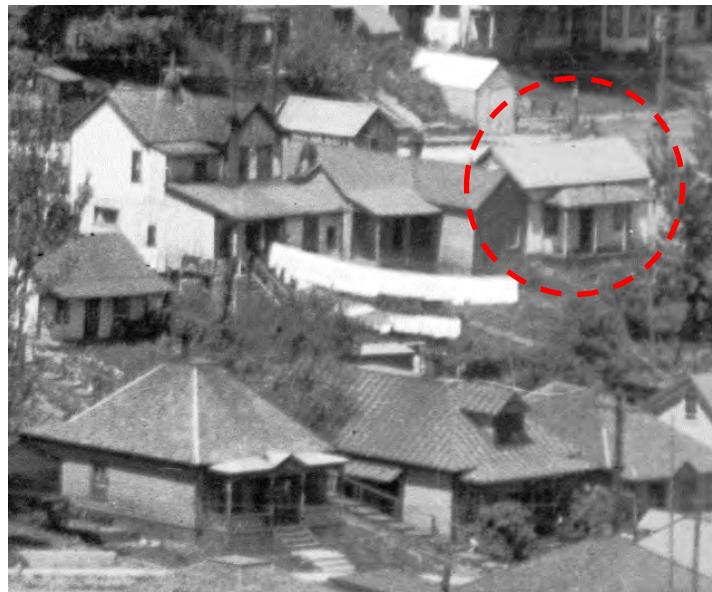
**Figure 9:** View of property at 424 Woodside in 1930, facing northwest. Note the retention of the simple hall-parlor form and addition of hip-roofed front porch, which was removed by 1941 according to the Sanborn Map. Photograph provided by Jonathan DeGray courtesy of Park City Historical Society and Museum.

**Figure 4.** View of property at 424 Woodside in 1930, facing northwest. Note the retention of the simple hall-parlor form and addition of hip-roofed front porch, which was removed by 1941 according to the Sanborn map. Photograph no. 1987-2-134.

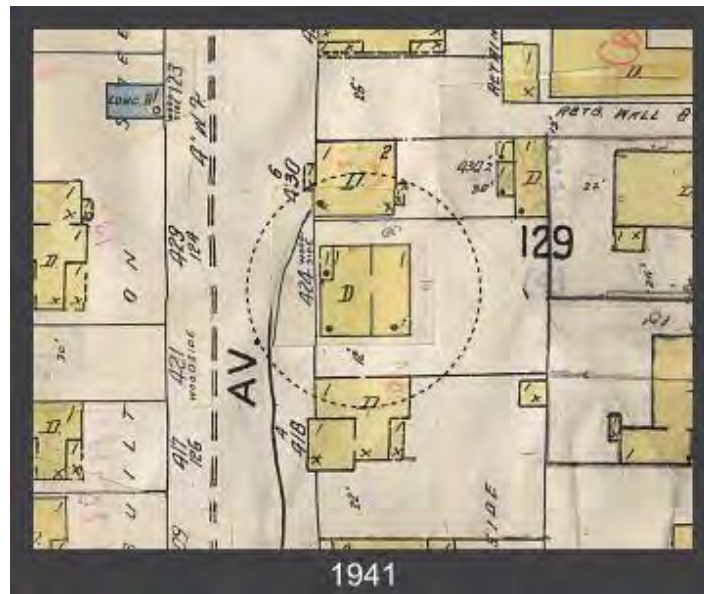
**Figure 10:** 1941 Sanborn Fire Insurance Map

- By 1941, a second shed-roofed addition had been built across the west side, incorporating the 1907 rear screened porch and essentially filling the terrace between the rear wall of the house and the retaining wall so that the eave was nearly at grade. The front porch had been removed and asbestos shingles had been applied over the original wood siding by this time.

- By 1941, a second shed-roofed addition had been built across the west side, incorporating the 1907 rear screened porch and essentially filling the terrace between the rear wall of the house and the retaining wall so that the eave was nearly at grade (Figure 5; see also Figure 1). The front porch had been removed and asbestos shingles had been applied over the original wood siding by this time (see Figures 1 and 5).

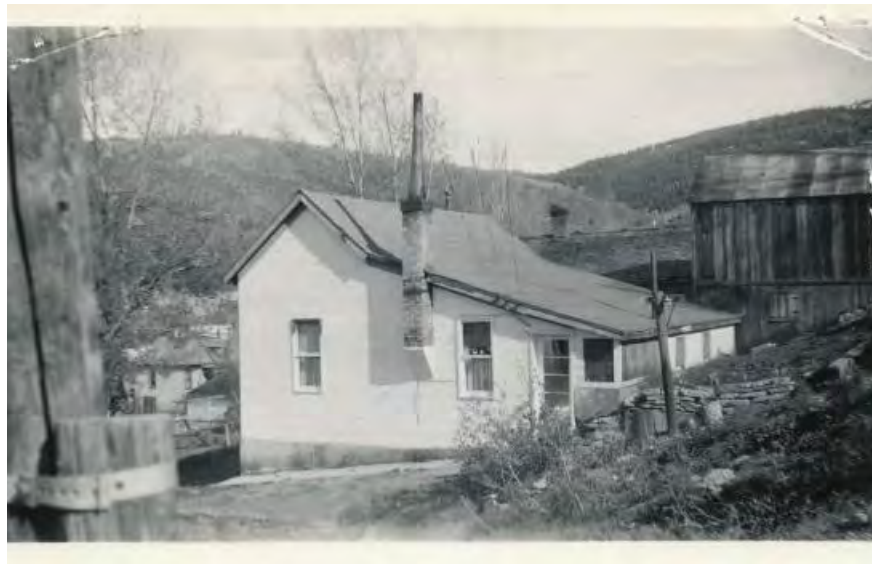
**Figure 11:** Tax appraisal photograph of property at 424 Woodside dating to ca. 1941, facing southeast.

**Figure 5.** Tax appraisal photograph of property at 424 Woodside dating to ca. 1941, facing southeast.

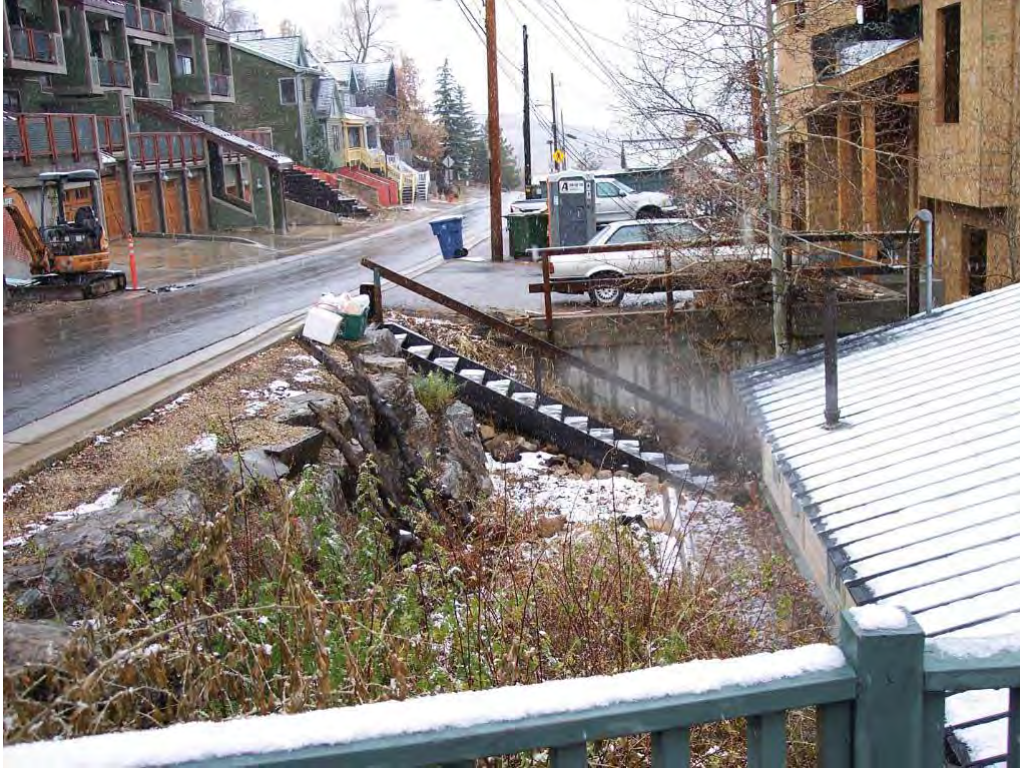
***The front of the property off Woodside Avenue has rock retaining wall that runs parallel with the street. The entry stairs are wood and are in fair shape. Stone walkway leads from the entry to the rear yard. All vegetation is natural and maintained.***

***Rock retaining wall and entry stairs along west elevation***

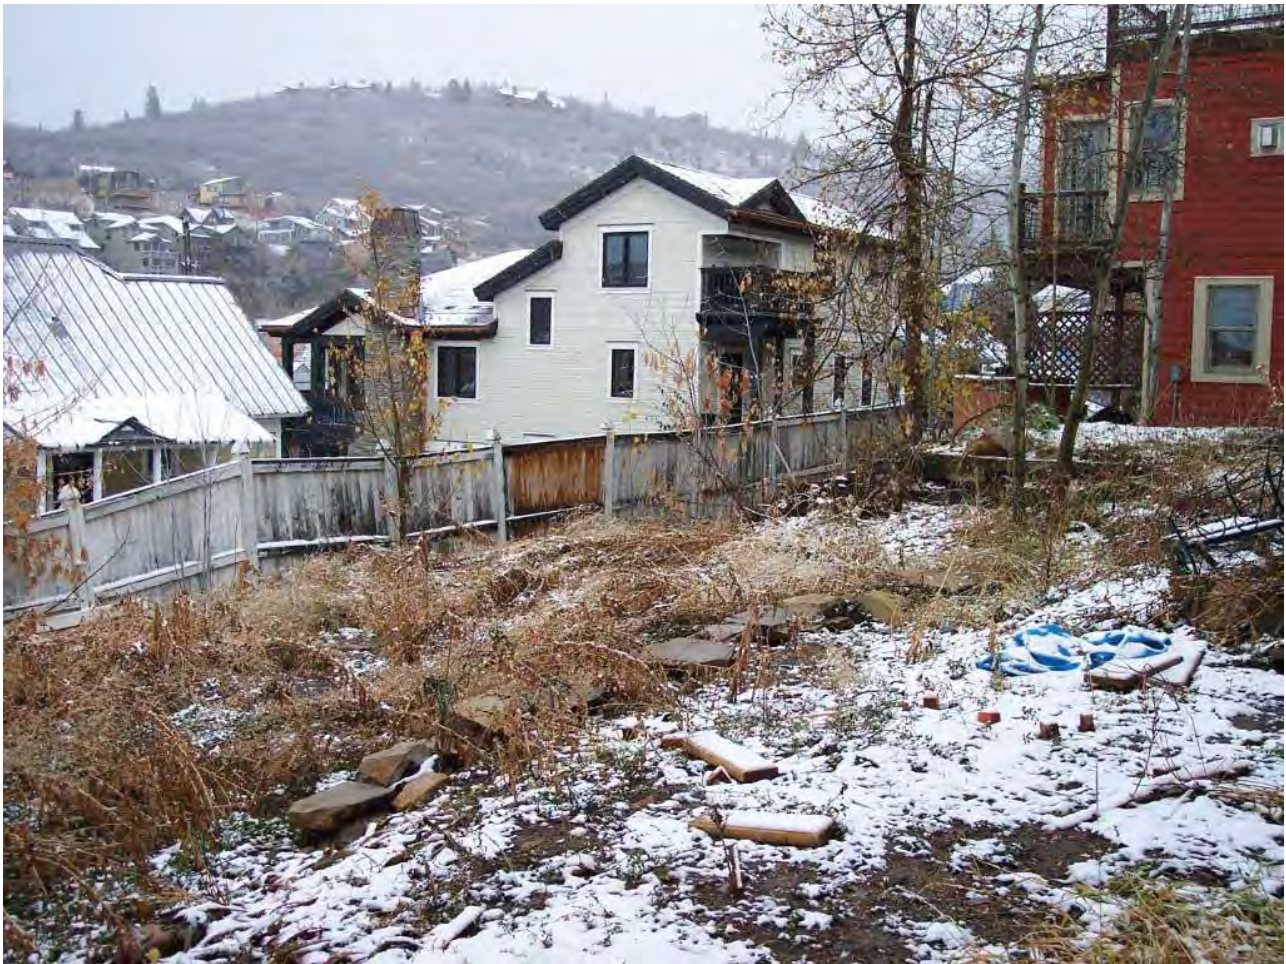
***Rear yard fence***

***The rear fence (owned by adjacent property) runs north to south and is 4x4 wood post with 1x4 wood slats in need of repair. The wood fence along the north property line is 6' length sections of 1x6 dog eared cedar slats and in need of repair.***

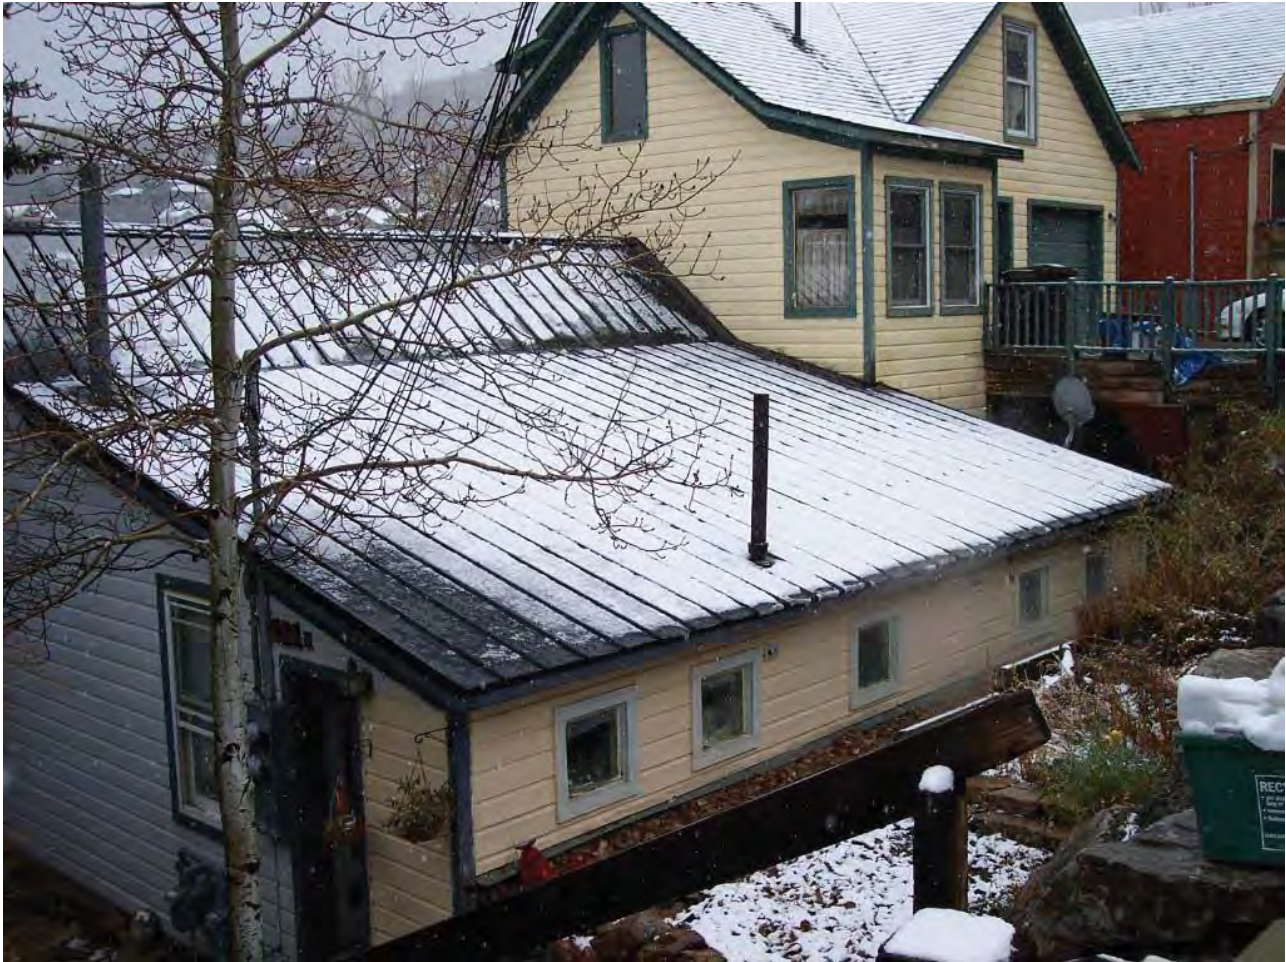
***West elevation***

***The west elevation is 1x8 horizontal lap siding applied after 1978, over historic 1x12 vertical plank on 2x4 studs at 24" o.c***

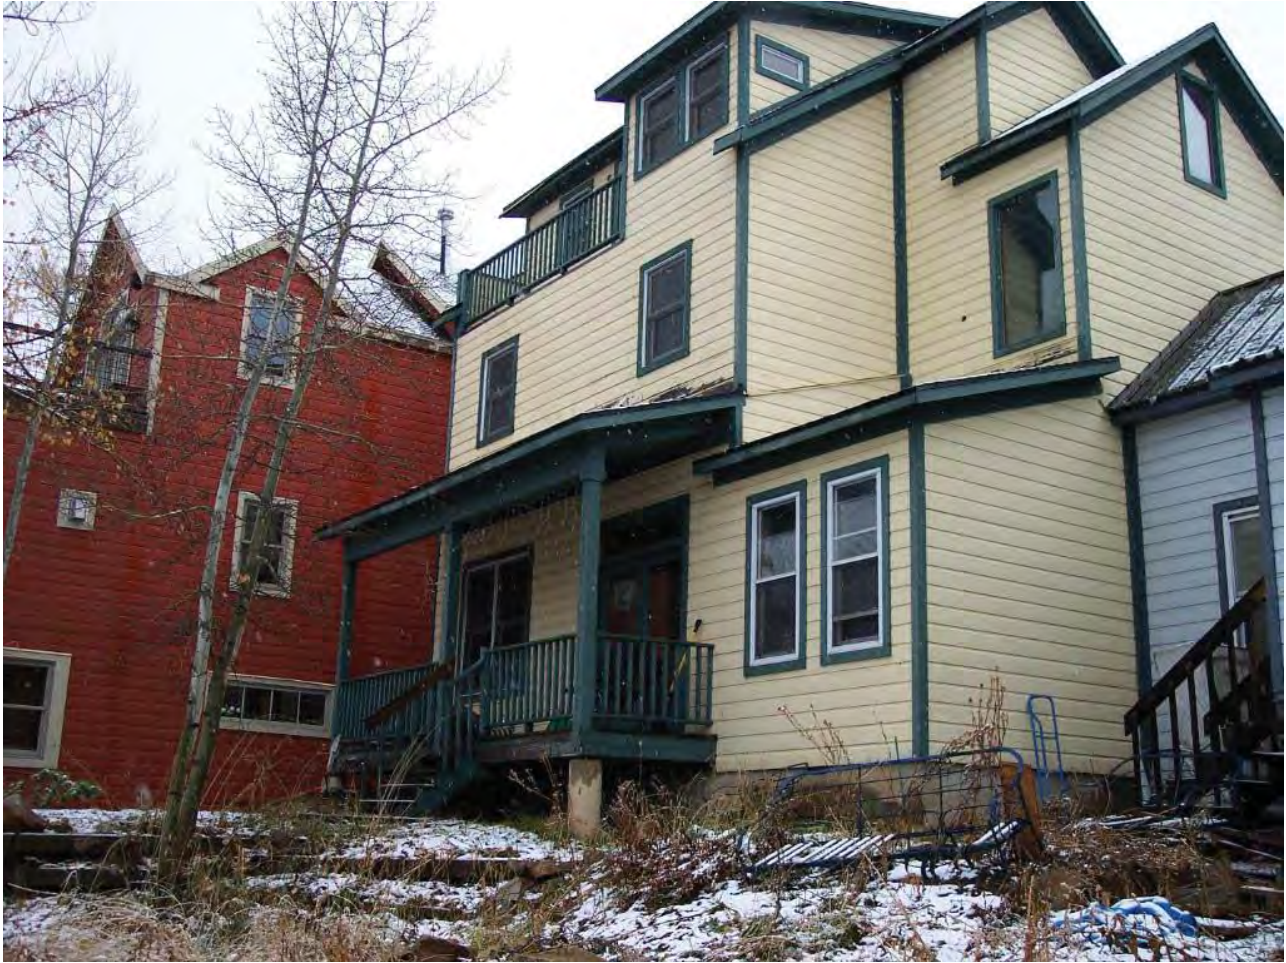
***Addition on the south elevation built after 1993***

***The south elevation has an addition built after 1993.***

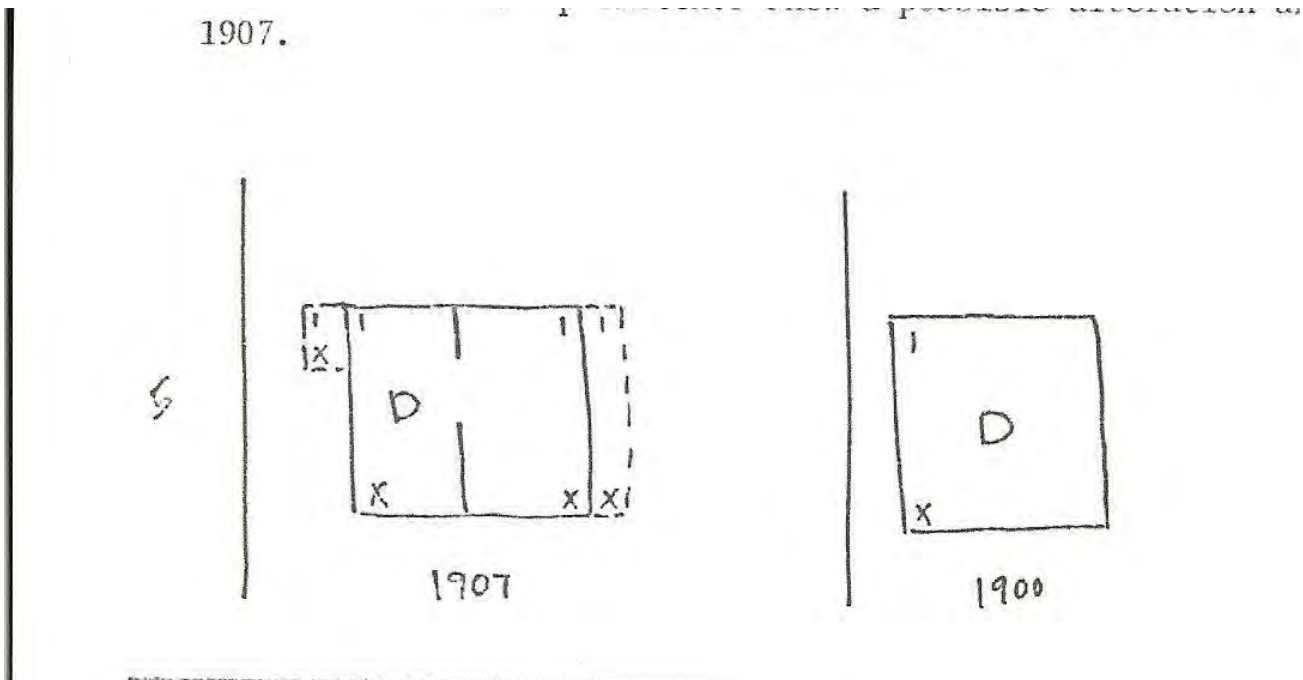
**1900-1907 Sanborn maps**

***The Sanborn maps show an alteration or addition between 1900-1907. No changes were made through 1941. There were updates/additions after 1978 to the east and west elevation. The addition on the south elevation was built after 1993.***

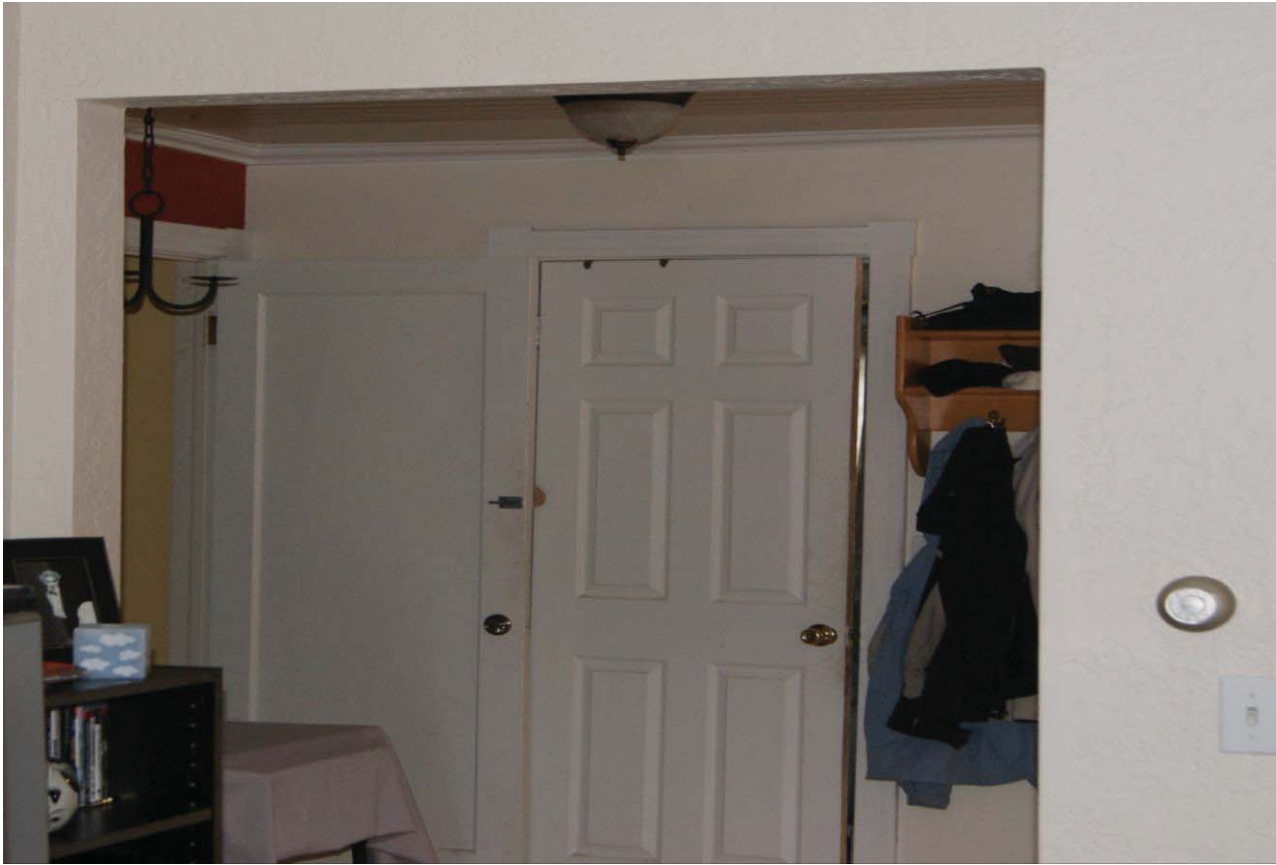
***Interior doors***

***The doors were updated after 1978 with solid core interior doors and the exterior patio door is insulated wood clad aluminum. No historic doors remain.***

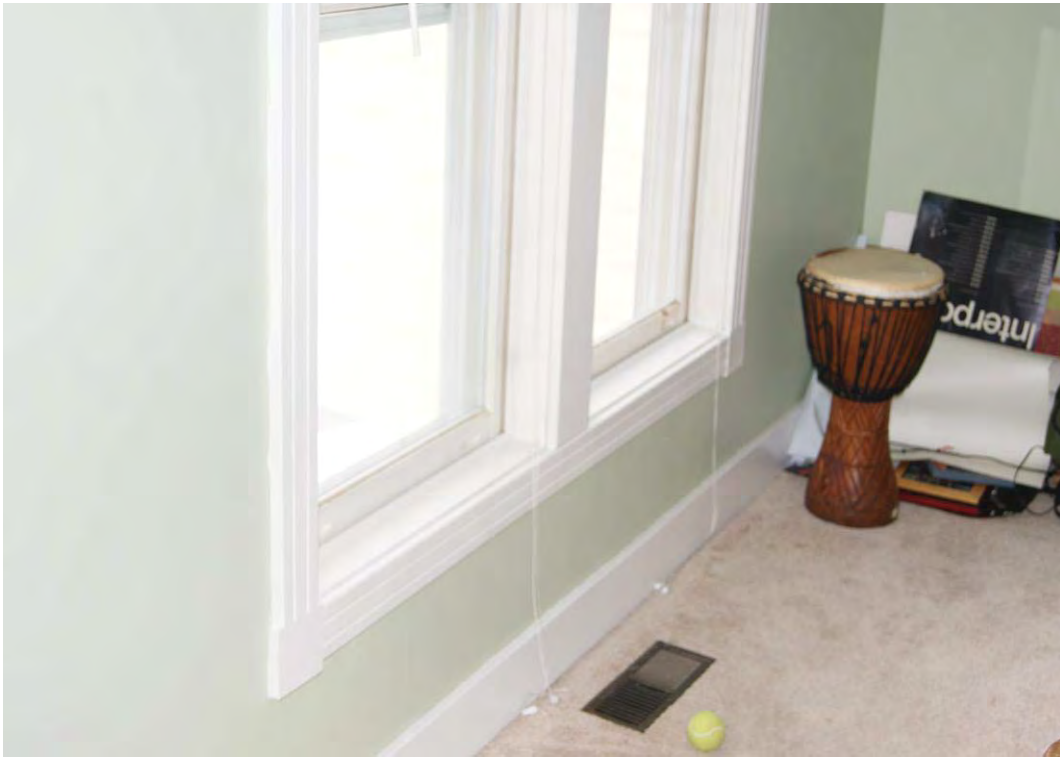
***Typical base and window casing***

***All exterior and interior trim was replaced after 1978. No historic trim remains.***

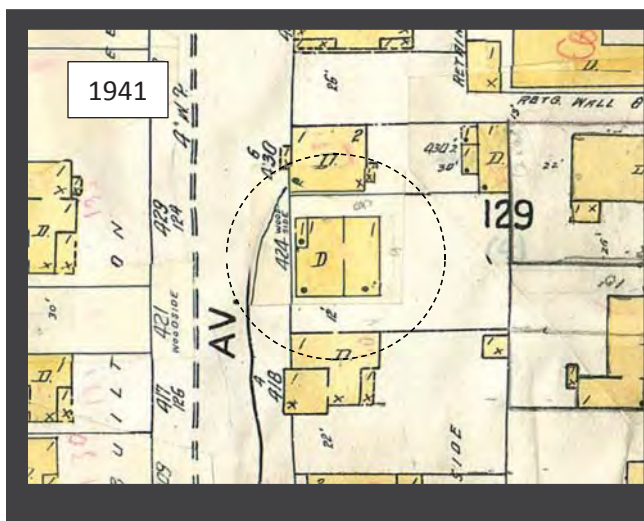
Figure 1. Sanborn Fire Insurance maps showing property at 424 Woodside 1889-1941 (from Carmen 2015).

- The wood-framed and wood-sided house originally faced east, providing a view over Main Street. Physical evidence and the 1889 Sanborn map indicate that it had a small shed-roofed wing on the south end of the rear (west) side but no front porch (see 1889 Sanborn in Figure 1).

- By 1900, the original shed-roofed wing had been extended across the rear (west) side (see 1900 Sanborn in Figure 1).
- In 1907, the Sanborn map indicates that a formal front porch was added to the east side, further defining it as the primary façade, at the same time that a secondary entry porch was added to the west side. The house retained this configuration through 1930 (Figure 4; see also Figure 1).

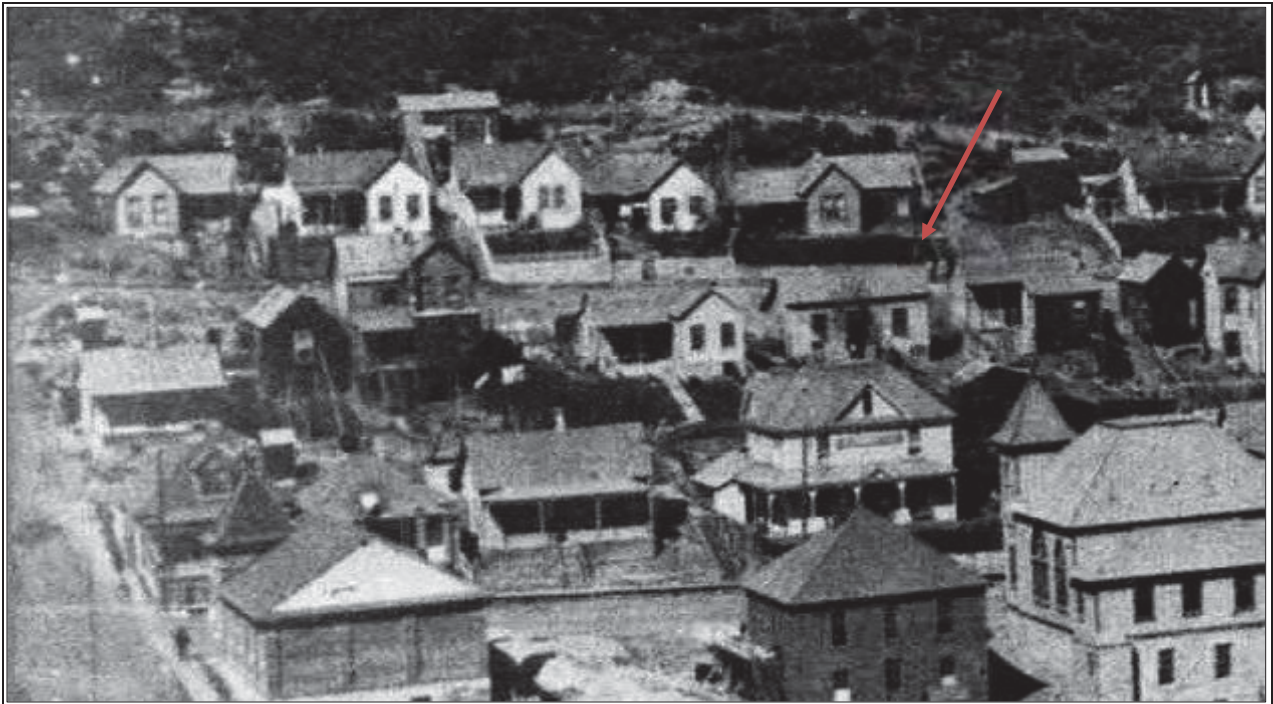
**Figure 2.** View of property at 424 Woodside ca. 1905-1907, facing west-northwest. Note retention of simple hall-parlor form and continued absence of front porch on east side. Photograph no. 1985-6-001.

- As visible in historic photographs, the principal façade was composed of a central doorway flanked by a window on each side (Figures 2 and 3). Woodside Avenue was present to the west but, in the pedestrian-oriented city of the time, access to the house was also via a footpath leading north from Fourth Street behind the Park Avenue houses, and then a short staircase leading up to the east façade (obscured by houses in the foreground). The orientation of houses along the uphill (west) side of Woodside was uniformly east-facing, while orientations along the downhill (east) side was mixed, with some facing the street and others the canyon.

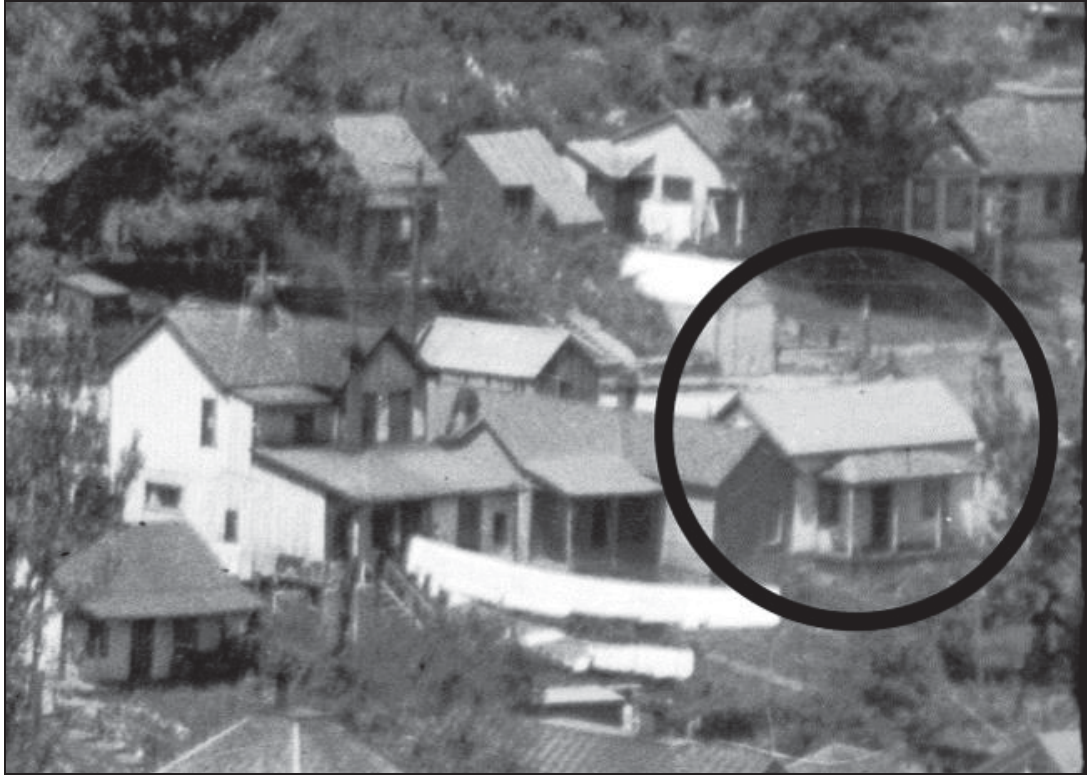
**Figure 3.** View of property at 424 Woodside in 1907, facing west-northwest. Note simple hall-parlor form, east-facing aspect with a view across canyon, and access via a footpath leading north from Fourth Street behind the Park Avenue houses. Note the absence of a front porch on east side, although according to the 1907 Sanborn map a porch was added in this year. Also note the mix of house orientations along the downhill (east) side of Woodside, with some facing the street and others the canyon. Photograph provided by Jonathan DeGray.

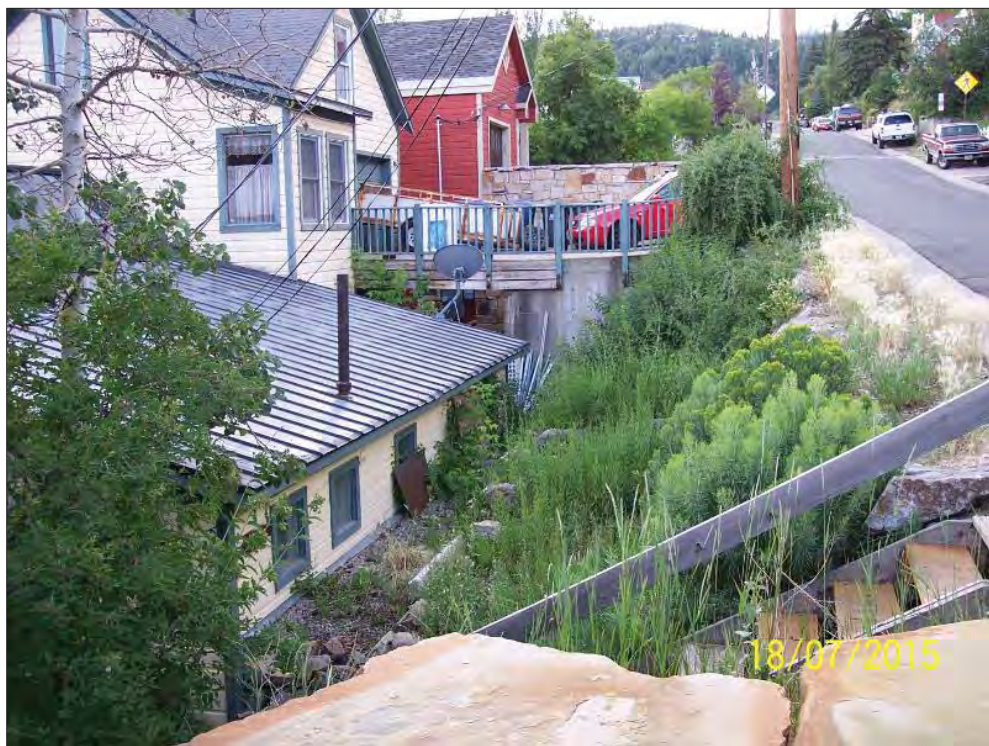
**Figure 6.** North and west sides of historic house at 424 Woodside, facing east-southeast, 2015.

- Between 1978 and 1993, the east façade was modified by the addition of a sunroom across the north two-thirds (which likely was created by enclosing the ca. 1968 front porch), covering the original doorway and north window. The interior floor plan indicates that these historic openings were completely removed or covered at the time. As well, the south window on the east façade was enlarged to accommodate two one-over-one windows (see as-built drawings in DeGray 2016). The asbestos shingles were also removed during this period and replaced with new drop siding; on the west and north elevations this was applied over the original 1 x 12 vertical plank sheathing (Figure 6). It appears that all original windows and doors were replaced as well (DeGray 2016).

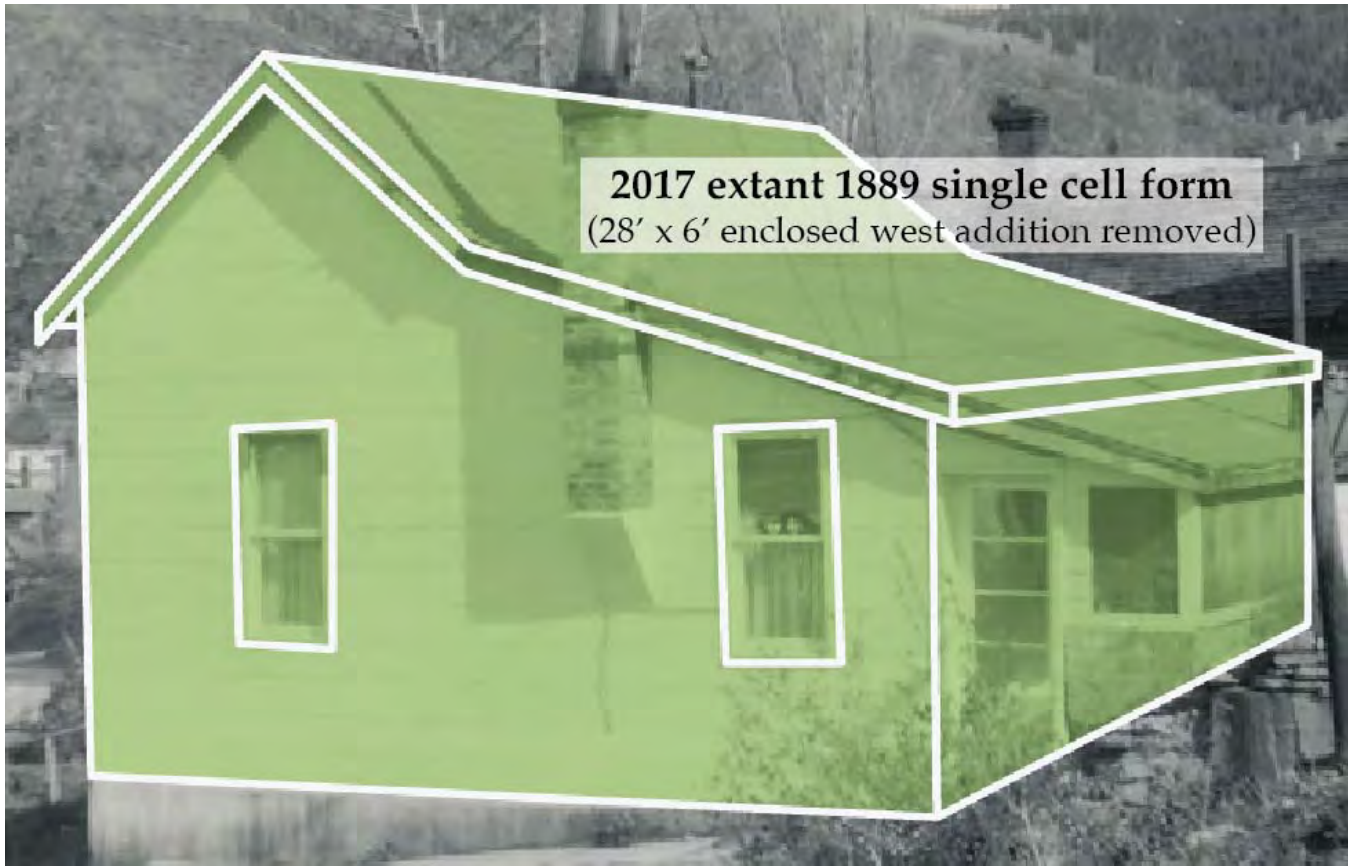
*"It is our intention to strip the existing historic form building down, removing all the contemporary material and then see what we have. We anticipate not finding any historic material other than 1 x 12 exterior wall sheathing attached to new stud walls. If this is the case we would propose to proceed as follows."*

**(Comment # 5.)** *See 'PHYSICAL CONDITIONS REPORT, 2016 (2011) COMMENTS' for analysis of existing historic material. Considering that the 1889 single cell roof form still exists entirely and unaltered, the 1889 single cell form still exists with no changes to the north façade other than superficial, minimal changes to the 1889 west façade (inside the newer west façade), some removal of the 1889 east façade, and with the possibility that south-façade historic material may still exist as a portion of the wall between the historic structure and the new addition (After soliciting the opinion of two local historic-preservation experienced contractors and one local project manager with prolific similar experience, the consensus is that south façade historic material probably still exists between the historic structure and the addition.), there may be a considerable amount of extant historic material. See the two images below that exhibit the current presence of the 1889 single cell form and the possibility of currently existing historic material.*
