**PARK CITY MUNICIPAL CORPORATION  
HISTORIC PRESERVATION BOARD  
CITY COUNCIL CHAMBERS  
February 7, 2018**

173 Daly Avenue - PL-17-03468 —Disassembly/Reassembly and Material Deconstruction—Significant House. The applicant is proposing to disassemble and reassemble the Historic House, Historic shed, and the east and south walls of the Historic single-car garage. The applicant is proposing to panelize the west and north walls of the Historic single-car garage. The non-historic siding will be removed. The applicant will be removing the existing Historic windows, an existing stack rubble wall on the east side of the building, the existing roofs and roof framing, the existing historic doors, and the east wall of the historic shed structure to accommodate a connection to the Historic house.

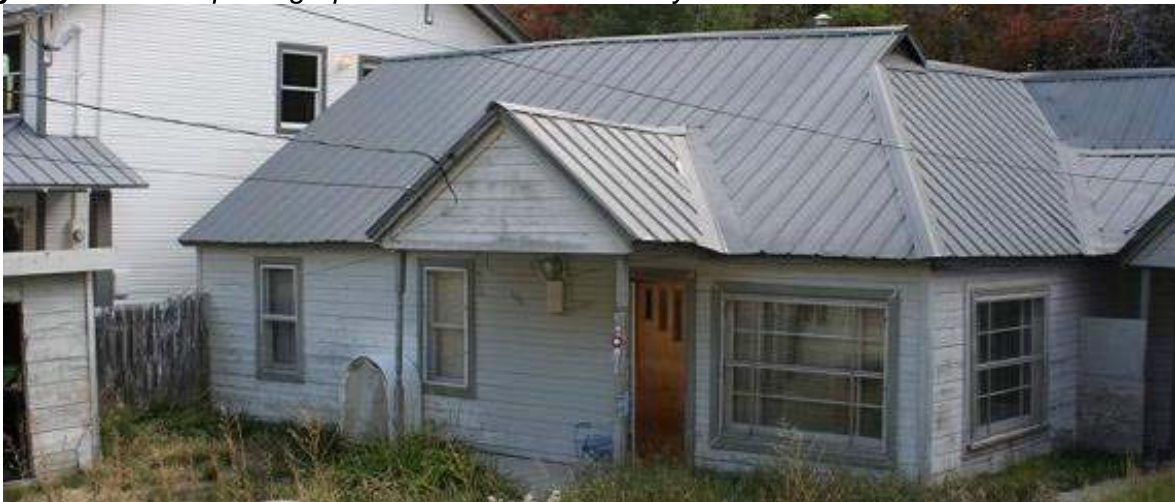
***Figure 1: Current photographs of the site at 173 Daly Avenue.***

***Historic House: West Elevation (northern end)***

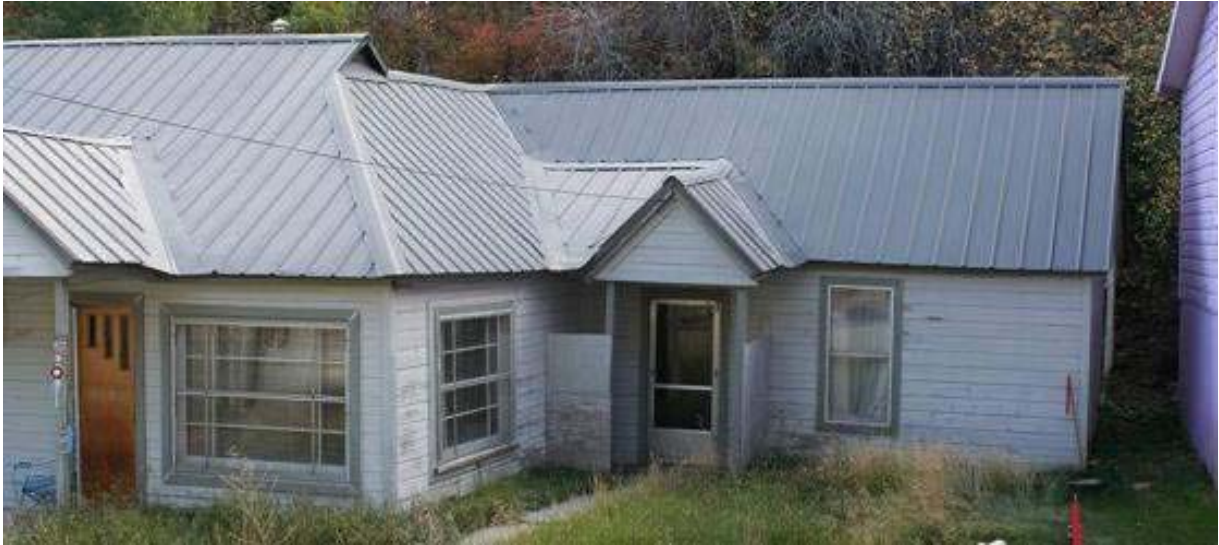
***Historic House: West Elevation (southern end)***

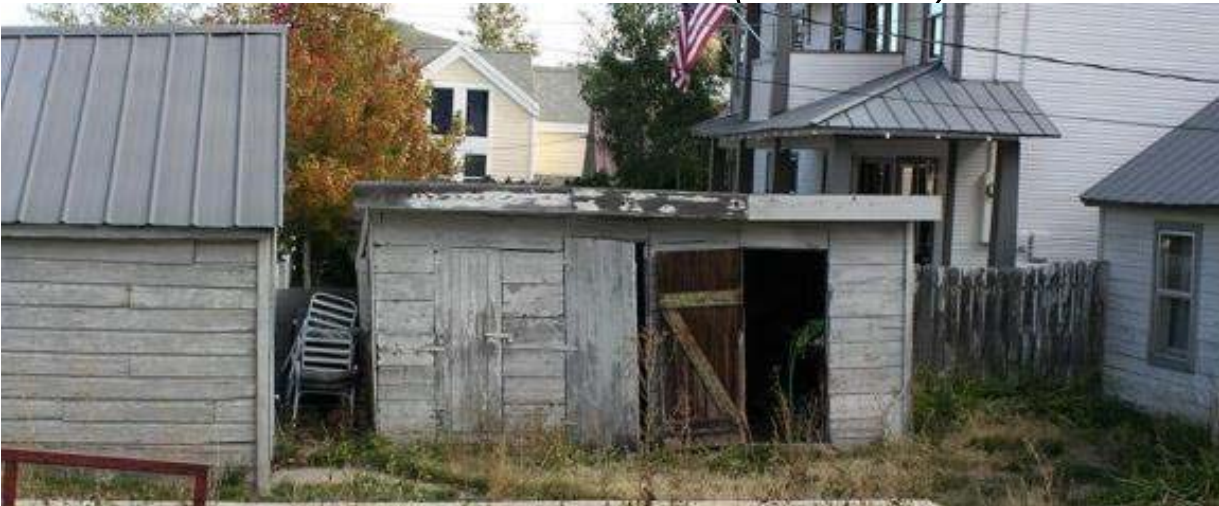
***Historic Shed: North Elevation***

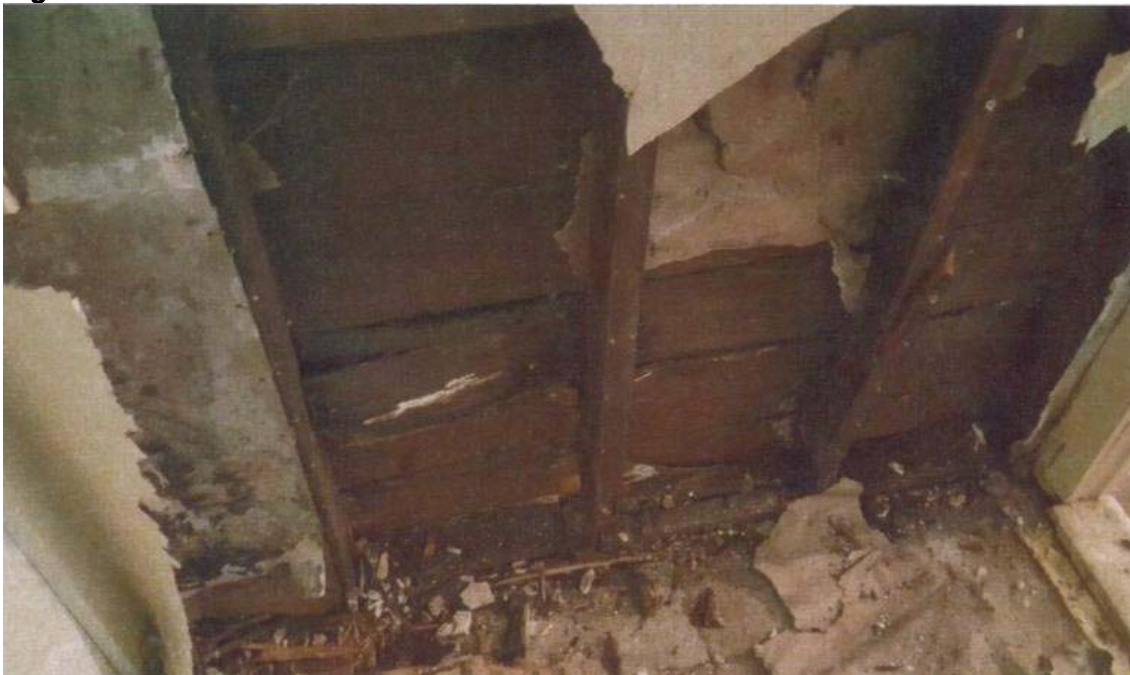
**Figure 4:** Detailed conditions of the interior of the Historic House.

*Rotted wall in the bathroom.*

- Due to the lack of foundation beneath the historic house, the floor structure has slumped and has considerably rotted. This has caused the walls to buckle and settle unevenly. It is no longer safe to enter the building due to its structural instability.
- The hillside has settled across the back of the historic house, accelerating the deterioration of the wood sided walls. Moisture has entered the structure through the deteriorated floor and rotted wood siding, causing black mold throughout the interior of the house, this can be clearly seen and creates an extreme health hazard.
- Asbestos has been discovered throughout the structure furthering the need to mitigate.

The Chief Building Official’s Determination Letter has been included as Exhibit I. Staff has included the photographs in Figure 3 that detail the conditions of the interior of the Historic House. These photographs were submitted by the applicant as a part of the Physical Conditions Report (Exhibit D) and supplemental submittals.

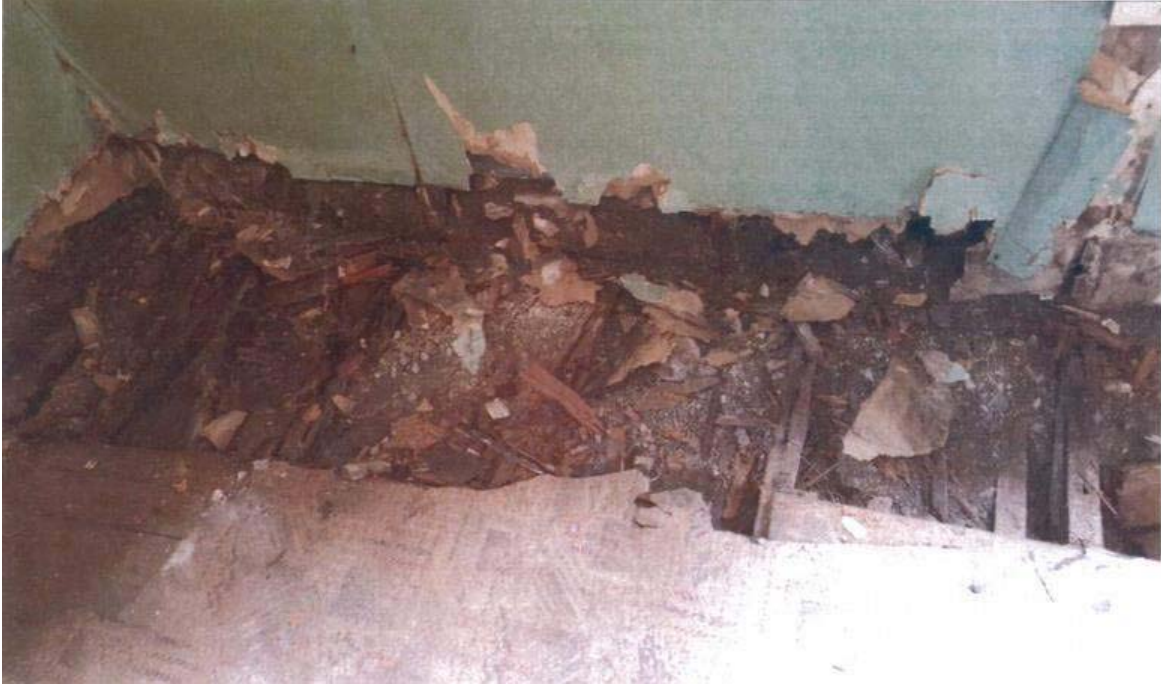
*Rotted floor in the south bedroom against the west wall.*

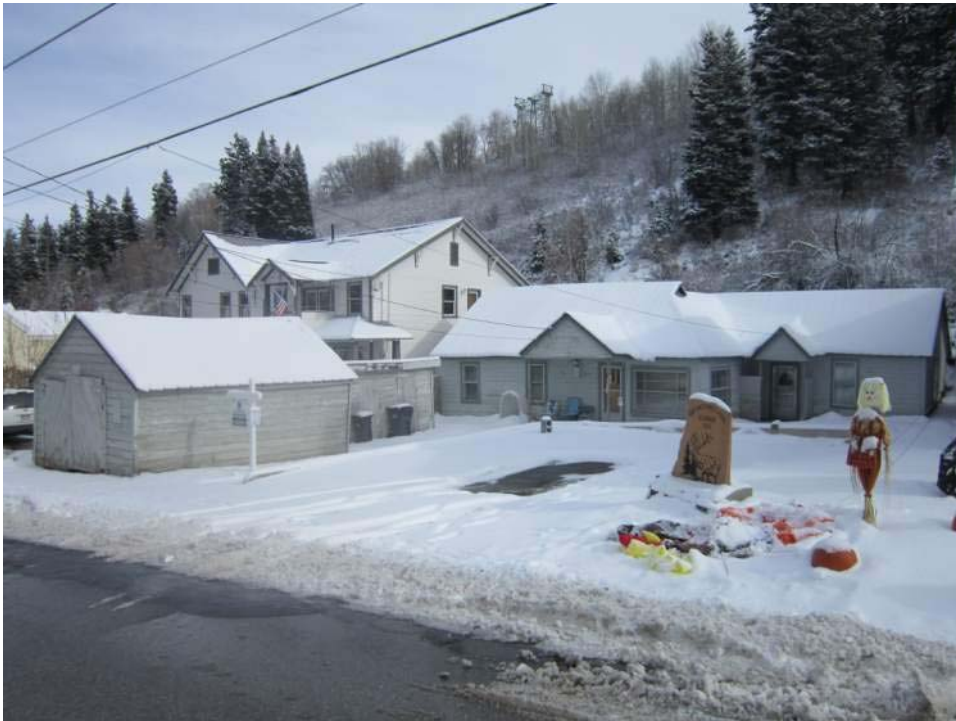
173 Daly Avenue. Southwest oblique. November 2013.

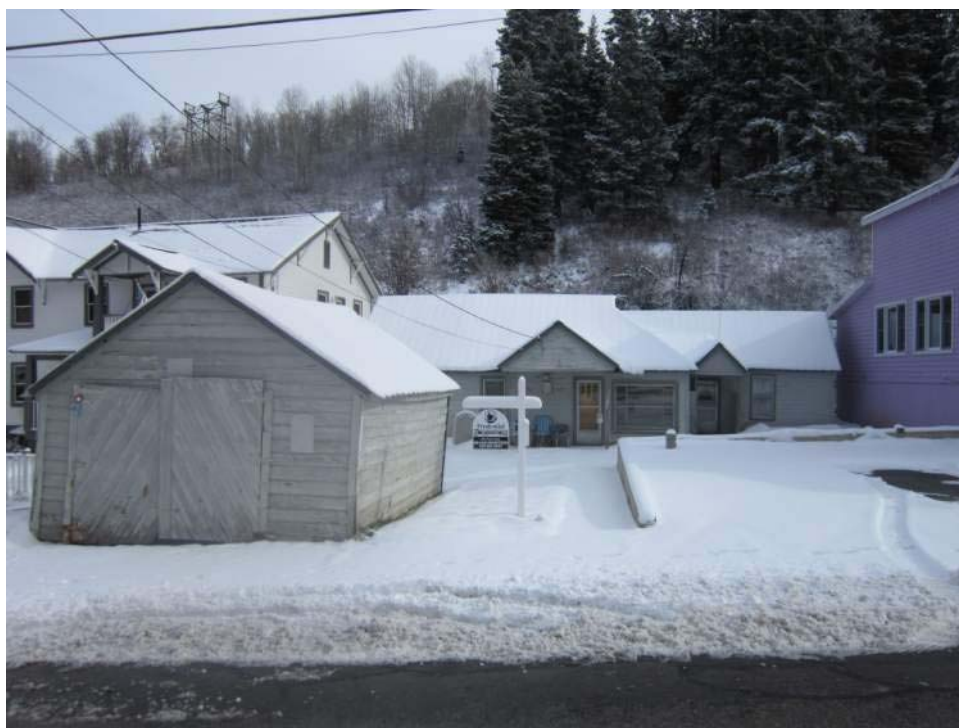
173 Daly Avenue. West elevation. November 2013.

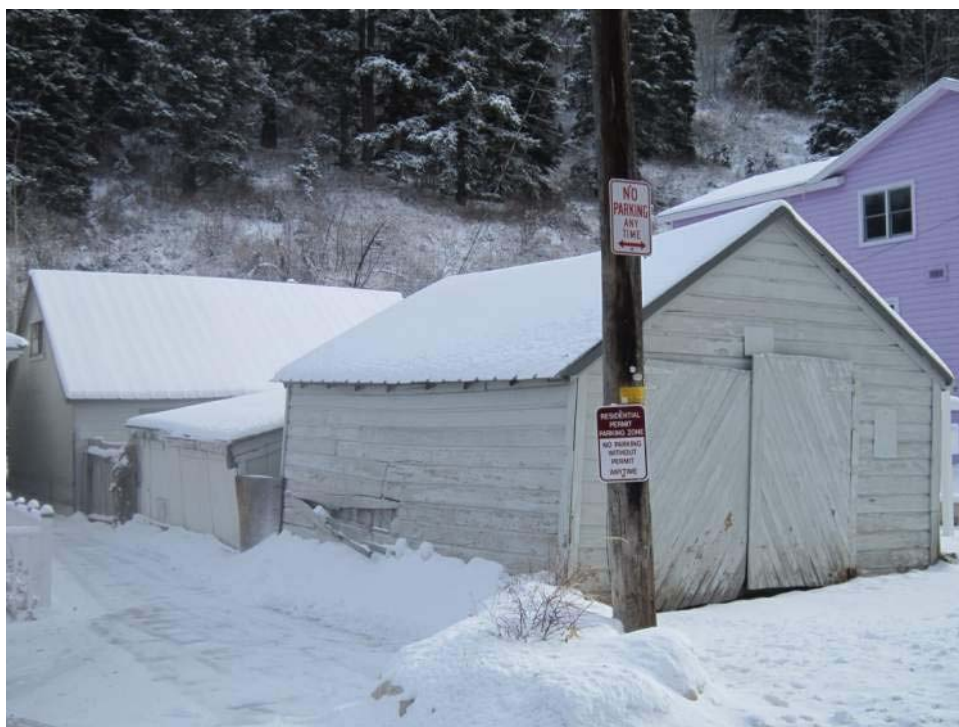
173 Daly Avenue. Northwest oblique. November 2013.

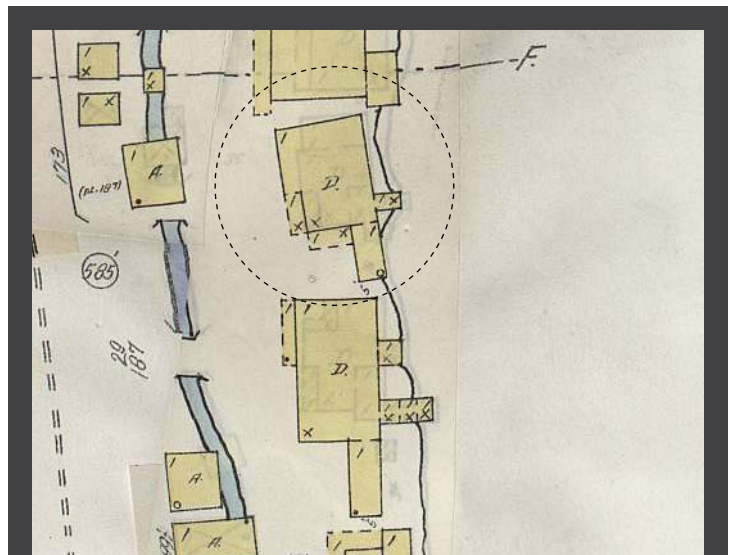
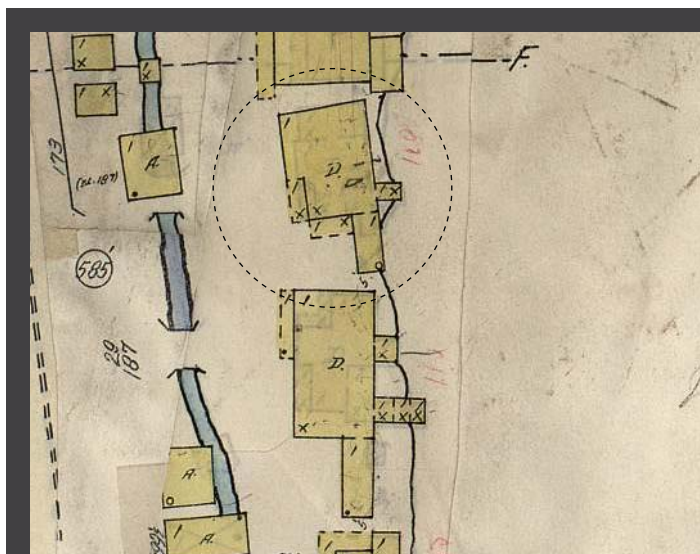
173 Daly Avenue, Park City, Summit County, Utah  
 Intensive Level Survey—Sanborn Map history

1889

1900

1907

1929

1941

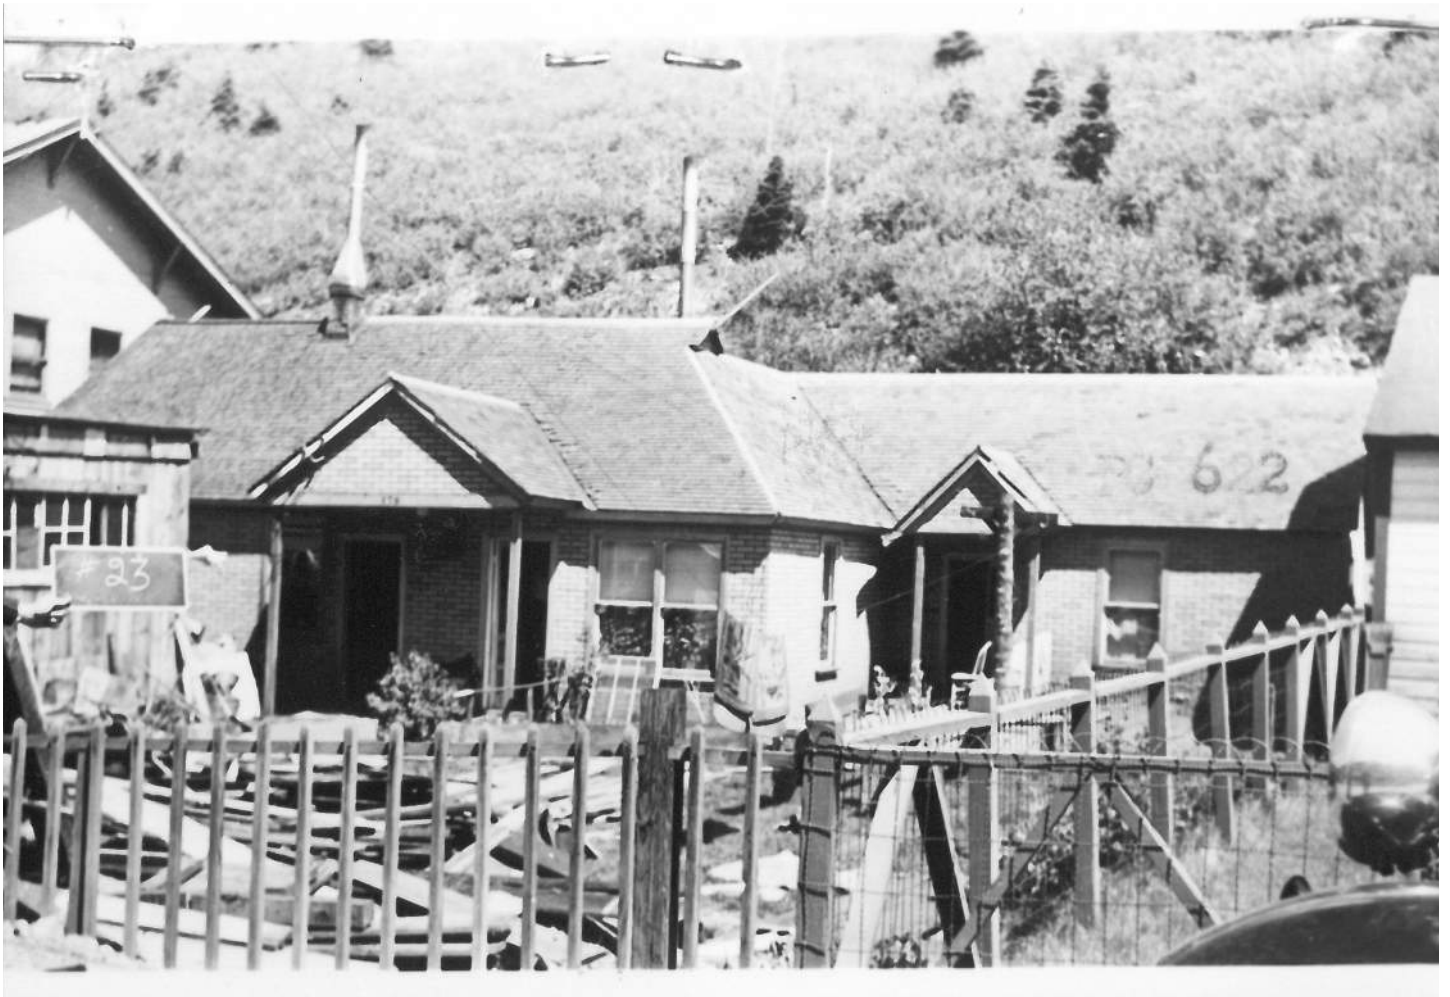
c. 1941 (Summit County)

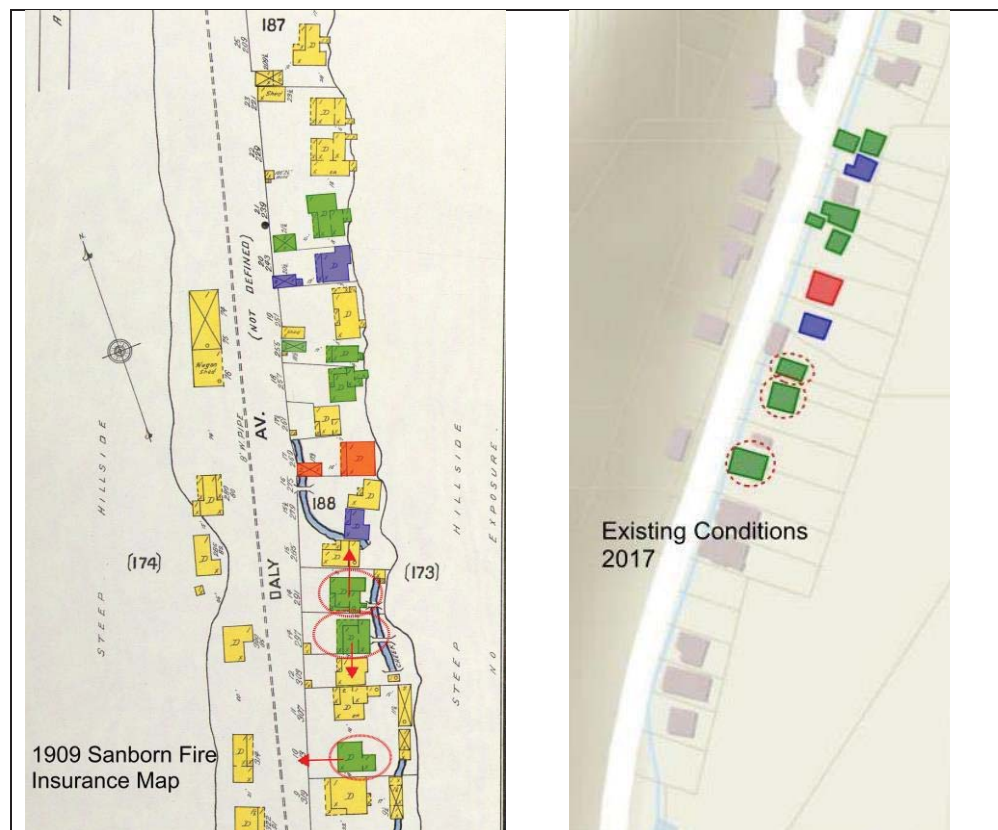
The map on the left is the 1909 Sanborn Fire Insurance Map; whereas, the map on the right is a current map. The map includes houses within the 200 and 300 blocks of Daly Avenue, but does not include all of the houses on the street. In both maps, 269 Daly Avenue has been highlighted in red. Of the nine (9) historic structures existing on the current map, only two (2) have been relocated; however, further analysis of the street showed that six (6) of the total 33 historic buildings on the street have been relocated. The bullet points provide a key.

- *Green buildings have been designated as Significant on the City's HSI*
- *Blue buildings are designated as Landmark on the City's HSI*
- *The red building is 269 Daly Avenue*
- *291 and 297 Daly Avenue are circled in a red dashed line. These houses were approved to be relocated north and south, respectively, in order to permit the development of the lot in between them.*
