**PARK CITY MUNICIPAL CORPORATION  
HISTORIC PRESERVATION BOARD  
CITY COUNCIL CHAMBERS  
December 7, 2016**

664 Woodside Avenue – Historic District Design Review – Material Deconstruction of non-historic stacked stone retaining walls, 2009 wooden staircase, 2009 standing seam metal roof, c.1900 extant chimneys on the east and west sides of the house; c.1940 Bricktex siding; c.1900 stacked stone and c.1920 concrete block foundation; c.1950 porch railings; seven (7) historic doors; c.1920 wood windows; and foundation of garage. PL-16-03330 39  
*Planner*  
*Grahn,*  
*Turpen*

**GARRETSON RESIDENCE**  
HISTORIC RENOVATION AND ADDITION  
664 WOODSIDE AVENUE, PARK CITY, UT 84060  
HISTORIC DISTRICT DESIGN REVIEW SET

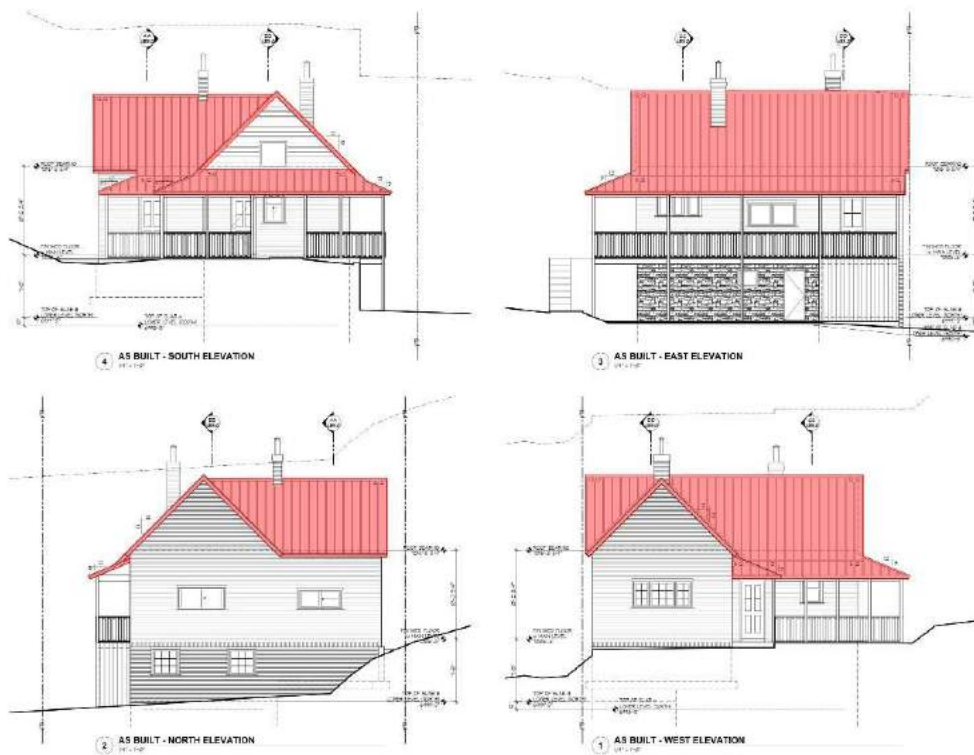
Currently, the original roof form is covered in a standing-seam metal roof that was installed by the City in 2009; heat tape was added in 2012. The applicant is proposing to remove the standing seam metal roof and install a new architectural grade shingle roof. The wood framing on the interior of the roof will remain; however, the structure will be upgraded by sistering the existing wood members with new wood members.

Staff finds that the proposed material deconstruction is required for the rehabilitation of the historic house. The areas to be replaced with asphalt shingles are highlighted in red below.

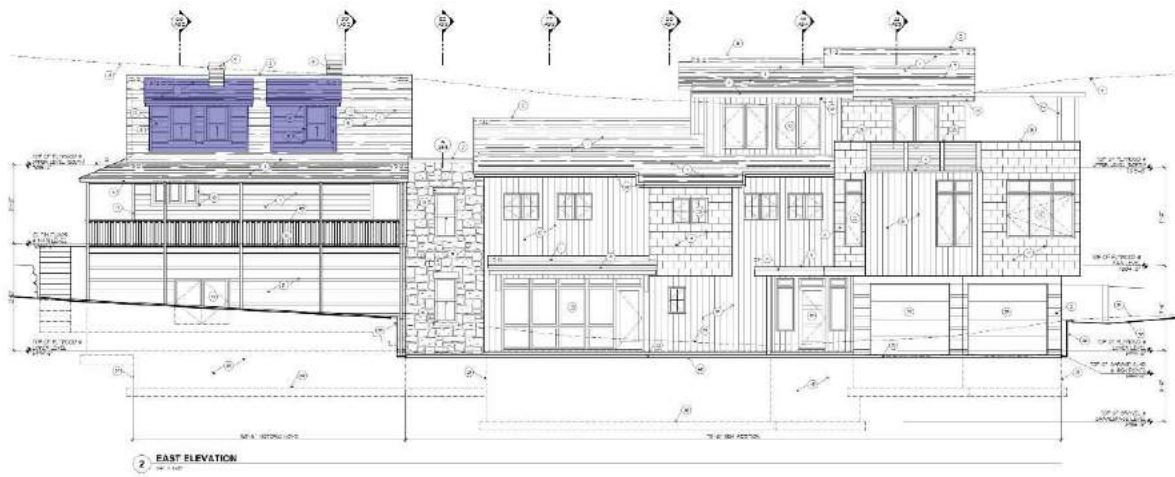
The applicant is also proposing to construct two shed dormers on the east (rear) elevation of the house in order to provide additional living space in the attic. The Design Guidelines permit the construction of new dormers and other new roof features so long as they are visually minimized when viewed from the primary public right-of-way on Woodside Avenue. Staff finds that the construction of new dormers on the rear elevation of the building will make them nearly invisible from the primary public rights-of-way. Further, the dormers will be constructed below the ridge of the original roof form to further conceal their visibility and maintain the original roof form.

Staff finds that the proposed changes will not damage or destroy the exterior architectural features of the subject property which are compatible with the character of the historic site. The proposed dormers are highlighted in blue below.

9. The applicant is also proposing to construct two shed dormers on the east (rear) elevation of the house in order to provide additional living space in the attic. The proposed changes will not damage or destroy the exterior architectural features of the subject property which are compatible with the character of the historic site.

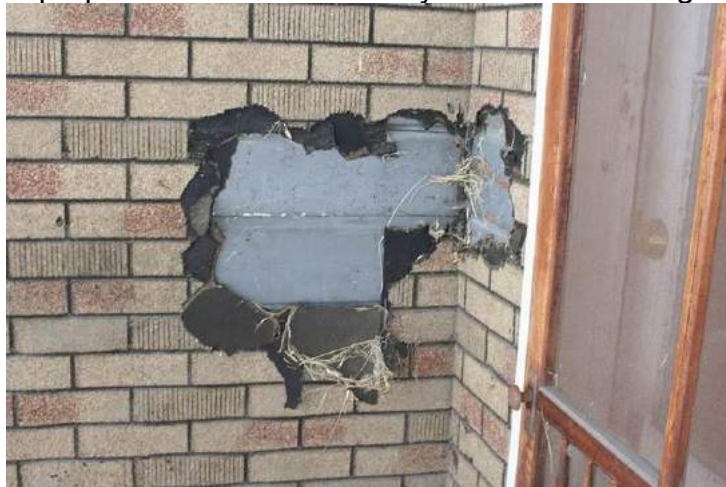
The exterior walls are covered with asbestos Bricktex siding that was likely added c.1940 when low-maintenance siding became popular. The historic drop-novelty siding exists beneath the Bricktex siding; however, it is unclear how much of the siding is salvageable. Staff finds that the removal of the Bricktex is necessary for the restoration of the historic house. As the condition of this wood siding is unknown, staff recommends adding Condition of Approval #3:

Staff finds that the proposed work is necessary to restore the original wood siding.

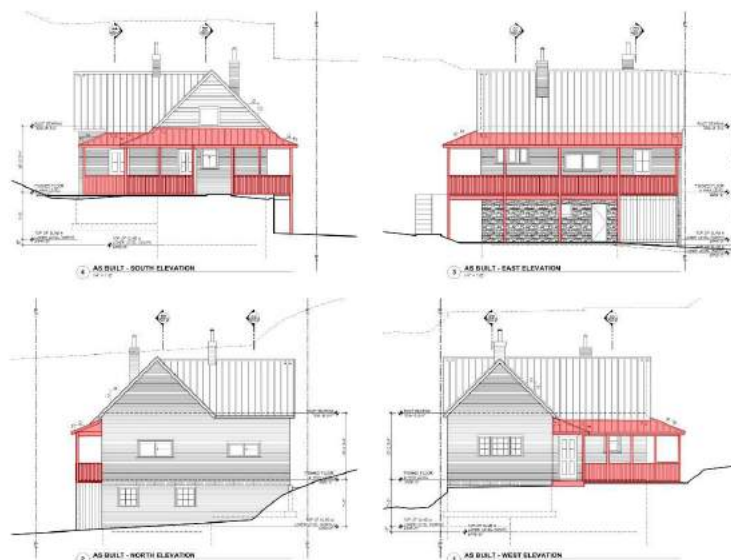
The existing wood frame porch wraps around the west façade, south elevation, and east (rear) elevations of the building. From the Sanborn Fire Insurance Maps, we know this wrap-around configuration appeared after 1907 when the livery was demolished and the house at 703 Park Avenue was replaced, creating further separation between the two buildings. The existing posts may be original; however, the railings were likely added after 1950 to replace the original railings. The porch floor consists of concrete and 1x wood flooring.

The applicant proposes to brace the existing porch roof and temporarily lift it with the house when the foundation is poured. The applicant will evaluate the existing roof framing and repair and replace the structural members as needed. The applicant anticipates constructing a new wood porch floor once the house is set on its new foundation.

15. The existing posts may be original; however, the railings were likely added after 1950 to replace the original railings. The porch floor consists of concrete and 1x wood flooring. The applicant proposes to brace the existing porch roof and temporarily lift it with the house when the foundation is poured. The applicant will

evaluate the existing roof framing and repair and replace the structural members as needed. The applicant anticipates constructing a new wood porch floor once the house is set on its new foundation. The proposed work is necessary in order to rehabilitate the historic house and restore the porch to its c.1907-1920 appearance.

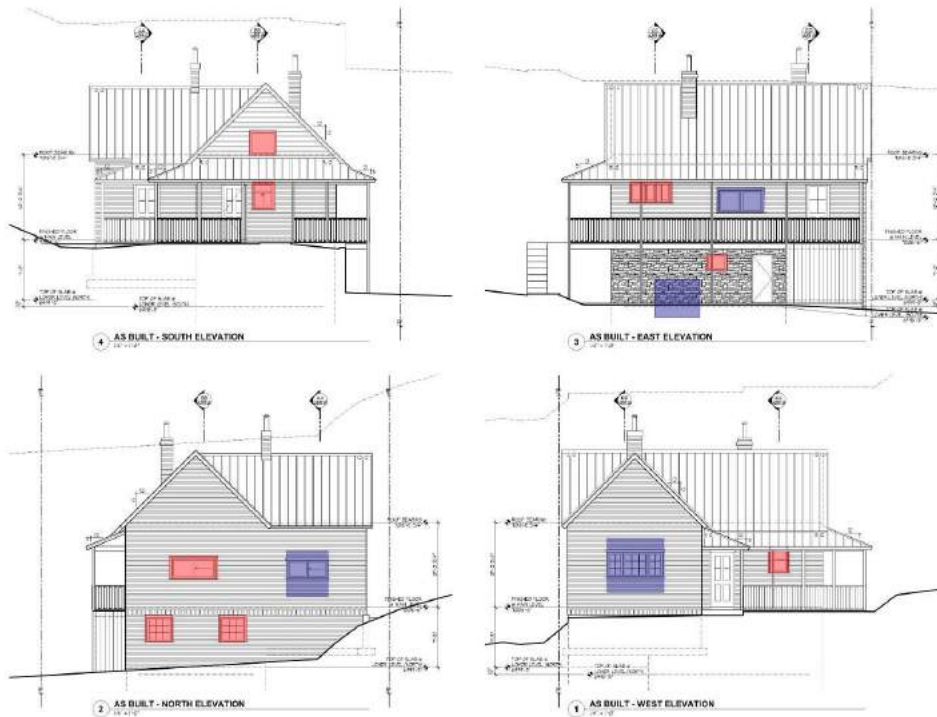
The window openings seen today were likely introduced in the 1920s in an effort to introduce more contemporary bungalow-inspired elements into the house. Any traces of original window openings are likely concealed beneath the Bricktex siding and the dry-wall and panelled interior walls. The windows are in varying degrees of poor condition with evidence of broken glass panes, wood rot, boarded window openings, and a missing window at the attic level.

Staff has highlighted the existing windows to be replaced in red and new window openings in blue.

17. The window openings seen today were likely introduced in the 1920s in an effort to introduce more contemporary bungalow-inspired elements into the house. Any traces of original window openings are likely concealed beneath the Bricktex siding and the dry-wall and panelled interior walls. The windows are in varying degrees of poor condition with evidence of broken glass panes, wood rot, boarded window openings, and a missing window at the attic level. The proposed changes to the existing window configuration are necessary to rehabilitate the historic house. Any modifications to the original and/or existing window configuration on the east (rear) elevation will not damage or destroy the exterior architectural features of the subject property which are compatible with the character of the historic site and are not included in the proposed scope of work.
