**PLANNING DEPARTMENT ADMINISTRATIVE PUBLIC HEARING  
SUMMIT COUNTY, UTAH  
July 3, 2025**

- 1.A. **176 Main Street – Historic District Design Review** – The Applicant Proposes to Construct an Addition on a Landmark Historic Structure in the Historic Residential - 2B Zoning District. PL-25-06472.  
(A) Public Hearing; (B) Action

# Planning Department Staff Report

**Subject:** 176 Main Street  
**Application:** PL-25-06472  
**Author:** Meredith Covey, Planner I  
**Date:** July 3, 2025  
**Type of Item:** Historic District Design Review

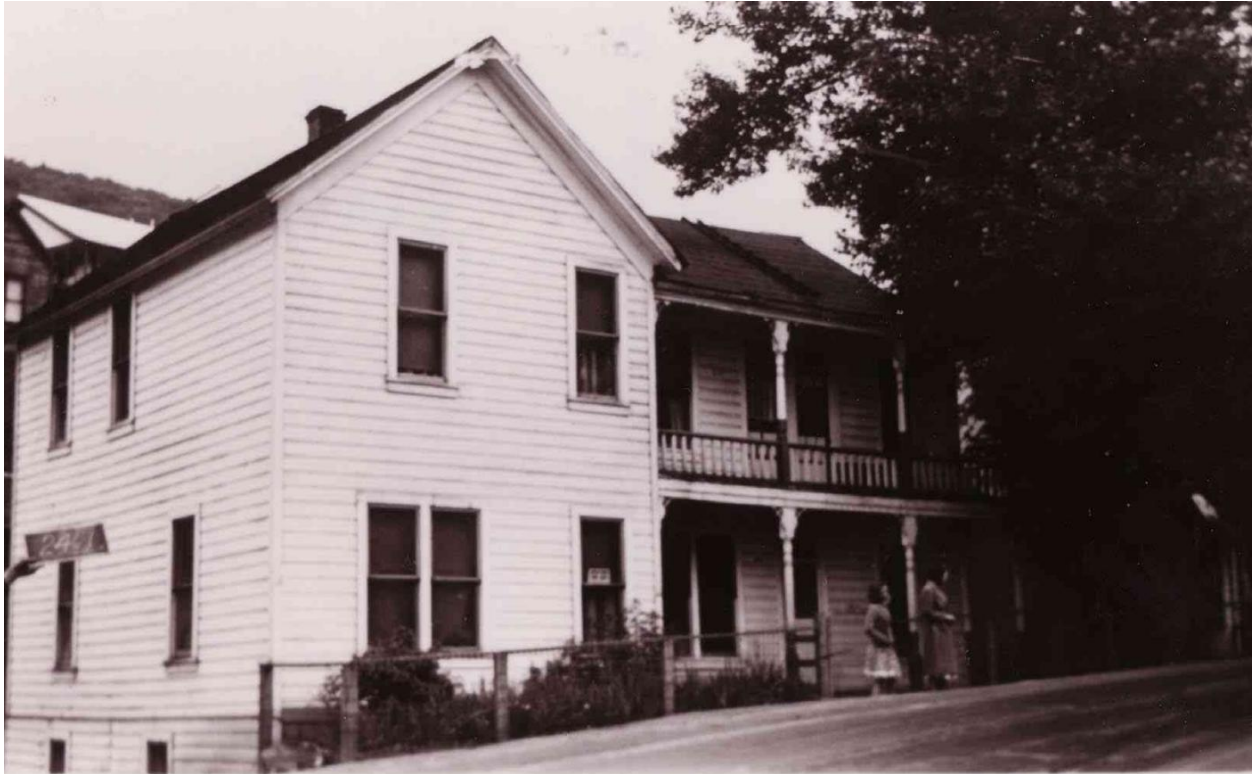
*Figure 1: 1940s Tax Photo of 176 Main*

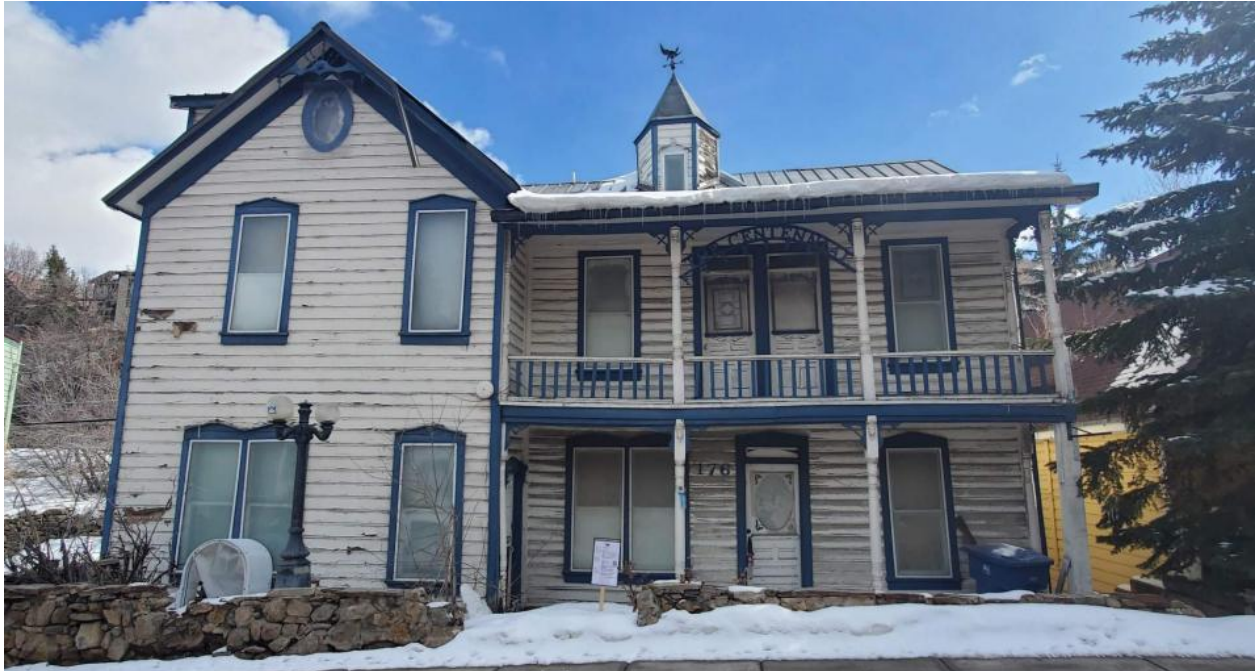
*Figure 2: 176 Main Street viewed from Main Street*

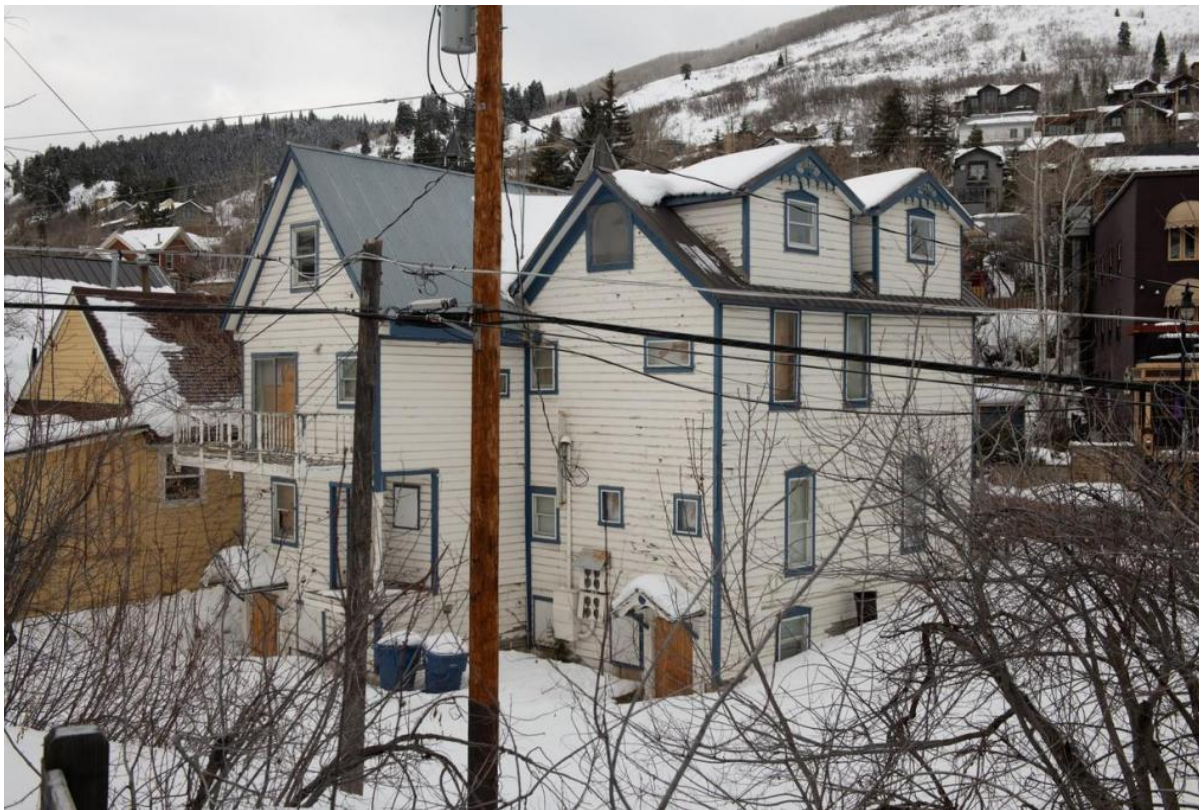
*Figure 3: 176 Main Street looking Southeast*

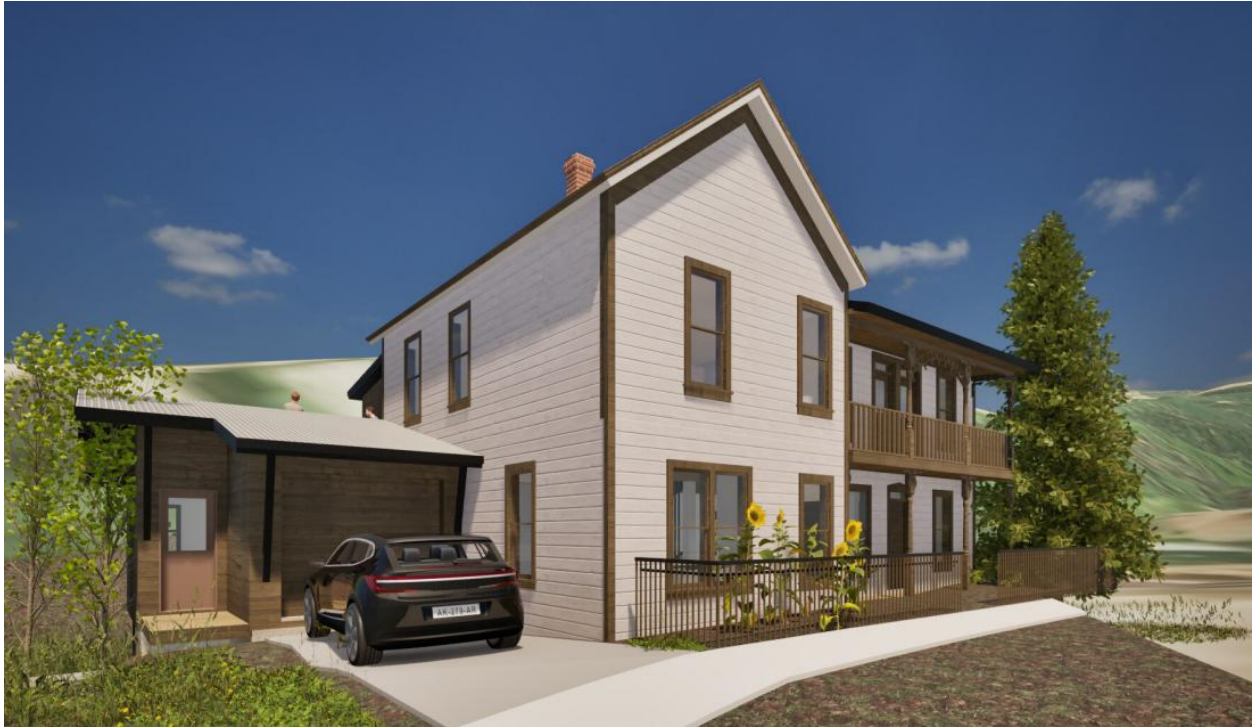
*Figure 8: Proposed elevation of 176 Main when viewed from Main Street*

- Deconstructing the Landmark Historic Structure and salvaging as many historic materials as possible.
- Constructing a new foundation.
- Reconstructing the Landmark Historic Structure using salvaged and replacement material to restore the 1907 form.
- Constructing an addition on the secondary (north) and tertiary (east) façades, as well as a basement addition.

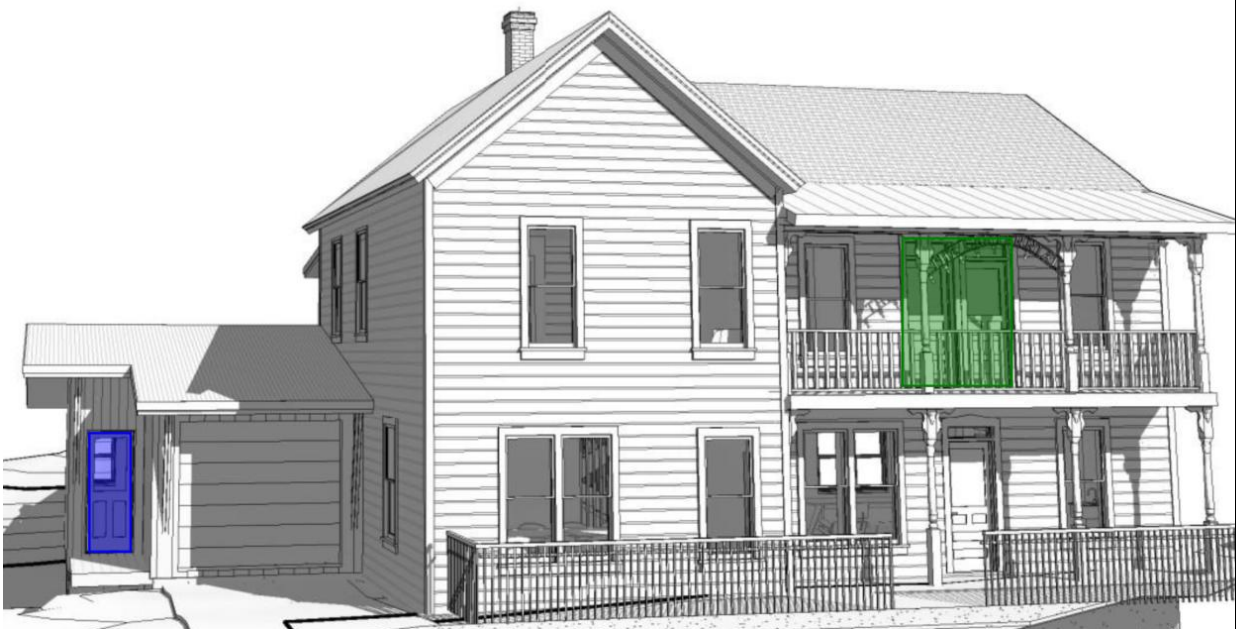
*Proposed Elevations – Doors proposed to be added are shown in blue, doors retained from existing conditions are shown in green*

*Front (west) Facade*

Approval 16 requires that the Applicant submit a report detailing the conditions of the doors and their salvageability and proposed repair or replacement.

Condition of Approval 21 requires that the Applicant avoid changing the position, proportions, or dimensions of historic door openings and not create additional openings or remove historic openings on primary or secondary façades that are visible from the primary public right-of-way.

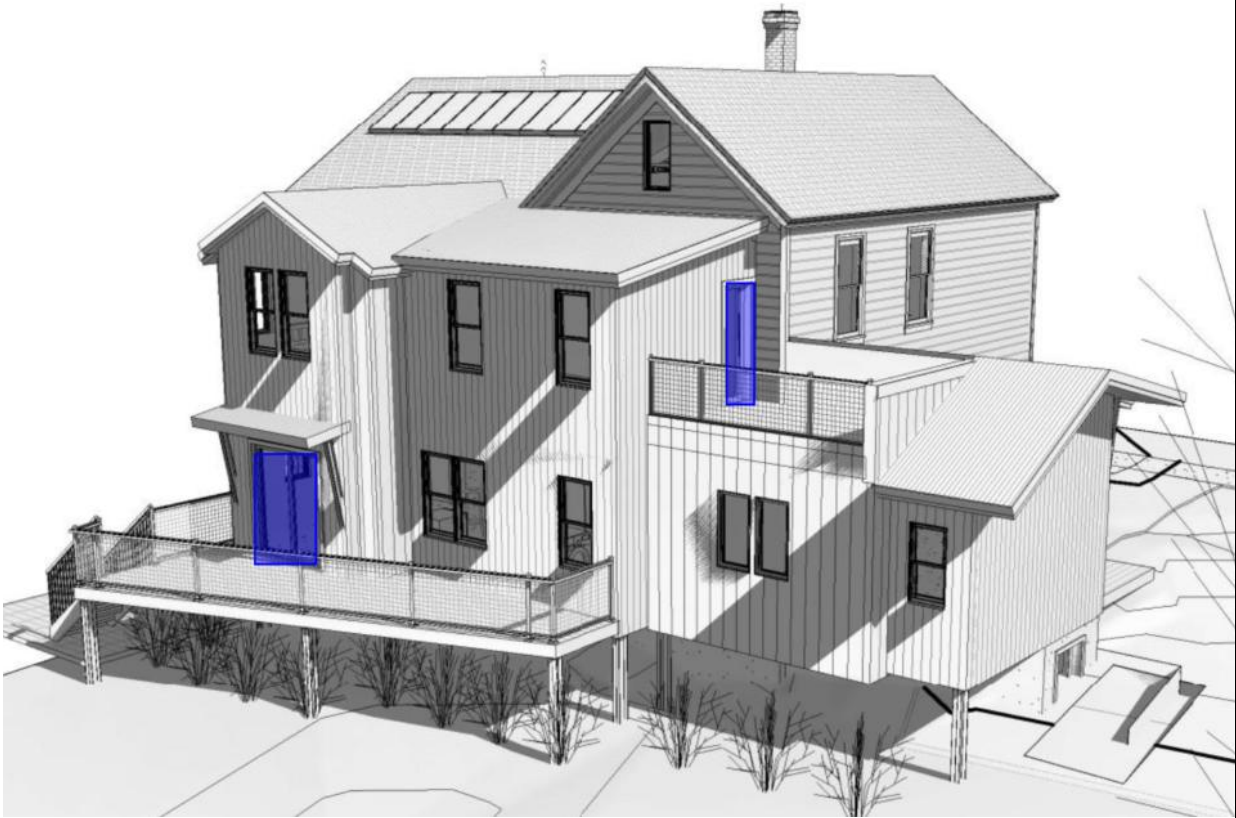
*Rear (east) and Side (north) Façade*

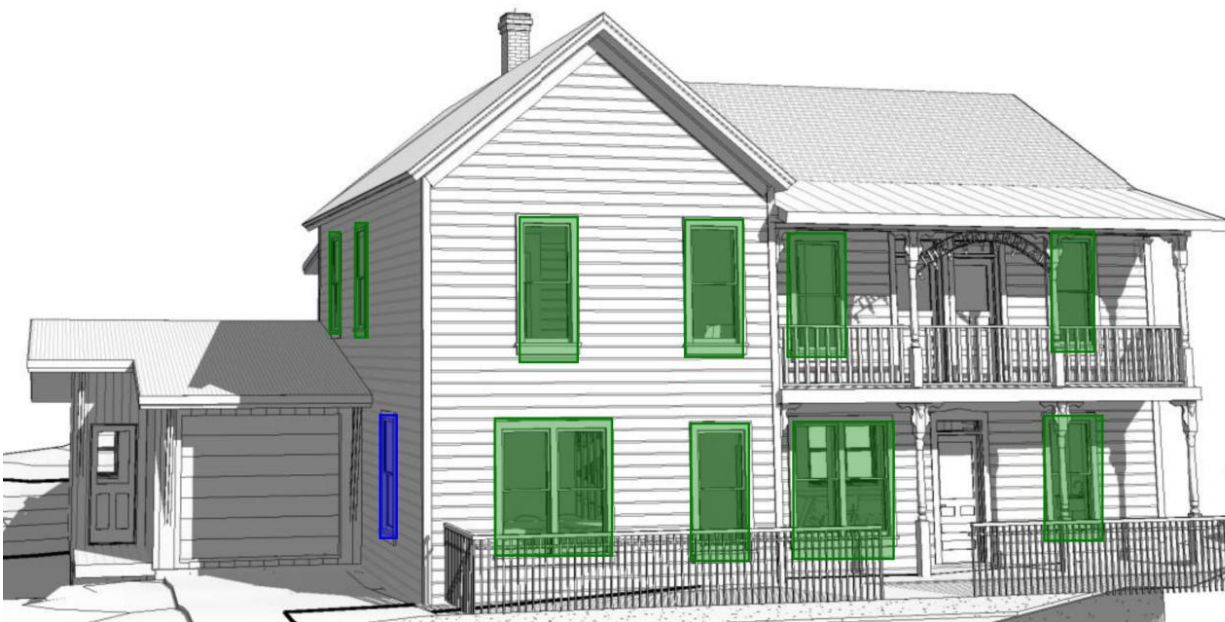
| <i>Proposed Elevations – Windows proposed to be added are shown in blue, windows retained from existing conditions are shown in green</i> | |

*Front (west) Facade*

The Applicant proposes to replace any windows that are not salvageable and to repair those that are able.

Condition of Approval 22 requires that the Applicant replace historic windows exactly in size, dimension, glazing pattern, depth, profile, and material.

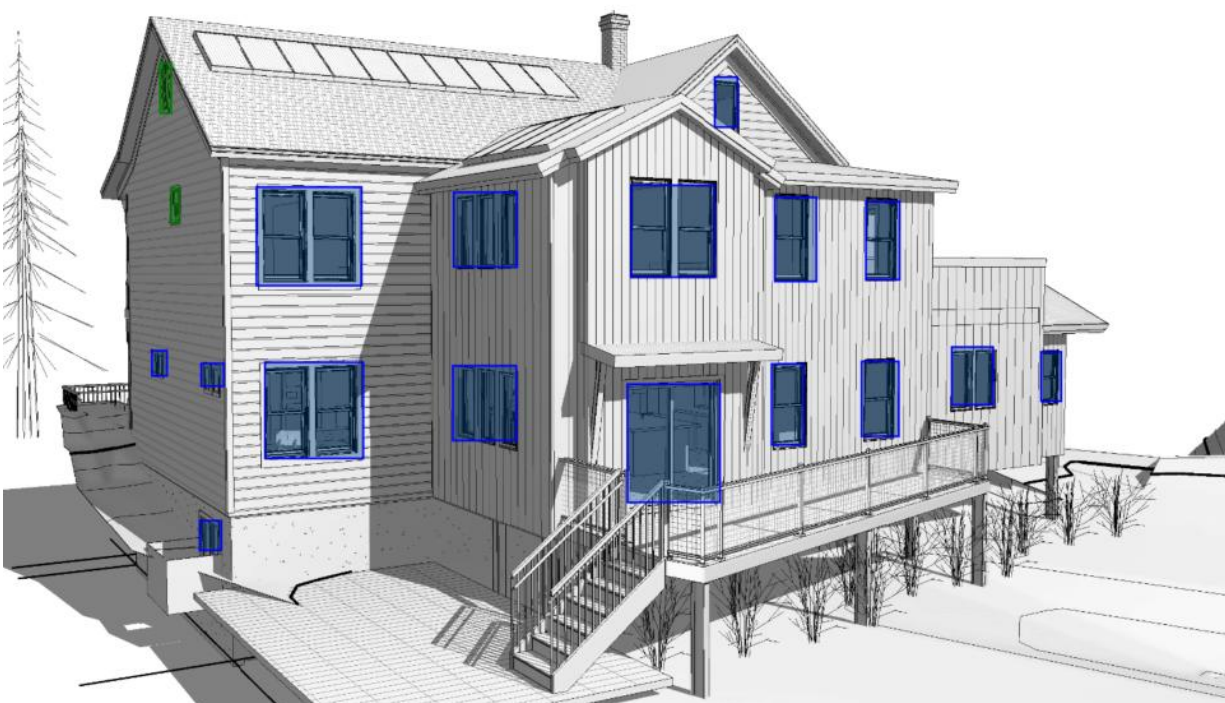
*Side (south) and Rear (east) Facade*

The Applicant notes that the gabled Structure that faces east (rear façade) was likely part of an addition to the Structure though the year is unknown. The Applicant proposes to remove the doors and windows on this previous addition and replace with openings that comply with current Historic District Design Regulations.

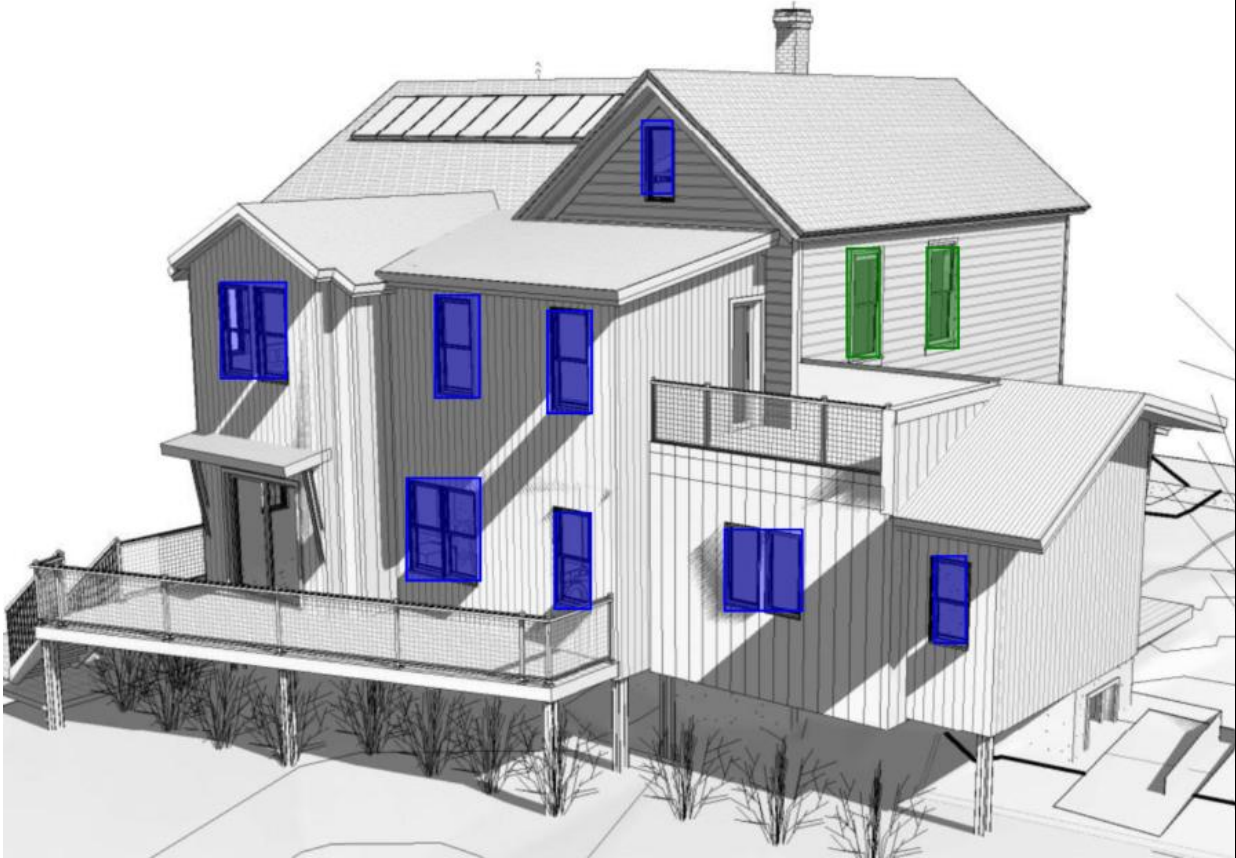
*Side (north) and Rear (west) Facade*

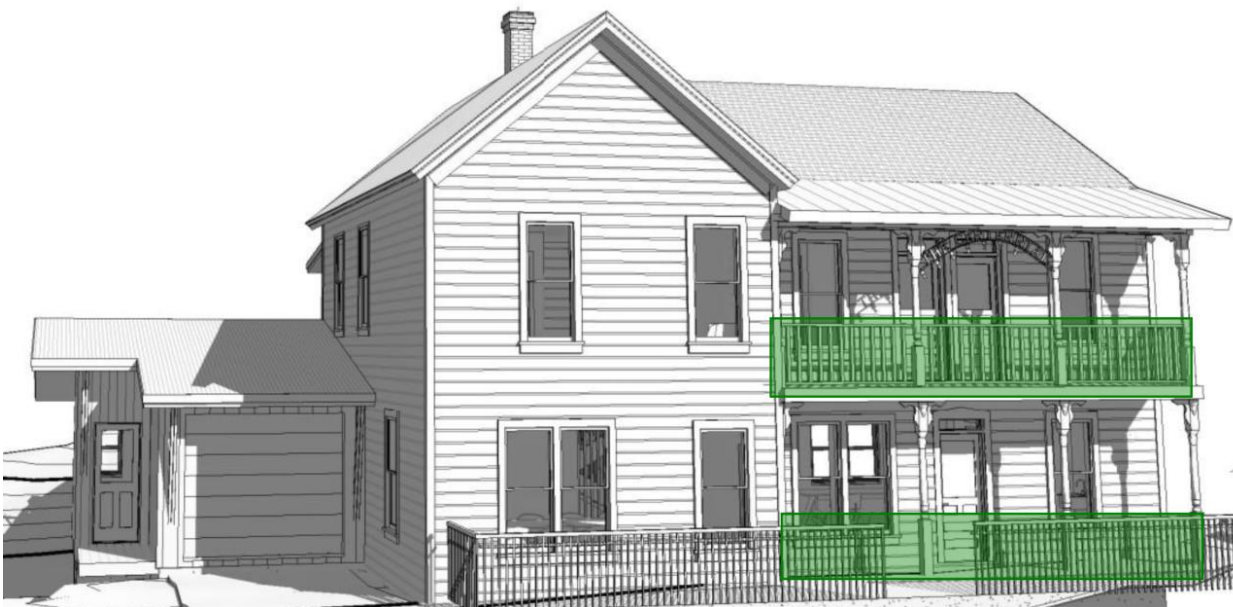
| <p><i>Proposed Elevations – Porches proposed to be added are shown in blue, porches retained from existing conditions are shown in green</i></p> | |
| <p><i>Front (west) Facade</i></p> | |

The Applicant proposes to repair the two historic porches on the front façade, and to remove two porches on the rear façade.

The Applicant proposes to analyze the materials on the front porches to determine what can be salvaged and used to repair the porch. The existing railing on the second story porch on the front façade does not meet current building code. The proposed replacement railing will be in the same form and style, but will be increased in height to comply with current Building Code.

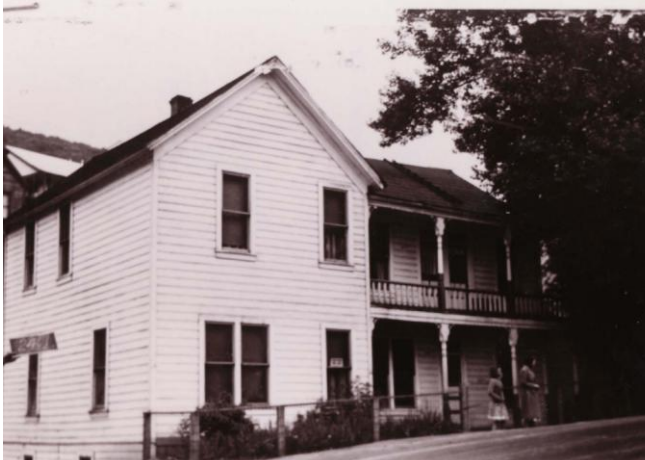
| <p><i>Original 1901 Structure</i></p> | <p><i>Existing Conditions – Two dormers, pediments, and ornamentation added after 1978 and proposed to be retained are shown in orange, the light post shown in red is proposed to be</i></p> |

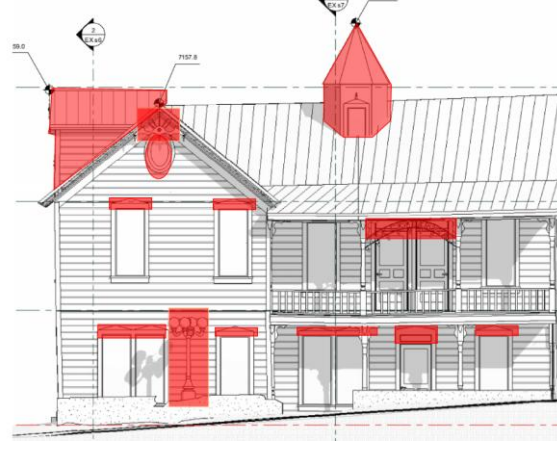
| | <p><i>removed</i></p> |

| <p><b>Architectural Features</b><br/> Preserve and maintain architectural features such as eaves, brackets, cornices, moldings, trim work, and decorative shingles.</p> <p>Replacement features shall exactly match the historic features in design, size, dimension, form, profile, texture, material and finish.</p> | <p>The Applicant proposes Reconstructing the Structure to the 1907 form. The Historic Site Form for the site suggests that the ornamental features such as the cupola, oval window, window pediments, dormers on the north roof, and architectural design elements on the front porch were added sometime between 1978 and 1983</p> |

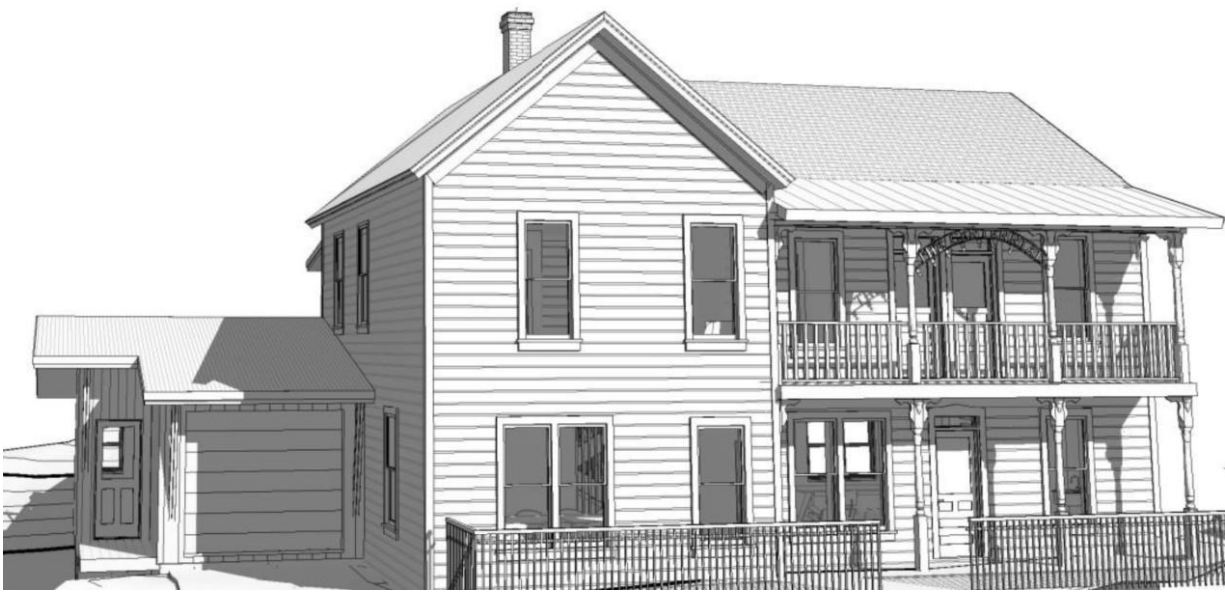
| <p><i>Proposed front elevation showing the restored 1907 form of the Structure and the proposed addition</i></p> | |

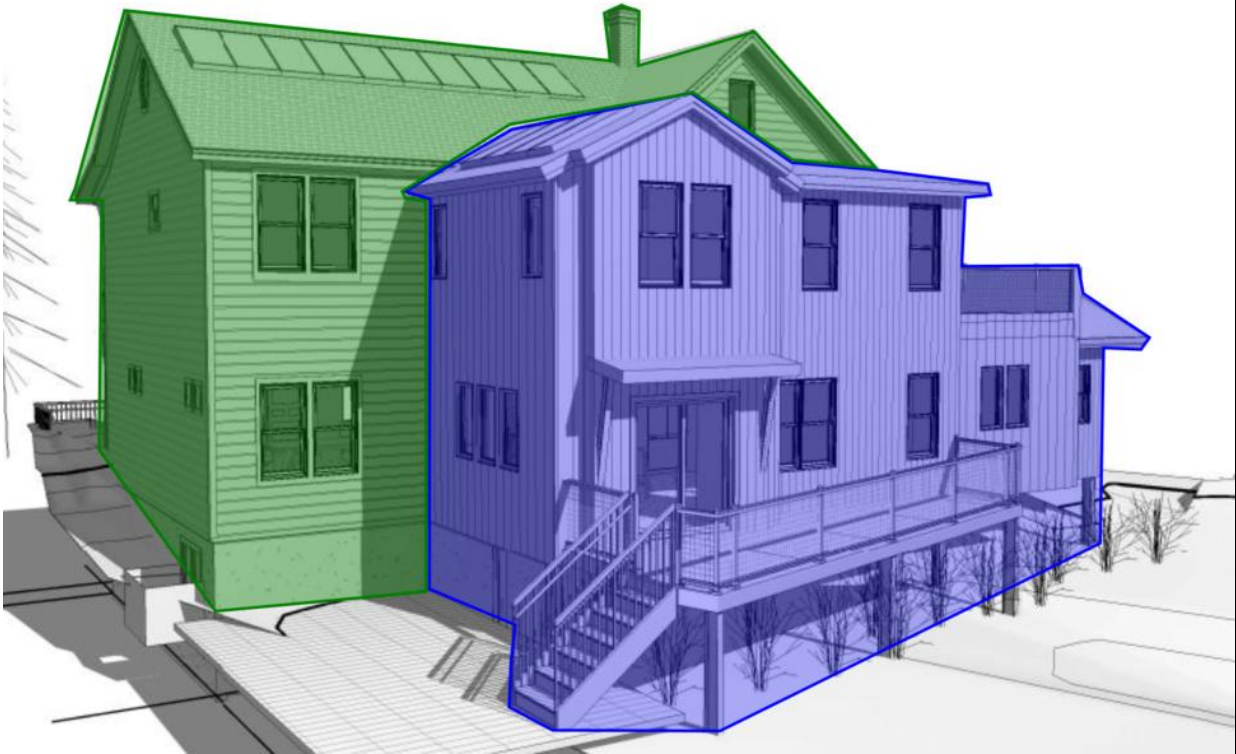
*Proposed Elevations – Existing Historic Structure proposed to remain is shown in green, proposed addition is shown in blue.*

*Rear (east) Facade*

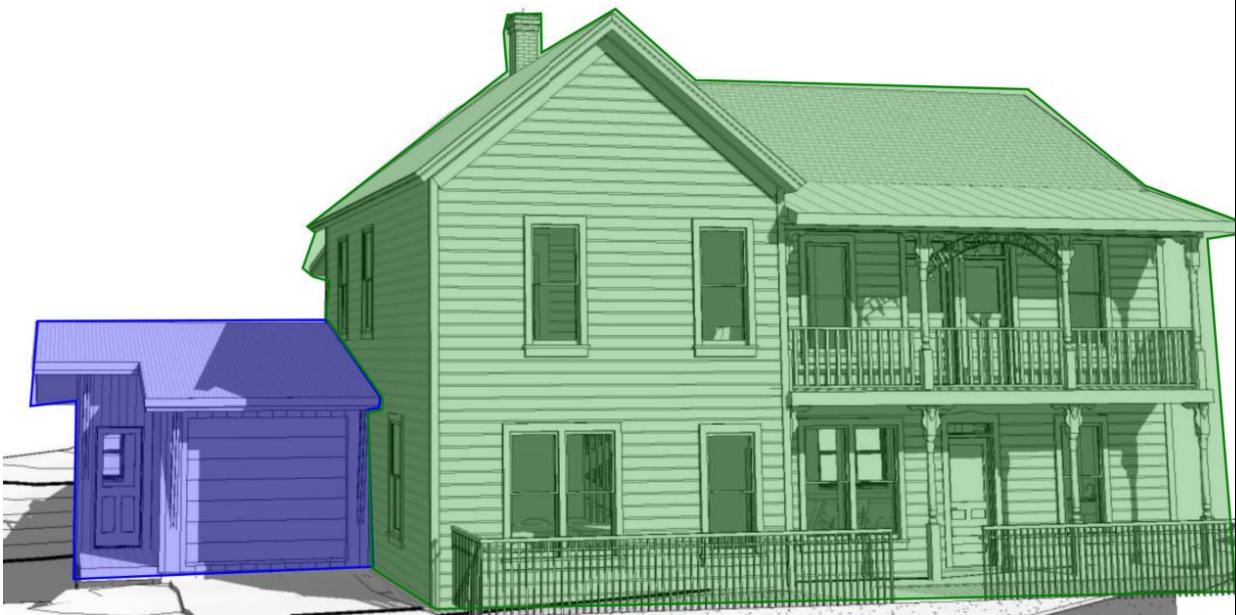
*North (west) Facade*

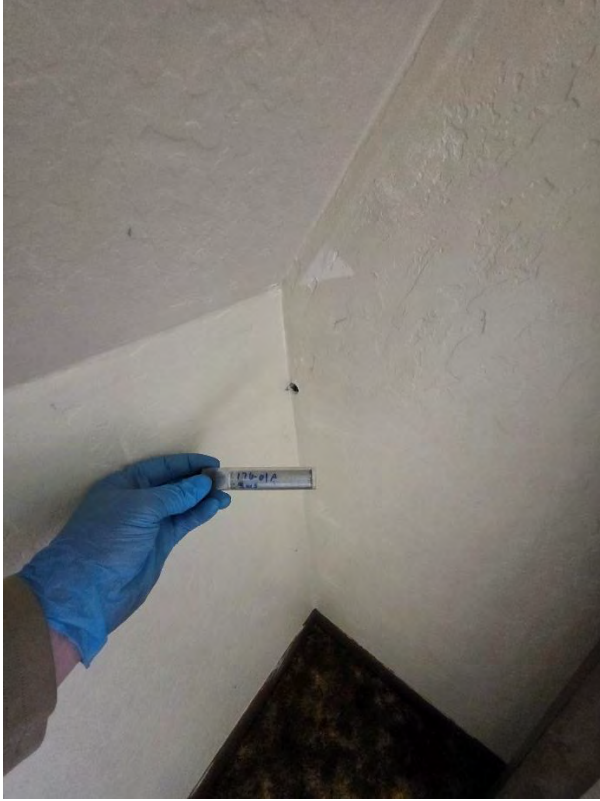
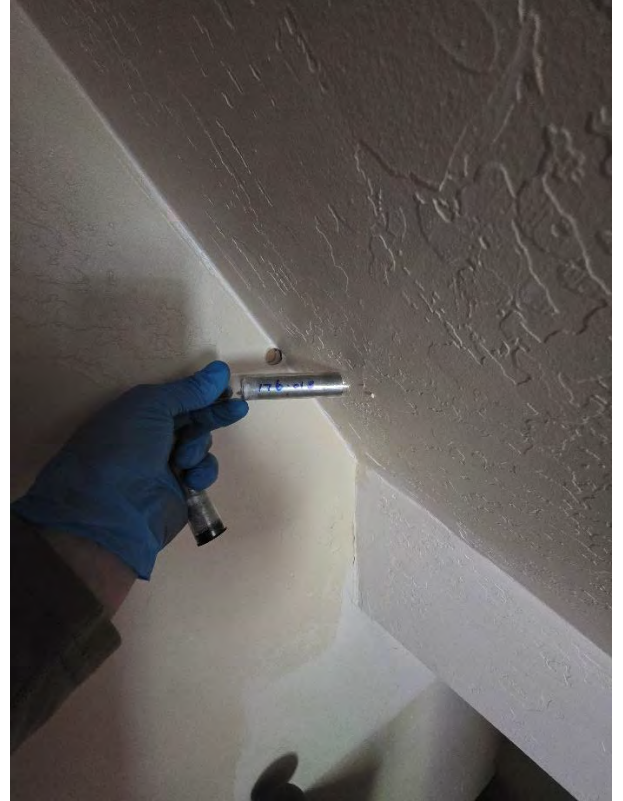
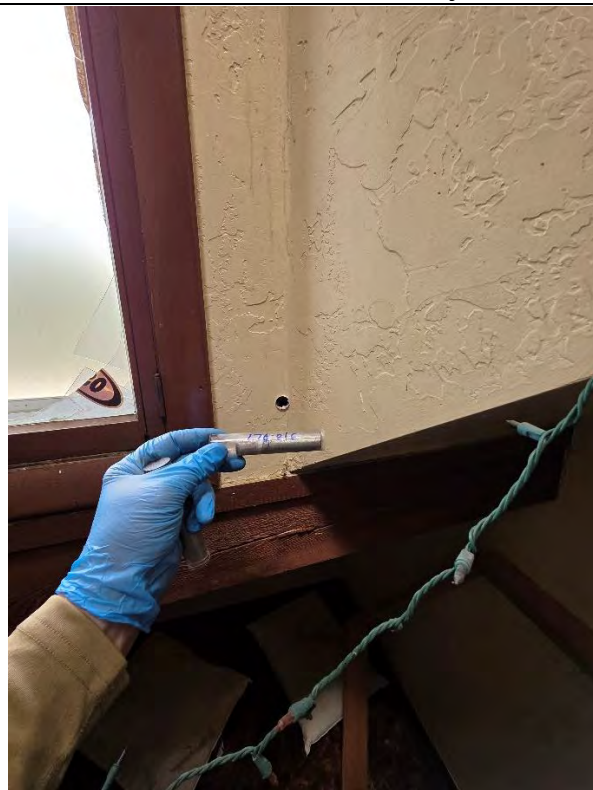
176 – 01A Sheetrock Wall System

176 – 01B Sheetrock Wall System

176 – 01C Sheetrock Wall System

176 – 01D Sheetrock Wall System

176 – 01E Sheetrock Wall System

**ACM** – Asbestos materials were identified within the structure that included vermiculite insulation, textured wall material, duct tape, and sheet vinyl flooring that will require abatement prior to deconstruction or renovations. Hill West recommends that prior to any asbestos abatement, the basement shall first be remediated for respiratory hazards including mold, dead animals, feces, and all garbage to allow safe access into this area prior to asbestos abatement.

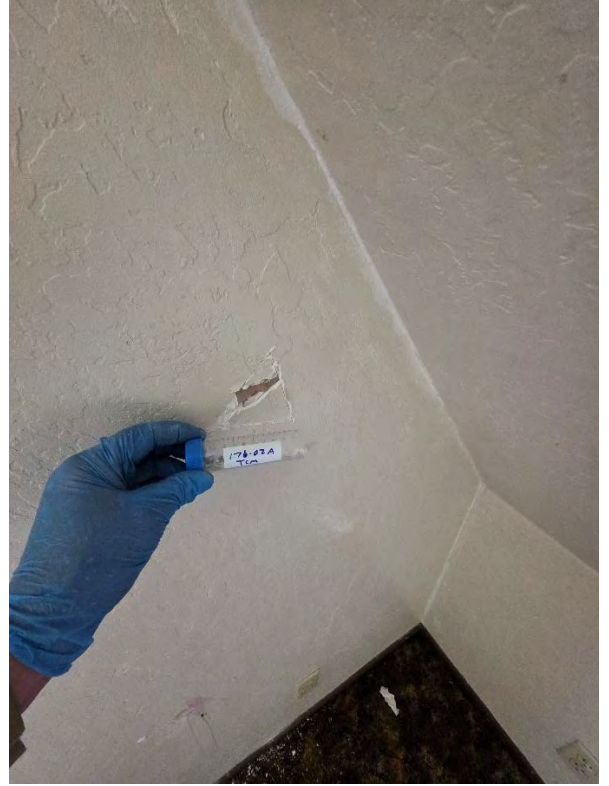
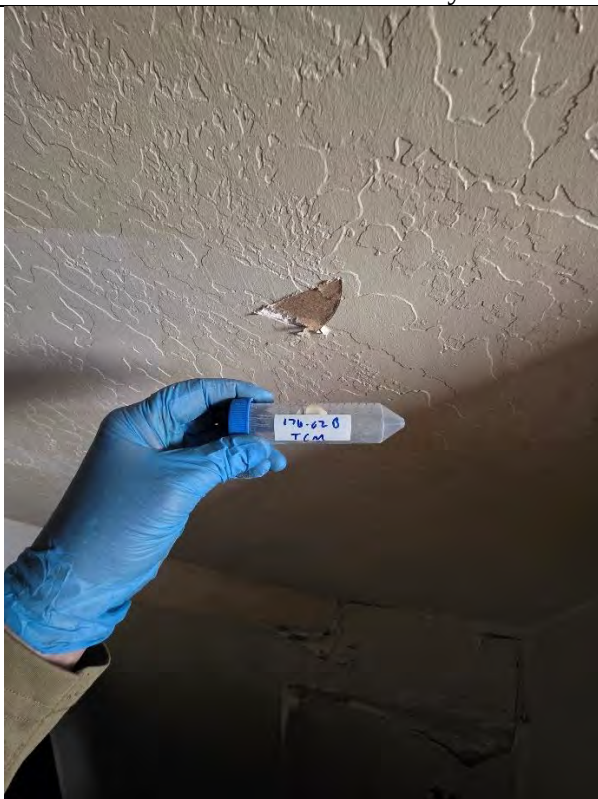
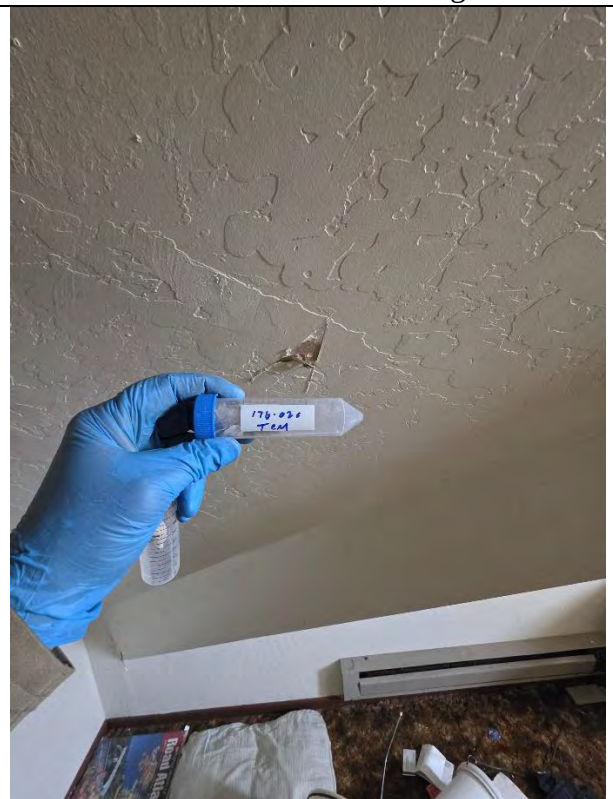
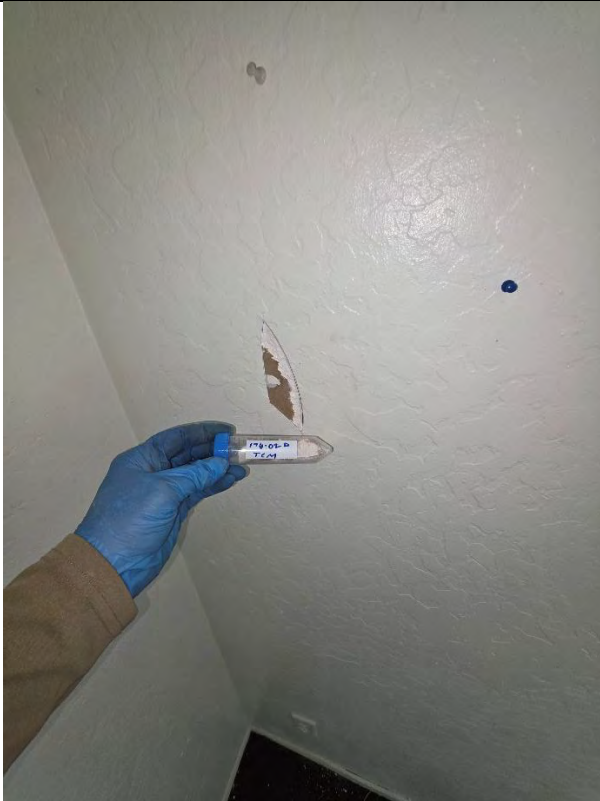
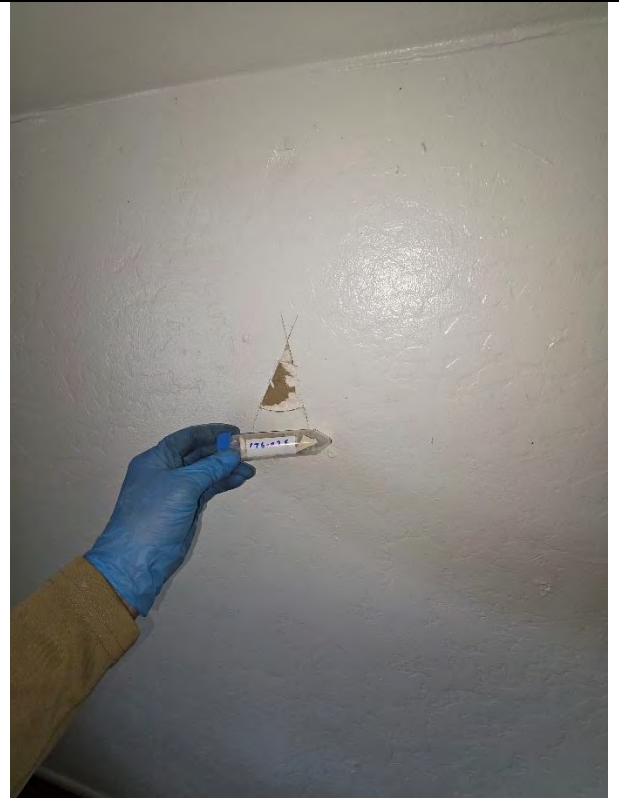
176 – 02A Textured Wall/Ceiling Material

176 – 02B Textured Wall/Ceiling Material

176 – 02C Textured Wall/Ceiling Material

176 – 02D Textured Wall/Ceiling Material

176 – 02E Textured Wall/Ceiling Material

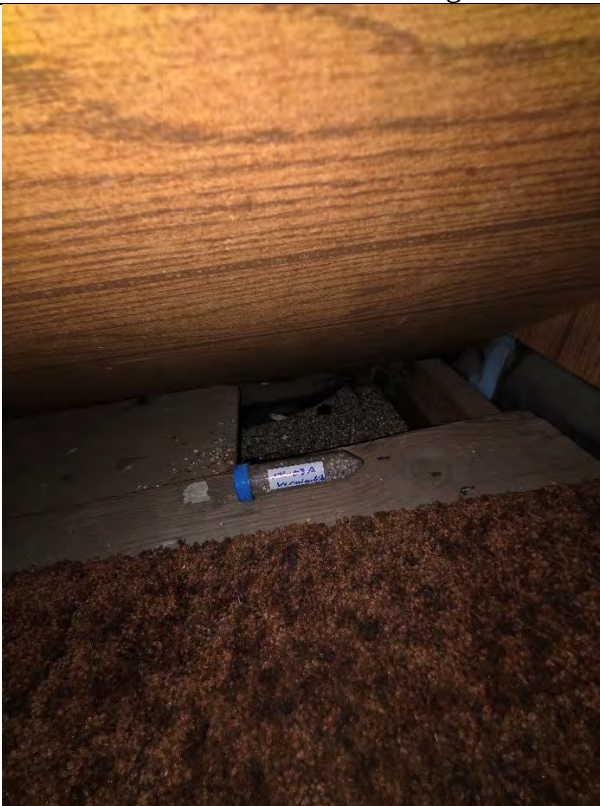
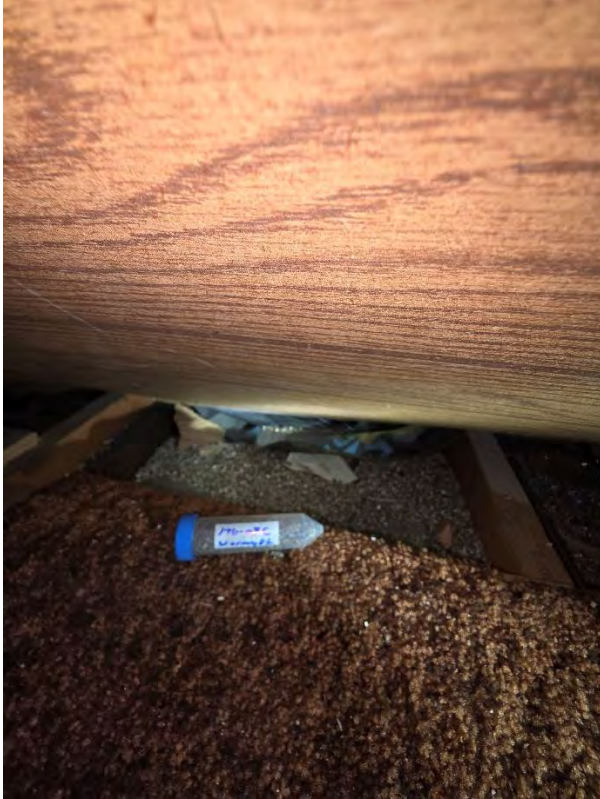
176 – 03A Vermiculite Insulation

176 – 03B Vermiculite Insulation

176 – 03C Vermiculite Insulation

176 – 03D/03E Vermiculite Insulation

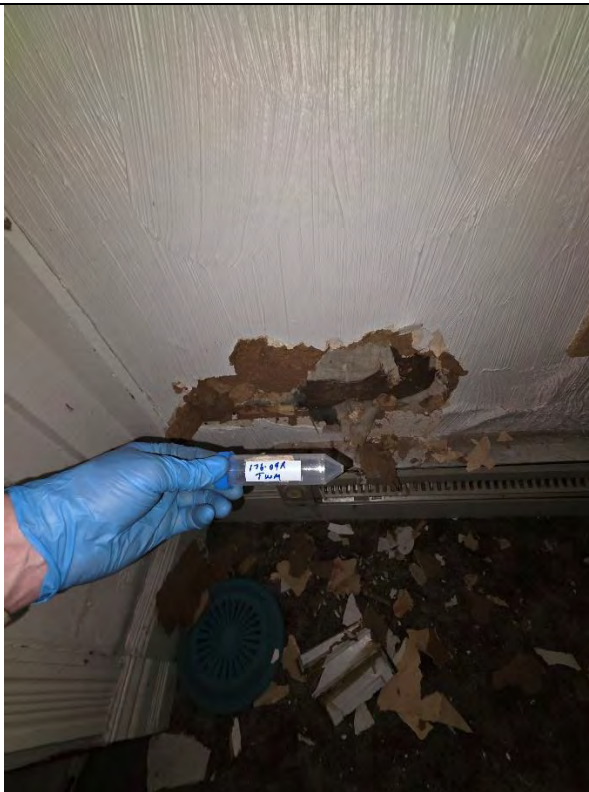
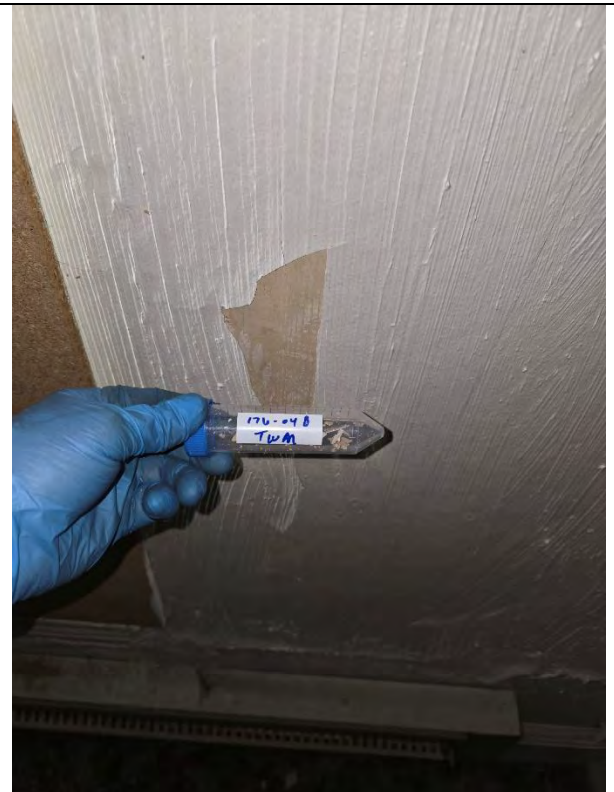
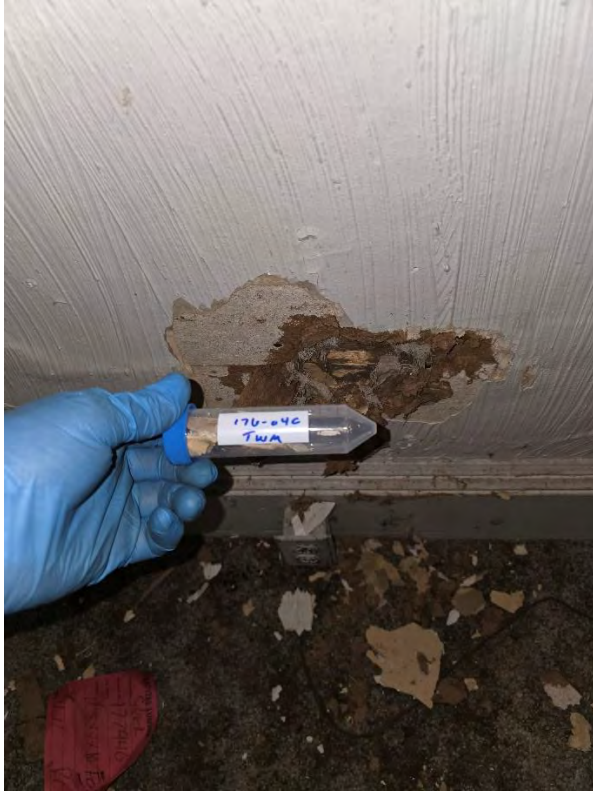
176 – 04A Textured Wall Material

176 – 04B Textured Wall Material

176 – 04C Textured Wall Material

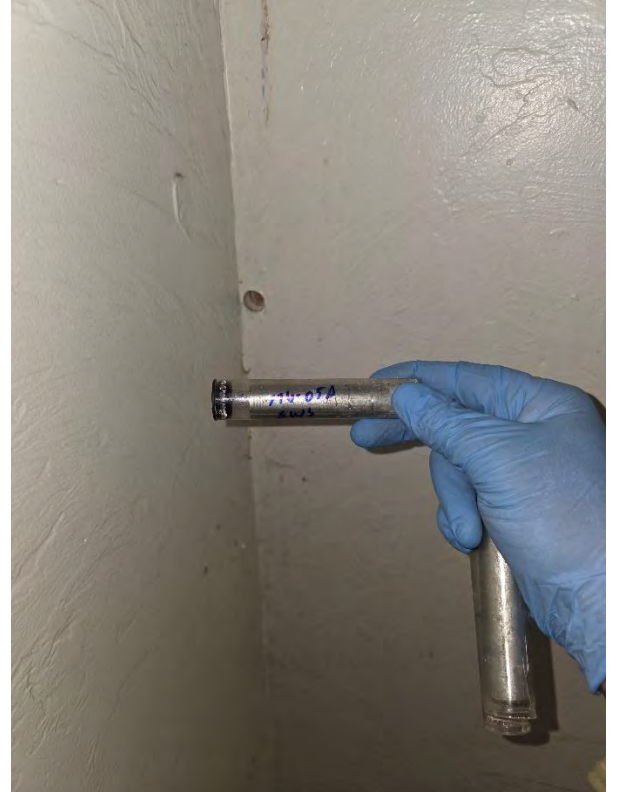
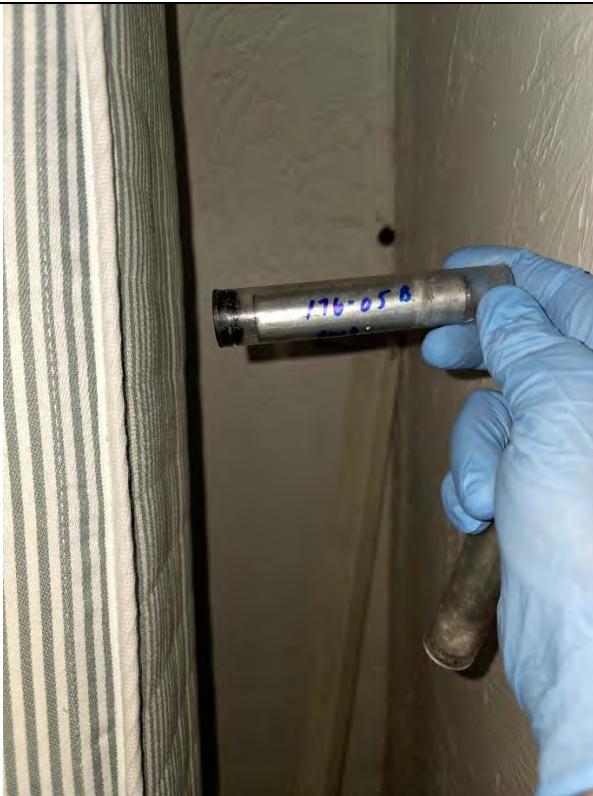
176 – 05A Sheetrock Wall System

176 – 05B Sheetrock Wall System

176 – 05C Sheetrock Wall System

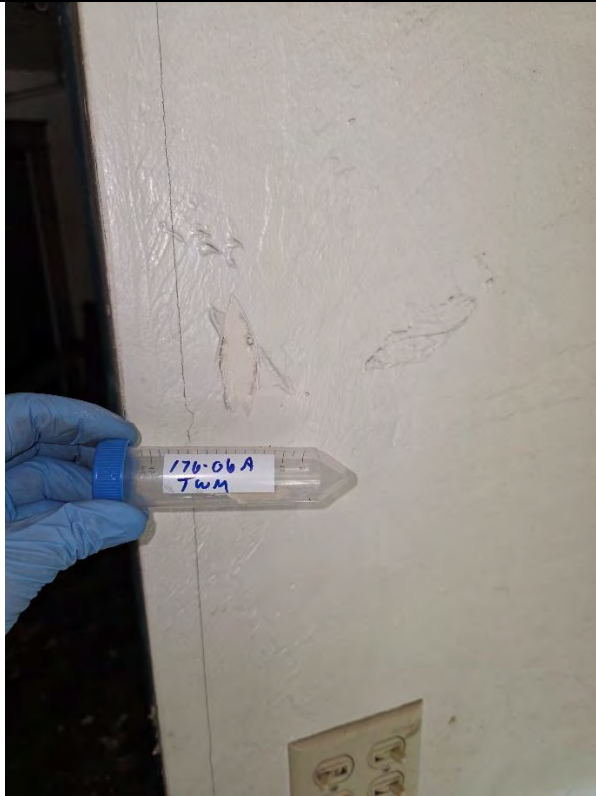
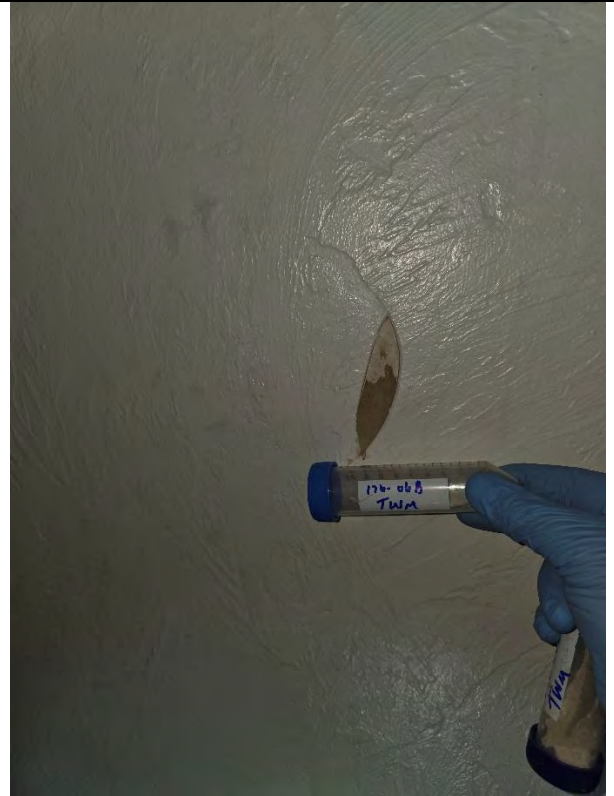
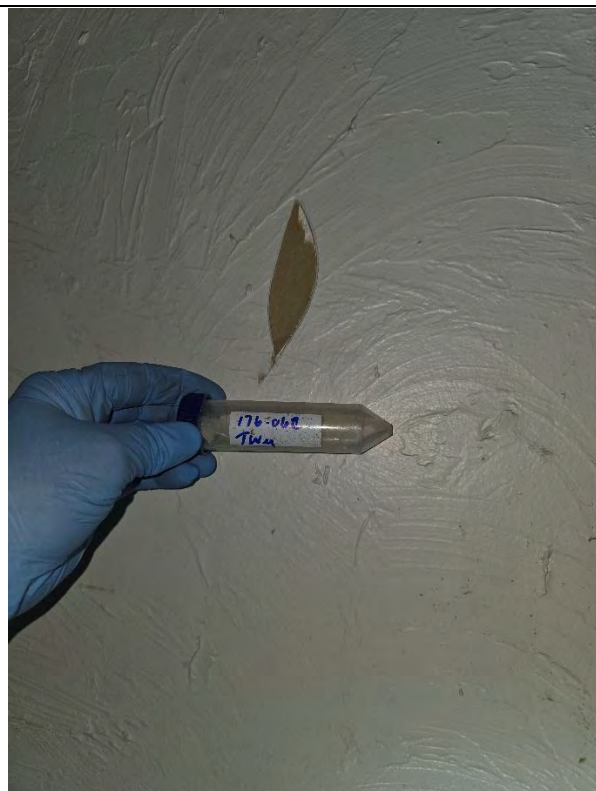
176 – 06A Textured Wall Material

176 – 06B Textured Wall Material

176 – 06C Textured Wall Material

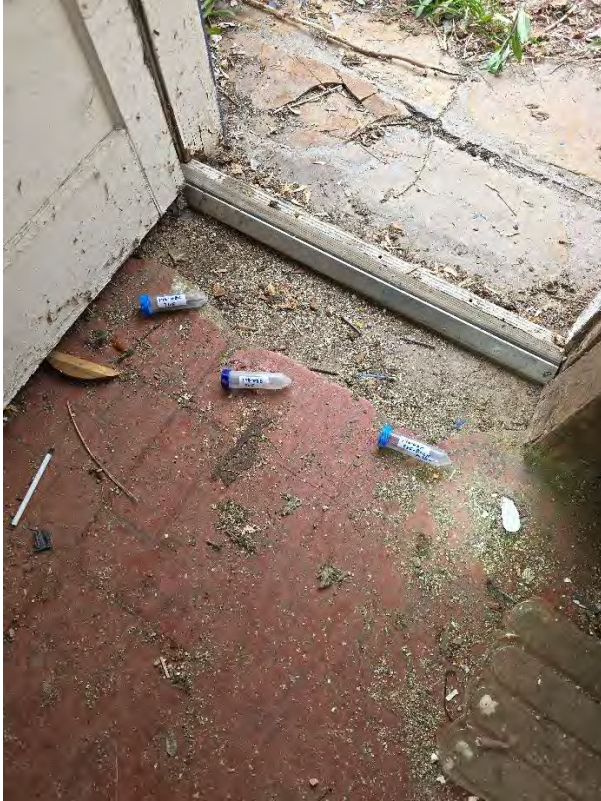
176 – 08A, B and C Sheet Vinyl Flooring  
Brick Pattern

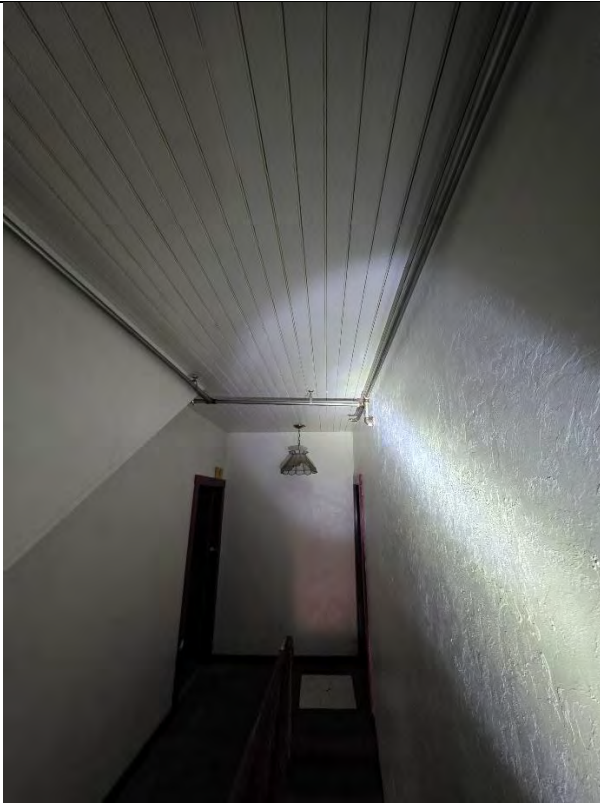
Green wood ceiling positive for lead

**Lead** – Lead was detected within all exterior painted wood surfaces and within the interior wood doors, windows and trim. Depending on the project (deconstruction/renovation) costs for lead removal are not provided within this report as the project scope is unknown at this time. Any renovation work will require removal of lead hazards by an EPA-certified company with appropriately trained and certified workers.
