**PLANNING DEPARTMENT ADMINISTRATIVE PUBLIC HEARING  
SUMMIT COUNTY, UTAH  
July 3, 2025**

- 1.A. **176 Main Street – Historic District Design Review** – The Applicant Proposes to Construct an Addition on a Landmark Historic Structure in the Historic Residential - 2B Zoning District. PL-25-06472.  
(A) Public Hearing; (B) Action

# Planning Department Staff Report

**Subject:** 176 Main Street  
**Application:** PL-25-06472  
**Author:** Meredith Covey, Planner I  
**Date:** July 3, 2025  
**Type of Item:** Historic District Design Review

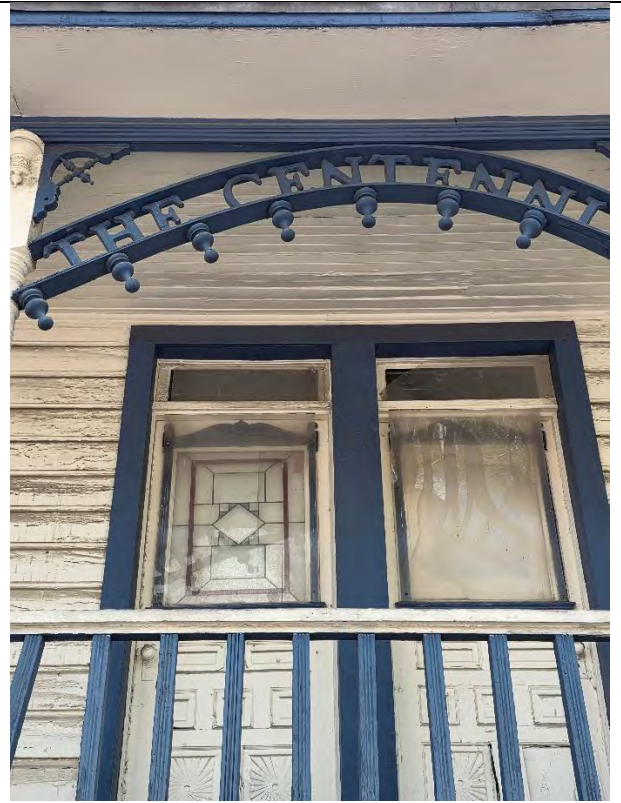
Exterior window frame, stair stringers and trim

**Lead** – Lead was detected within all exterior painted wood surfaces and within the interior wood doors, windows and trim. Depending on the project (deconstruction/renovation) costs for lead removal are not provided within this report as the project scope is unknown at this time. Any renovation work will require removal of lead hazards by an EPA-certified company with appropriately trained and certified workers.

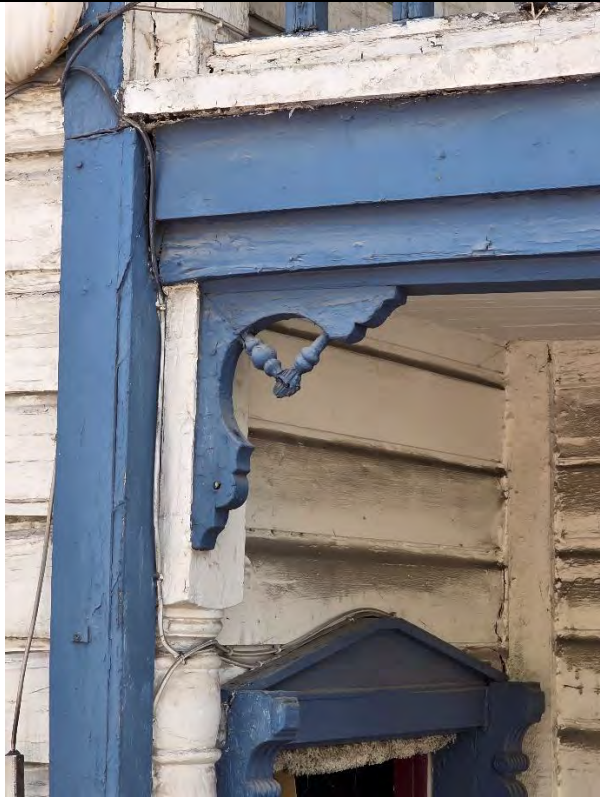
Lead exterior trim

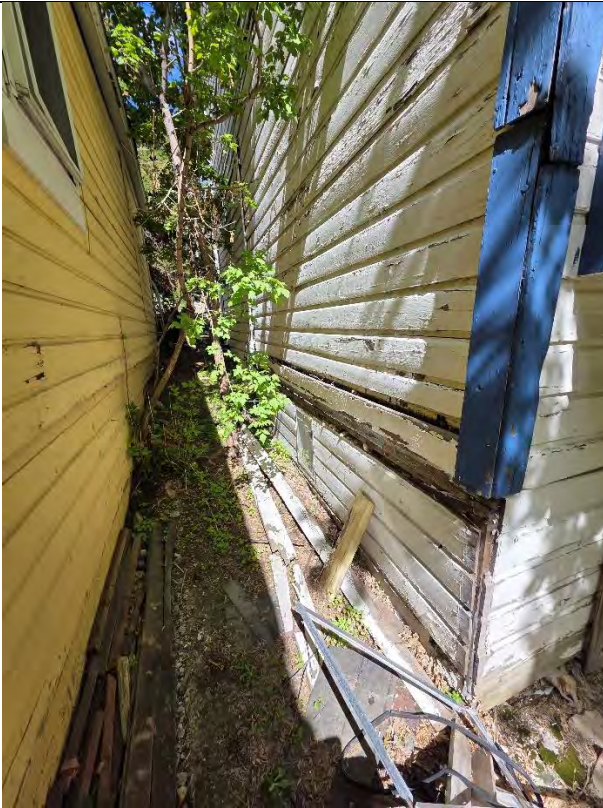
Lead exterior siding and trim

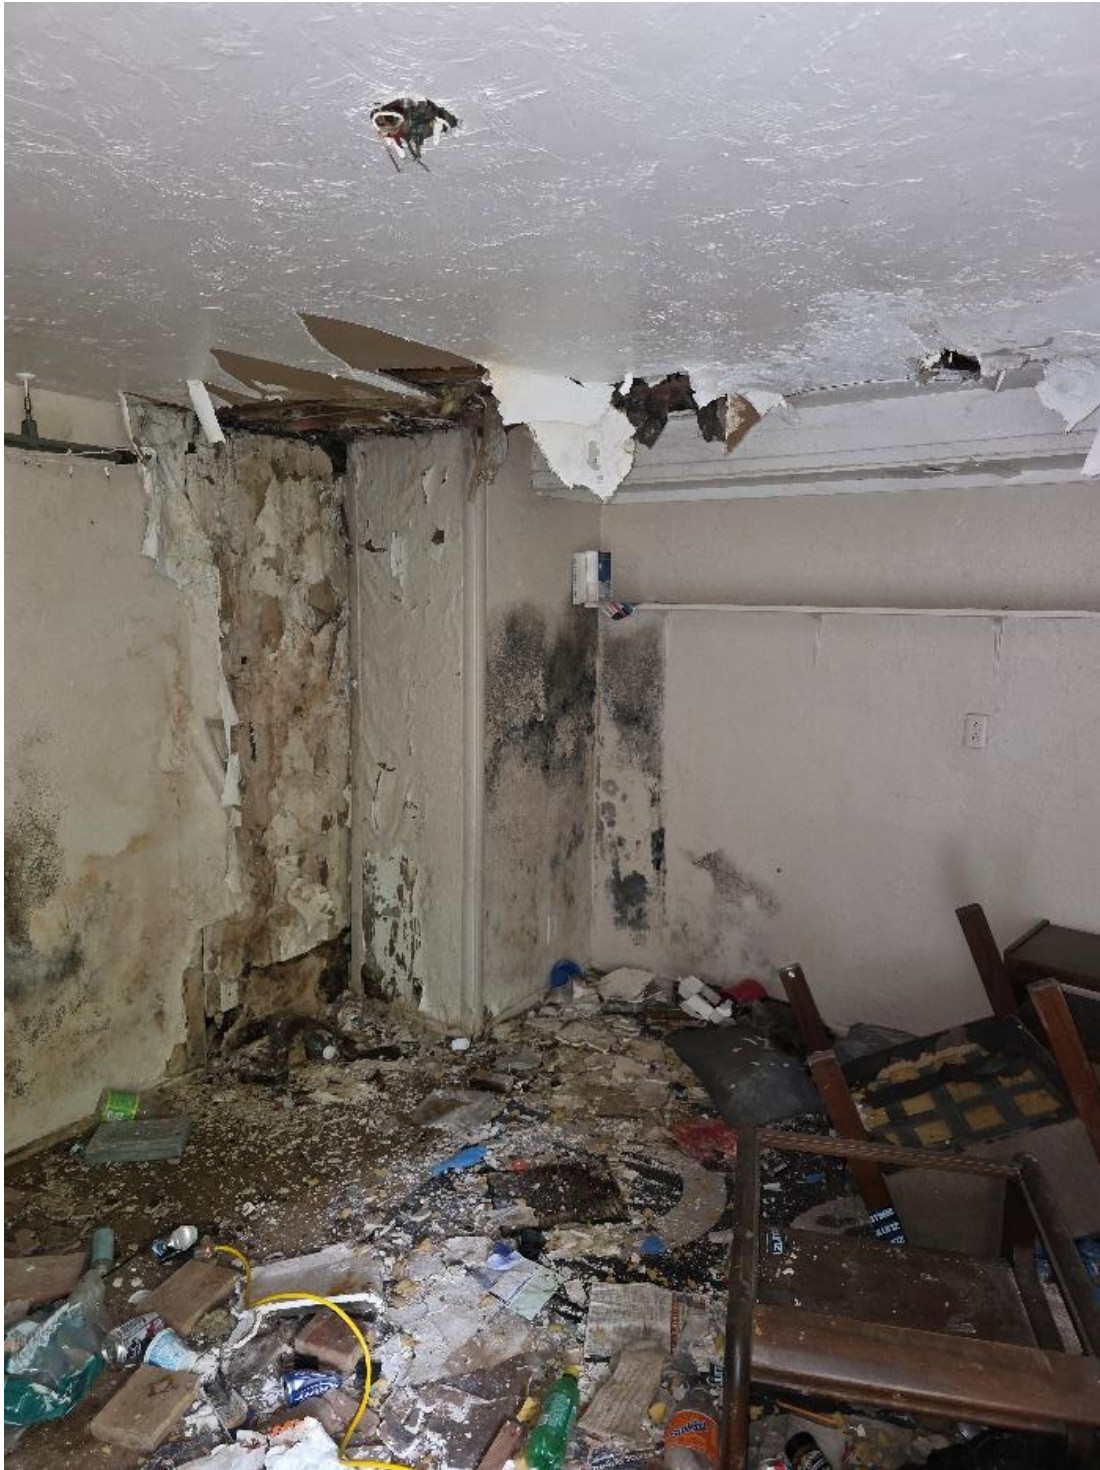
South Basement Apartment Living Room – Three (3) dead raccoons, feces, visible mold on all walls within the basement area.

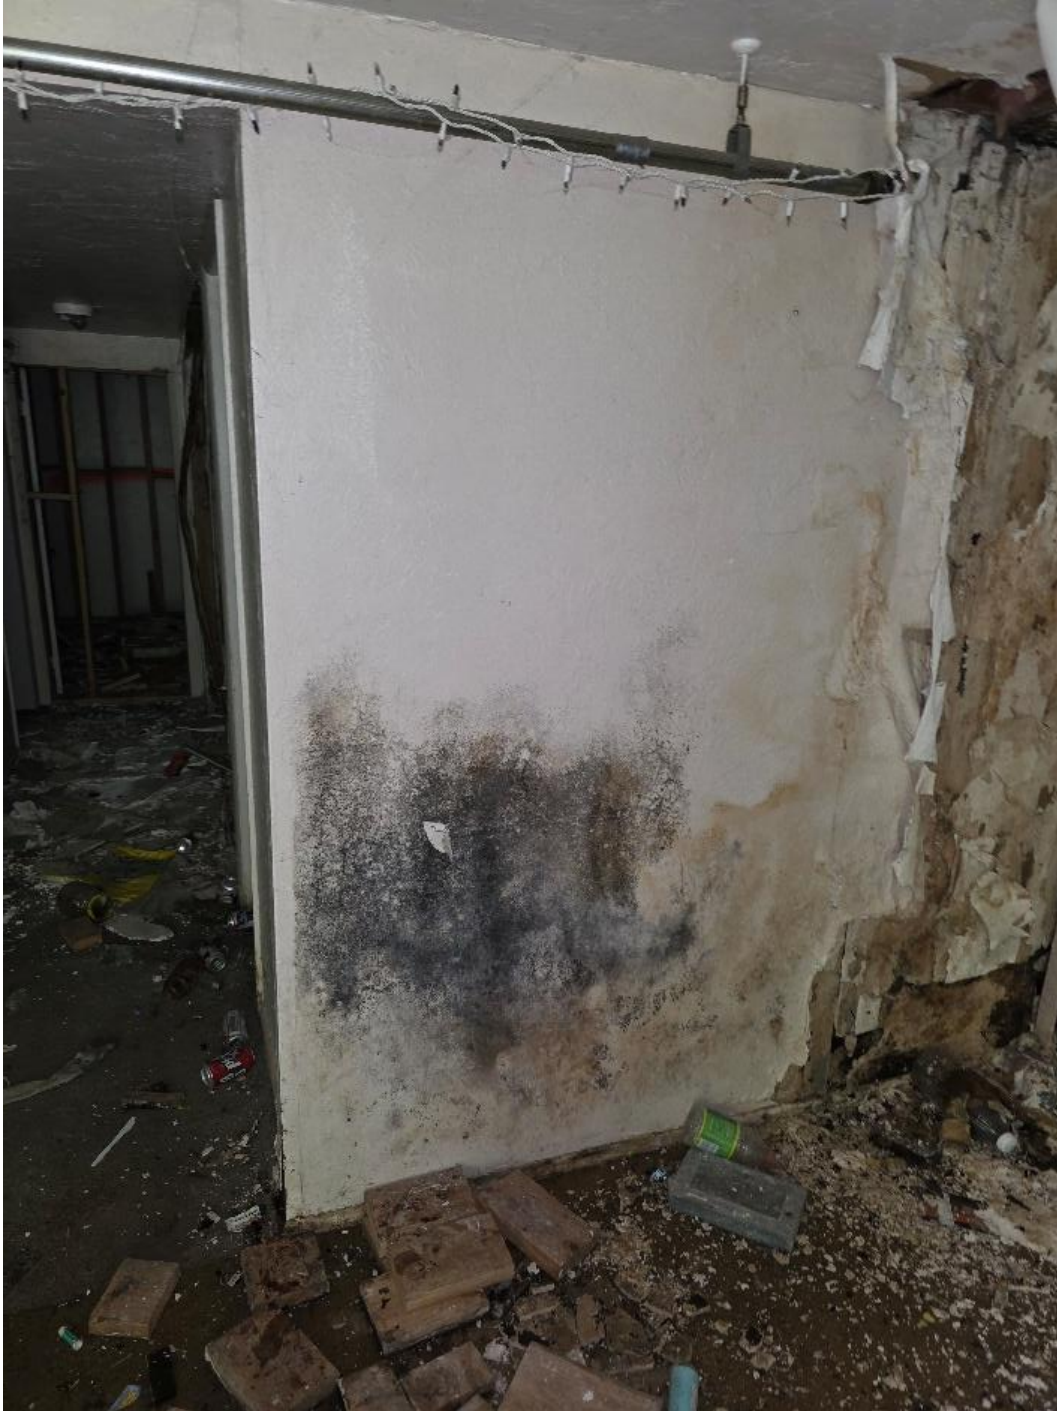
Visible mold growth on wood paneling Office 103/104.

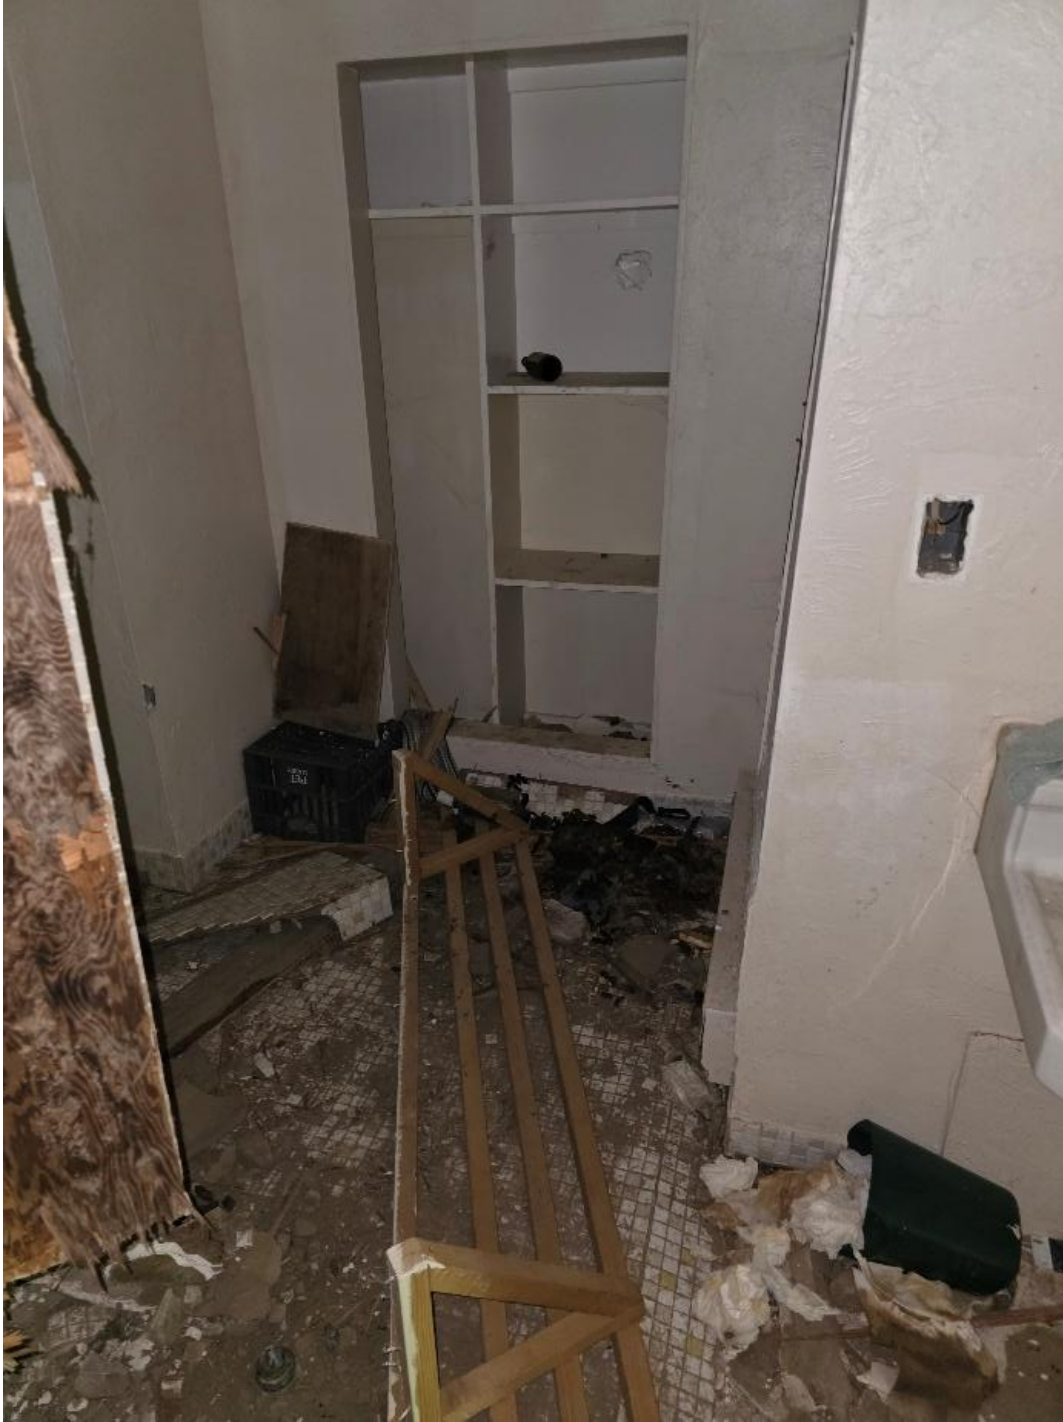
Visible mold growth on sheetrock wall Basement South Apartment Bathroom.

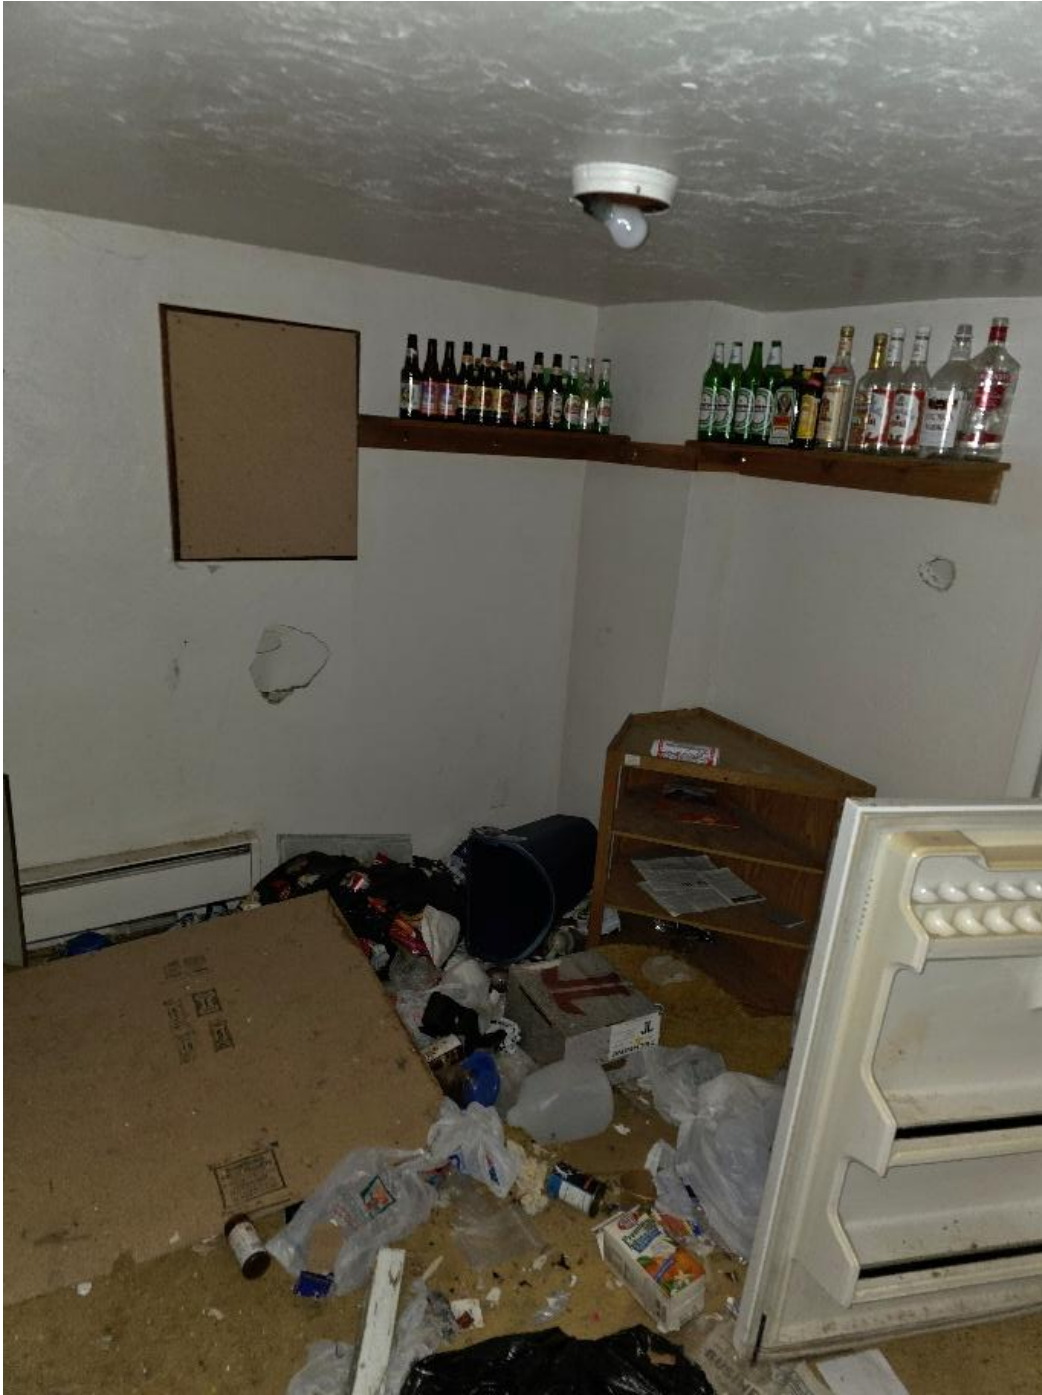
Basement South Apartment Kitchen with visible mold growth and feces.

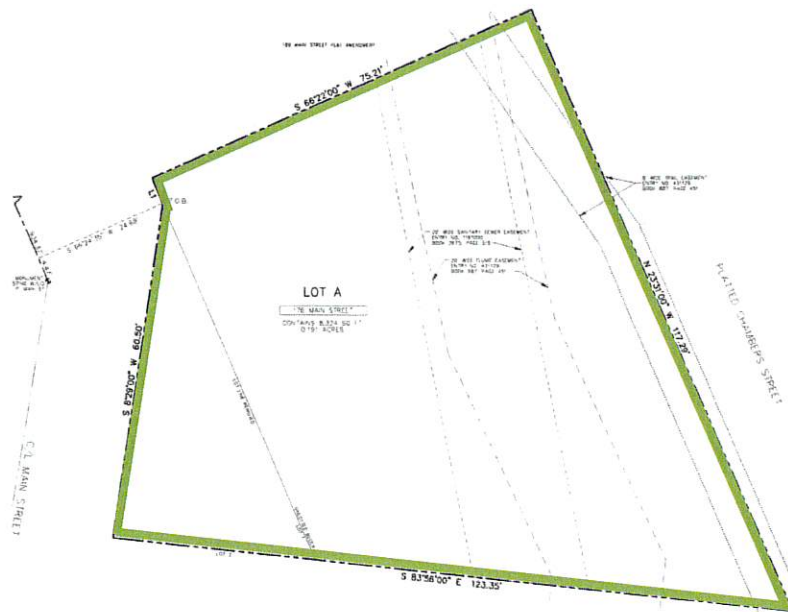
176 Main Street is a metes and bounds parcel located in Subzone B of the Historic Residential-2 Zoning District. The parcel is currently undergoing a Subdivision to create one Lot. 176 Main Street will have an unusual lot configuration due to its five (5) Lot Lines highlighted in green below on an excerpt from the Centennial Subdivision.
