**PARK CITY MUNICIPAL CORPORATION  
HISTORIC PRESERVATION BOARD  
CITY COUNCIL CHAMBERS**

**August 1, 2018**

227 Main Street – HDDR Material Deconstruction and Reconstruction – The applicant is proposing to reconstruct the historic boarding house designated as “Significant” on the City’s Historic Sites Inventory. In addition the applicant will be removing the existing c.1920 retaining and post-1976 retaining walls; c. 1889, c.1920, and 1976-1977 roof structures, non-historic asphalt and corrugated metal roofing materials; c.1920 brick chimney; c. 1889 wood drop novelty siding and wall structures, c.1920 stucco and wall structures, and 1976-1977 framed walls and wood paneling; c.1920 and 1976 enclosed piazza; c.1920 and contemporary doors units; and c.1889 double-hung wood window, c.1920 wood casement windows, 1976 picture windows, and contemporary aluminum and vinyl window units.

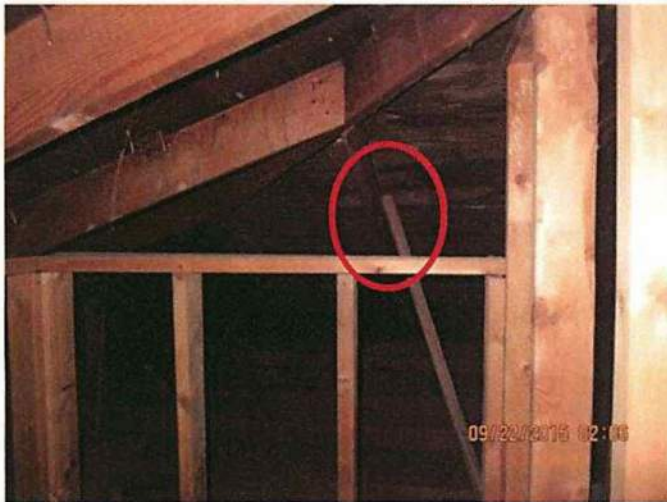
**Photo 4** Structural members not properly supported

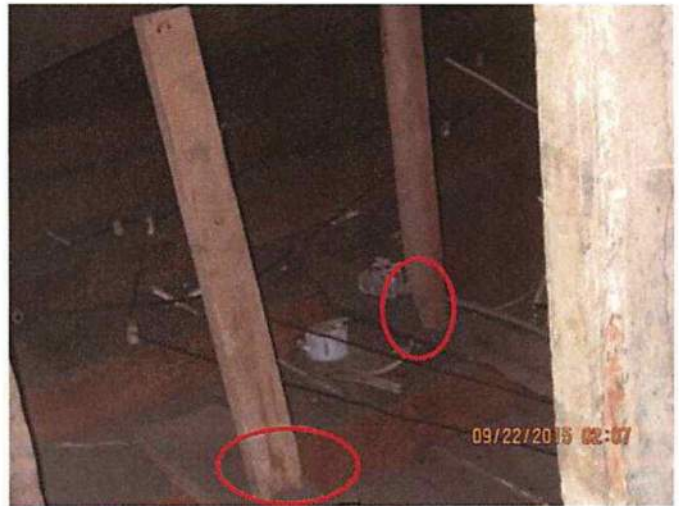
**Photo 5** Support member not properly fastened

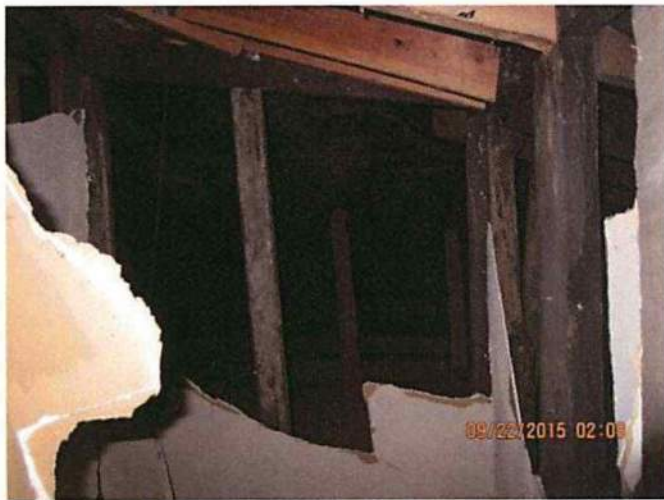
**Photo 6** Support members not fastened and are not perpendicular to the load they serve

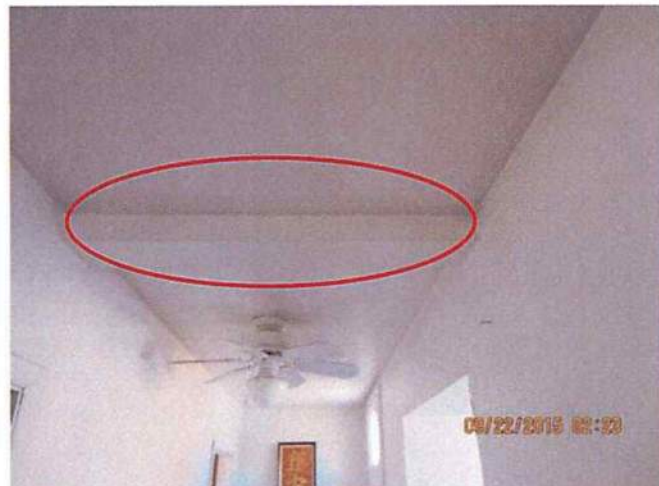
**Photo 8** Note structural beam. Refer to photo 9

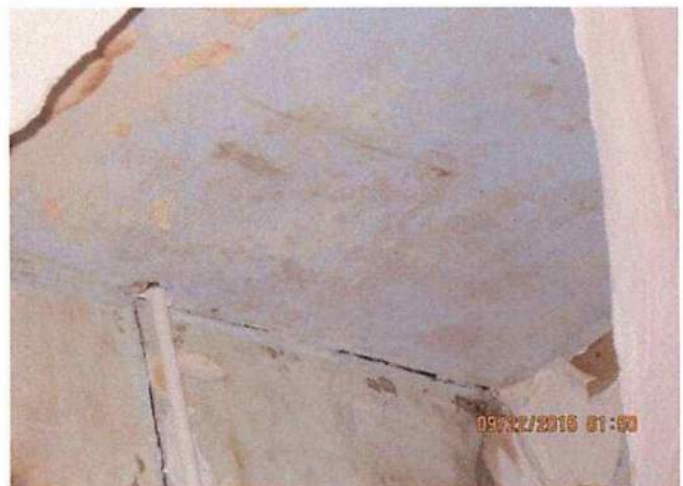
**Photo 9** The third level of the structure was added in the 1970's. The addition will need to be evaluated by a structural engineer. The support beam in this photo is missing a point load.

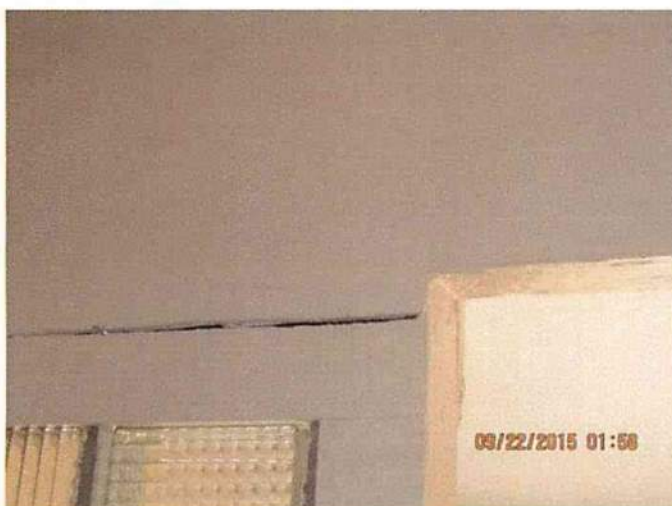
**Photo 14** Structural separation in second floor bedroom. Consistent with missing point loads and missing foundation

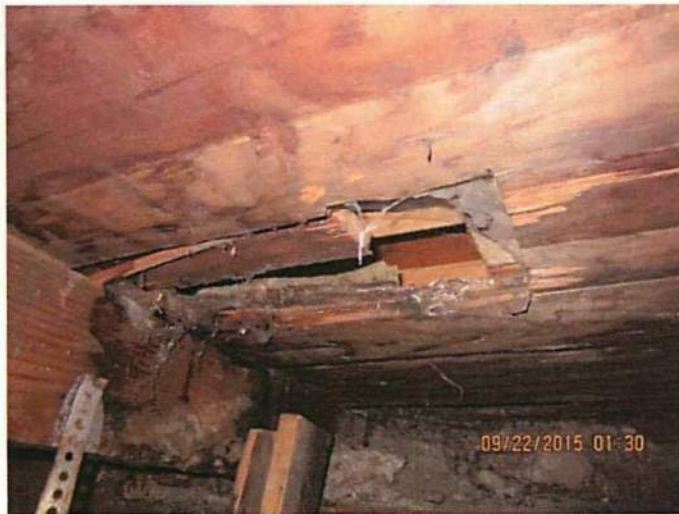
**Photo 18** Several shims have been used to level the building. These shims have not been properly installed

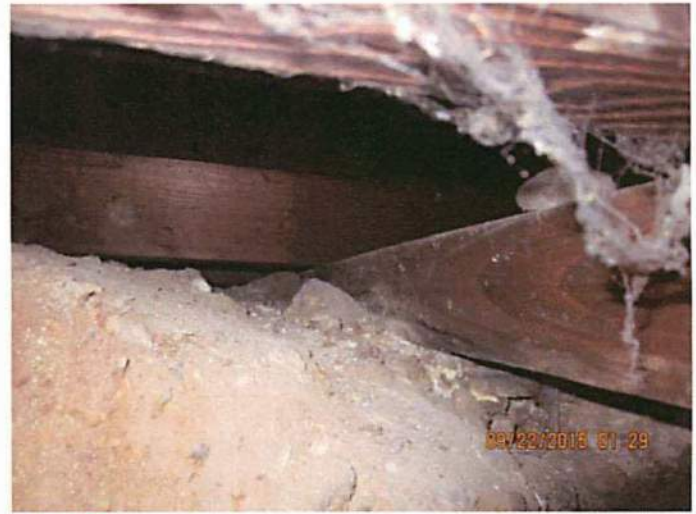
**Photo 19** Several shims and braces have been used to level the building. These shims and braces have not been properly installed

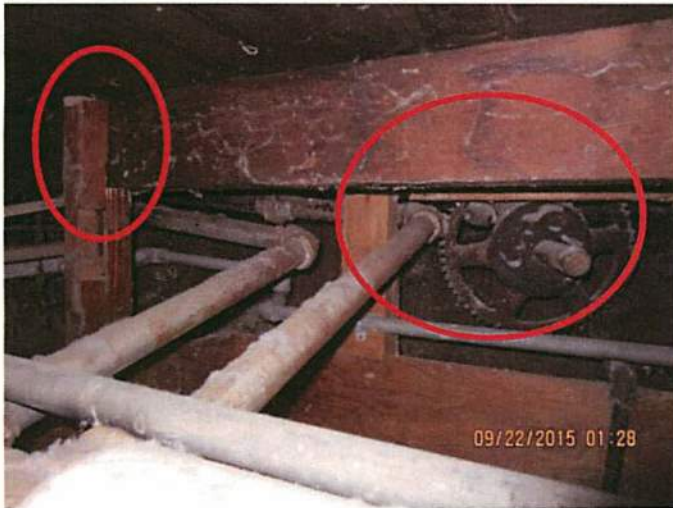
**Photo 22** Floor joist bearing directly on dirt. Shims and bracing added for support. Improperly installed

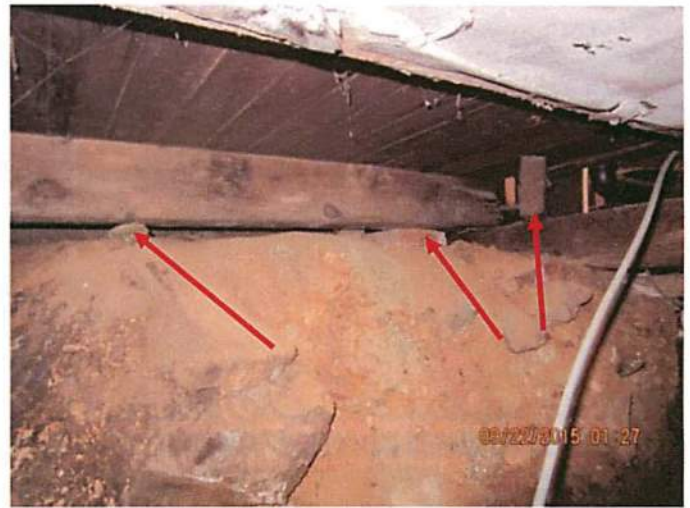
**Photo 23** The addition of bracing and shims to prevent settling of the building. Cannot have bearing directly on soils. All bearing is directly on soils. Engineer to justify

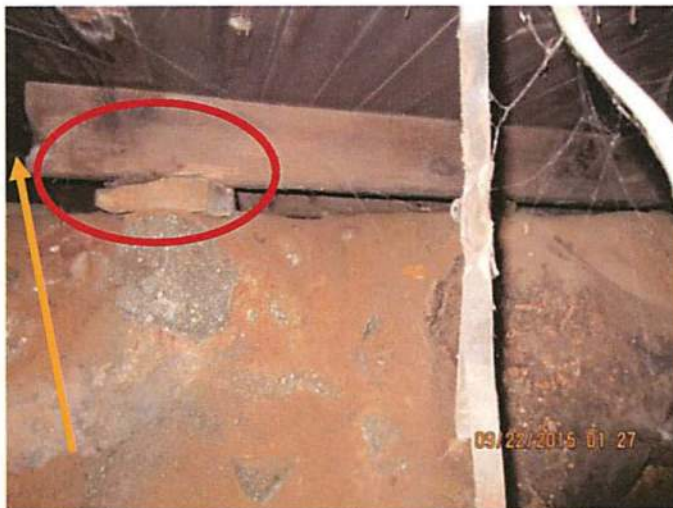
**Photo 24** The addition of bracing and shims to prevent settling of the building. Cannot have bearing directly on soils. All bearing is directly on soils. Engineer to justify

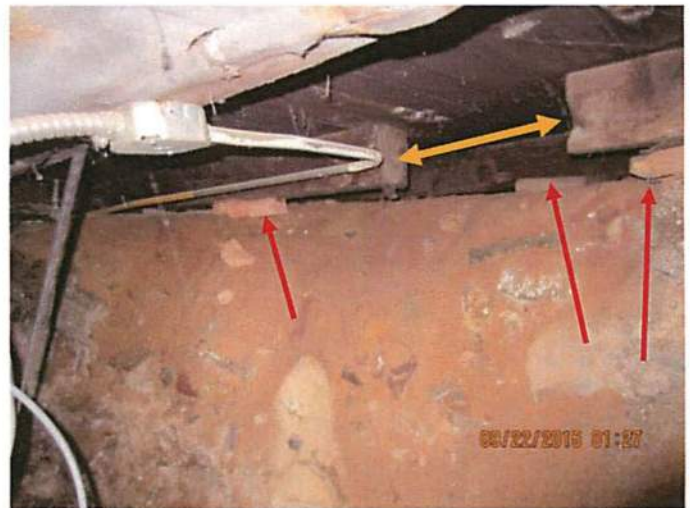
**Photo 25** The red circle shows a direct load at the end of a cut off floor joist. The blocking is bearing directly on soils. The yellow arrow shows the removal of a floor joist. The area above is the dining room

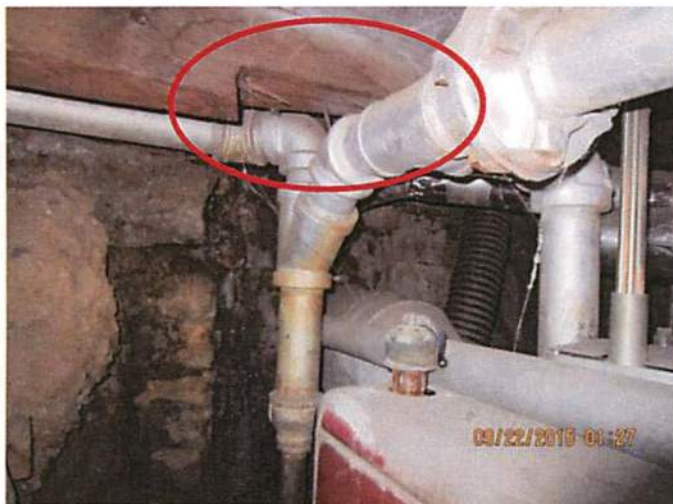
**Photo 26** The addition of bracing and shims to prevent settling of the building. Cannot have bearing directly on soils. All bearing is directly on soils. Engineer to justify

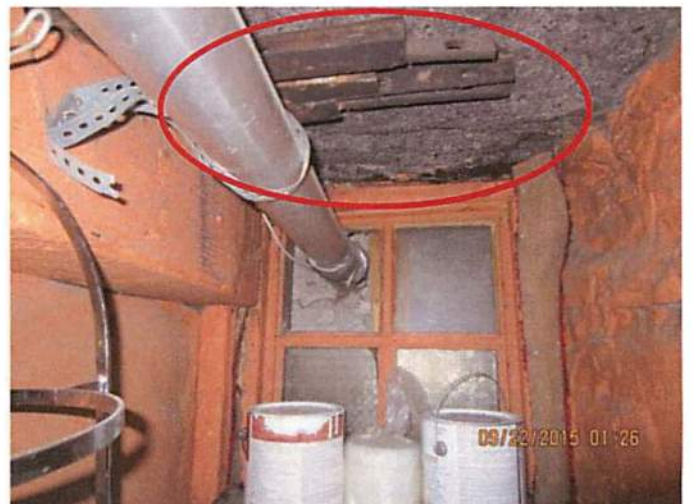
**Photo 27** Over notching of floor joist. Area above, dining room

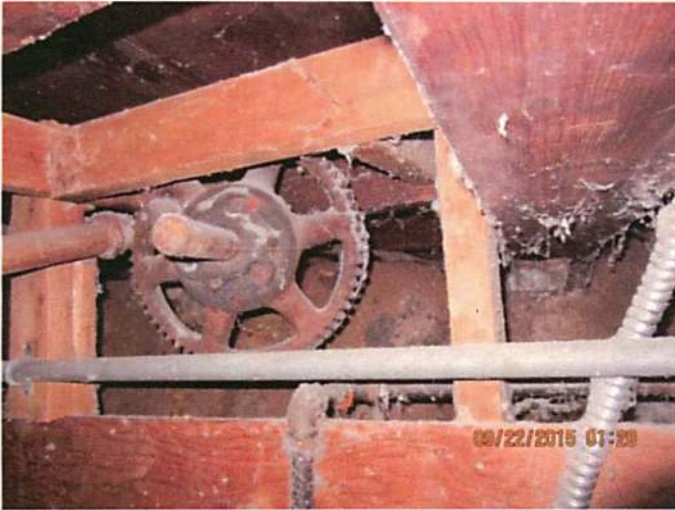
**Photo 4** Unsecured gas lines, unknown valves that are not properly maintained or marked

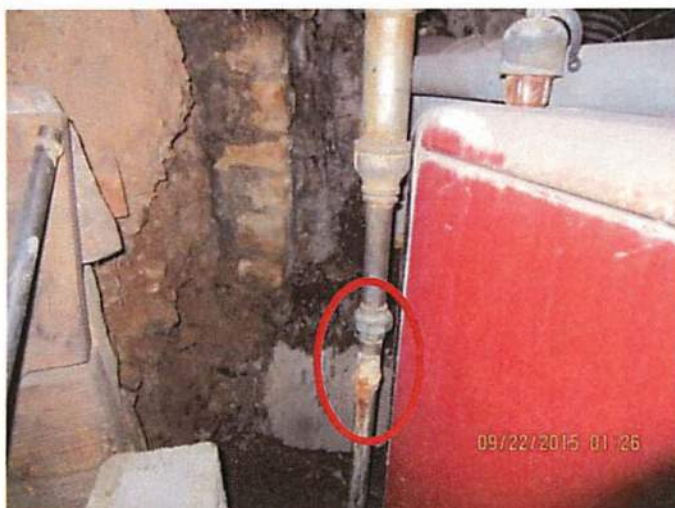
**Photo 8** Improperly installed plumbing repairs. Ends not properly capped. Copper to galvanized requires a brass coupler

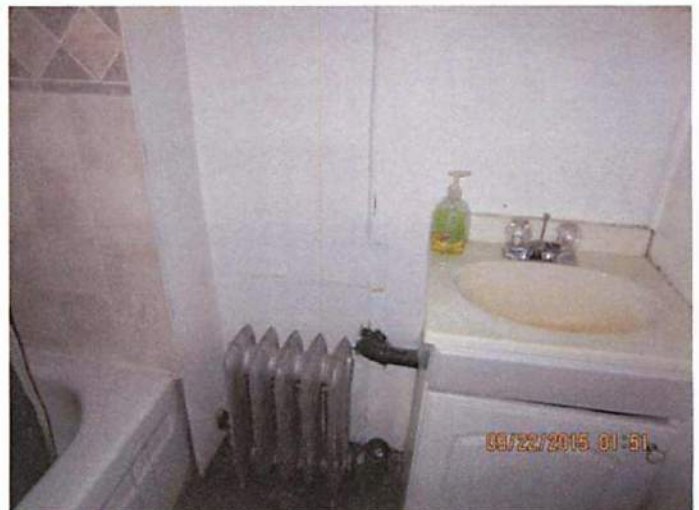
**Photo 12** Example of the radiator heating system that uses the boiler to heat the building

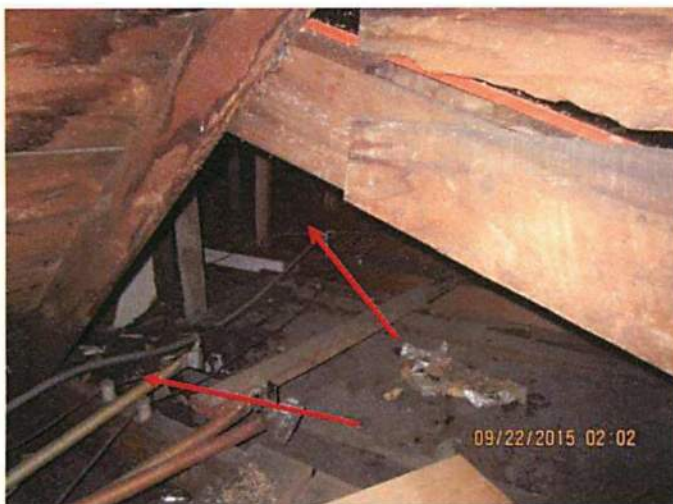
**Photo 14** Knob and tube electrical is located throughout the building. Knob and tube type wiring is classified as a possible health, life and safety concern if not properly maintained. It is common practice and a requirement of the electrical code to remove knob and tube wiring if any portion of the building is upgraded with newer electrical wiring. The building shows numerous upgrades in wiring and electrical upgrades, such as electrical panels, breakers, outlets and lighting. The knob and tube may not be able to support the current electrical upgrades in a safe manner and may be a fire concern. An electrical engineer needs to evaluate the electrical for the entire building before the electricity is turned on.

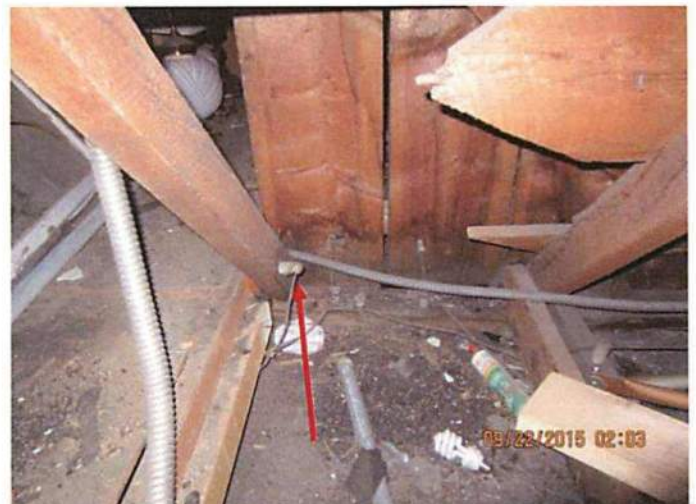
**Photo 15** Knob and tube wiring located throughout the attic area

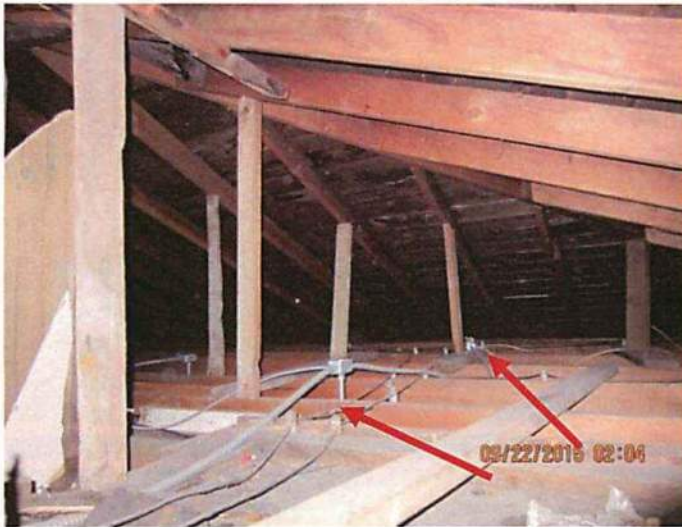
**Photo 16** Knob and tube wiring located throughout the attic area

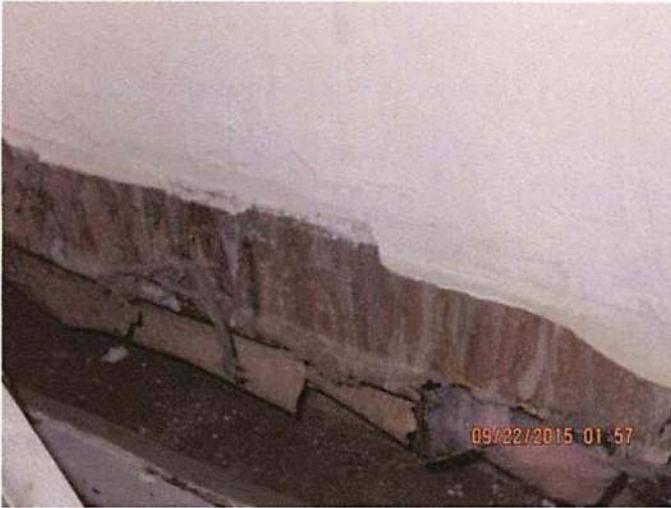
**Photo 21** Outlets located under windows that are damaged. Moisture and decay surrounds the electrical outlet

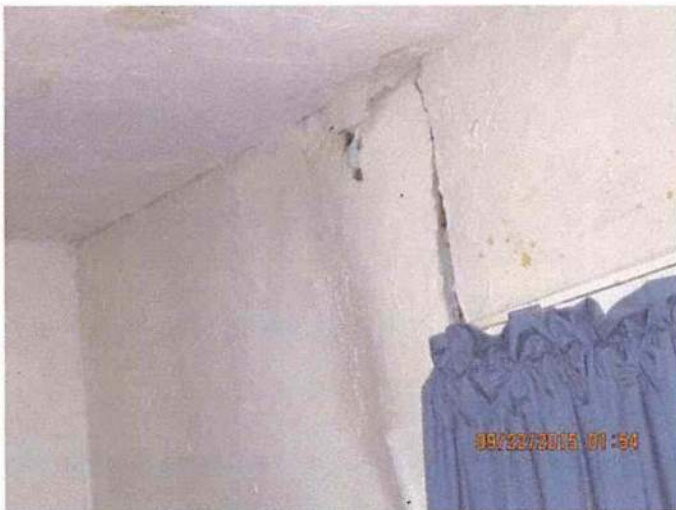
**Photo 23** Decay and deterioration noted throughout the building, cause appears to be lack of proper maintenance and infiltration of water from damaged roof

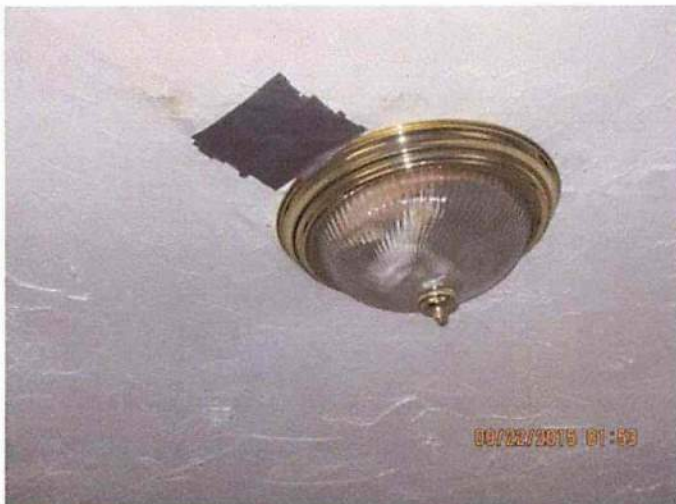
**Photo 25** Decay and deterioration noted throughout the building, cause appears to be lack of proper maintenance and infiltration of water from damaged roof

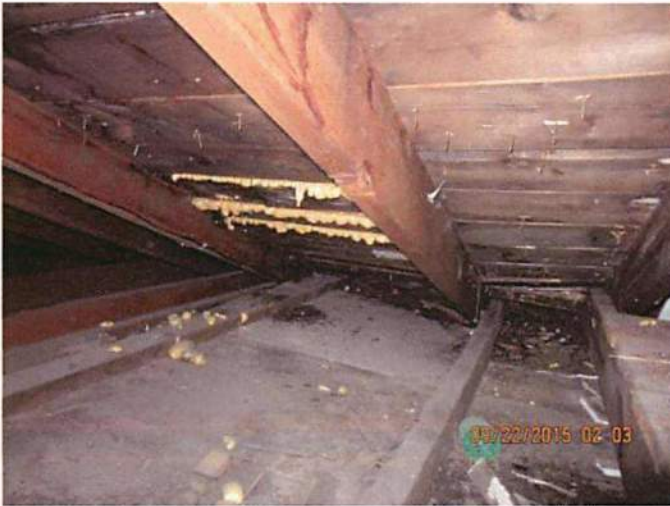
**Photo 27** Water damage and structural concern behind wall

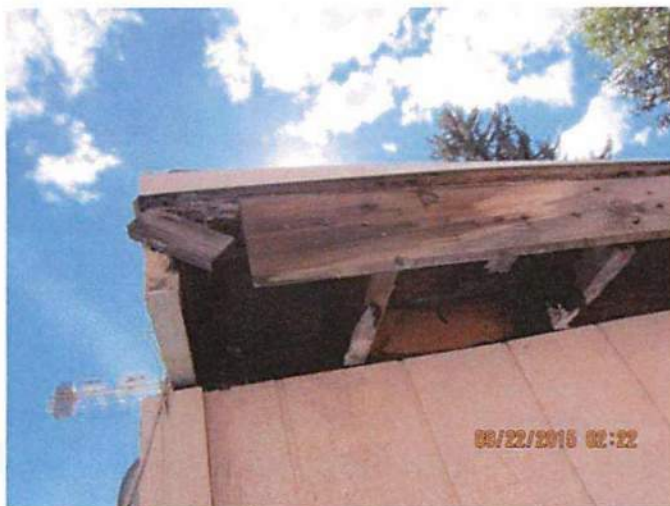
**Photo 31** Roof shows sign of decay and rot damage, soffit and fascia are missing, possible location of water infiltration

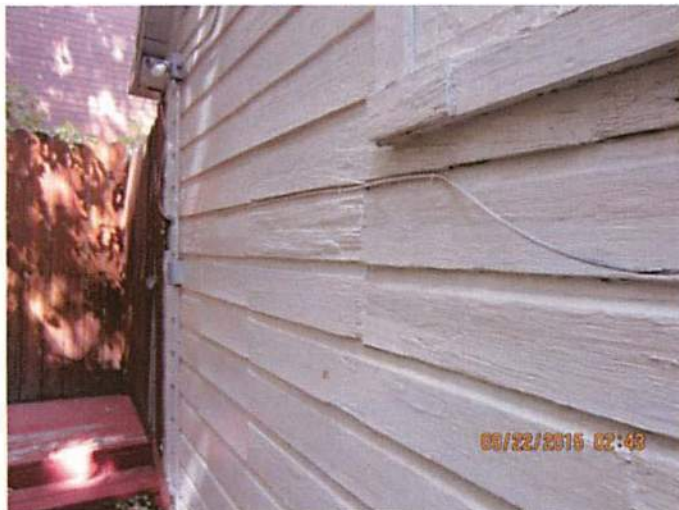
**Photo 36** Egress path rear of building. No access to safe location

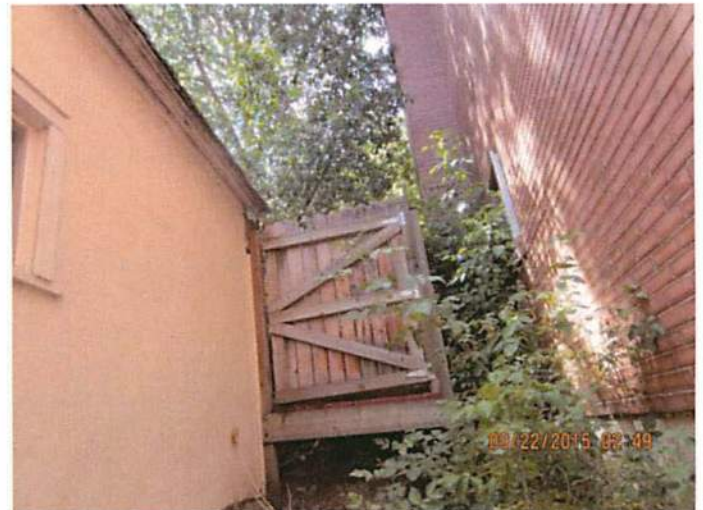
**Photo 37** Egress path rear of building. No access to safe location

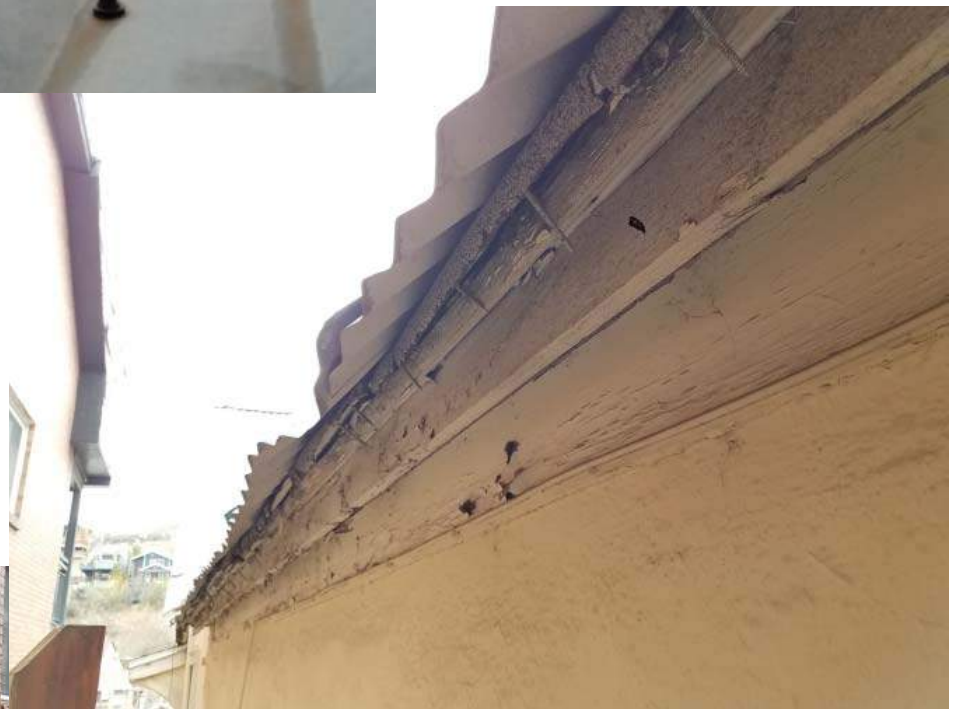
**9 - North Roof Eave Detail**

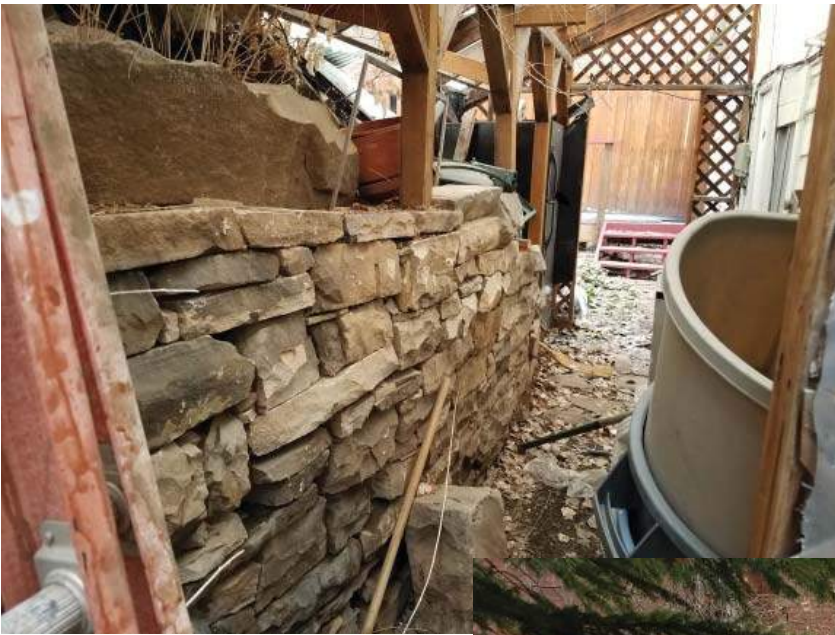
**13 - West Retaining Wall**

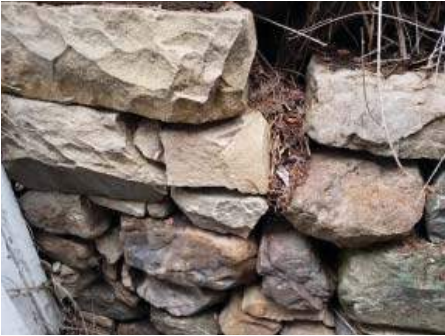
**16 - West Retaining Wall Composition**

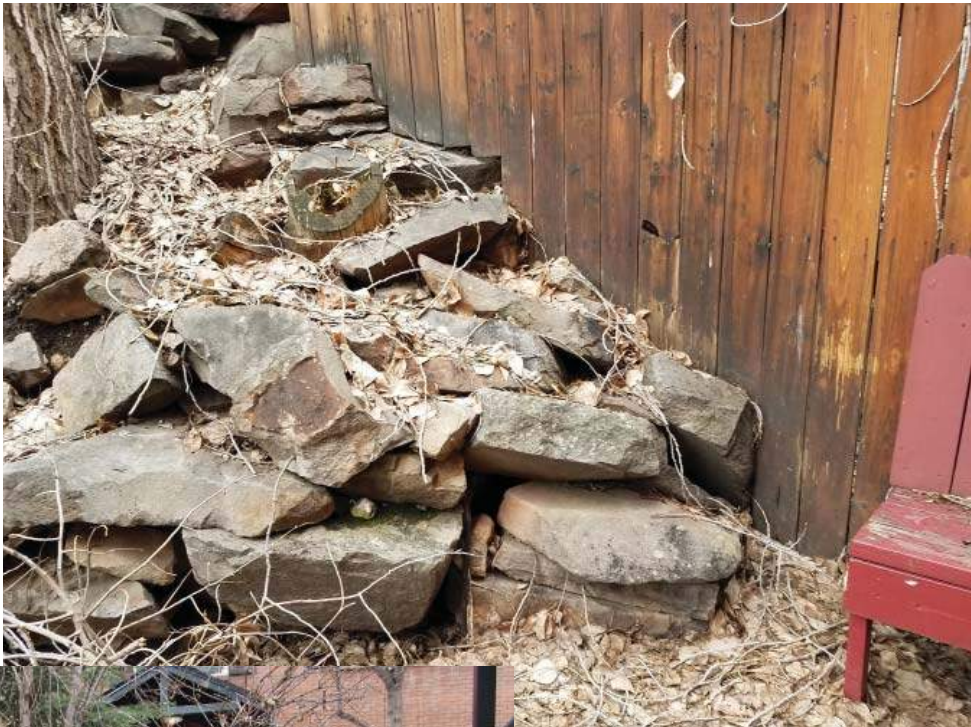
**17 - West Deck & Retaining Wall**

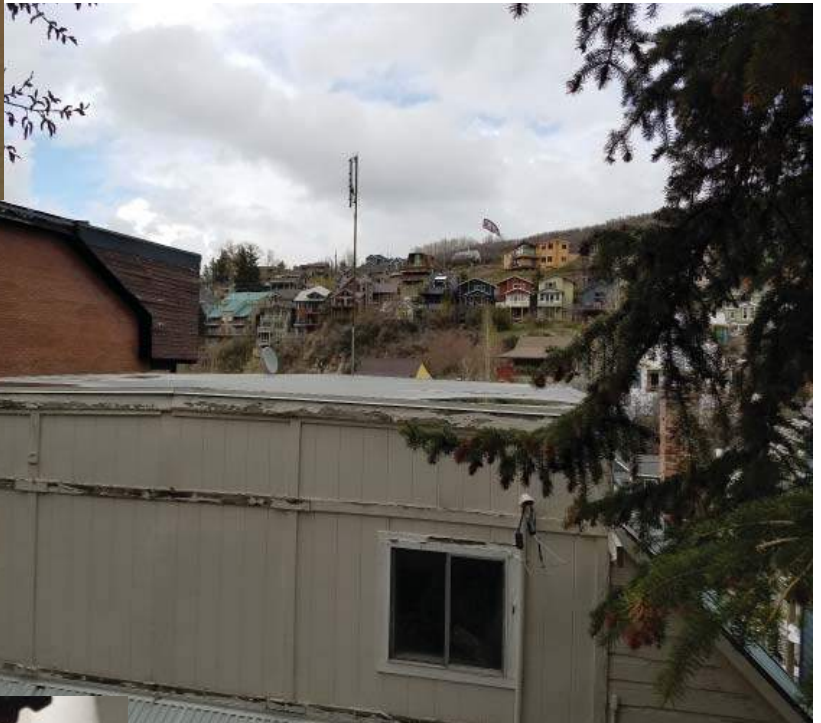
**26 - West Flat Roof**

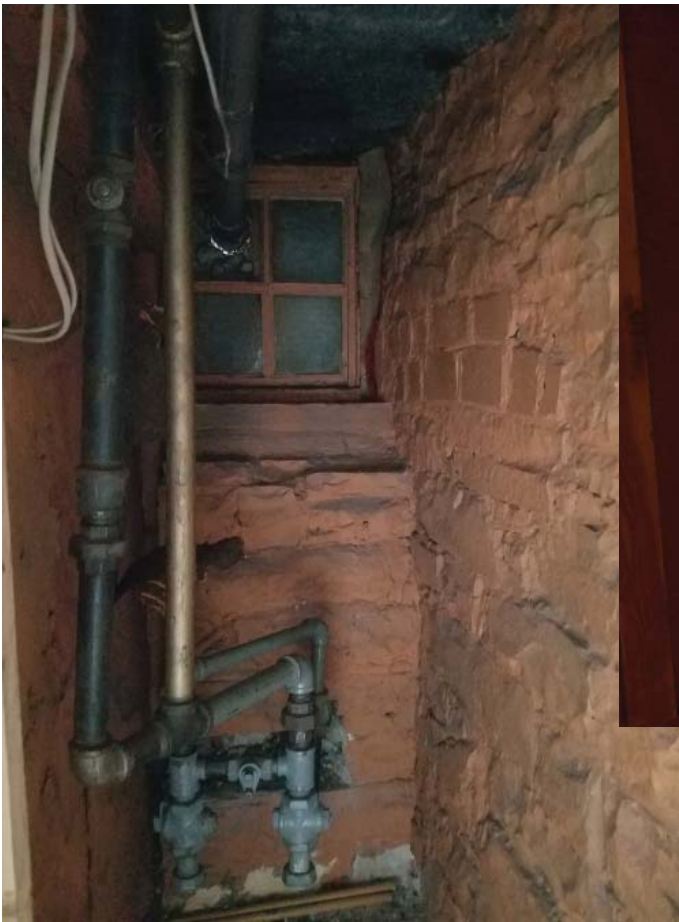
**54 - L0 - Retail Hidden Window**

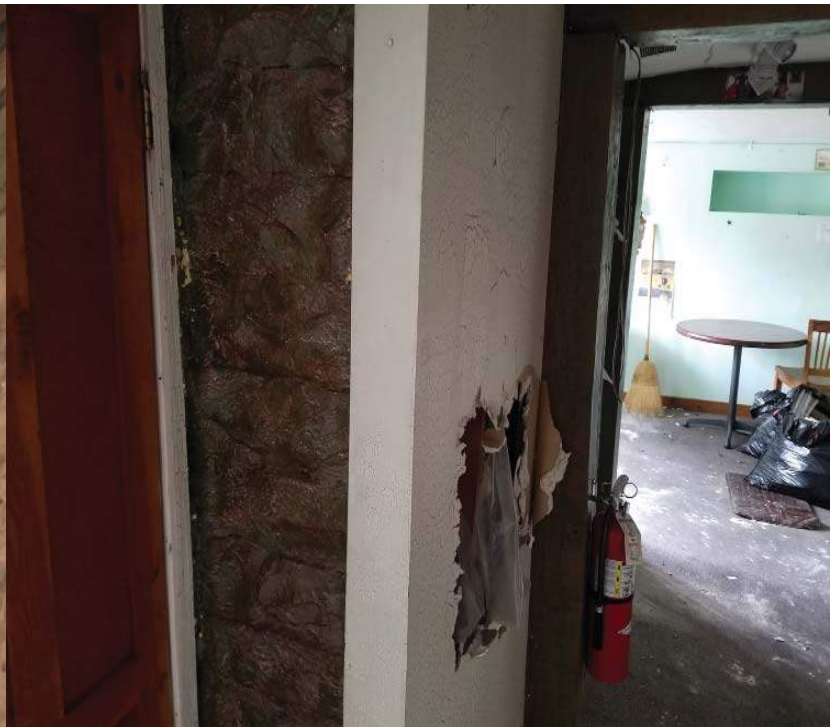
**55 - L0 - Stone Transition**
