**PARK CITY MUNICIPAL CORPORATION  
HISTORIC PRESERVATION BOARD  
CITY COUNCIL CHAMBERS  
May 16, 2018**

1021 Park Avenue –Historic District Design Review – Material Deconstruction on Landmark Site. The applicant is proposing to impact a portion of the rear (west) elevation for a new addition, modifications to historic window and door openings. The house was approved to be reconstructed through the Historic District Design Review (HDDR) process in 2016.

115 Sampson Avenue – HDDR Material Deconstruction and Reconstruction – The applicant is proposing to reconstruct the historic house designated as “Significant” on the City’s Historic Sites Inventory. In addition the applicant will be removing existing non-historic parking pad along with its associated wood staircases and railroad tie retaining wall; non-historic stacked stone retaining walls and 1990s wood slat fences; post-1947 addition on the west elevation and an underground root cellar; rebuilding the historic pyramid roof and dormers; reconstructing the existing masonry chimney; raising the house 2 feet to pour a new foundation; reconstructing the historic ca.1900 wraparound porch on the east and south elevations; replacing t

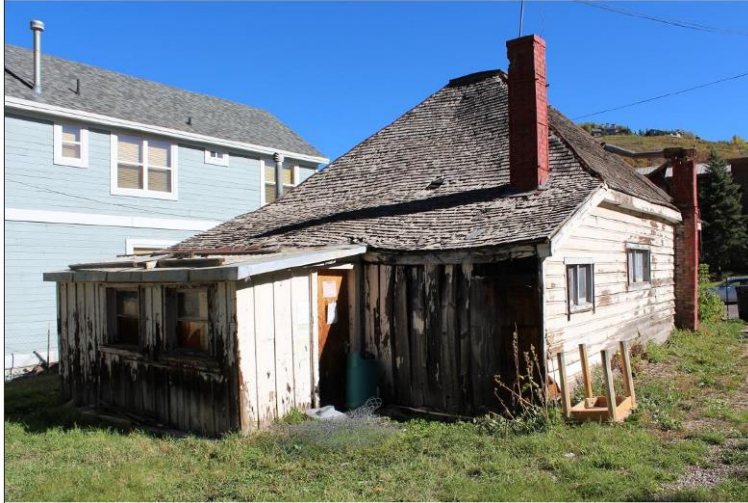
*This photograph shows the condition of the two additions in 2014. The additions had begun to pull away from the original pyramid-shaped roof and had significantly deteriorated due to inadequate foundations.*

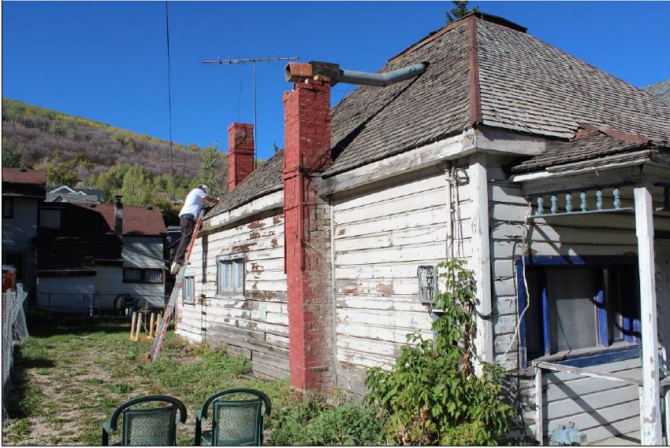
***South Elevation***

At the time of the documentation in 2013, this house had two chimneys. The first chimney was attached to the south side of the historic four-room house and the second chimney was on the west (rear) side of the historic house and had been enclosed by the first addition. These chimneys were in disrepair and did not appear to be original to the pyramid-roof cottage.

Staff does not believe these chimneys were original to the pyramid-roof cottage as they were constructed on exterior walls. Staff finds that these chimneys do not need to be reconstructed as they do not contribute to the historic integrity or historical significance of the structure or site.

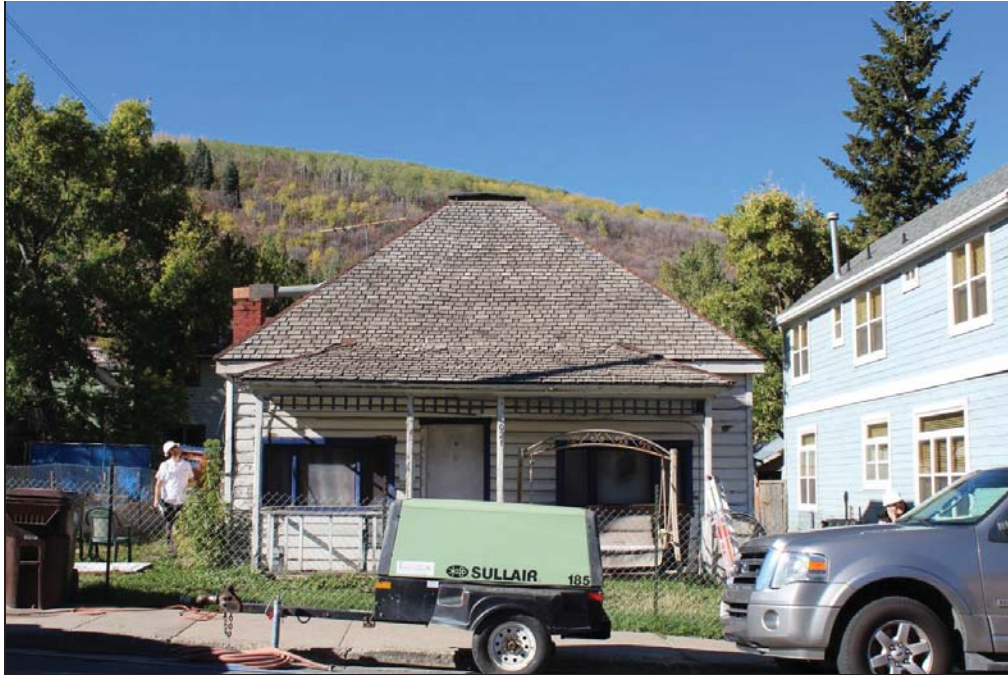
**A.1. TOPOGRAPHY:** General view of site, facing west.

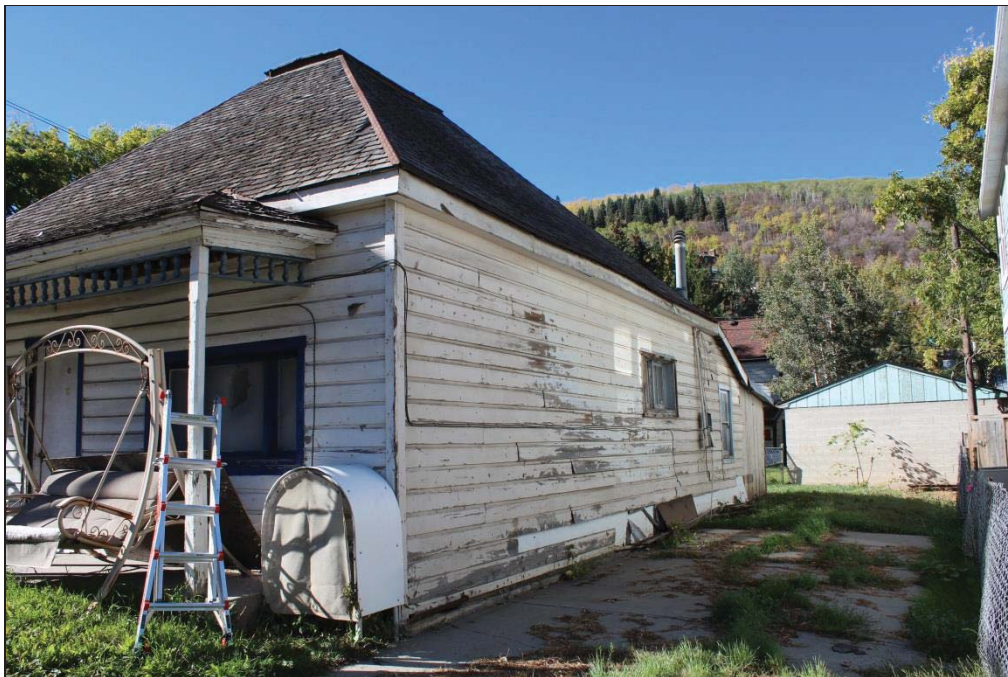
**A.2. LANDSCAPING:** Concrete parking pad on north side, facing southwest

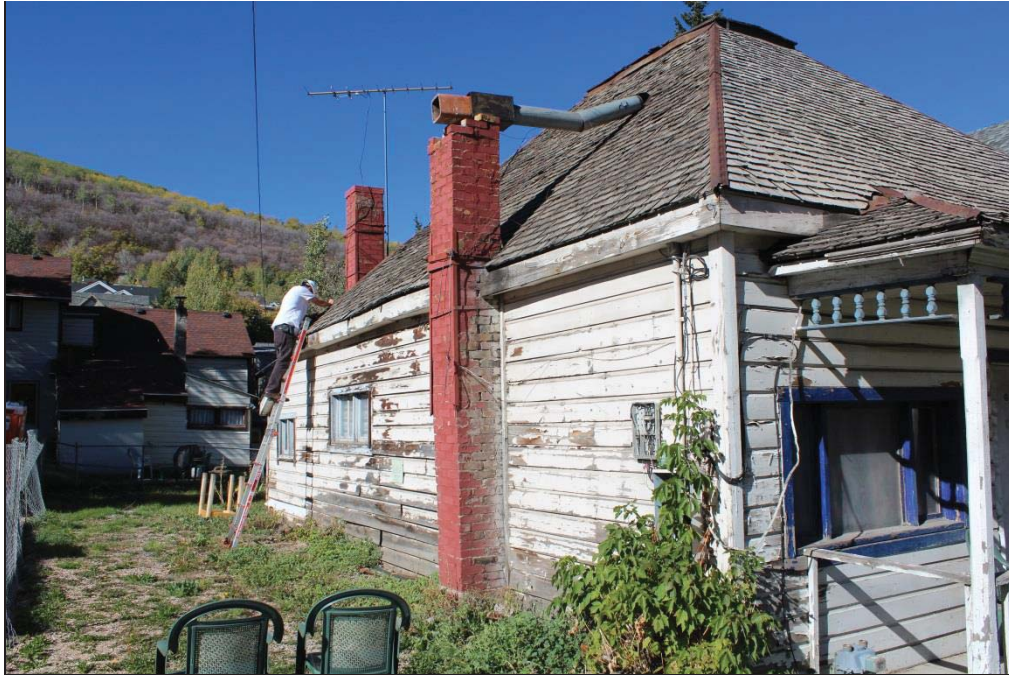
**A.2. LANDSCAPING:** Gravel parking area on south side, facing northwest.

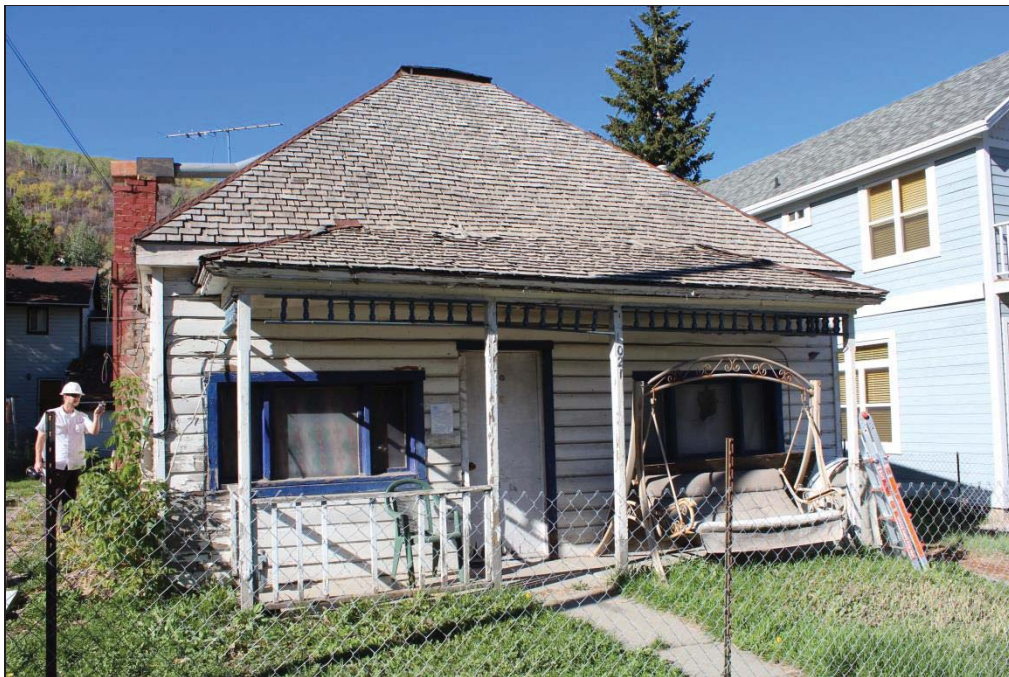
**A.4. FENCES:** Temporary chain link fence in foreground, facing west.

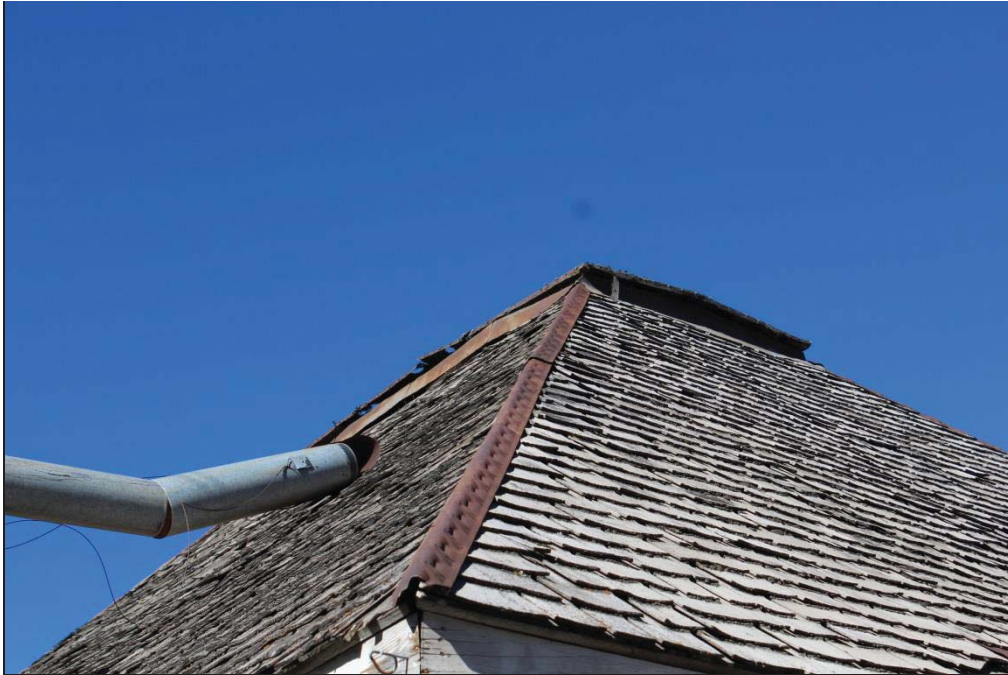
**B.1. ROOF:** East and south sides relatively planar, older wood shingles, metal ridges and cap.

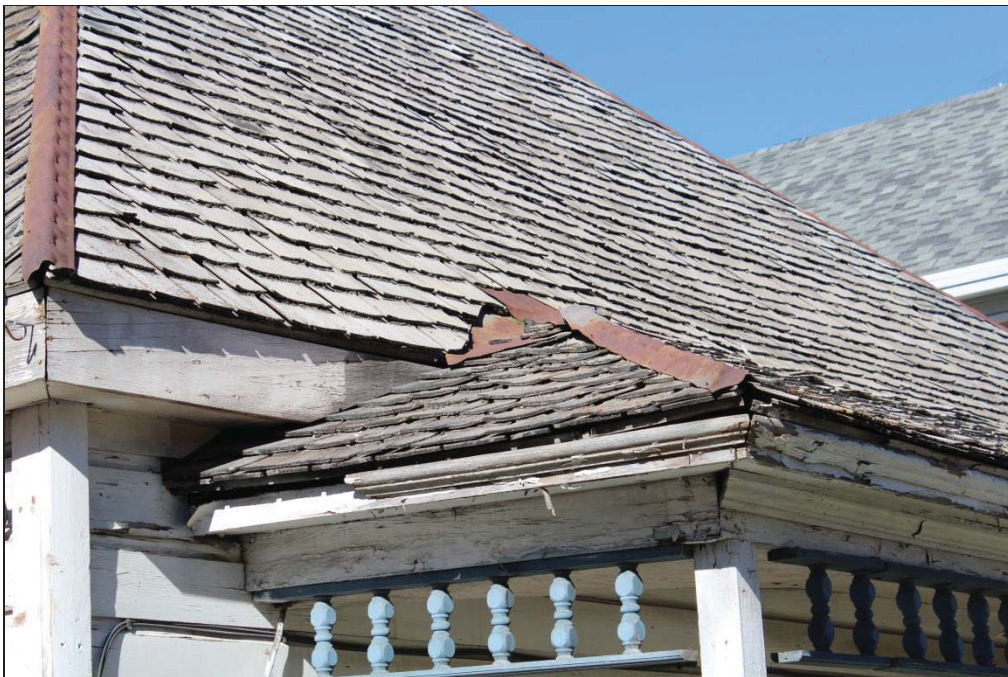
**B.1. ROOF:** East side and porch, showing similar materials and age of porch roof and cornice.

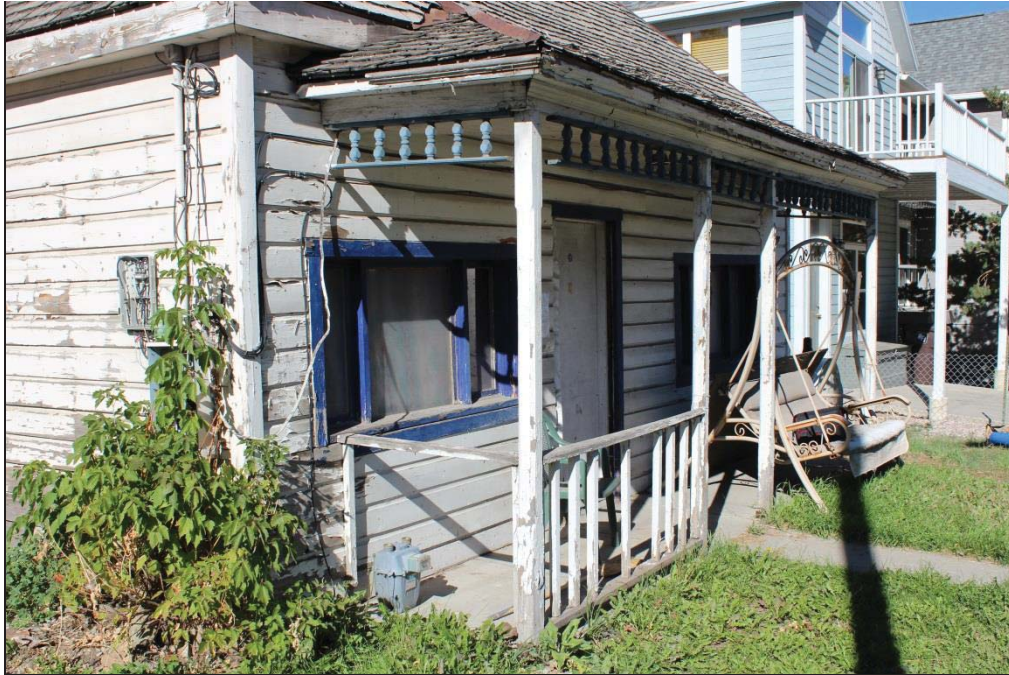
### B.2. EXTERIOR WALL – PRIMARY FAÇADE: Facing northwest.

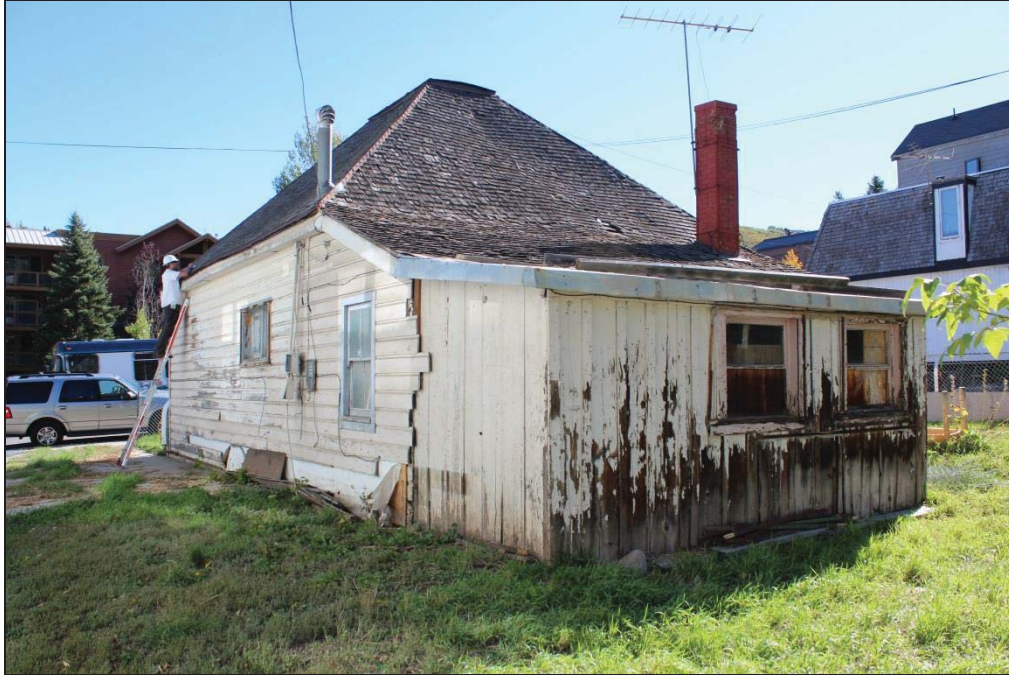
### B.3. EXTERIOR WALL – SECONDARY FAÇADE 1: North wall, facing southeast.

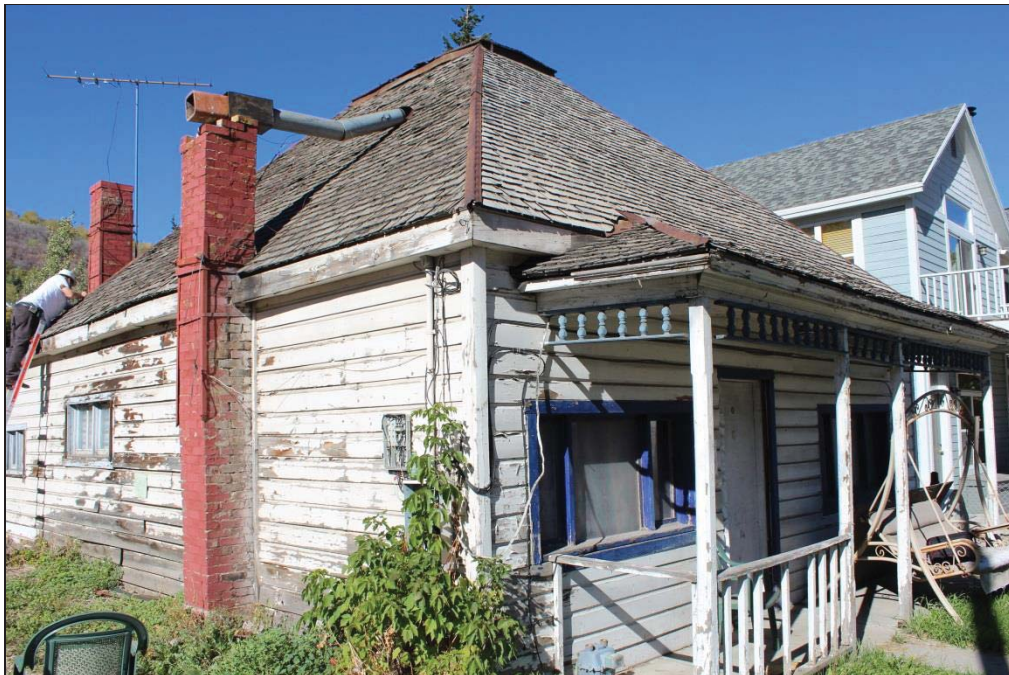
**B.4. EXTERIOR WALL – SECONDARY FAÇADE 2:** South wall, facing northwest.

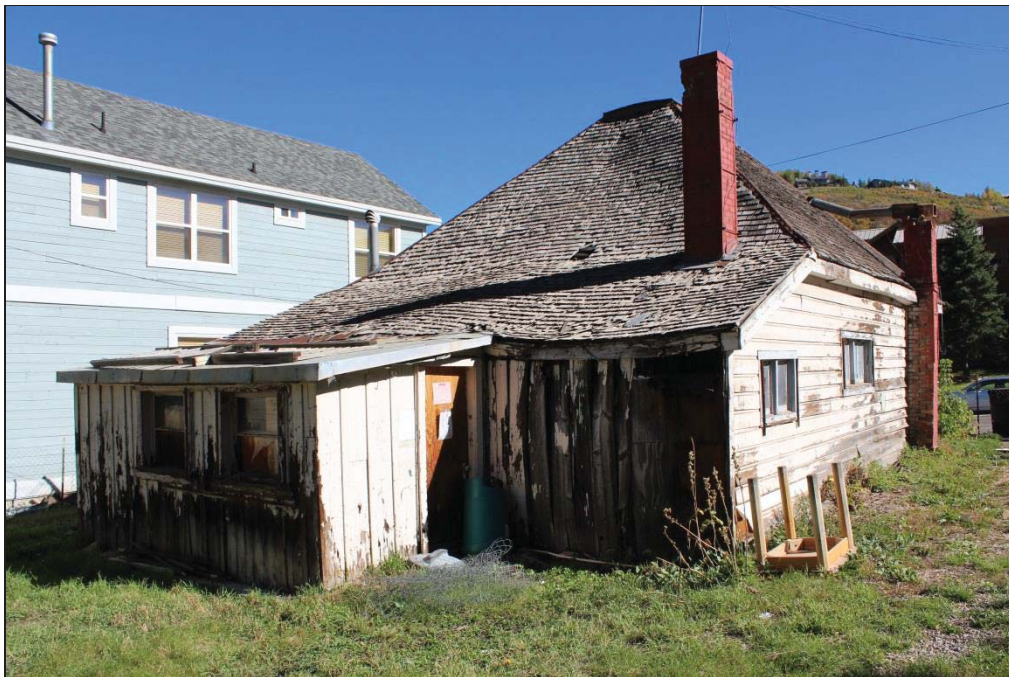
**B.5. EXTERIOR WALL – REAR FAÇADE:** West side, facing northeast. Rear wall formed by west walls of Addition 2 (at left) and Addition 1 (at right).

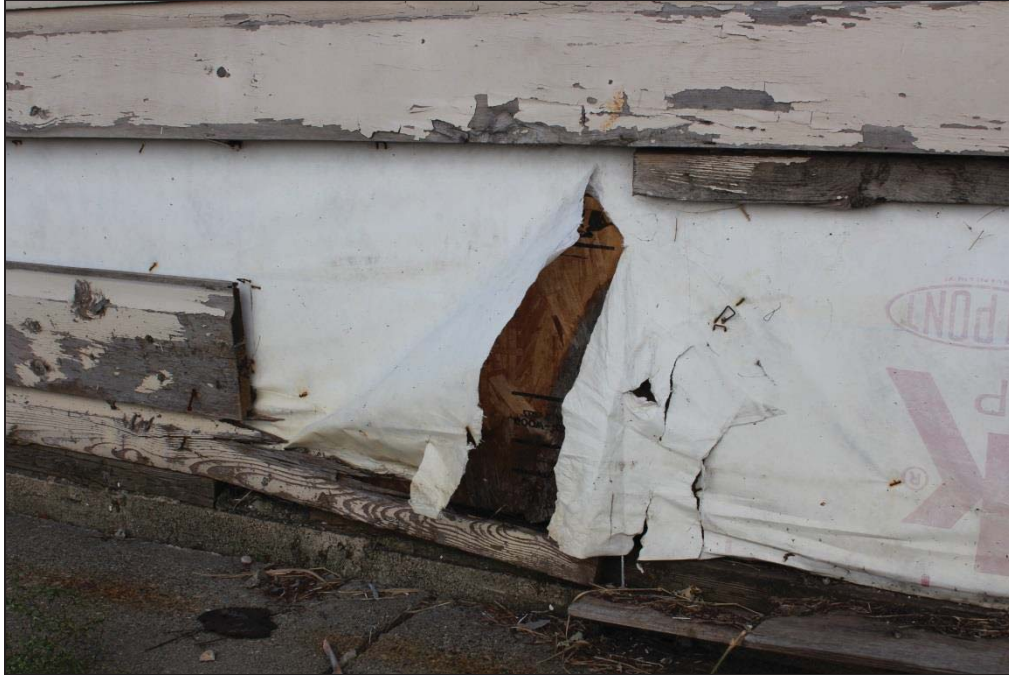
SWCA's Physical Conditions Report in 2014 found that the majority of the house and later additions had been constructed without a foundation. A concrete foundation and intermittent piers had been added where possible c.1995; however, the foundation was not continuous. Where the new foundation was not present, the sill plate and lower ends of the original siding and wall materials sat directly on the dirt. The foundation and lower levels of the wall had rotted out and were deteriorated beyond repair in 2013.

**B.6. FOUNDATION:** Base of north wall, facing south, low concrete foundation visible.

The applicant is proposing to construct a new basement foundation. The historic house will be lifted two feet (2') to construct this foundation; however, the site will be re-graded so the house does not appear to sit taller than it did historically. The remnants of the c.1995 concrete foundation work do not contribute to the historic integrity or historical significance of the structure and can be removed.

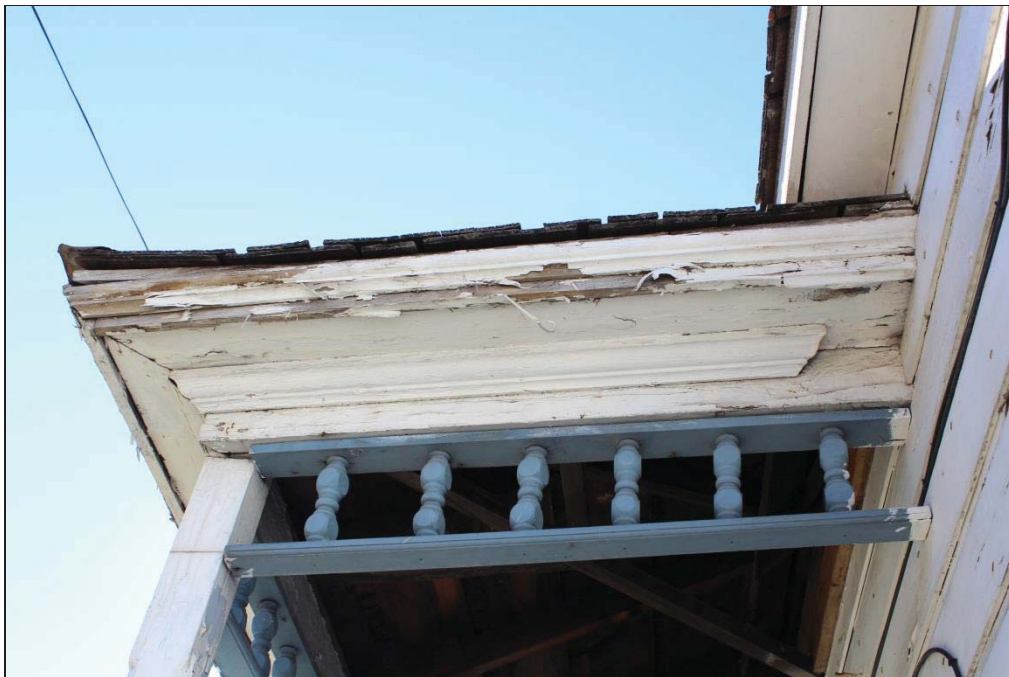
**B.7. PORCH:** See photos A.4., B.1., B.2., and B.4. Detail of older eave/cornice and newer spindles, north side of porch roof.

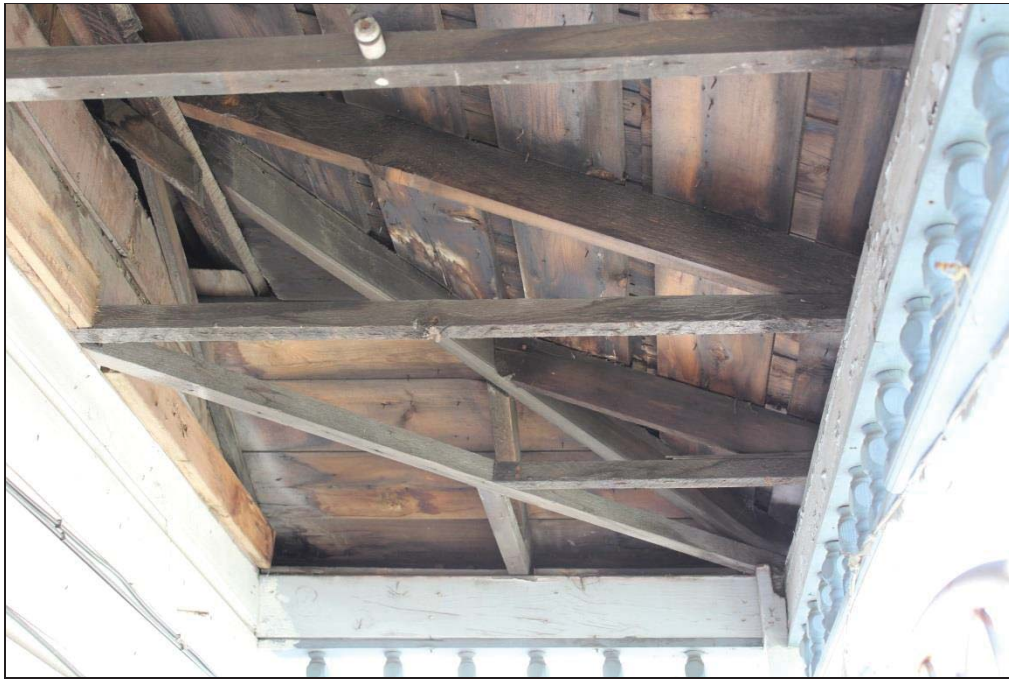
**B.7. PORCH:** Detail of older roof framing and sheathing. Also note porcelain knob for early electrical system at top of photo.

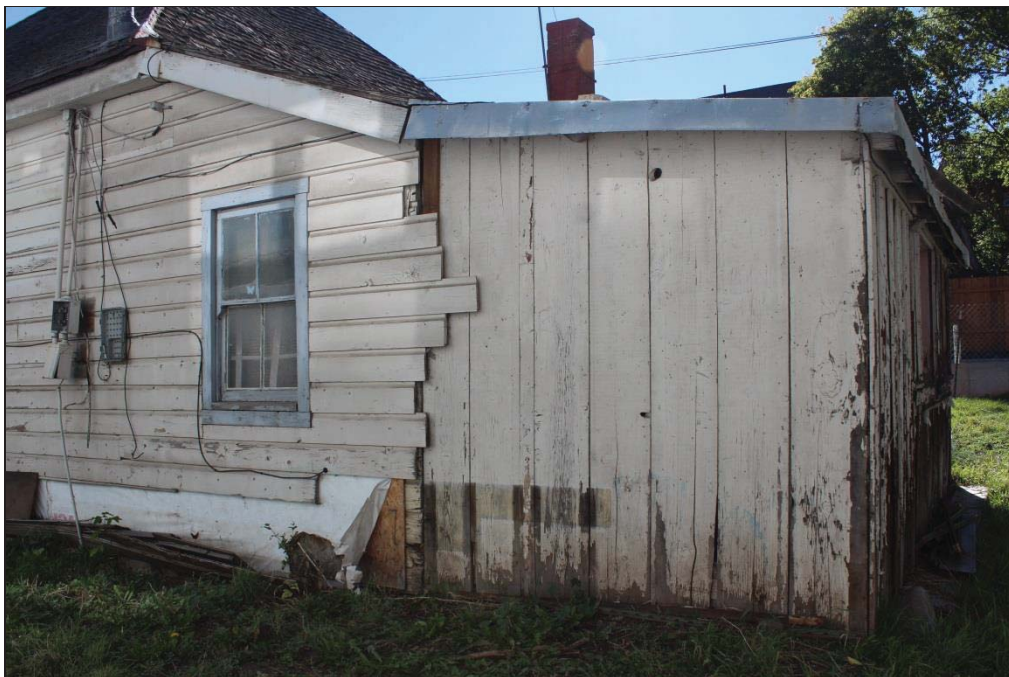
**B.9. ADDITIONS:** North wall of Addition 1 (with window) and Addition 2 (with vertical boards), facing south.

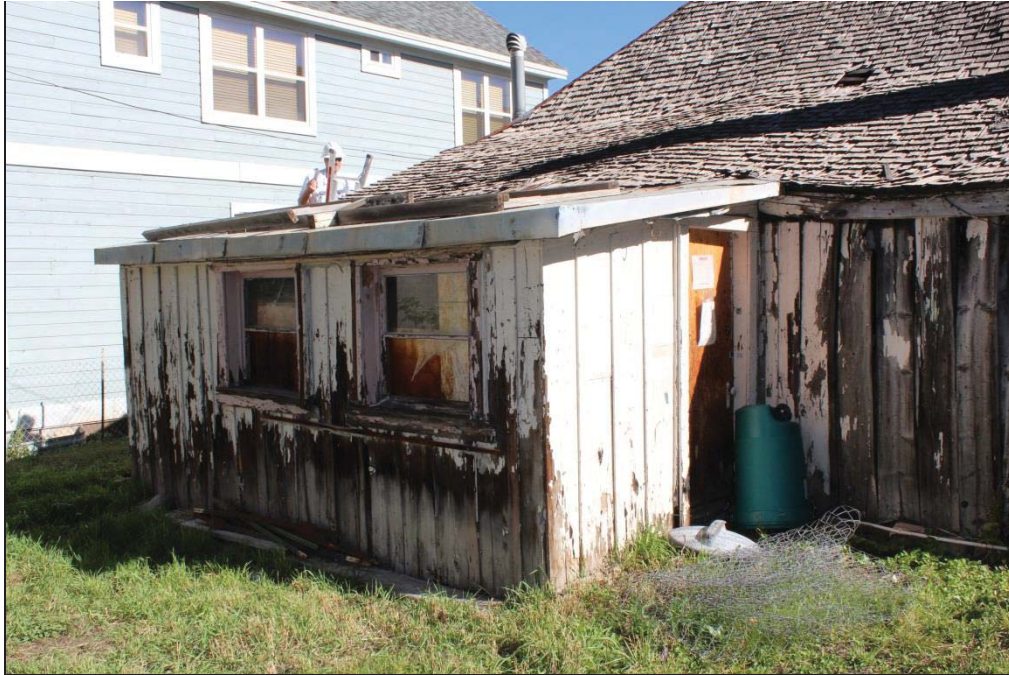
**B.9. ADDITIONS:** West and south walls of Addition 2, facing northeast.

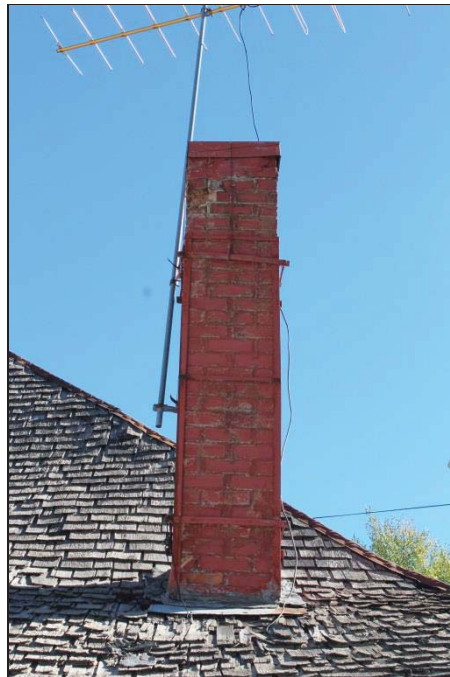
**B.10. MECHANICAL SYSTEM:** East side of brick chimney constructed around or in place of metal stovepipe, facing east.

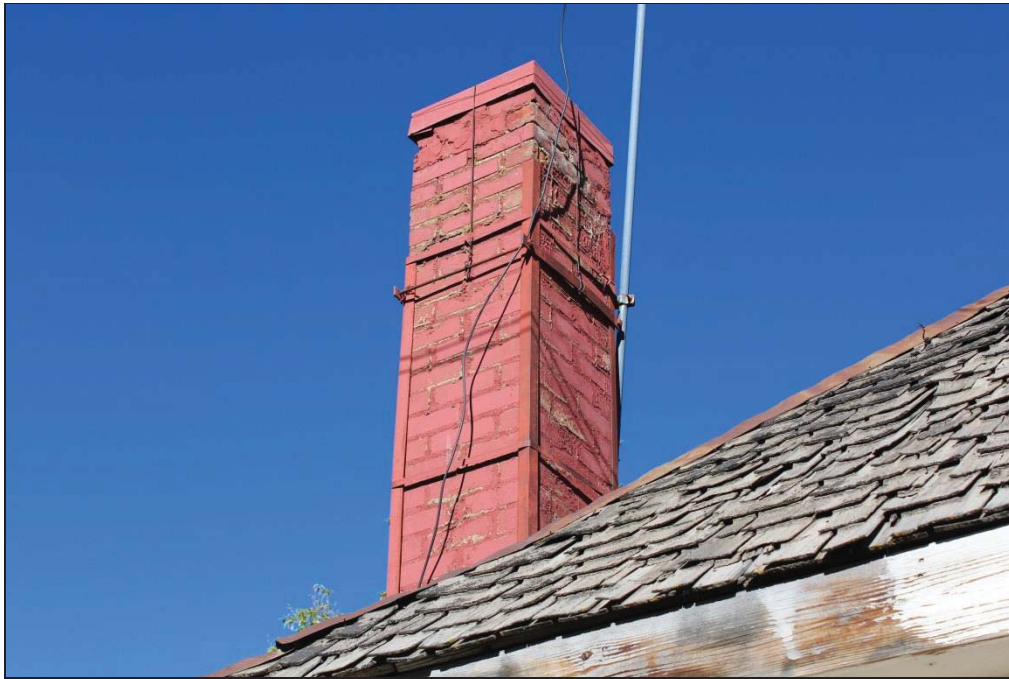
**B.10. MECHANICAL SYSTEM:** South and east sides of brick chimney constructed around or in place of metal stovepipe, facing northwest.

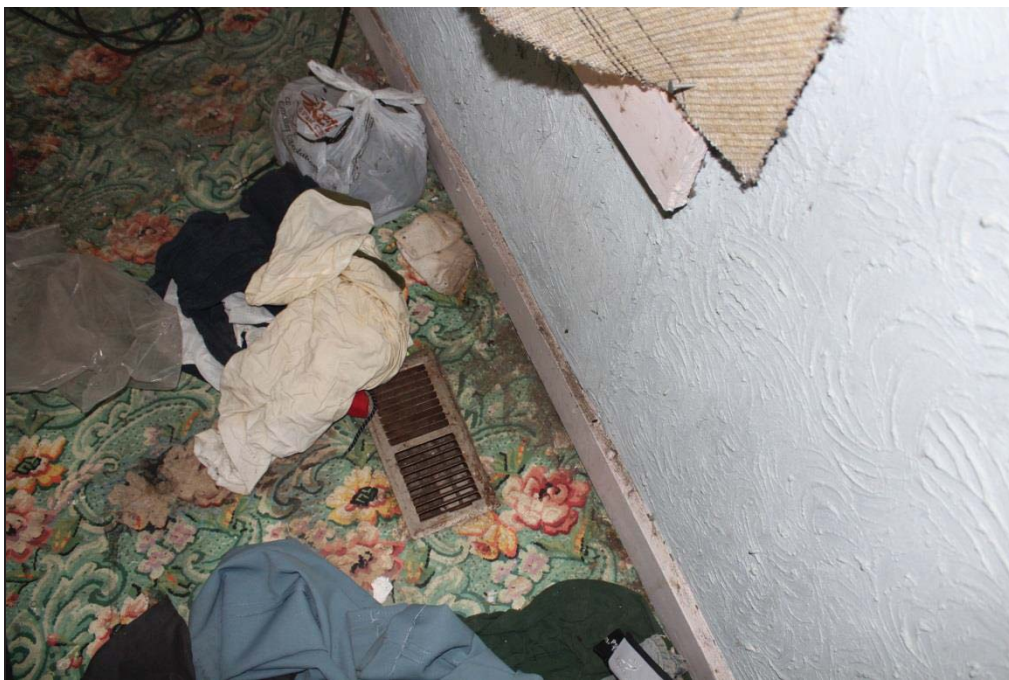
**B.10. MECHANICAL SYSTEM:** Newer forced-air duct cover in floor of house.

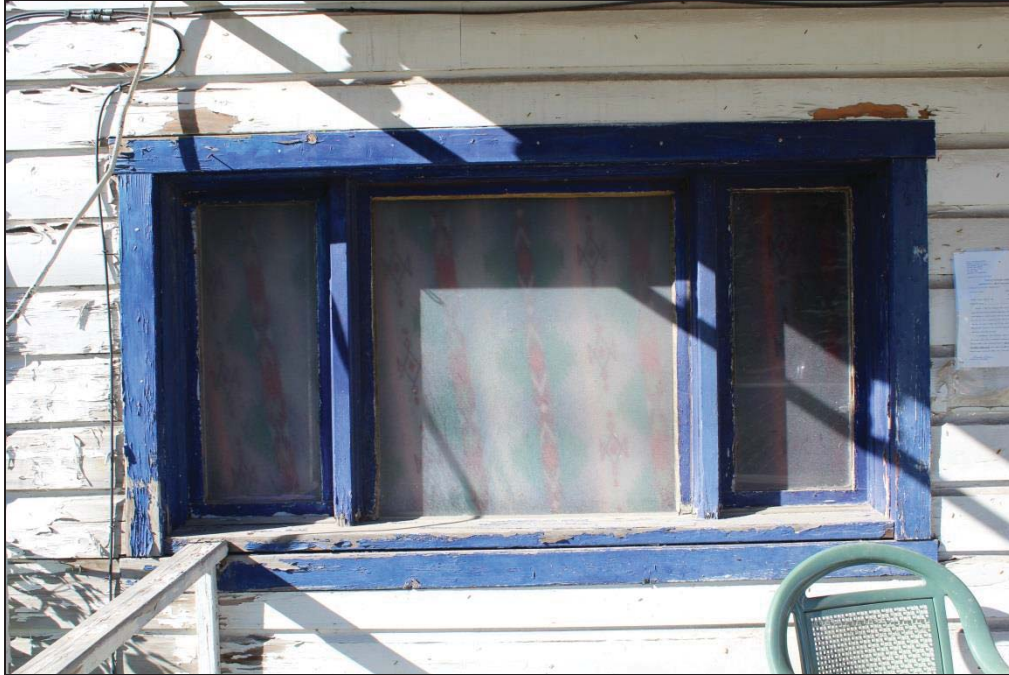
**C.1. WINDOWS:** Ca. 1920s wood replacement window on east façade.

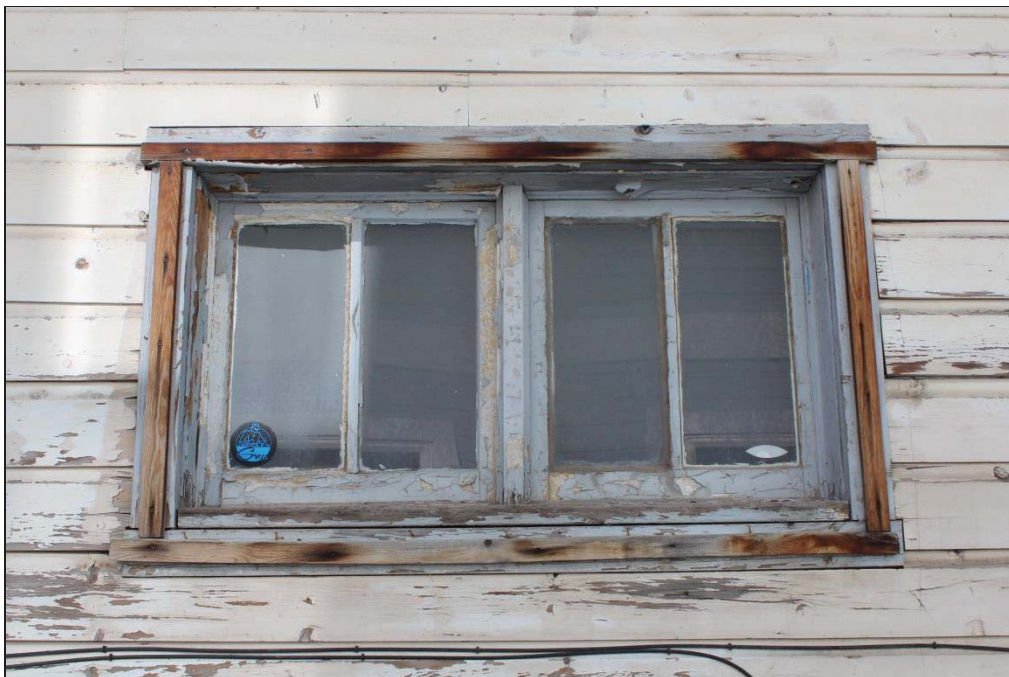
**C.1. WINDOWS:** Ca. 1920s pair of wood casement windows on north wall.

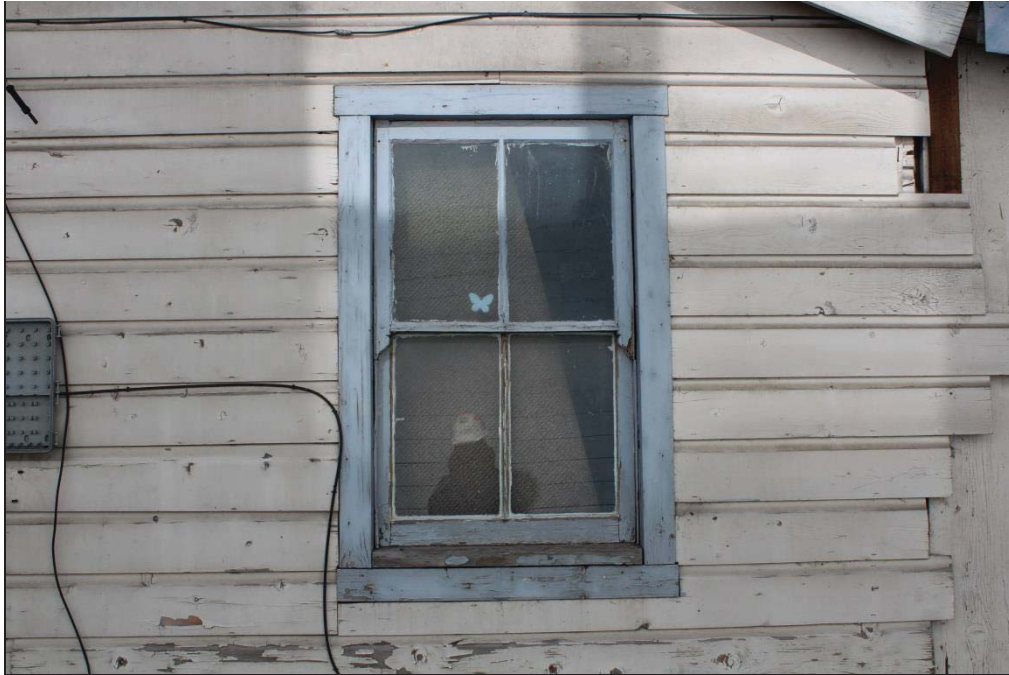
**C.1. WINDOWS:** Possible original, double-hung wood window on north wall of Addition 1.

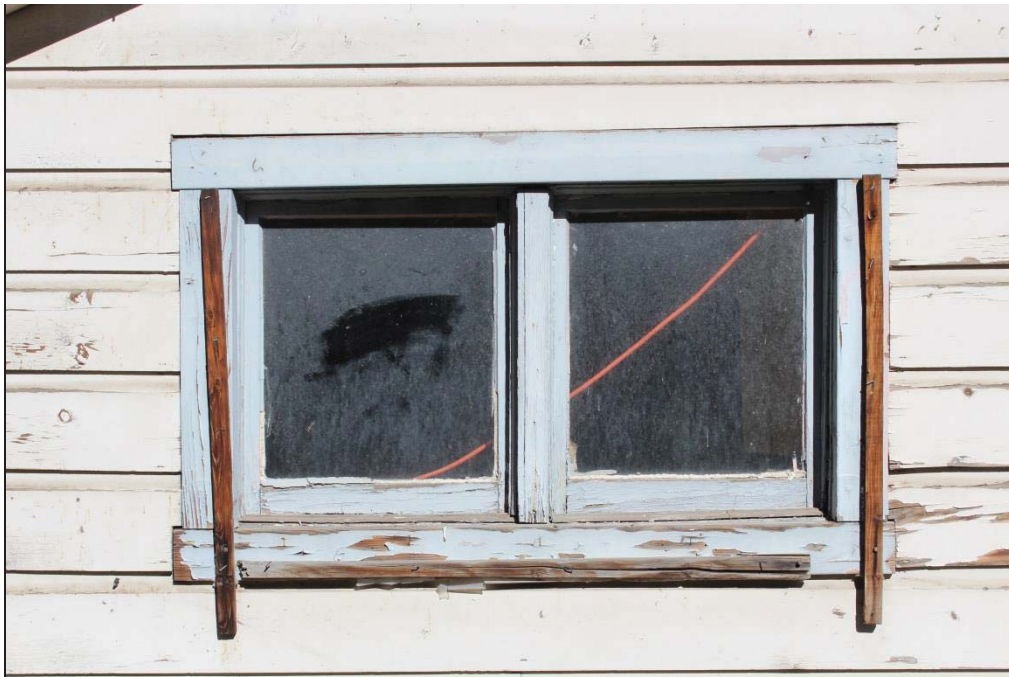
**C.1. WINDOWS:** Ca. 1920s pair of wood casement windows on south wall of Addition 1.

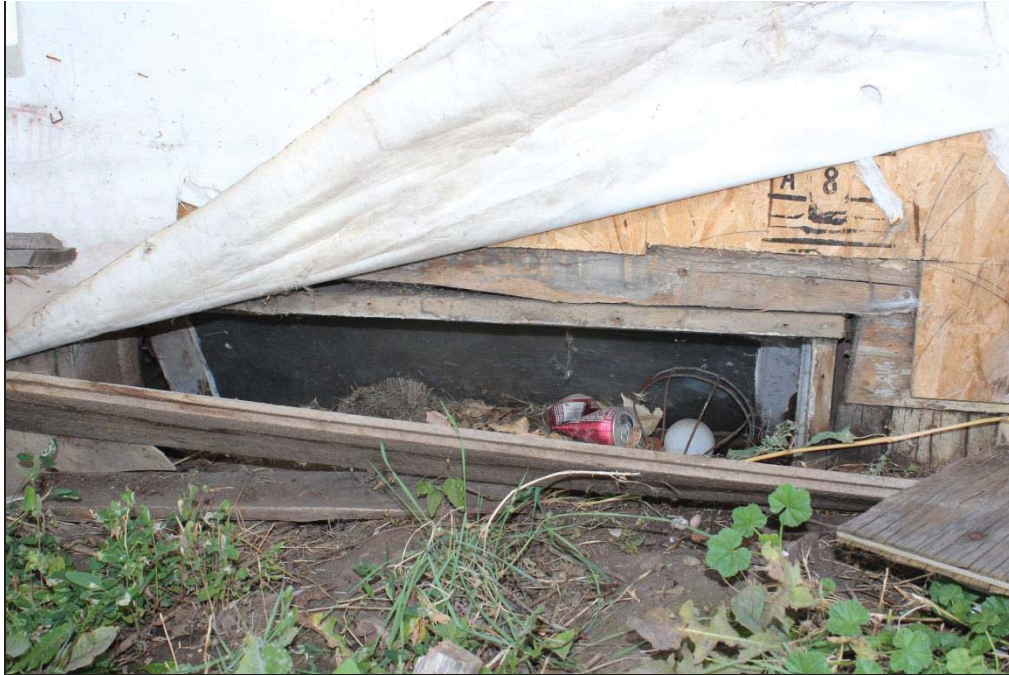
**C.1. WINDOWS:** Wood-framed window lighting crawl space on north side.

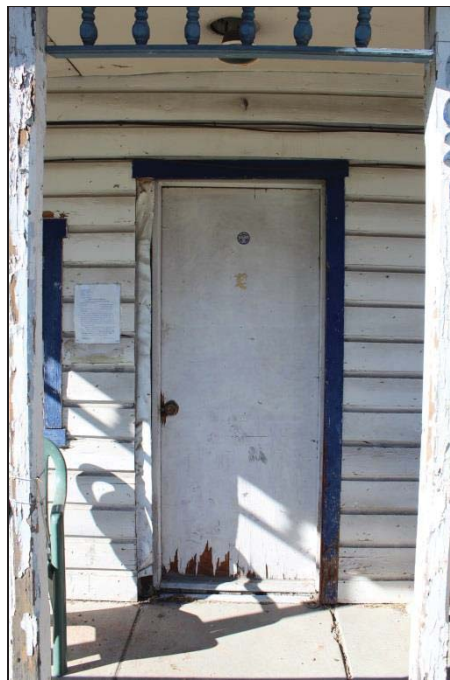
**C.2. DOORS:** Ca. 1990s replacement door on east façade, facing west.

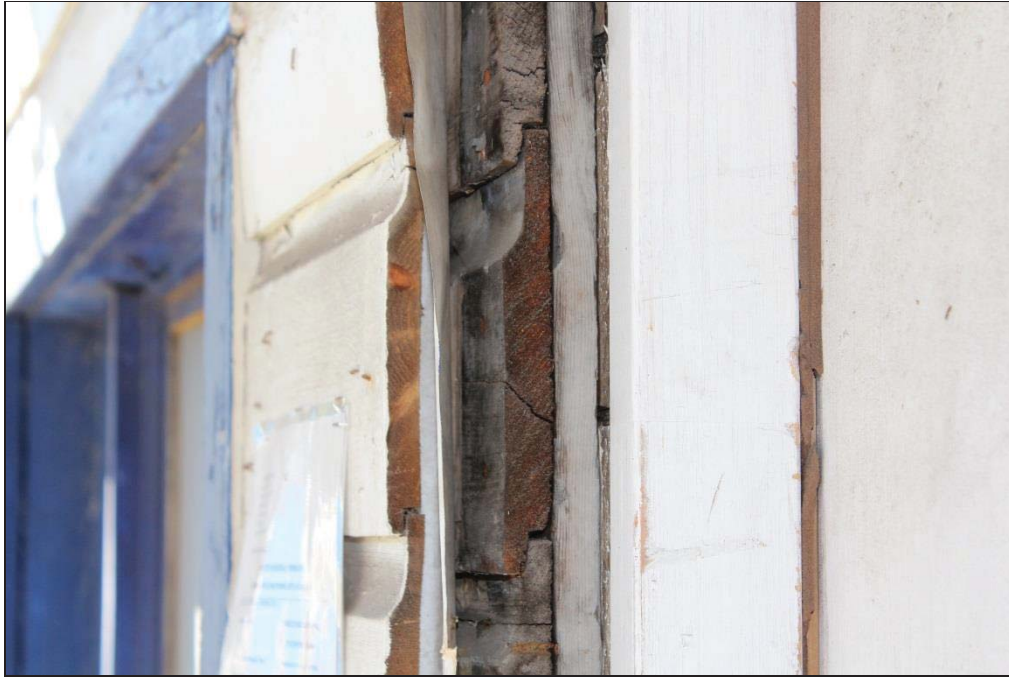
**C.2. DOORS:** South side of door jamb on east façade showing paint shadow on original siding, indicating early or original presence of door or window opening in this location, facing south.

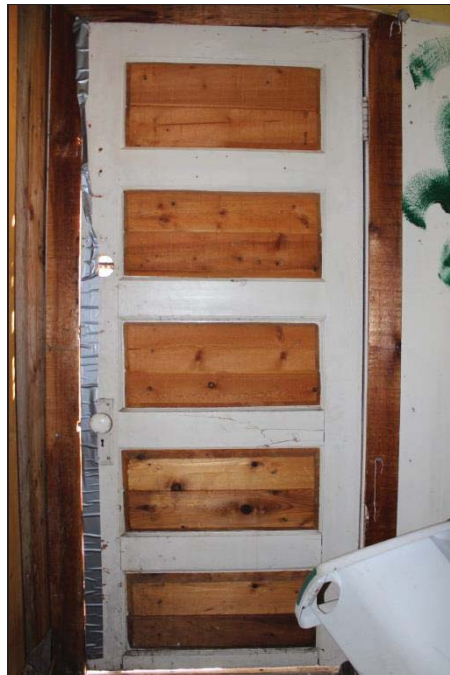
**C.2. DOORS:** Interior side of five-panel wood door in south wall of Addition 2, facing south. See B.4. for exterior view.

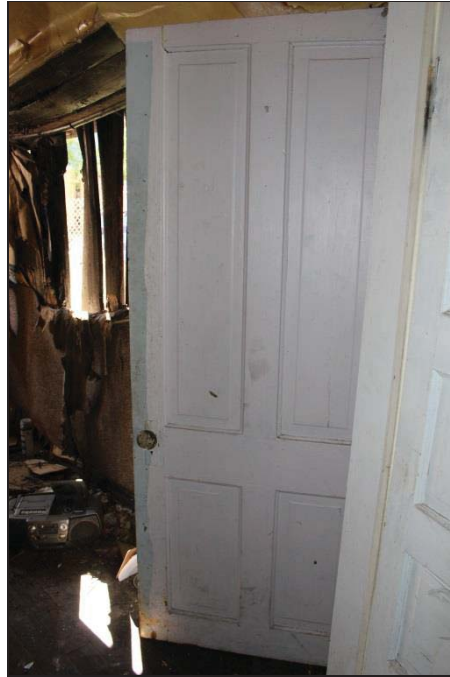
**C.2. DOORS:** Older or original four-panel wood door between Addition 1 and Addition 2, facing southwest.

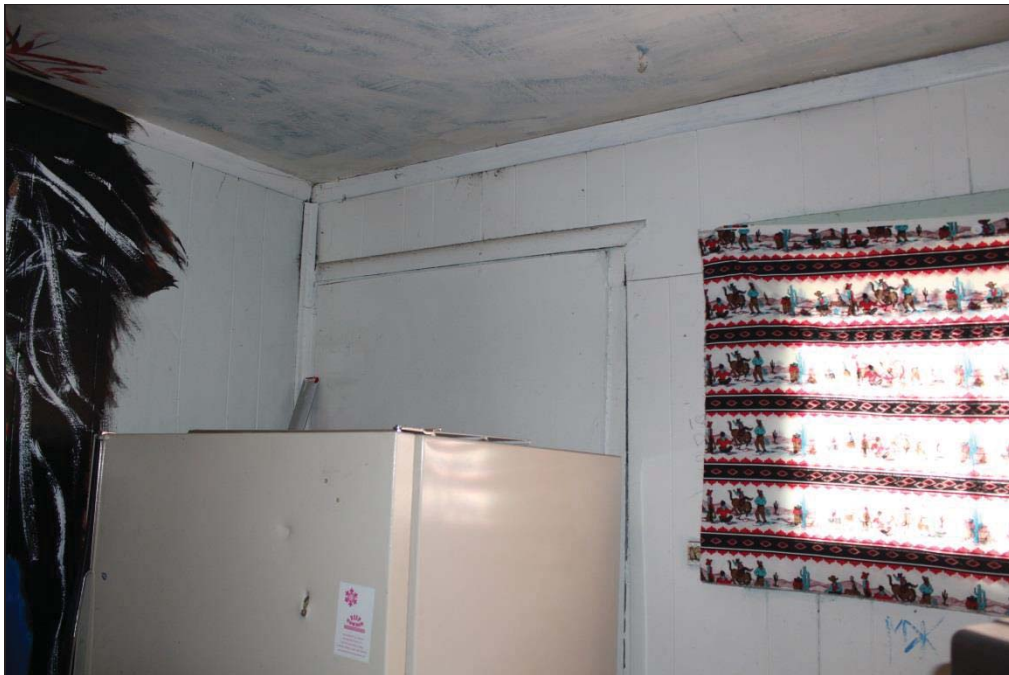
**C.2. DOORS:** Location of blocked south door visible behind refrigerator in southwest room of original building, facing southeast.

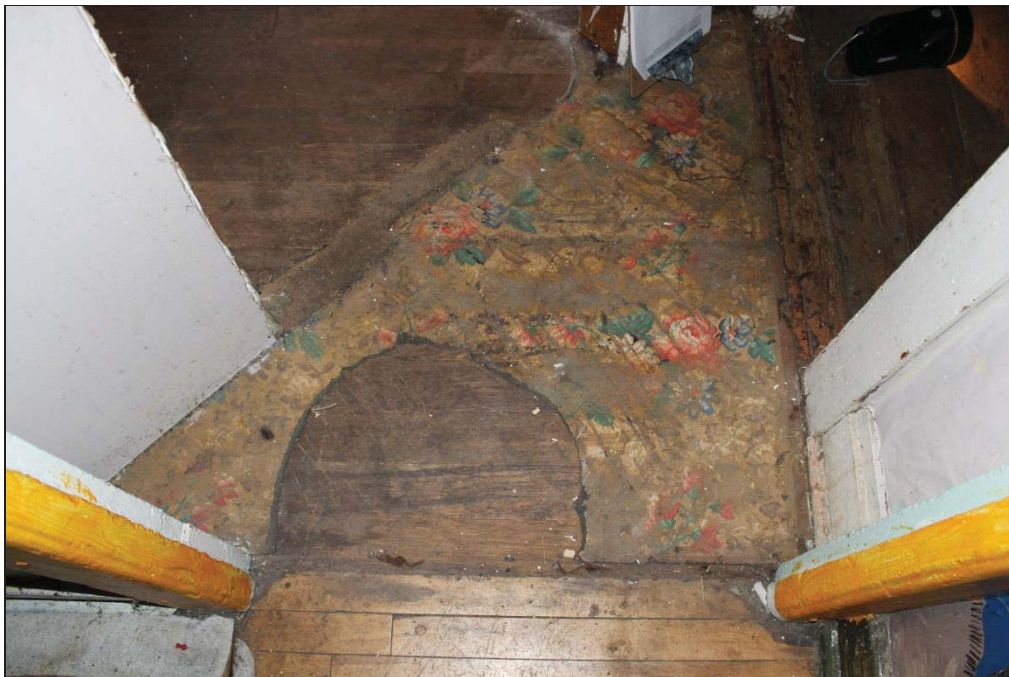
**C.5. OTHER (INTERIOR):** Interior flooring, including original wide fir boards, sometimes covered with older resilient flooring/linoleum, and newer, narrow oak boards.

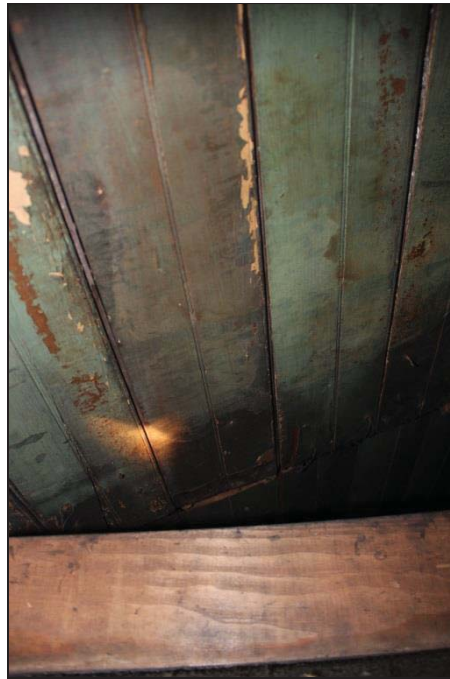
**C.5. OTHER (INTERIOR):** Original sloping, painted-board ceiling above flat, false ceiling in Addition 1.

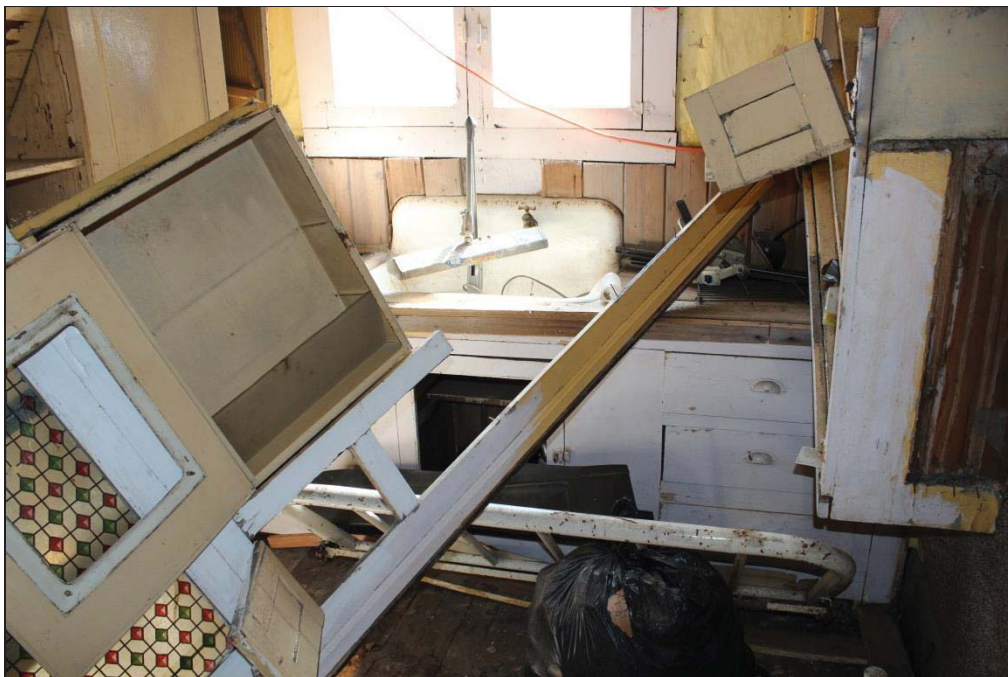
**C.5. OTHER (INTERIOR):** Ca. 1920s kitchen sink and cabinetry at south end of Addition 1, facing south.

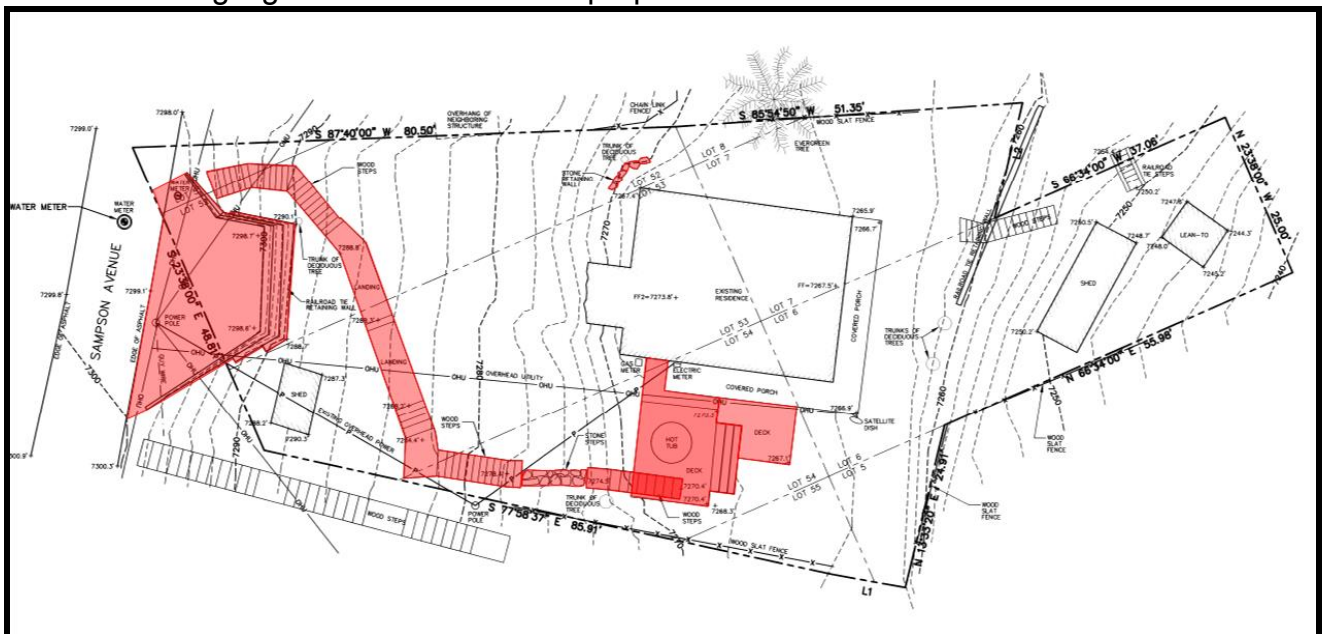
Currently, access to the site is from Sampson Avenue. There is a concrete parking pad that measures approximately 15 feet by 12 feet along the street. The parking pad is retained by 10 foot high railroad tie retaining walls. There are a series of wood stairs leading from the parking pad to the historic house; the architect believes that the upper stairs and landing were constructed in the 1990s and the lower stairs and landing were built before 1970. These improvements are not historic and are in dangerous condition.

The decks, fences, and retaining walls on this property are not historic and do not contribute to the historical significance of the property. The applicant is proposing to remove these dilapidated improvements in order to redevelop the site and construct a new addition to the house. These additions to the Historic Site have been found to be non-contributory to the historic integrity and historical significance of the site.

Staff has highlighted the site features proposed to be removed in red below:
