**PARK CITY MUNICIPAL CORPORATION  
HISTORIC PRESERVATION BOARD  
CITY COUNCIL CHAMBERS  
May 16, 2018**

1021 Park Avenue –Historic District Design Review – Material Deconstruction on Landmark Site. The applicant is proposing to impact a portion of the rear (west) elevation for a new addition, modifications to historic window and door openings. The house was approved to be reconstructed through the Historic District Design Review (HDDR) process in 2016.

115 Sampson Avenue – HDDR Material Deconstruction and Reconstruction – The applicant is proposing to reconstruct the historic house designated as “Significant” on the City’s Historic Sites Inventory. In addition the applicant will be removing existing non-historic parking pad along with its associated wood staircases and railroad tie retaining wall; non-historic stacked stone retaining walls and 1990s wood slat fences; post-1947 addition on the west elevation and an underground root cellar; rebuilding the historic pyramid roof and dormers; reconstructing the existing masonry chimney; raising the house 2 feet to pour a new foundation; reconstructing the historic ca.1900 wraparound porch on the east and south elevations; replacing t

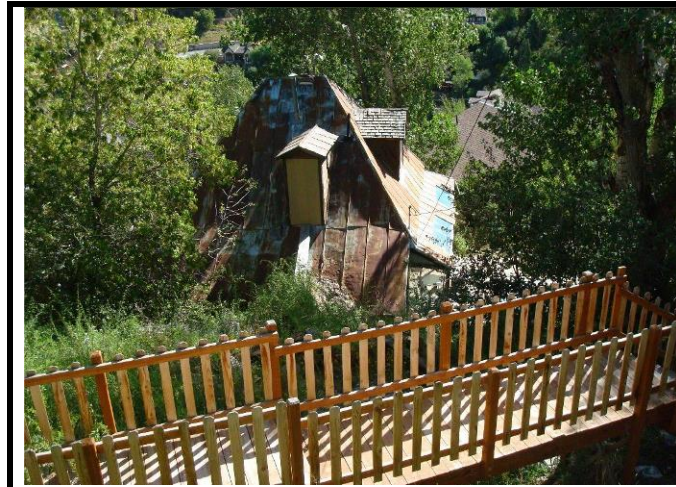
There is a one-story addition along the west side of the historic house that was constructed after 1947. It is seven feet wide and covered with aluminum siding. It attaches to an eight foot-wide addition that is buried in the hillside. It is walled off

from the interior of the house. The walls consist of eight inch wide railroad ties with dry stacked stone on the exterior. The walls and roof are in severe disrepair.

***View of the house from the Sampson Avenue right-of-way.***

The applicant is proposing to remove these post-1947 additions. These additions to the Historic Site have been found to be non-contributory to the historic integrity and historical significance of the site.

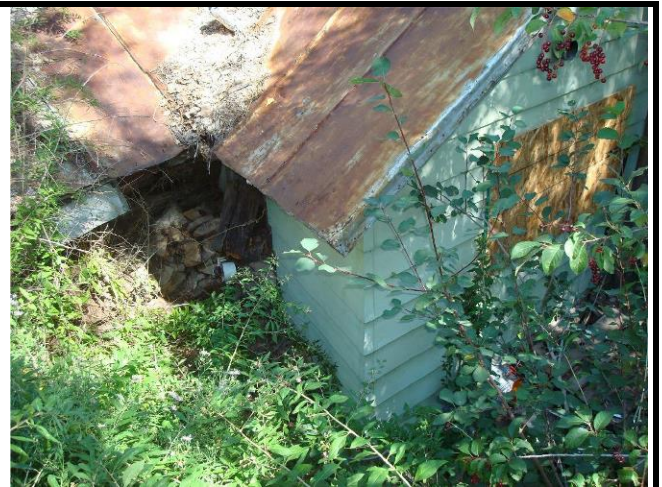
***Addition buried in the hillside, west side of the house.***

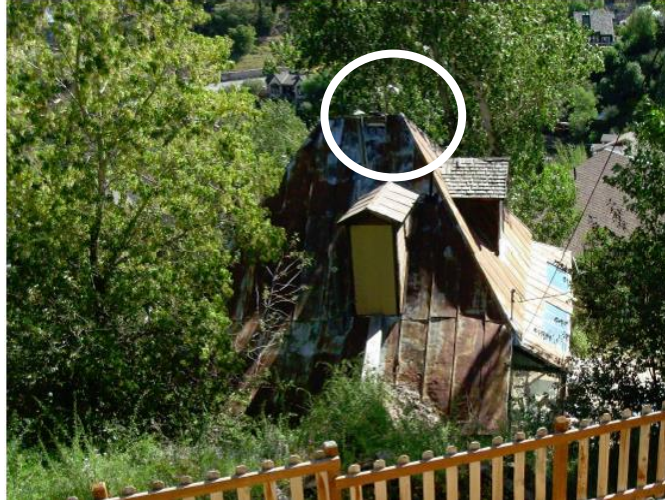
There is an existing masonry chimney that protrudes from the top of the pyramid roof structure. The chimney is original to the structure, but has been modified over the years and no longer functions as a smoke flue. It has been significantly shortened, likely as layers of the brick deteriorated. The applicant is proposing to salvage the bricks from the historic chimney and reconstruct it on the outside of the house. Staff finds that this is necessary to restore the original chimney.

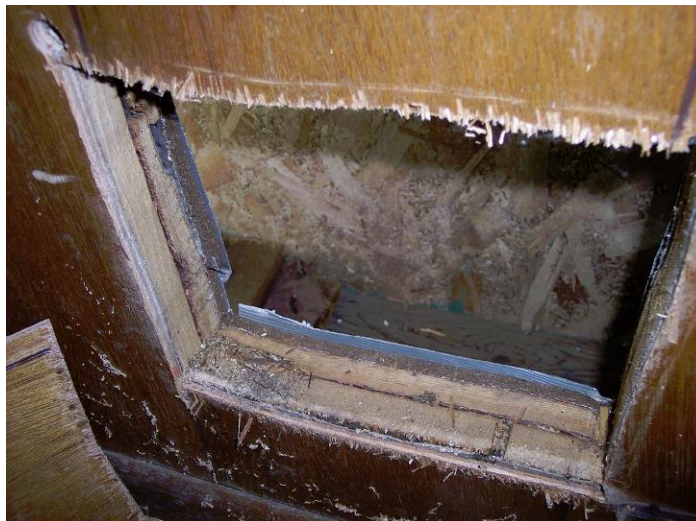
The exterior walls are comprised of single-wall construction with 1x12 vertical planks beneath 1 inch by 6 inch horizontal planks. They have been covered with ½ inch fiberboard and aluminum siding that was added after 1970. The structural engineer has determined that the exterior walls have no capacity for wind, seismic, or gravity loads. On the west side of the house, these walls retain the hillside, and the moisture from exposure to the ground has caused them to rot. The structural engineer found that 75% of the walls were deteriorated and would require reconstruction.

The photograph below shows the typical exterior wall construction with aluminum siding, fiber board, 1x8 horizontal lap siding and 1 inch by 10 inch vertical planks to form an interior wall.

The applicant is proposing to disassemble and preserve the north, south, and east walls of the historic house; the west wall is too deteriorated to be saved. The walls will then be reassembled over a new framed wall structure. Staff finds that the

*#7. Where the historic siding materials cannot be repaired, they shall be replaced with materials that match the original in all respects: scale, dimension, texture, profile, material, and finish. The replacement of existing historic material shall be allowed only after the applicant has demonstrated to the Planning Department that the historic materials are no longer safe and/or serviceable and cannot be repaired to a safe and/or serviceable condition. The Planning Department shall approve in writing the disposal of any historic siding materials.*

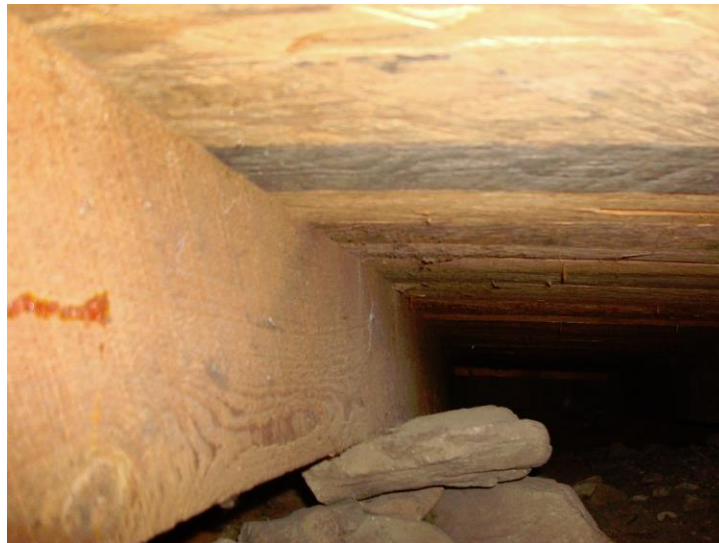
The historic structure does not have a foundation, but there are some minimal foundation walls around the perimeter of the structure. The posts, beams, and bearing walls all sit on stacked stone, wood piles, and/or soil (see following photo). The floor joists are 2 inch x 6 inch at 24 inches on center; many of the floor joists span 8 to 12 feet unsupported. The structural engineer estimates that 90% of the posts supporting the floor structure have rotted due to the amount of moisture beneath the floor structure. He recommends removing the existing foundation walls and constructing a new foundation.

The applicant is proposing to raise the historic house two feet (2') as permitted by the Design Guidelines in order to construct a new code-compliant foundation. Staff finds that the proposed work mitigates any impacts that will occur to the architectural integrity of the structure.

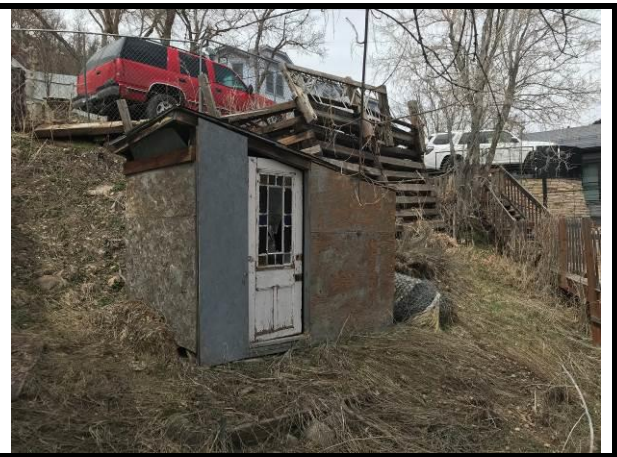
There are three (3) existing sheds on the property. These sheds were not designated as Historic on the 2009 Historic Sites Inventory. Upon closer examination, staff finds that they were likely constructed of reclaimed materials after 1960. The sheds were built on flatter portions of the lot, so that one shed is visible near the parking pad along Sampson Avenue and two are in the eastern corner of the site. Because the eastern side of the site is overgrown, staff was not able to successfully photograph these two sheds. The shed on the west side of the property is constructed of plywood.

The applicant is proposing to demolish these sheds as part of their site improvements. Staff finds that these sheds are not historic and do not contribute to the historical significance of the site.
