**PARK CITY MUNICIPAL CORPORATION  
HISTORIC PRESERVATION BOARD  
CITY COUNCIL CHAMBERS  
May 2, 2018**

945 Norfolk Avenue – HDDR Material Deconstruction– The applicant is proposing to remove existing improvements in the front yard such as the non-historic stone retaining walls in the front yard, stairs and decks in the south side yard, and a c.1990 rock retaining walls in the backyard; reconstruct the historic c.1896 roof form and c.1990 wood shake roofing materials; reconstruct two c.1896 chimneys; reconstruct c.1997 basement; reconstruct c.1983 reconstructed front porch; replace c.1900 front door and two non-historic doors; replace 12 total historic wood windows.

PL-17-03686 43  
*Planner Grahn*

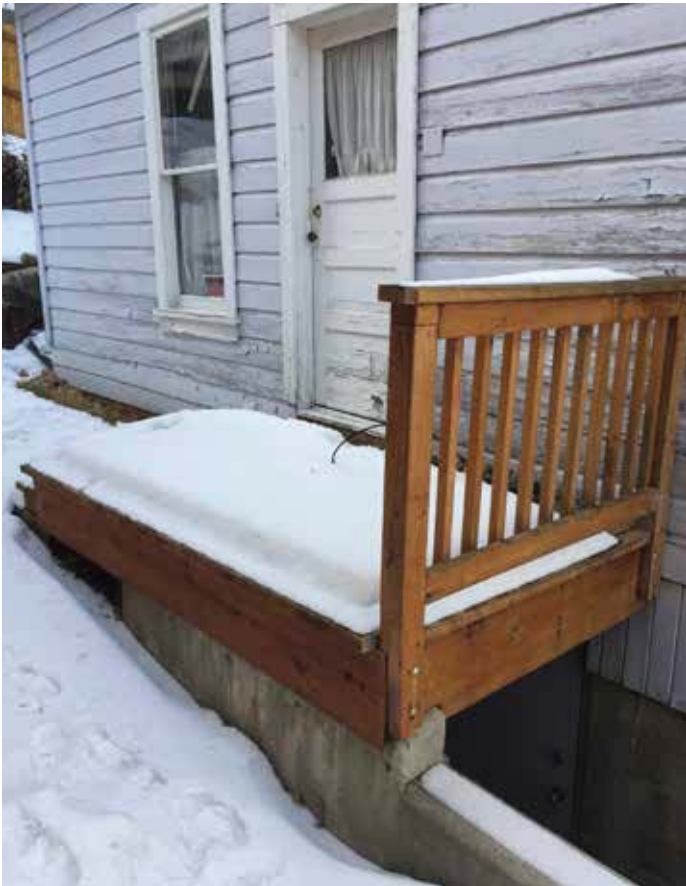
Photo #8: Added Wood Deck

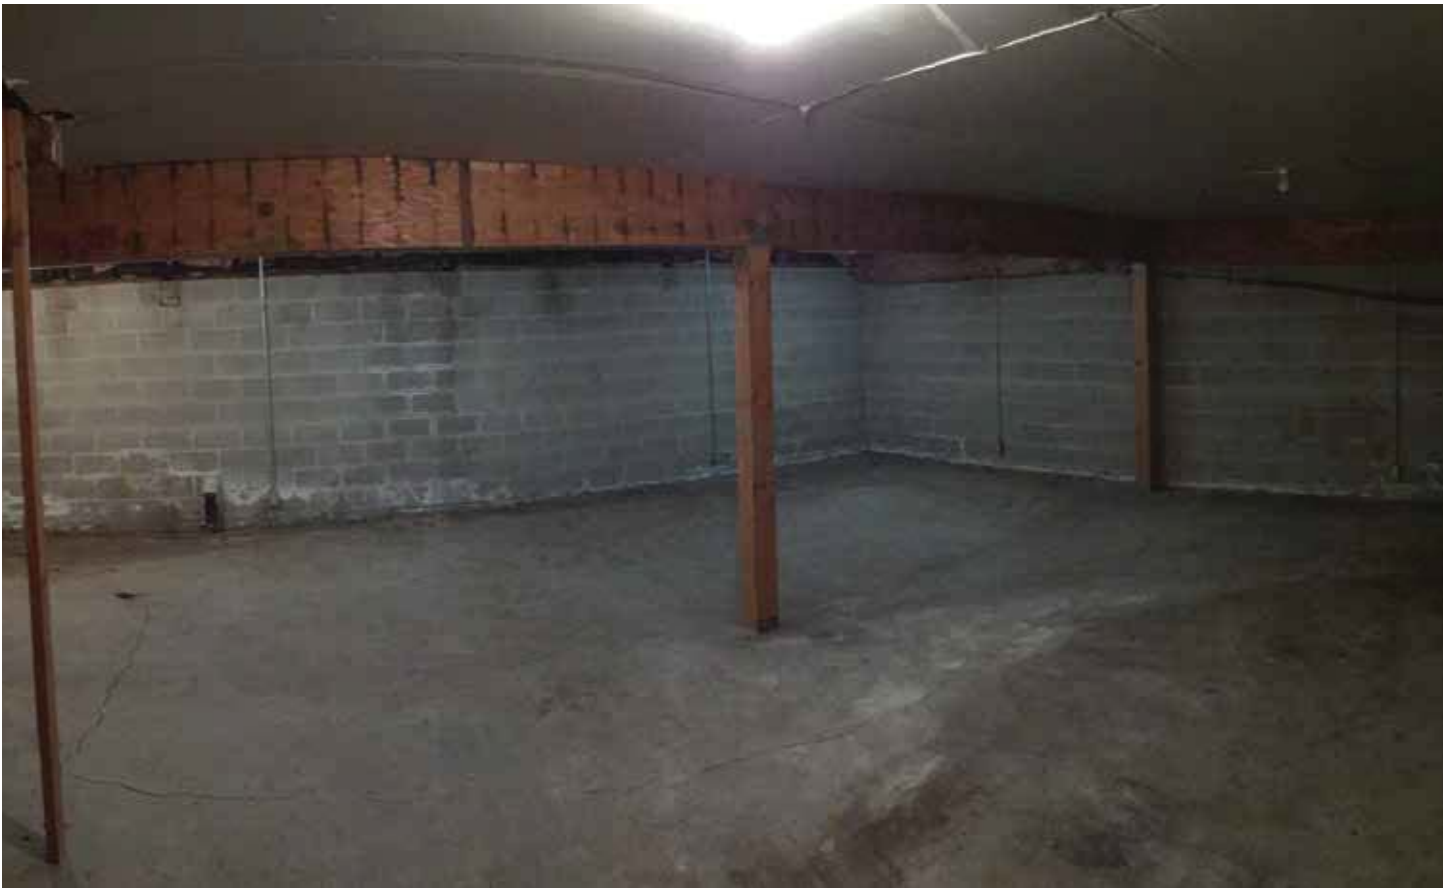
Photo #10: Basement Level Slab With New Beam and Columns Holding Main Level Floor
