**PARK CITY HISTORIC PRESERVATION BOARD MEETING  
SUMMIT COUNTY, UTAH  
June 4, 2025**

**PARK CITY MUNICIPAL CORPORATION  
HISTORIC PRESERVATION BOARD MEETING  
MARSAC MUNICIPAL BUILDING  
COUNCIL CHAMBERS  
445 MARSAC AVENUE  
PARK CITY, SUMMIT COUNTY, UTAH  
MINUTES OF MAY 7, 2025**

# PHYSICAL CONDITIONS REPORT

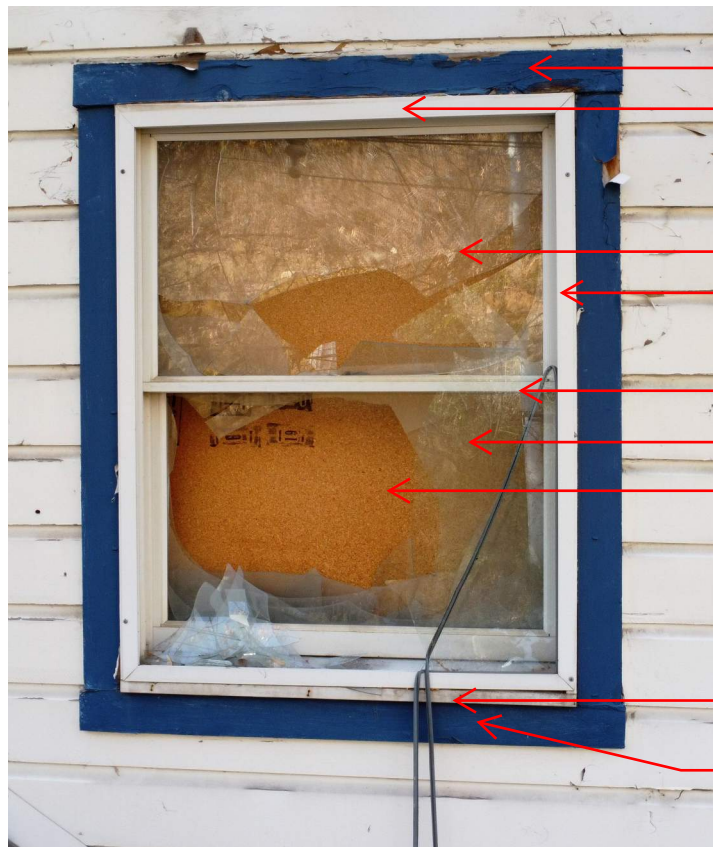
PHOTO #W14

Storm Window Cover (Broken)

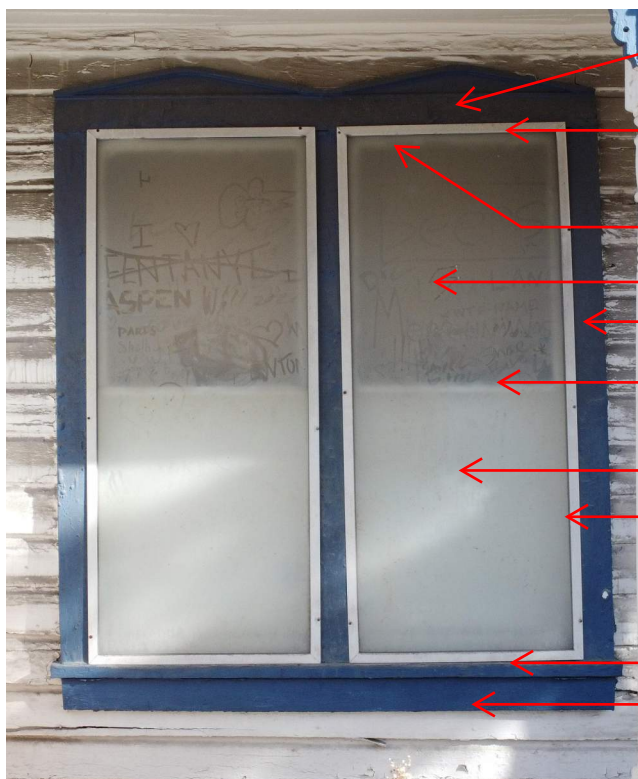
PHOTO #W36

| | Window #: | Existing Condition<br>(Excellent, Good, Fair, Poor): | Describe any deficiencies: | Photo<br>#: | Historic (50<br>years or older): |
|---|---|---|---|---|---|
| ✓ | W36 | Poor | Sashes may be missing glass -wood material degraded and wall is bowing - covered by storm sash - boarded from inside | W36 | Yes |

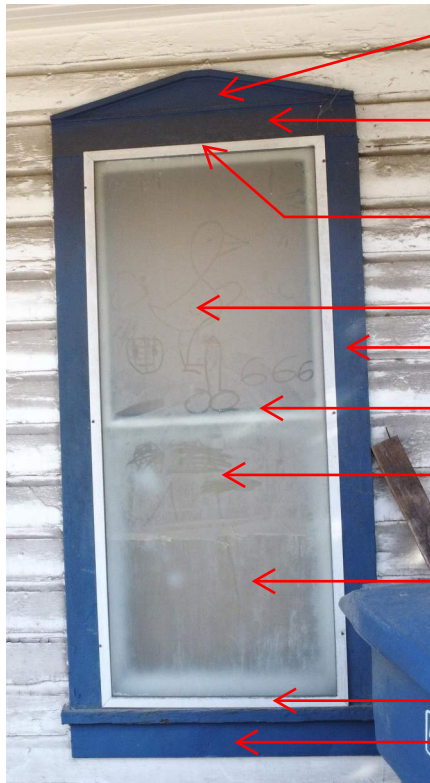
PHOTO #W37

| | Window #: | Existing Condition<br>(Excellent, Good, Fair, Poor): | Describe any deficiencies: | Photo<br>#: | Historic (50<br>years or older): |
|---|---|---|---|---|---|
| ✓ | W37 | Fair to Poor | Sashes may be missing glass -wood material degraded - single pane - covered by storm sash - boarded from inside | W37 | Yes |

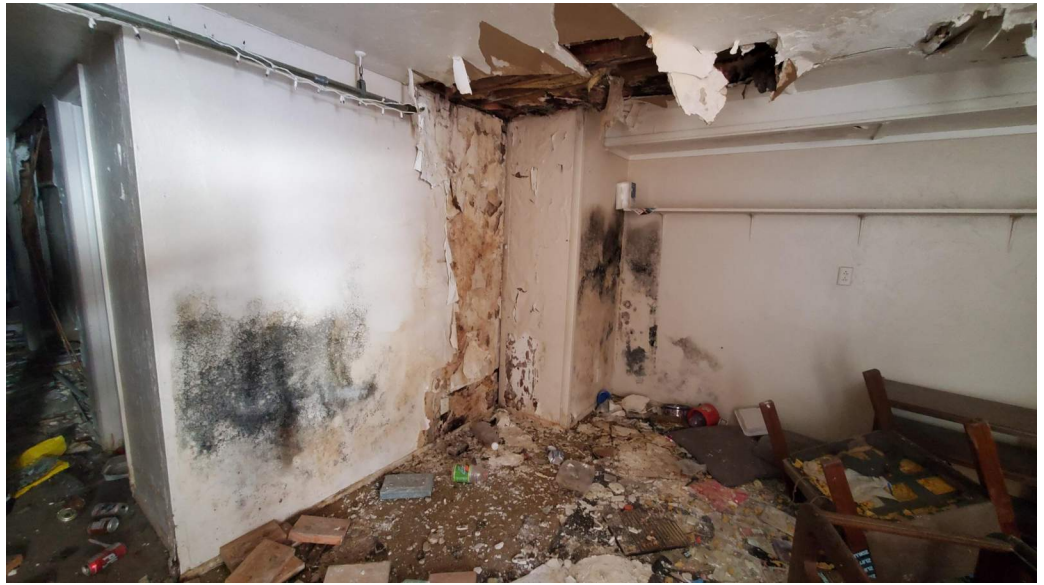
PHOTO #0-2

- Walls and ceilings water damaged with drywall falling apart
- Refuse from previous tenants/ squatters - mostly trash but also old furniture mattresses and appliances
- Broken glass on the floors
- General overall questionable for safety

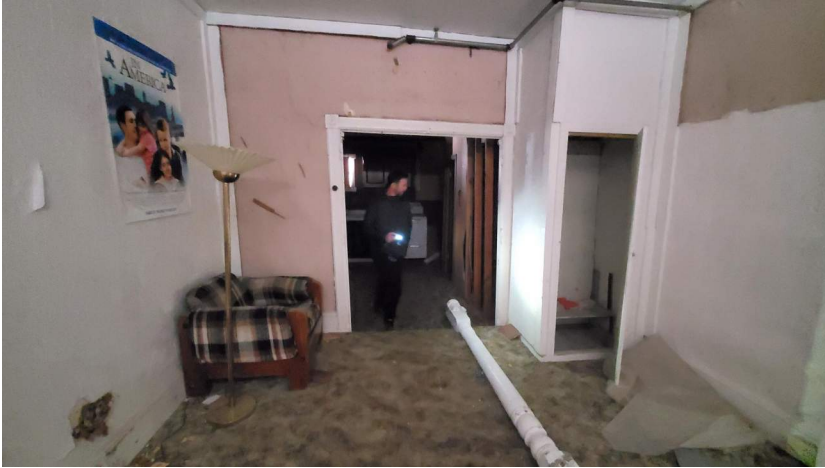
PHOTO #1-1

- Walls and ceilings water damaged with drywall falling apart
- Extensive mold visible in kitchen (photo 1-6)
- Refuse from previous tenants/ squatters prevalent
- Furniture stacked or left by previous tenants
- Floor structure itself has soft spots when walking on it.
- No wall or ceiling is undamaged by water, age or graffiti

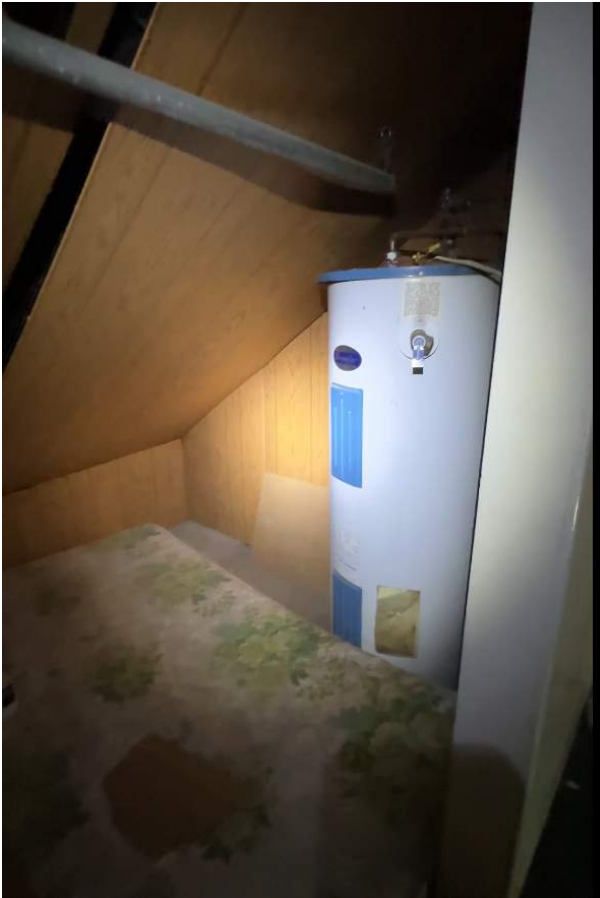
PHOTO #3-1

Level 3 follow also show varying levels of deprecation and destruction. There is no structural shoring on this level to affect ceilings as much but there are still areas where roof insulation is exposed (photos 3-1, 3-2). The general condition of the 3rd level is better than the 3 below it but there is still evidence of water damage (photo 3-11) that looks to be at a vulnerable roof valley and also looks to be a major contributor to water in the basement. Railings (or the lack thereof) on the stairways are too short to meet code. Stair are also not wide enough to meet current code. Photos highlight living situations that were made to work outside of safety and code concerns (mattresses next to water heater, 3' tall closets), not atypical from other old town situations but not a recommended way to have occupants living. Almost all the windows have been boarded from the inside to prevent further damage from weather and exterior conditions.

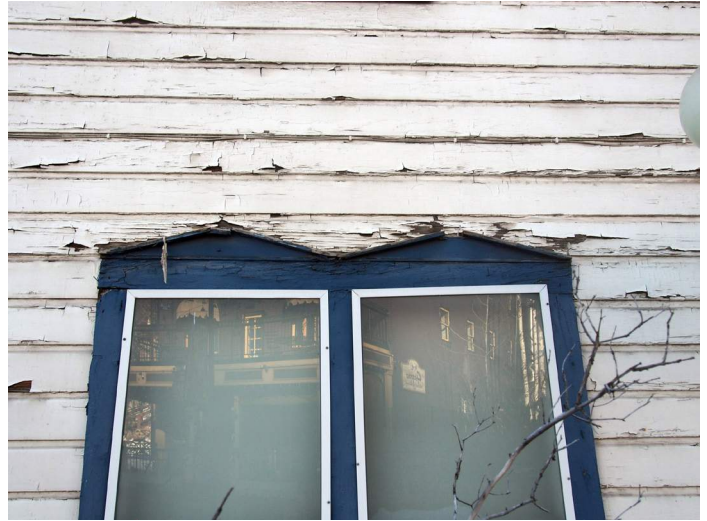
Missing finials on window trim and peeling paint

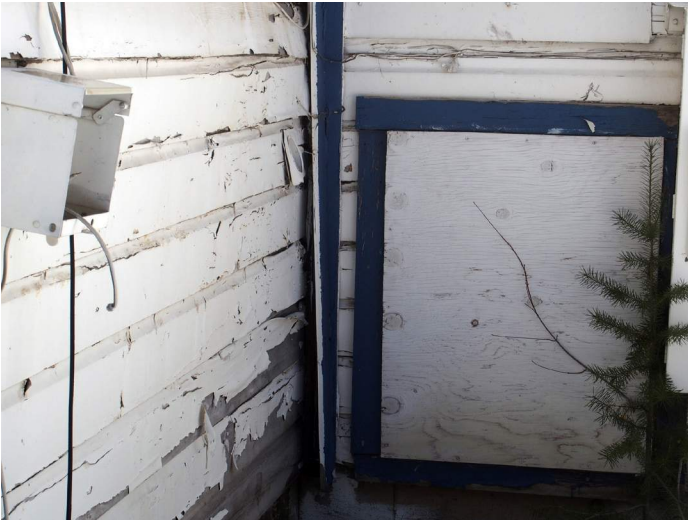
Peeling trim and paint at South and East inside corner

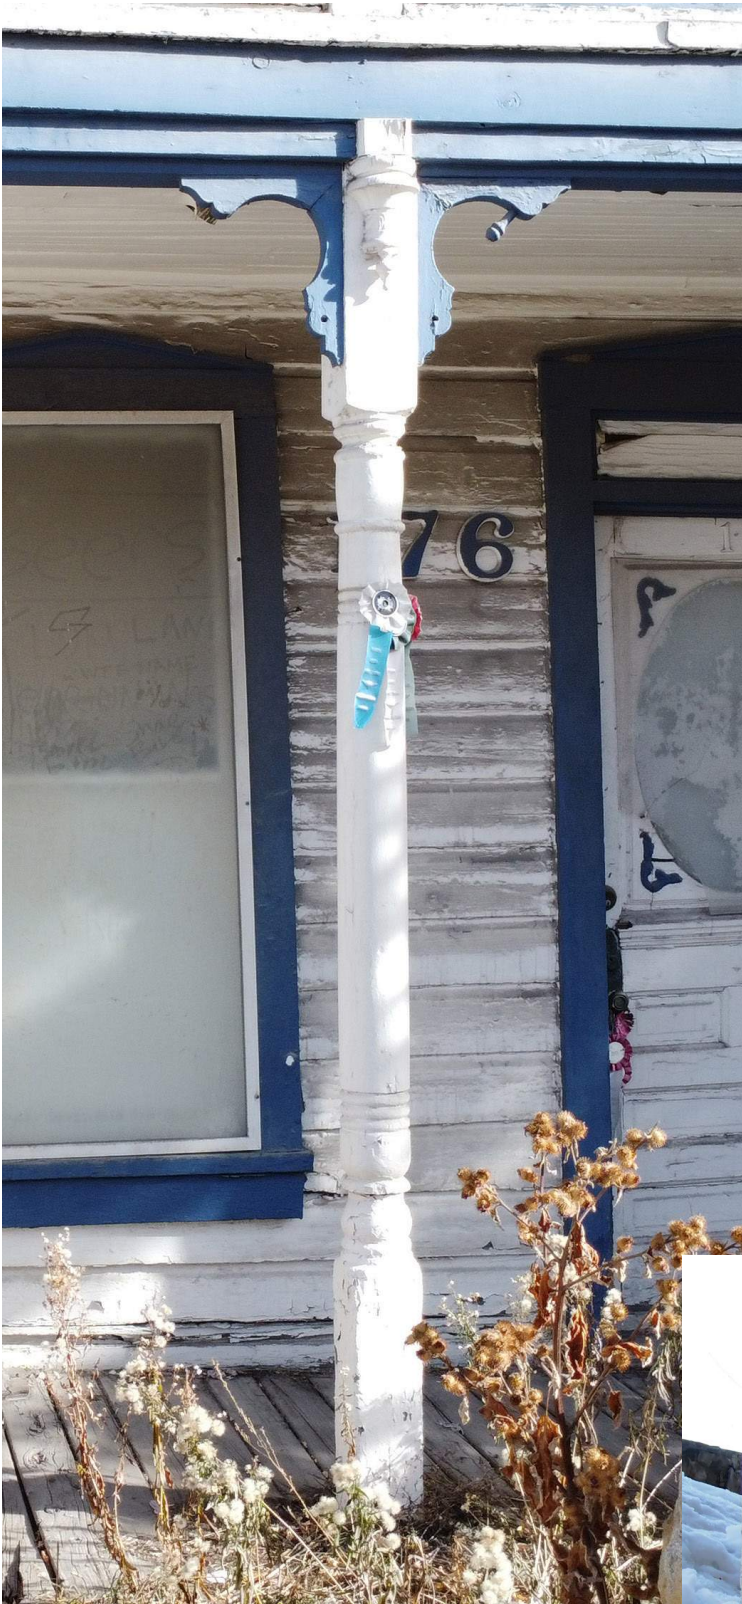
Front Porch Post

One of the posts has been removed and is residing in one of the apartments, assuming it's structural life had expired. The replacement is a 6x6 standard wood column that could be purchased at any hardware store

There are numerous posts to document but generally they are in poor condition and likely need replacement to perform structural duties. Photographs from historic documentation should be used to augment the remaining decorative elements in a rehabilitation of posts where possible and reconstruction where necessary.
