**PARK CITY MUNICIPAL CORPORATION  
HISTORIC PRESERVATION BOARD  
CITY COUNCIL CHAMBERS  
November 2, 2016**

## **AGENDA**

227 Main Street (Star Hotel) – Determination of Significance

**Physical Conditions Report  
Internal Demolition Report  
227 Main Street - Star Hotel  
Submitted by Westlake Land, LLC**

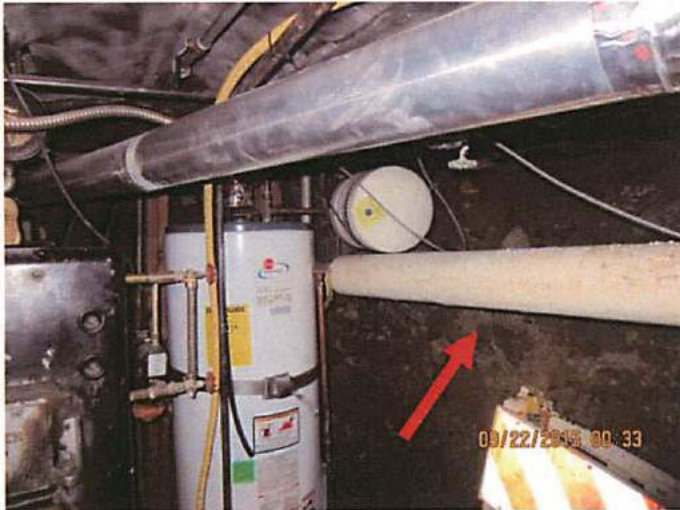
**Photo 1** The structure has no concrete or stable foundation. The foundation consists of rubble, dirt and loose stone matter.

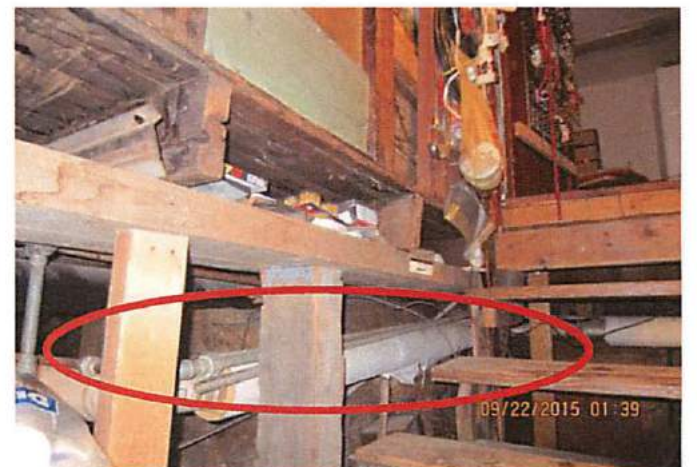
**Photo 10** Example of missing foundation under support member. Connection to support from attic 3rd floor

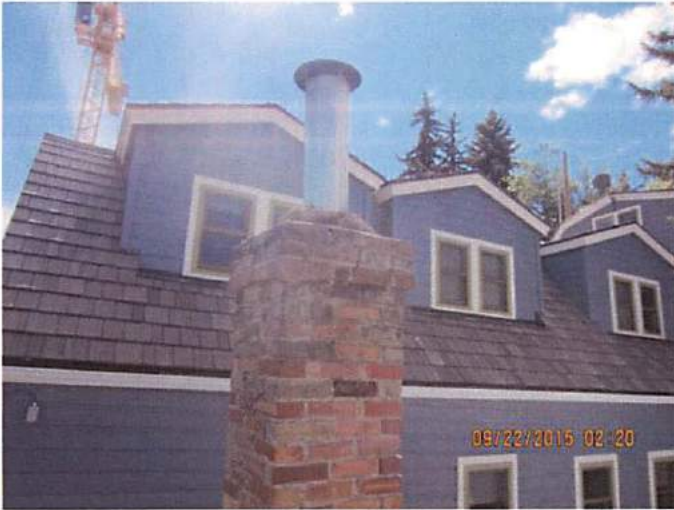
**Photo 1** The chimney shows signs of decay and instability. To be removed or evaluated by a structural engineer

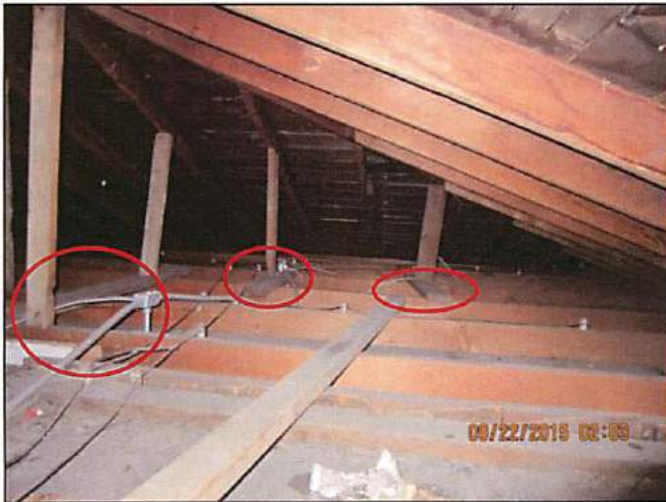
**Photo 1** The structural members supporting the roof are not properly installed and are not plumb. Excessive load could cause the members to fail

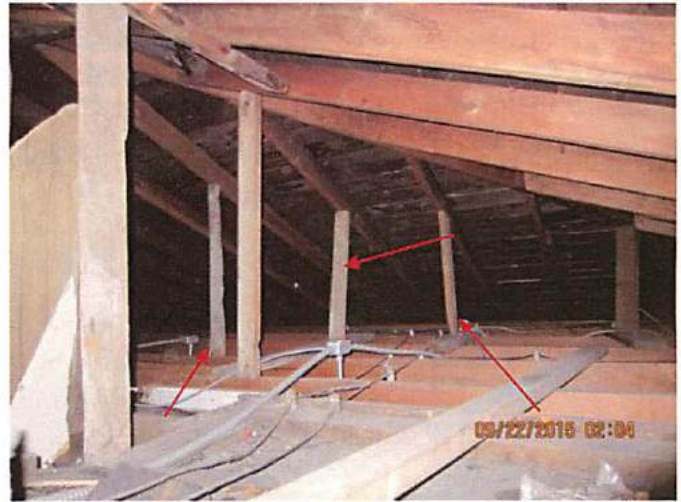
**Photo 2** Support members for roof are not adequate for the purpose being served. Engineer to justify

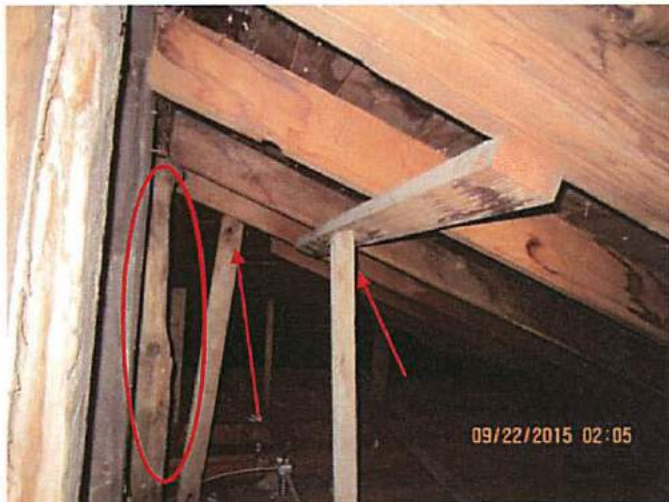
**Photo 3** Damaged, decayed or improperly installed structural members

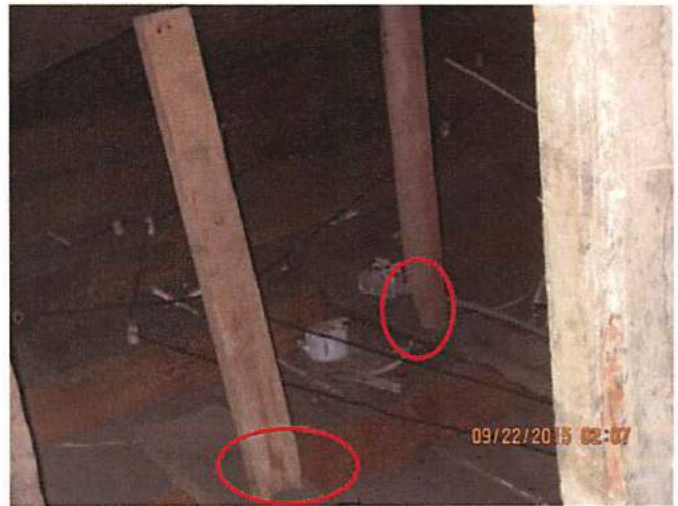
**Photo 6** Support members not fastened and are not perpendicular to the load they serve

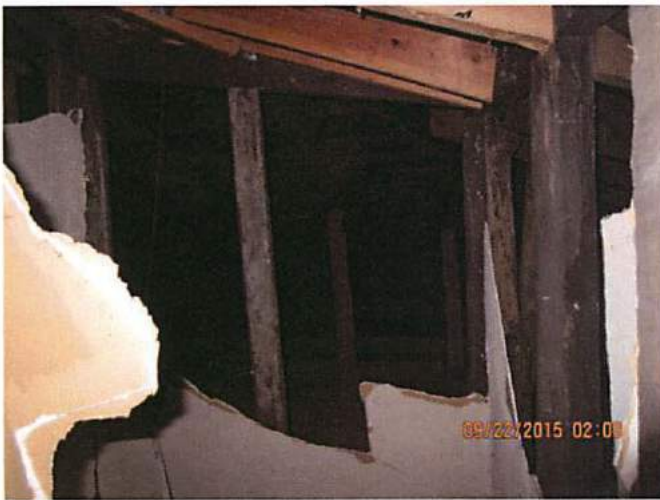
**Photo 7** Roof has been repaired, support members not properly installed. Engineer to evaluate and justify

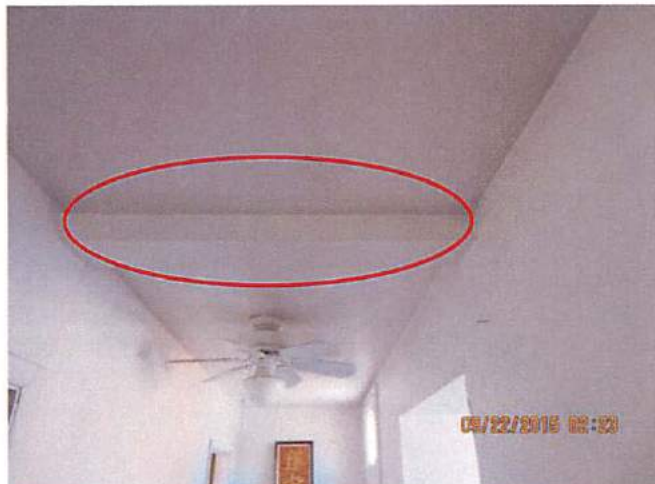
**Photo 9** The third level of the structure was added in the 1970's. The addition will need to be evaluated by a structural engineer. The support beam in this photo is missing a point load.

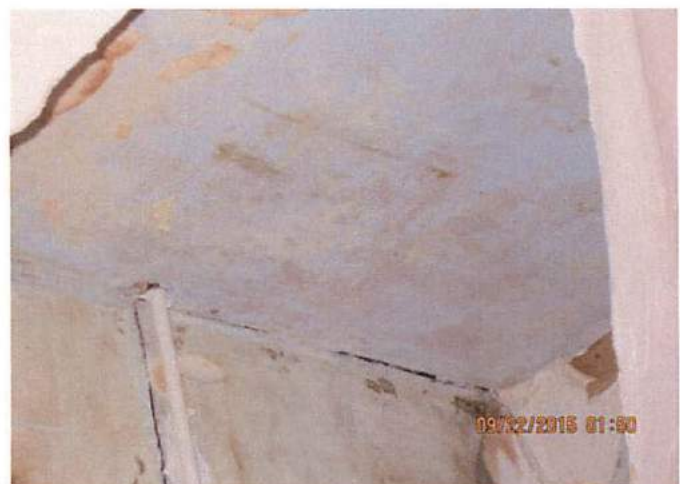
**Photo 10** Water damage second floor. Settling cracks noted. Structural engineer to justify

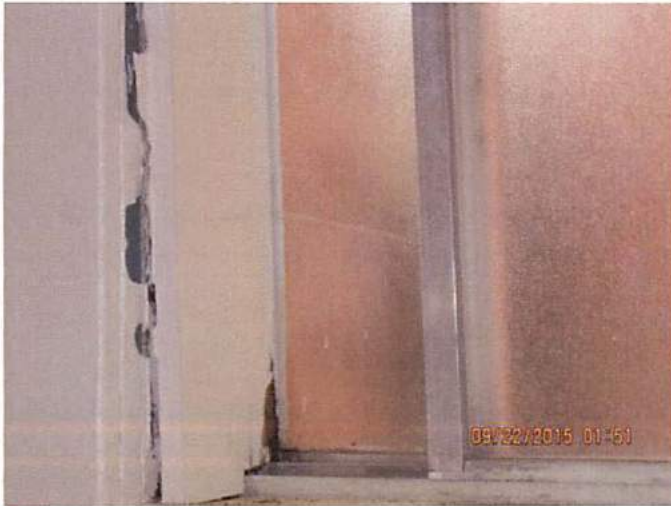
**Photo 11** Noted settling around the bathroom window on the second floor. Consistent with improperly installed support beam on third floor.

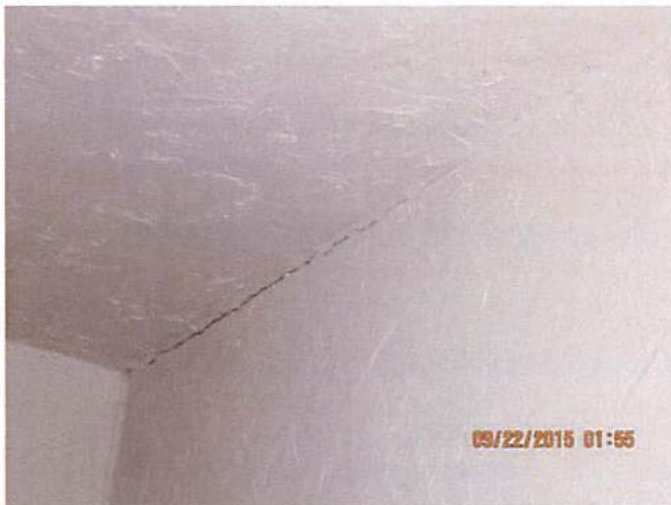
**Photo 13** Structural separation in second floor bedroom. Consistent with missing point loads and missing foundation

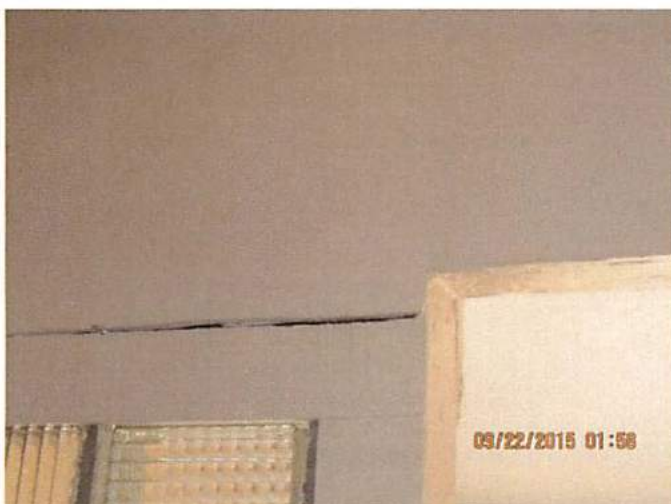
**Photo 15** Structural separation in second floor bedroom. Consistent with missing point loads and missing foundation

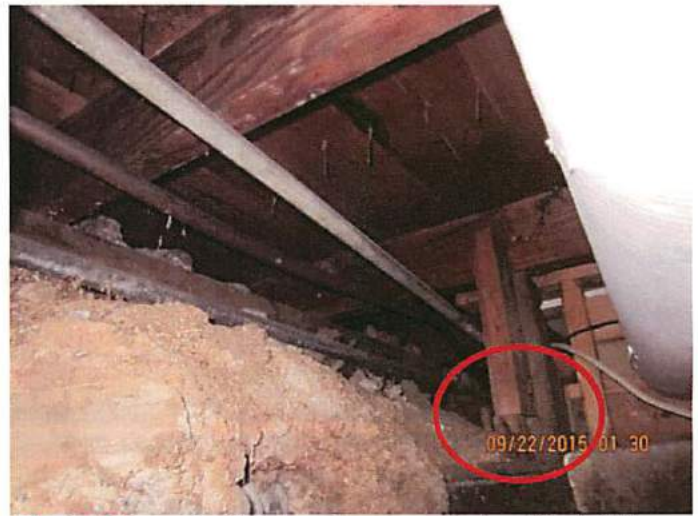
**Photo 18** Several shims have been used to level the building. These shims have not been properly installed

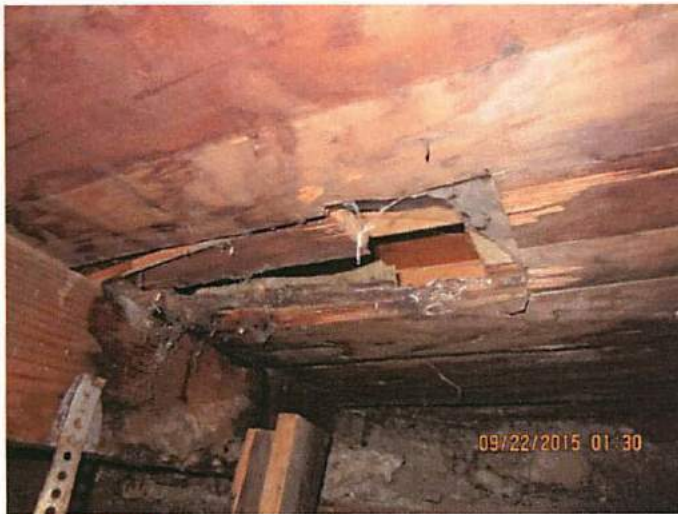
**Photo 19** Several shims and braces have been used to level the building. These shims and braces have not been properly installed

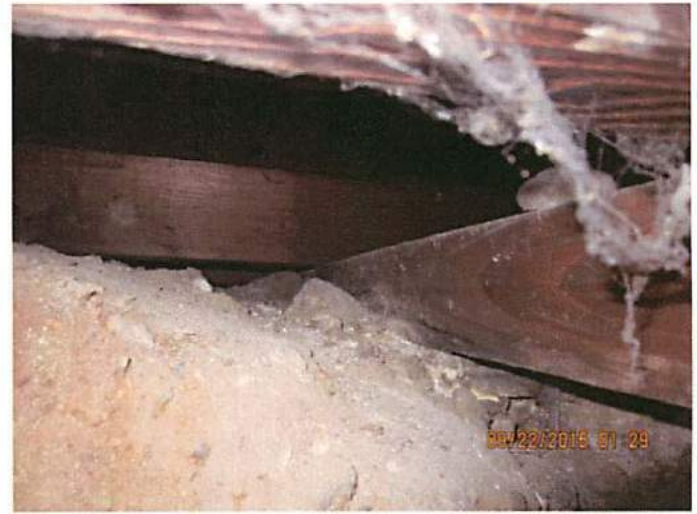
**Photo 20** Floor joist are bearing directly on top of soils. This is not permitted by code

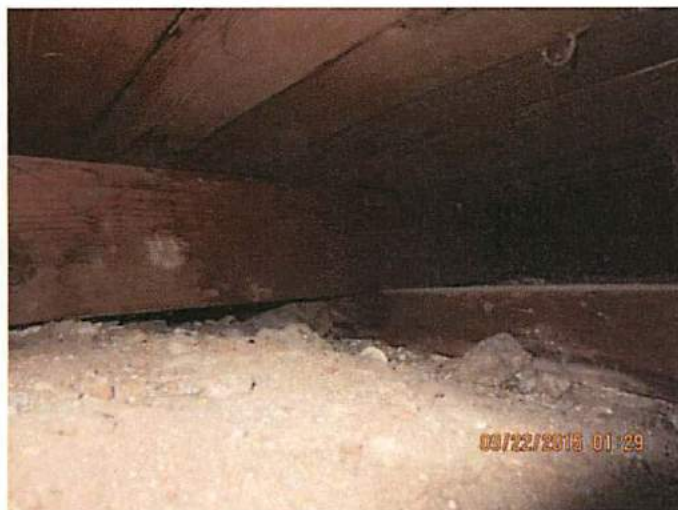
**Photo 21** Floor joist are bearing directly on top of soils. This is not permitted by code

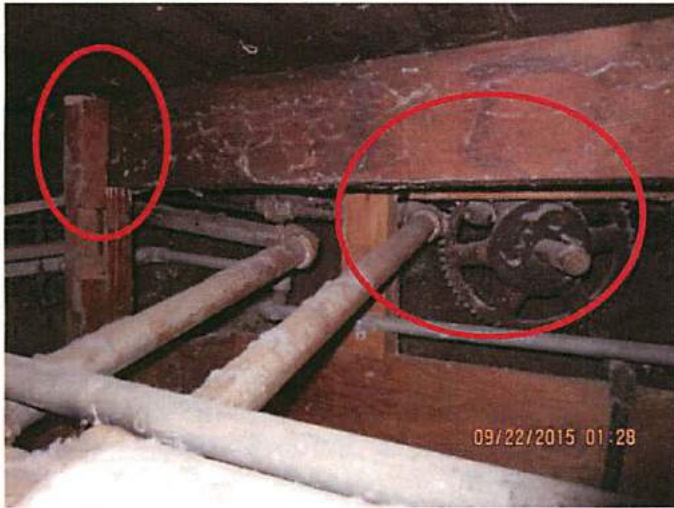
**Photo 23** The addition of bracing and shims to prevent settling of the building. Cannot have bearing directly on soils. All bearing is directly on soils. Engineer to justify

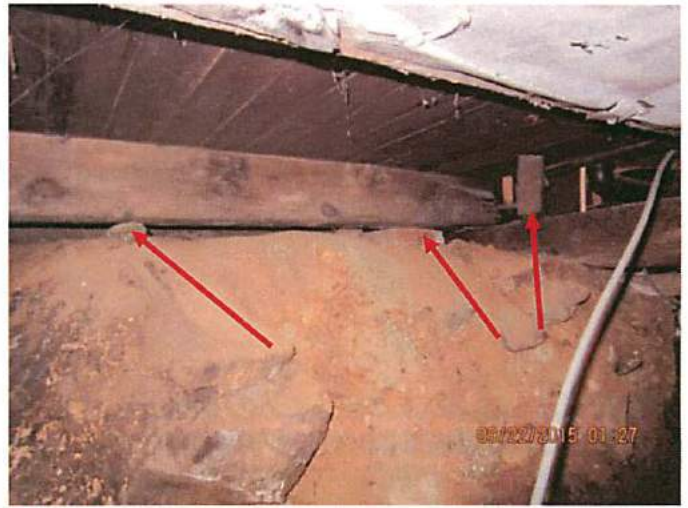
**Photo 24** The addition of bracing and shims to prevent settling of the building. Cannot have bearing directly on soils. All bearing is directly on soils. Engineer to justify

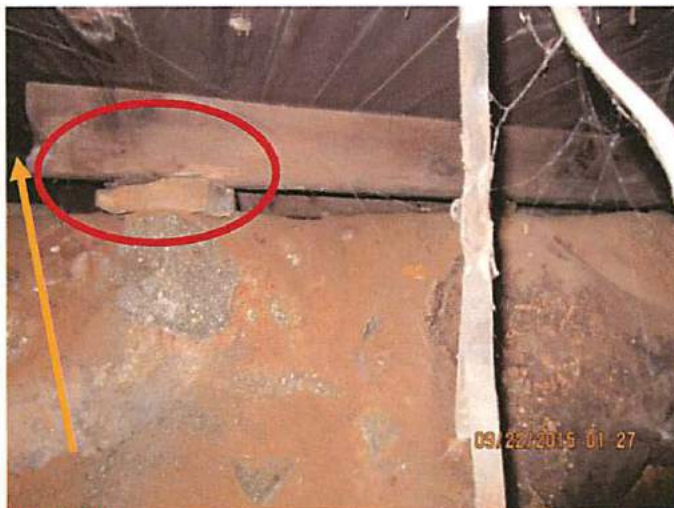
**Photo 25** The red circle shows a direct load at the end of a cut off floor joist. The blocking is bearing directly on soils. The yellow arrow shows the removal of a floor joist. The area above is the dining room

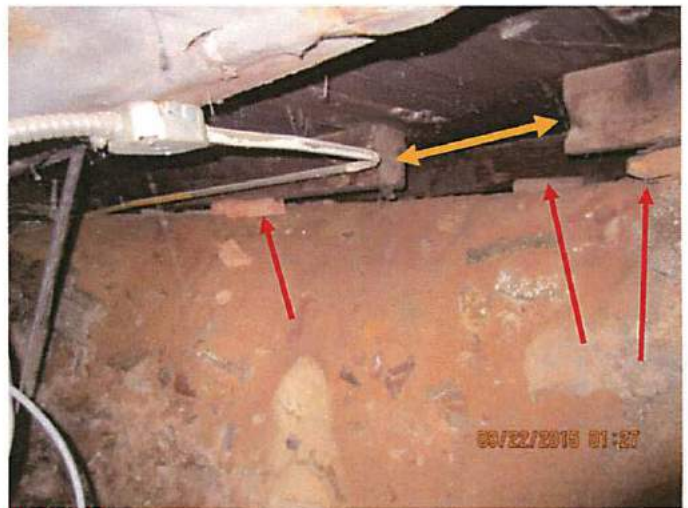
**Photo 26** The addition of bracing and shims to prevent settling of the building. Cannot have bearing directly on soils. All bearing is directly on soils. Engineer to justify

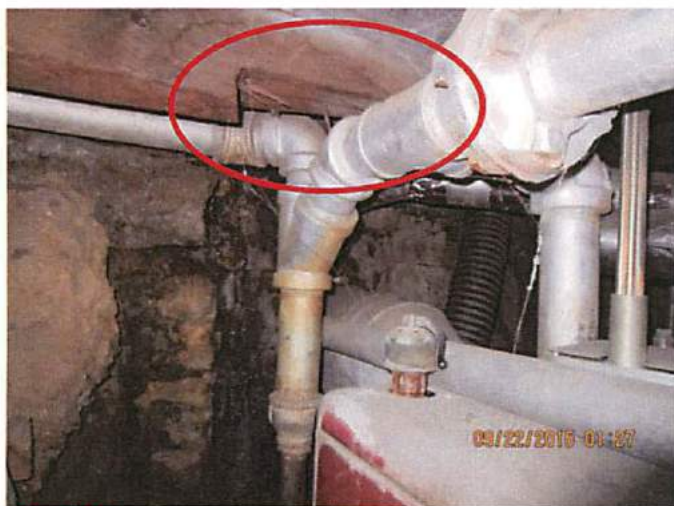
**Photo 27** Over notching of floor joist. Area above, dining room

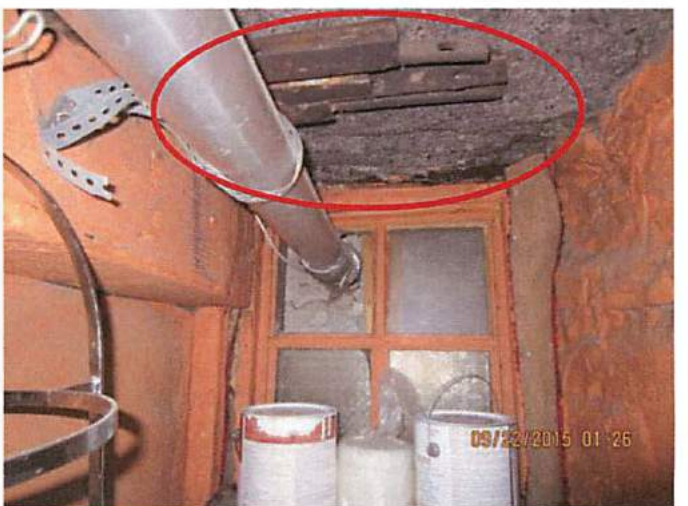
**Photo 28** Rail road rails being used as shims for floor above. This area would be Approximately 18 feet into front entry main level.

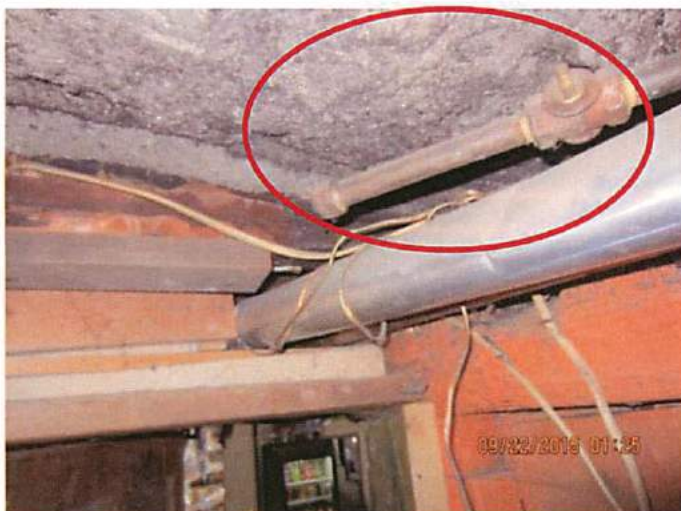
**Photo 1** Gas lines that have terminated in hidden rooms that are not properly secured. This room is located in the deli in the front area between entry doors

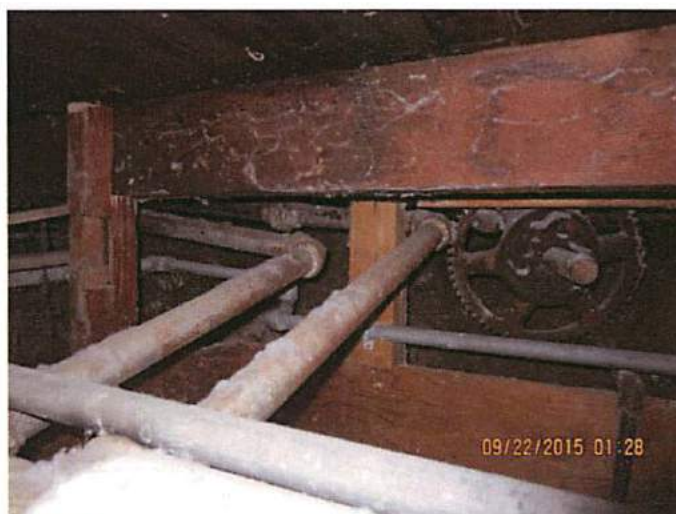
**Photo 4** Unsecured gas lines, unknown valves that are not properly maintained or marked

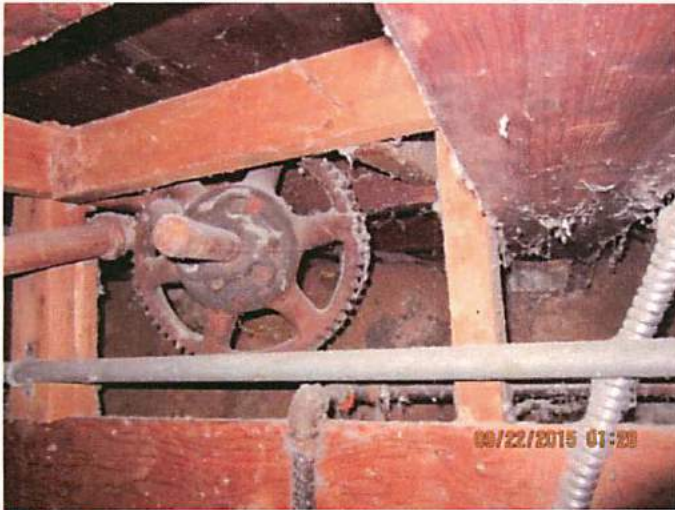
**Photo 5** Unknown valves that are not properly maintained, marked or accessible

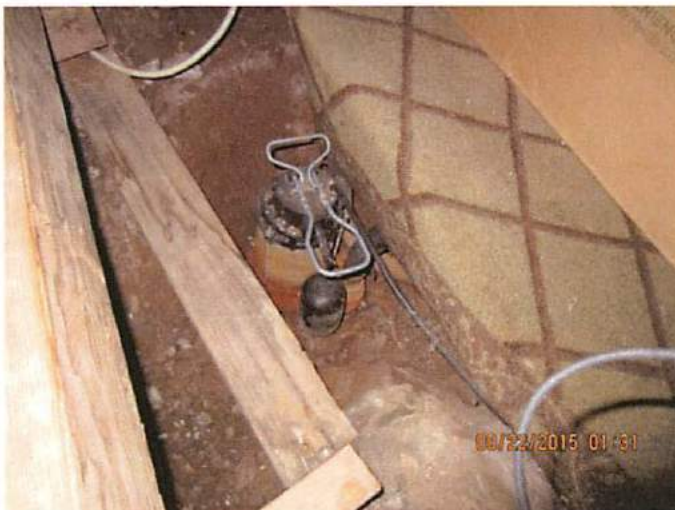
**Photo 7** A water/trash pump is located directly below photo 6, the pump is not in working condition

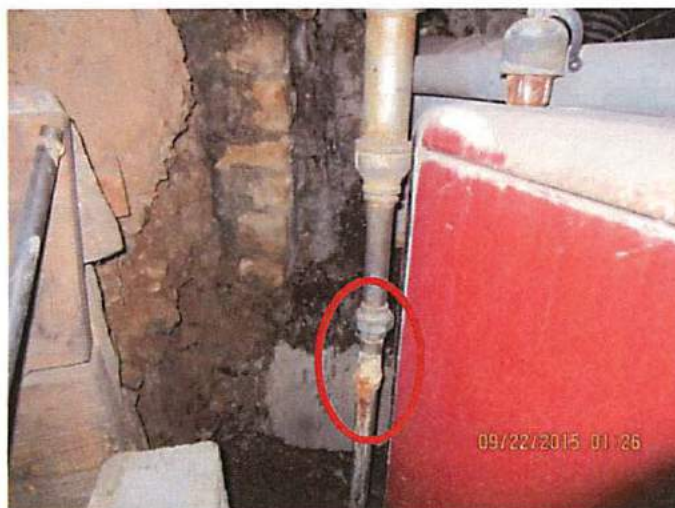
**Photo 9** Gas line shows decay and deterioration needs to be shut off ASAP

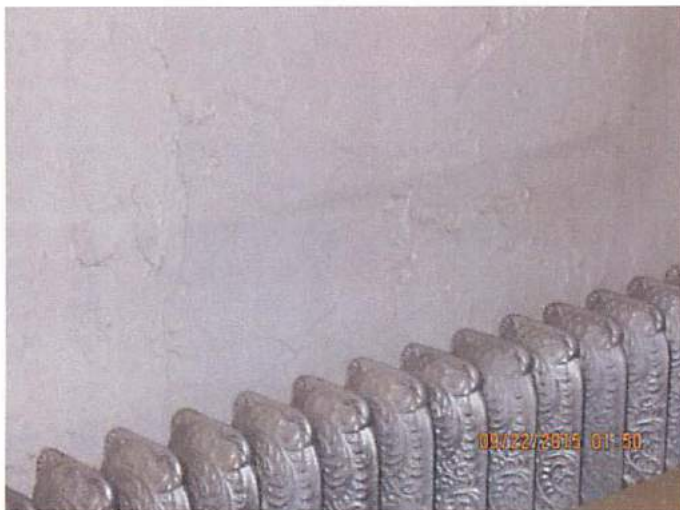
**Photo 12** Example of the radiator heating system that uses the boiler to heat the building

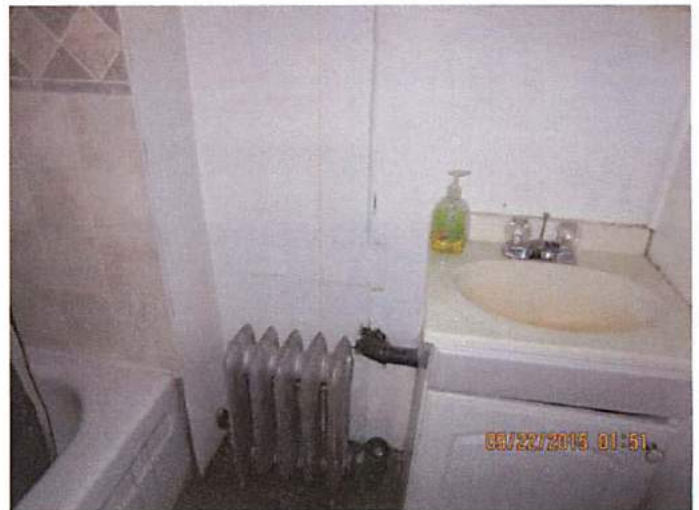
**Photo 13** Example of the radiator heating system that uses the boiler to heat the building

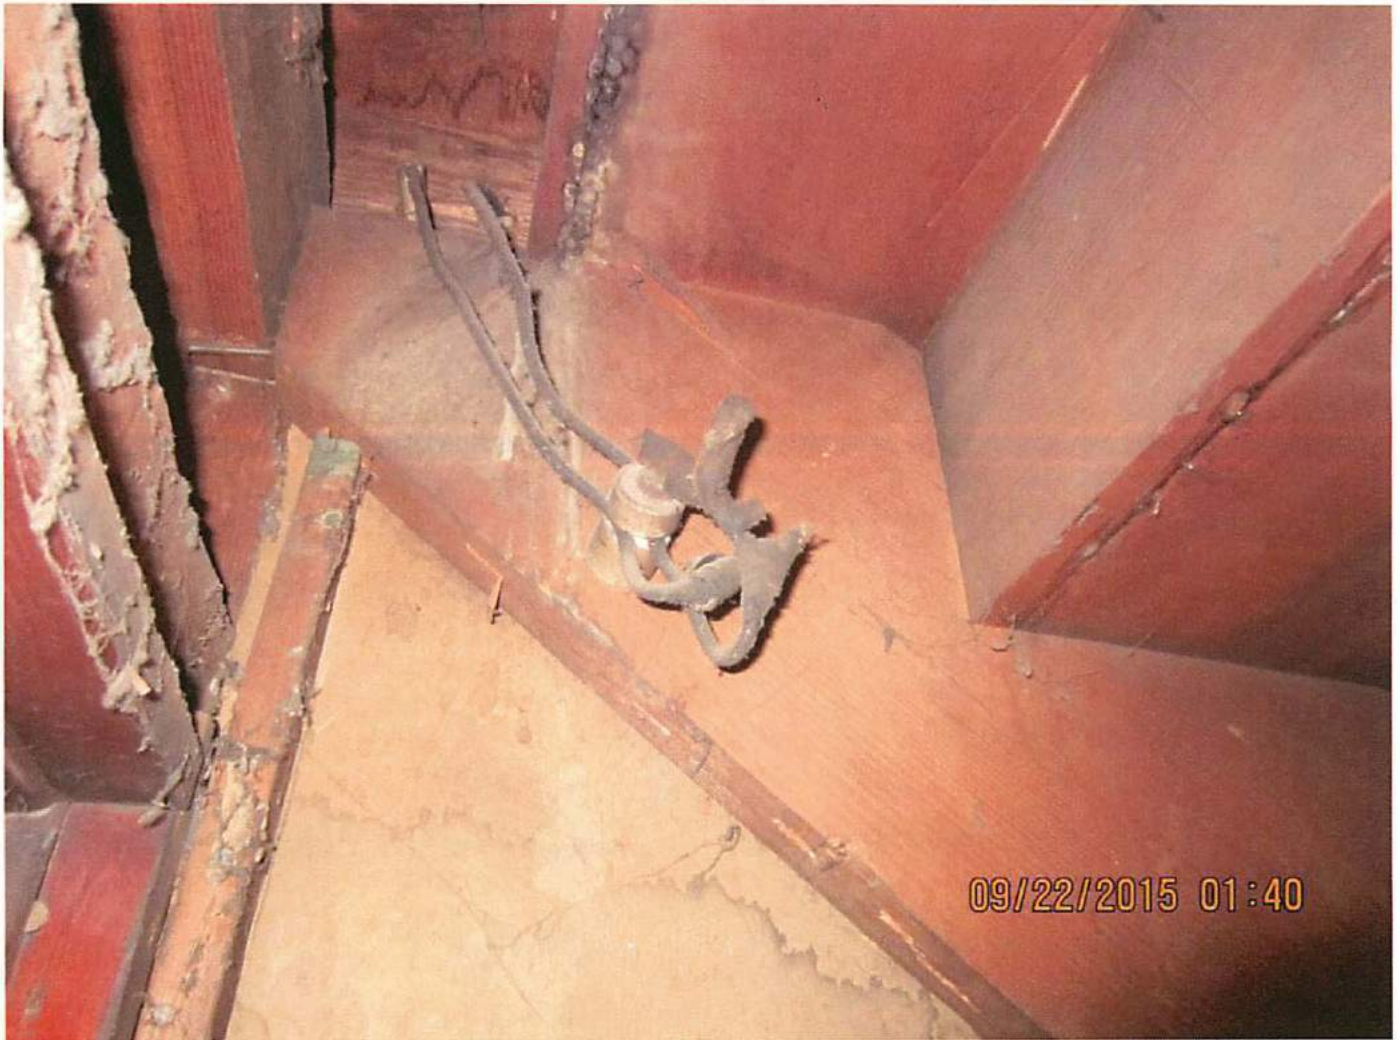
**Photo 14** Knob and tube electrical is located throughout the building. Knob and tube type wiring is classified as a possible health, life and safety concern if not properly maintained. It is common practice and a requirement of the electrical code to remove knob and tube wiring if any portion of the building is upgraded with newer electrical wiring. The building shows numerous upgrades in wiring and electrical upgrades, such as electrical panels, breakers, outlets and lighting. The knob and tube may not be able to support the current electrical upgrades in a safe manner and may be a fire concern. An electrical engineer needs to evaluate the electrical for the entire building before the electricity is turned on.

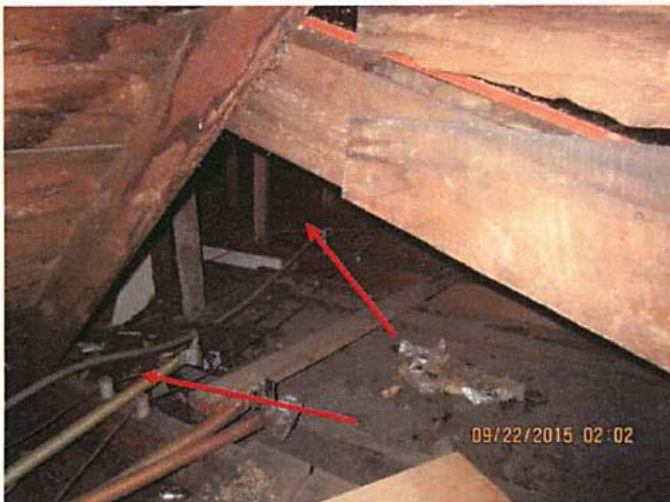
**Photo 15** Knob and tube wiring located throughout the attic area

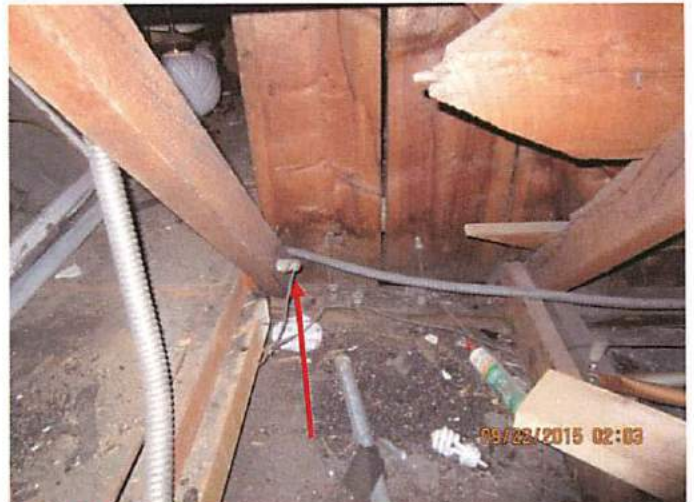
**Photo 16** Knob and tube wiring located throughout the attic area

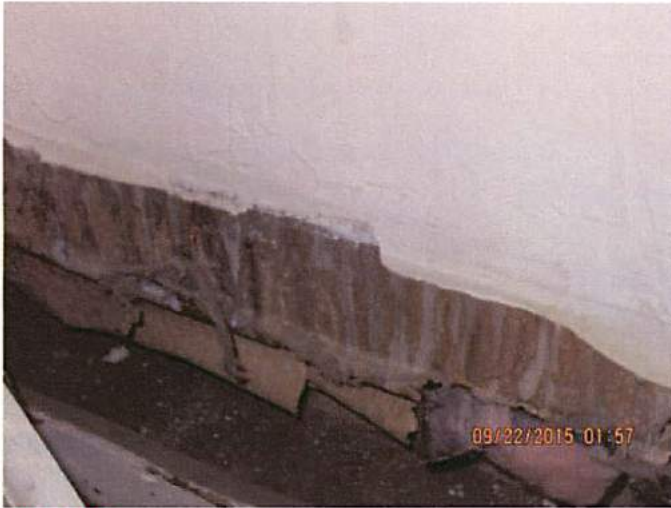
**Photo 22** Decay and deterioration noted throughout the building, cause appears to be lack of proper maintenance and infiltration of water from damaged roof

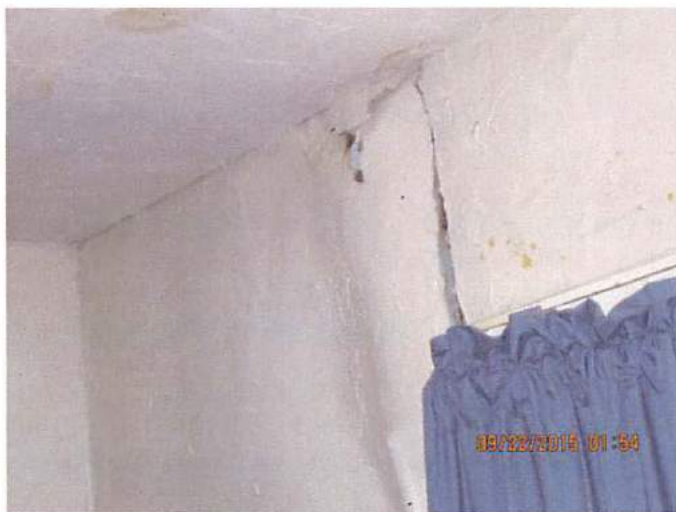
**Photo 24** Decay and deterioration noted throughout the building, cause appears to be lack of proper maintenance and infiltration of water from damaged roof

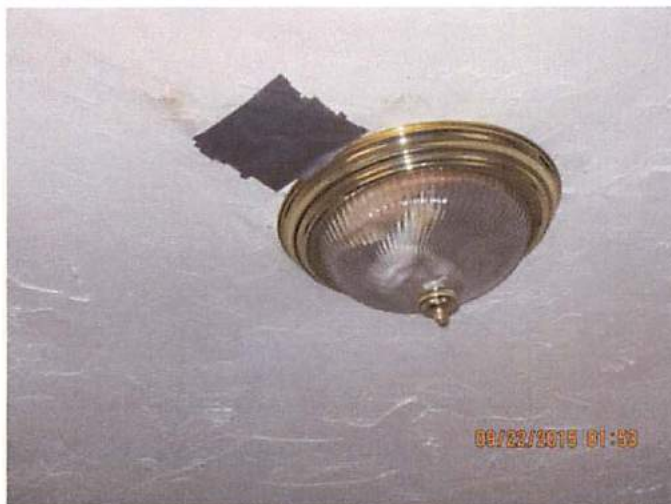
**Photo 26** Tape being used to cove water damage next to electrical outlet that feeds light

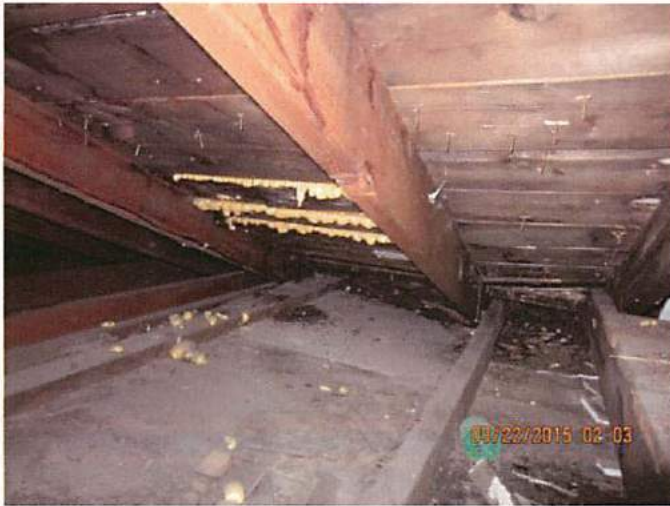
**Photo 28** Roof leaks being repaired with a product that is not designed for such use

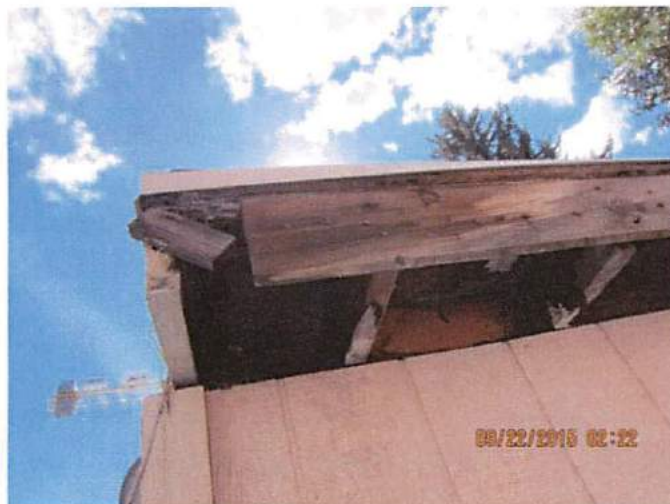
**Photo 32** Roof shows sign of decay and rot damage, soffit and fascia are missing, possible location of water infiltration

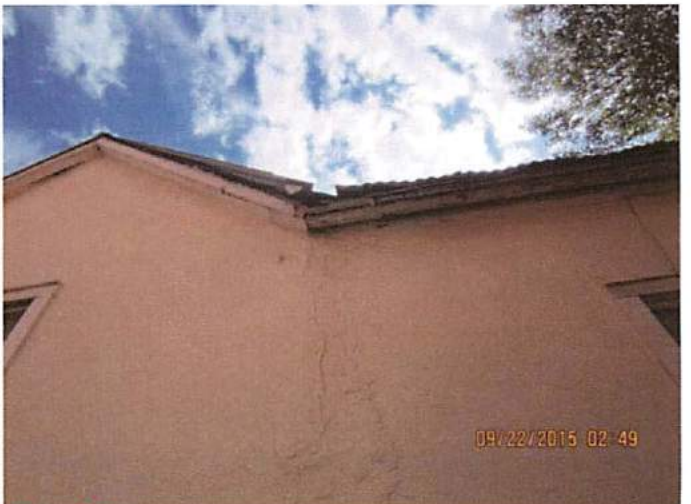
**Photo 33** Structural concerns possibly related to the drainage from the roof

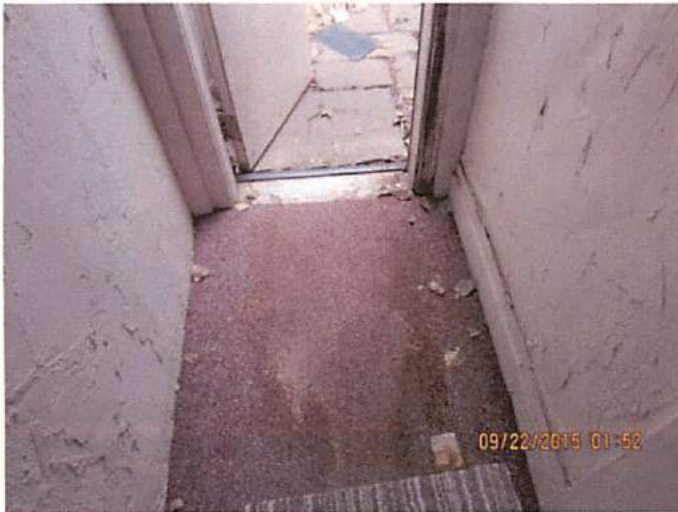
**Photo 35** Egress from the back of the dwelling serving 50% of 8 units or 22 occupants cannot be used. Gates are locked to prevent escape and no safe access to the front of the building is provided. Limited egress, direct violation of the fire code for egress requirements for type R-3 buildings and occupant load

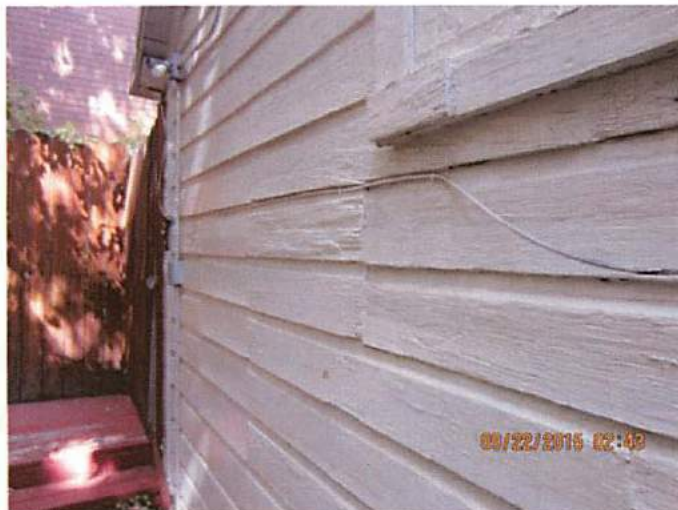
**Photo 37** Egress path rear of building. No access to safe location

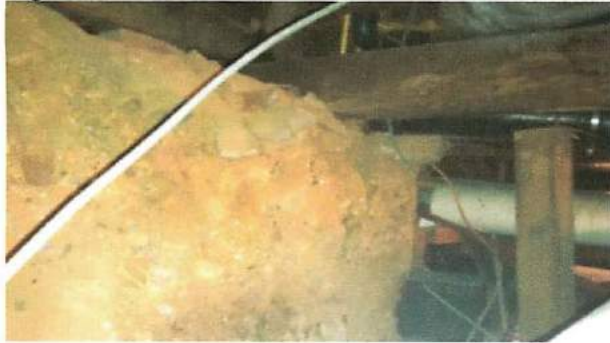
**Figure 2 – Foundation Conditions**

The original floor framing of the structure can be viewed at the basement level at the rear of the existing restaurant. The floor framing consists of 2 x 8 members @ 16" o.c. that are supported by intermediate 4 x 4 beams. The beams are supported by 4 x 4 posts approximately 12 feet apart. The posts do not bear onto footings, but onto the soil. I could not find evidence of a foundation around the perimeter of the structure. There are 2 x boards laid horizontal with vertical supports used to prevent soil from falling into the storage area. From my observations I could not find evidence of a stone or concrete foundation.

The floor framing was constructed directly onto soil and leveled using stone or wood shims. As seen in figure 1 the beams and joists are supported onto the soil.

The existing soil consisted mostly of bedrock or large boulders that were held firmly into place. There were sump pumps located at the two storage rooms in the basement that most likely are in place to de-water the areas during spring run-off. There was no evidence of a concrete floor in the basement area. As seen in Figure 1 the lower level was used as a parking garage. Since the area is now a restaurant floor covering was placed over the floor. It appears the floor covering was placed directly over the soil due to the un-even floor which varied substantially in height.

There is a very high liability risk associated with this property for the building owner and for the building tenants. It is my professional opinion that the building should be demolished and re-constructed. The design life of the existing building has been exceeded. Improper construction techniques and methods were used in the buildings original construction. It is not cost effective to try and correct the structural problems outlined in this report by leaving the existing structure in place. In order for the building to be used as a hotel it should comply with all of the current life safety and structural requirements of the current building code.

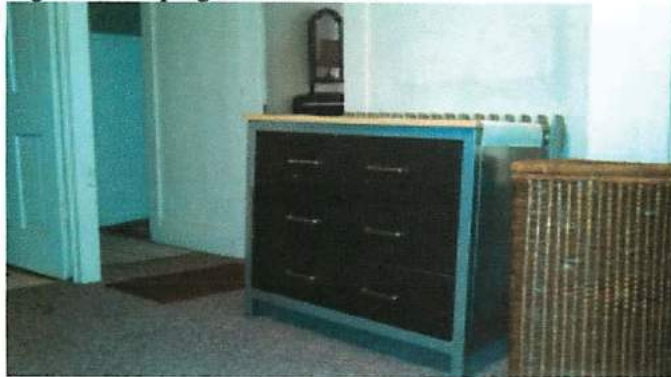
**Figure 3 - Sloping Floors**

The second floor framing of the hotel seems to be consistent with the joist size and direction of the main level. There were defects noticed in the sagging ceiling above and the sloping and un-even floors. The most notable issue with the floor framing is the amount of settlement noticeable towards the North side. Shown in Figure 3 the floor is at the lowest point directly below the wall behind the dresser shown in the photo. This wall supports the roof framing above and most likely is supported onto an inadequately sized beam at the floor framing.

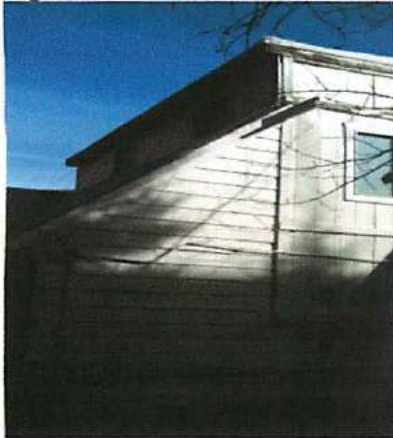
**Figure 4 - Rear Elevation**

The original home had a modification to add a 3<sup>rd</sup> and 4<sup>th</sup> level. It is not known when this remodel occurred. As seen in Figure 4, the outline of the modification can be seen. It appears the original roof was interrupted by adding exterior walls that were supported onto the floor framing of the 2<sup>nd</sup> level to allow space to be captured in the original attic. Notice the outline as defined by the horizontal siding where it intersects the vertical siding. The roof above the 4<sup>th</sup> level is a flat roof that is supported by the exterior walls. This added additional load to the floor framing by as seen in Figure 3 causing the deflection of the floor joists / beams.
